Informal document No. GRSG-90-30 (90th GRSG, 24-28 April 2006 agenda item 1.4.7.)

FRONTAL COLLISION BUSES AND COACHES. RESEARCH AND PROBLEMS

APSN Workshop on Bus and Truck Passive Safety

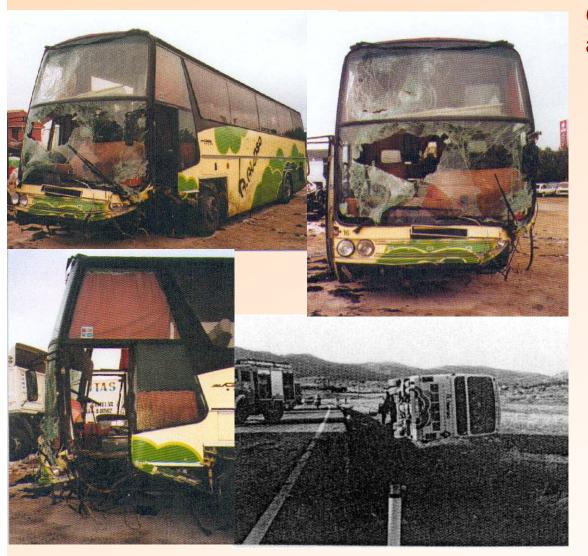
Frontal – Rollover

A car crashes semi-frontally with the bus while finishing a wrong overtake. Finally the coach left the road and rolled over 90 degrees, standing on its right side.

The right side of the bus damaged because of the rollover. The left front corner was badly damaged because of the impact with the car.

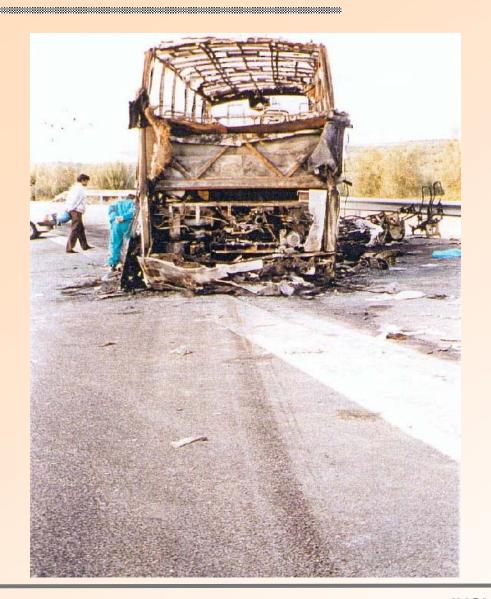
Frontal (Bus) and Frontal (Car)

The coach was driving by a dual carriage way, in a left curve. A car crashes frontally (40% offset) into the bus, at 130kph, and reaches coach fuel tank. Coach starts burning.

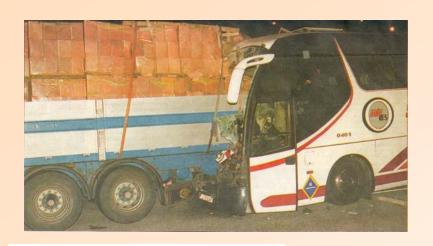
Collision – Frontal (Bus) and Rear (Opponent)

The coach was driving by a motorway, when crashed (65% offset) against the rear part of a truck,

Height(m)	Intrusión (mm)			
0.4	0			
0.6	553			
0.8	661			
1	899			
1.2	1164			
1.4	1148			
1.6	1089			
1.8	872
