RibEye for WorldSID 50th

February 16, 2011

Original WorldSID RibEYE, Model 8700

New WorldSID RibEye, Model 10000

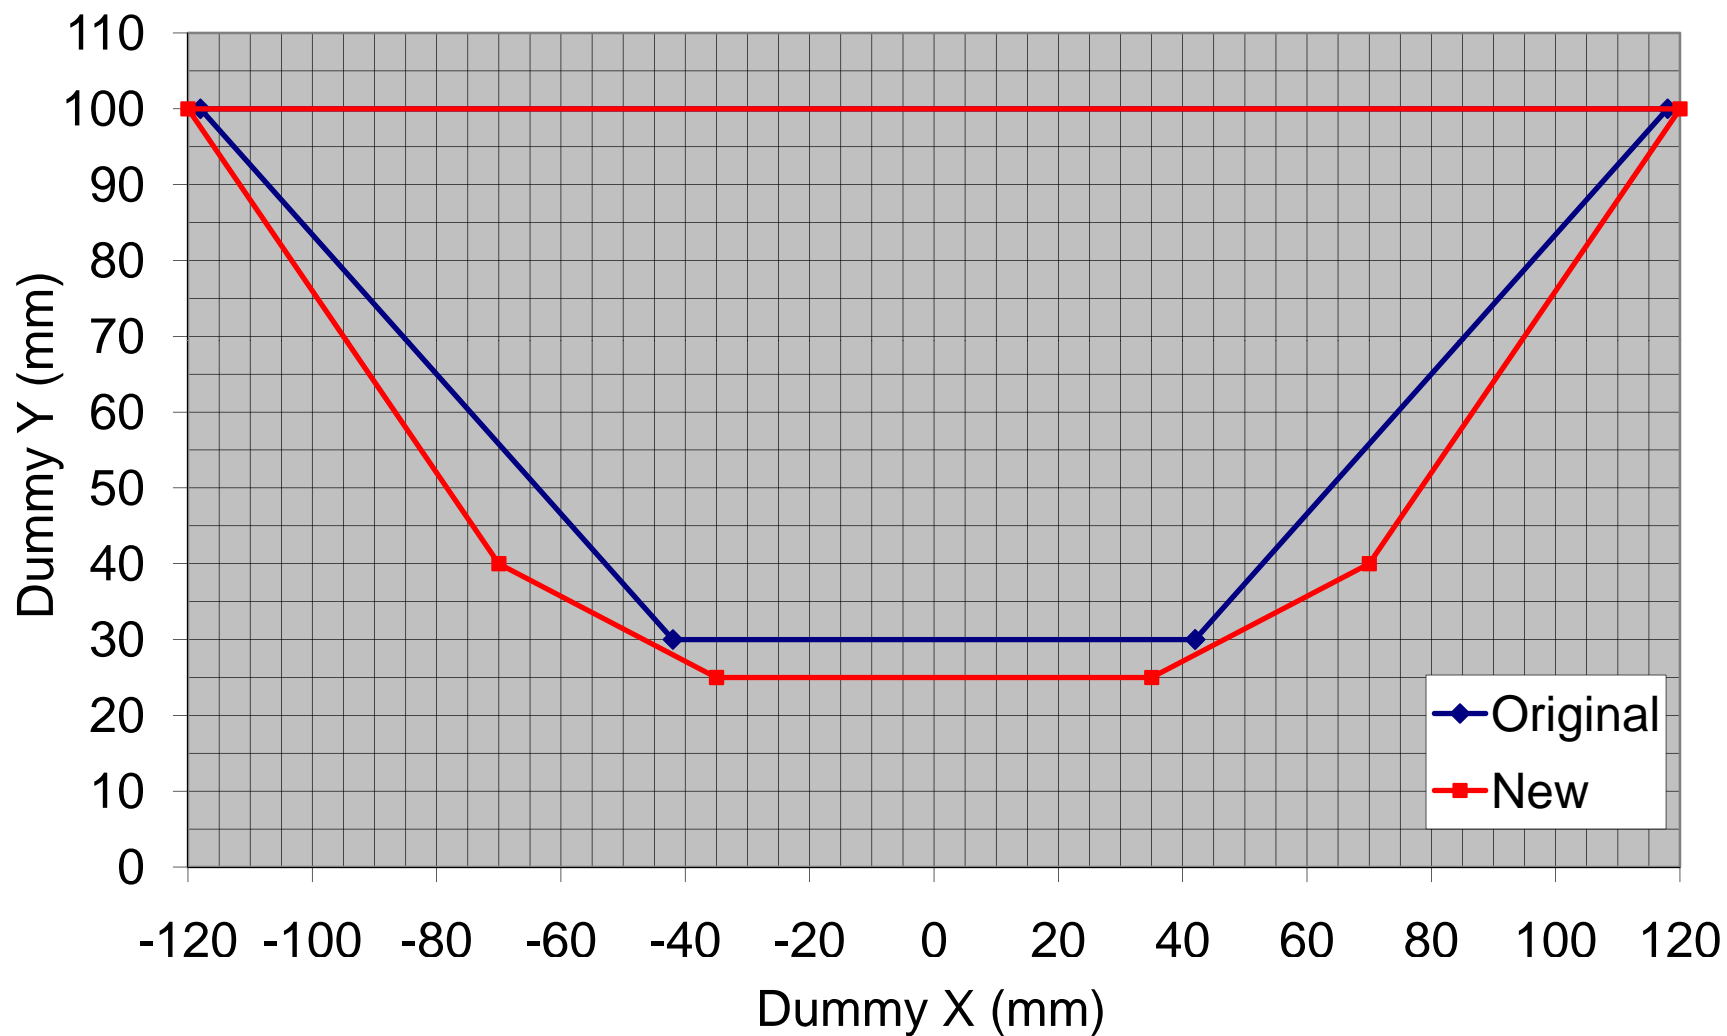
XY Range for all ribs for Y and Z error <1 mm, X error <2 mm

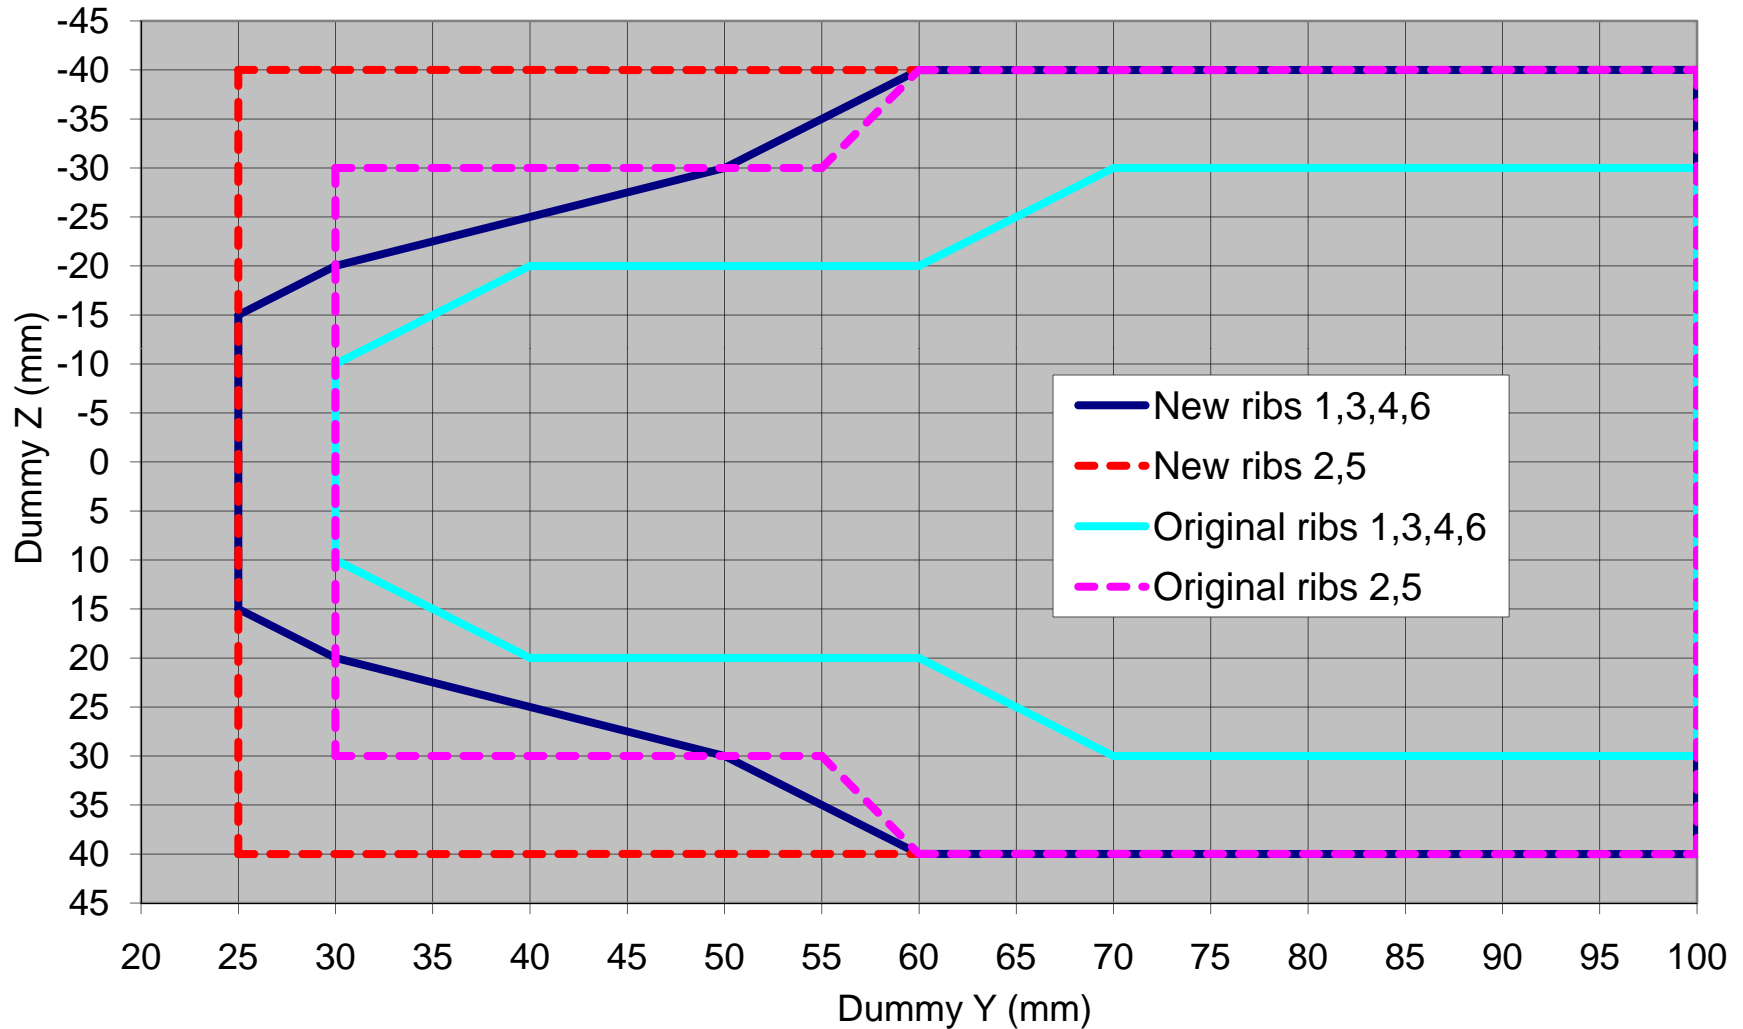
New and Original Y-Z Range for Y and Z errors <1 mm, X errors < 2 mm

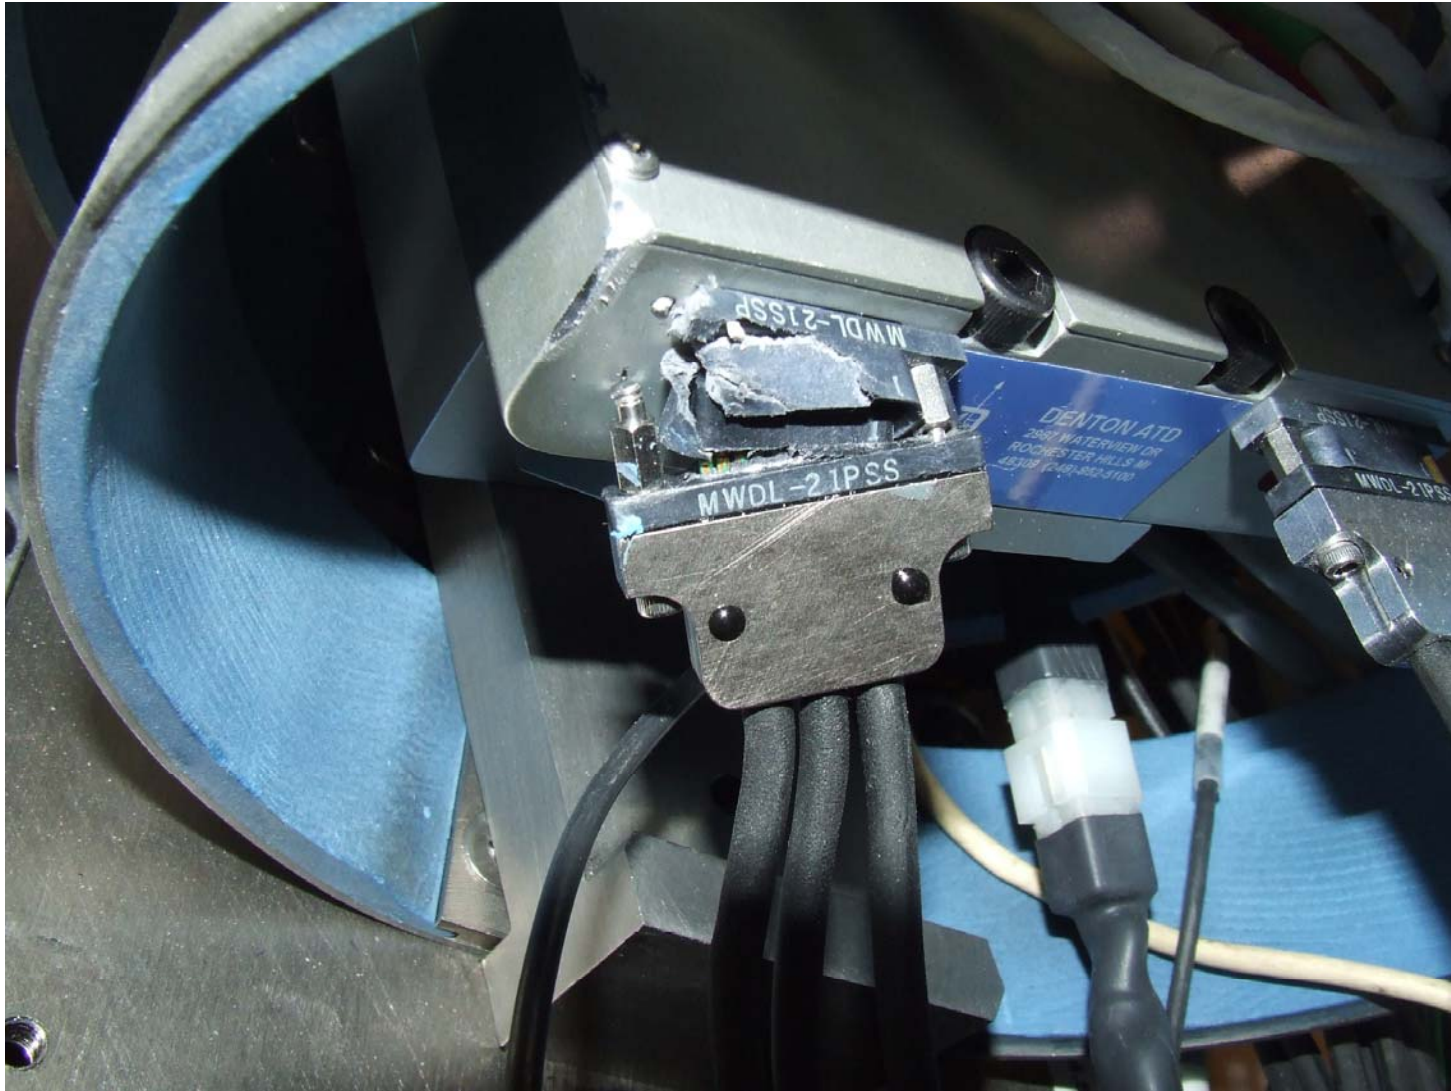
Bottom of thorax, non-struck side

Sensor input connector damage

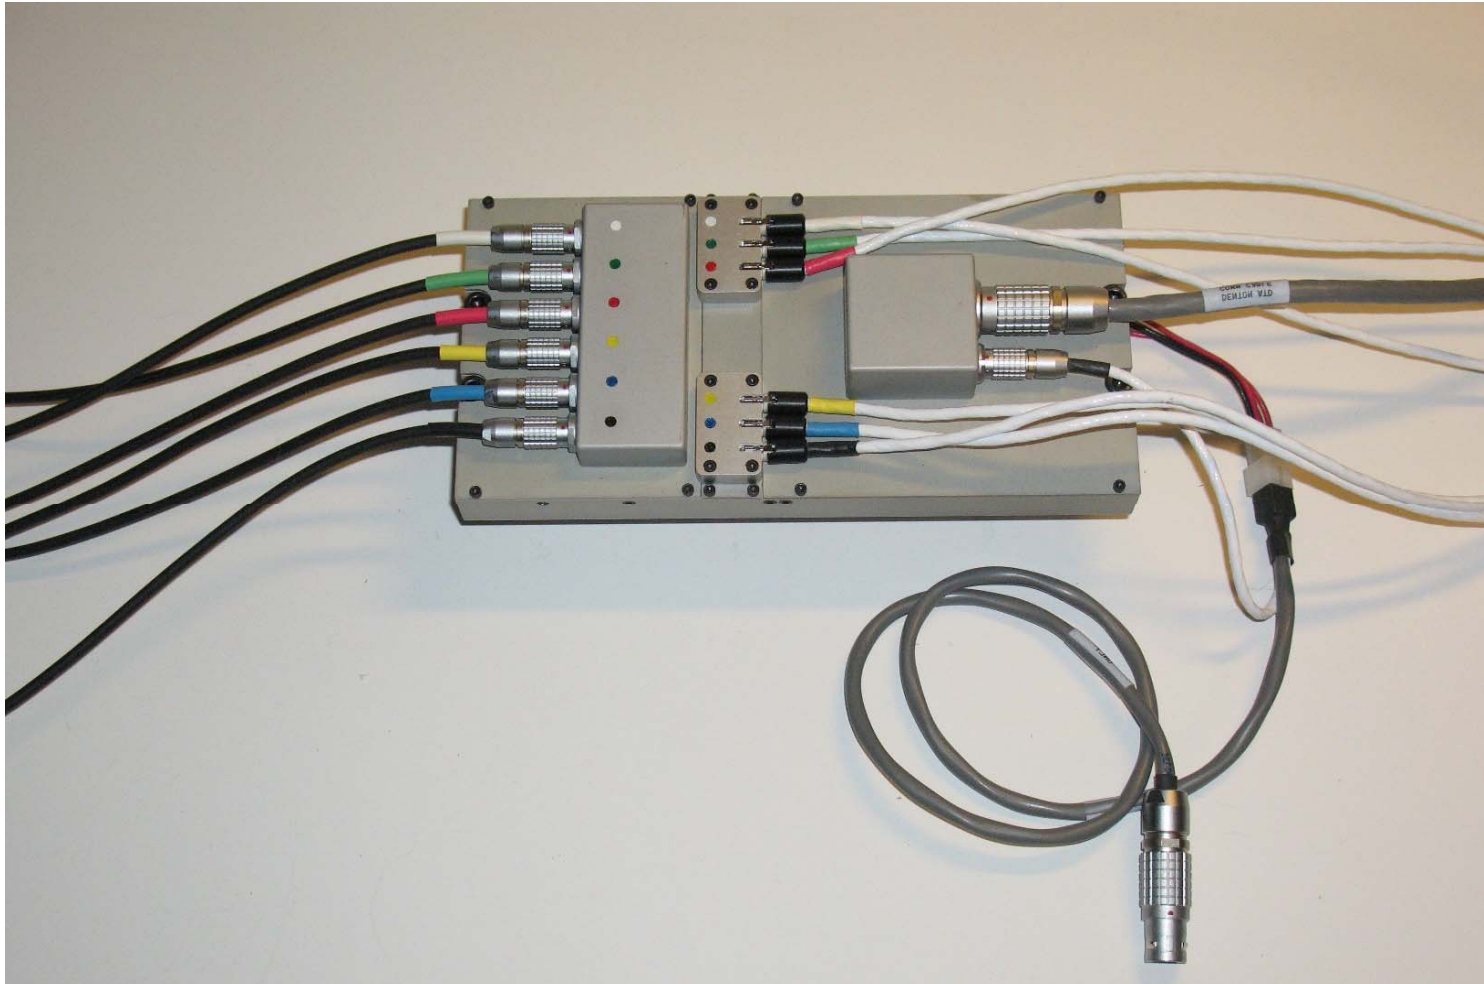
Control enclosure with connectors installed

- Increased range
 - LED and sensor angles optimized
 - LEDs relocated on rib mounting blocks
 - Mounting block thickness minimized
 - Updated electronics with improved LED current control
- Improved durability:
 - Sensor connectors relocated on controller
 - Sensor lenses bonded in position
- Firmware improvements

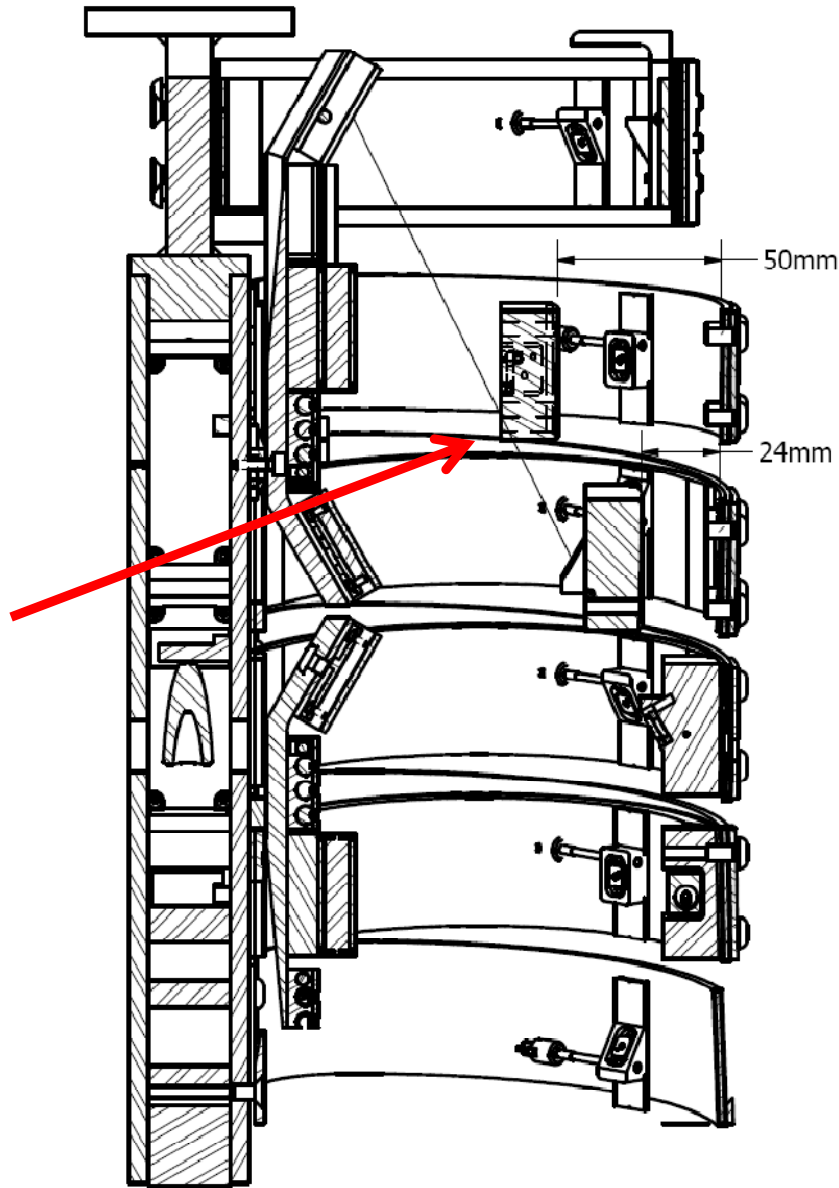
Model 8700 Middle Rib (Thorax 1 and Abdominal 1) Interference

Middle Rib
LED can
block light
path

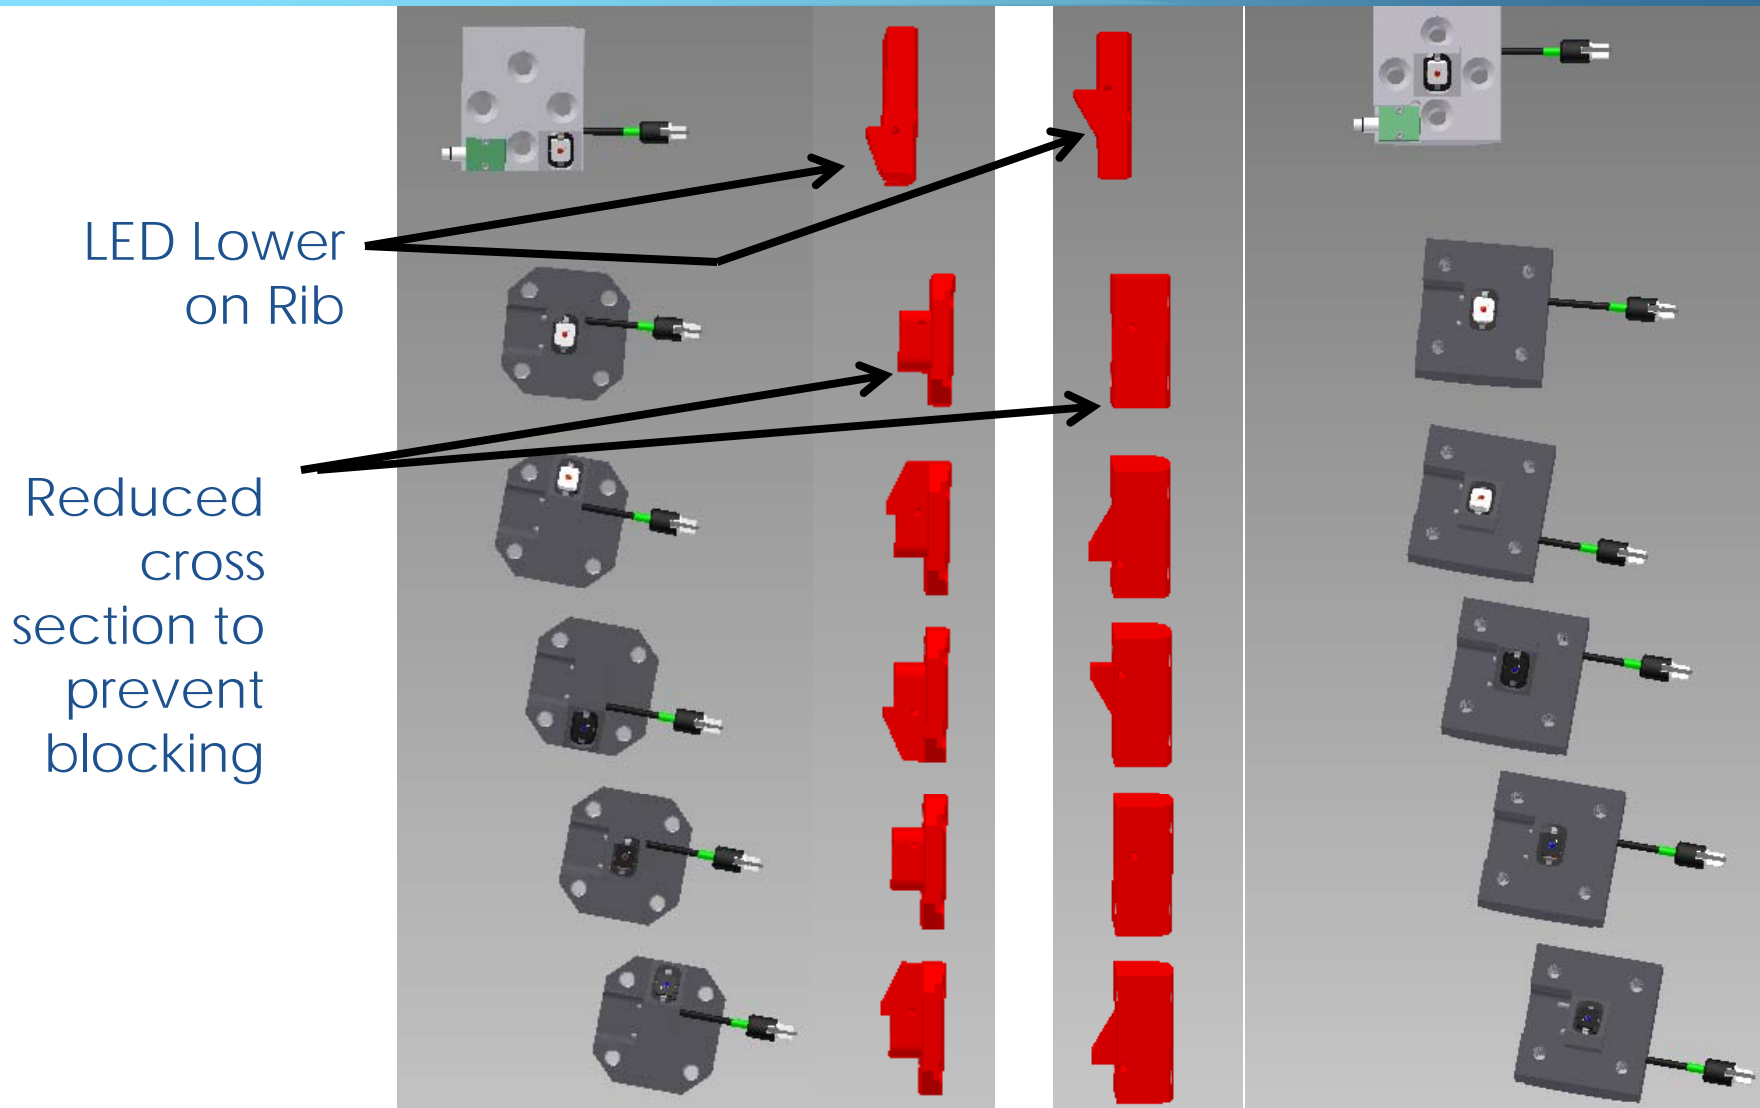
Improved LED Housings
