SFBM S.p.A.

Specific tests on CNG4 cylinders

Provider 2

Doc. No. 19500-R Rev. 2 – March 2018

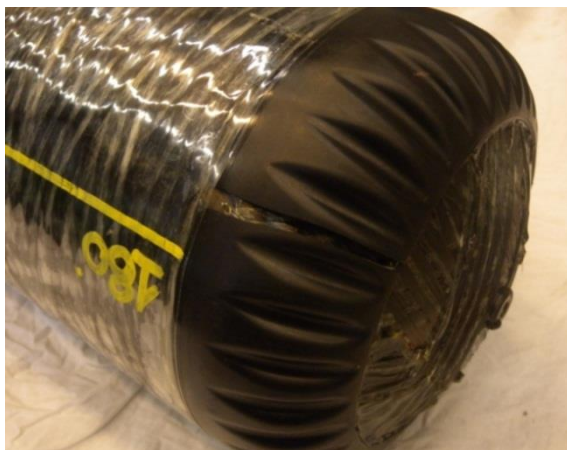
Figure 1-3: Damaged dome – Cylinder 1

Some cylinders showed the protection dome of the capped side damaged. In particular, the damage consisted in a fracture of the dome (from Figure 1-3 to Figure 1-8).

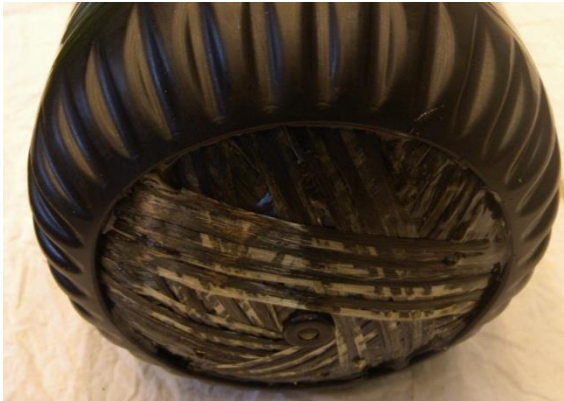
- ✓ exposed fibers in the dome of the capped side of cylinder 3 (Figure 1-9);
- ✓ exposed and frayed fibers on both side domes of cylinder 5 (Figure 1-10 and Figure 1-11);
- ✓ partially exposed fibers for cylinder 12 (Figure 1-12).

Figure 1-9: Exposed fibers – Cylinder 3

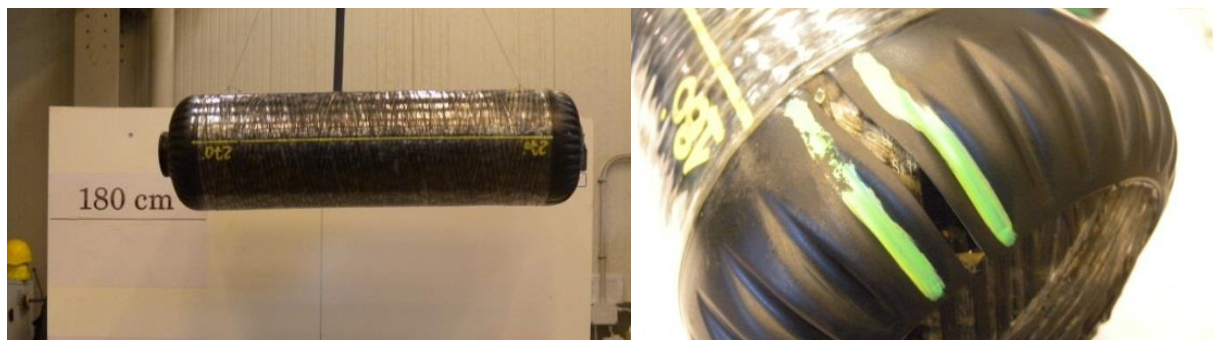
Cylinder 1 was horizontally drop tested on the 180° generatrix. After the test, an increment of the initial fracture on the dome of the capped side was observed, as shown in Figure 3-1.

Figure 3-1: Horizontal drop test and dome damage – Cylinder 1

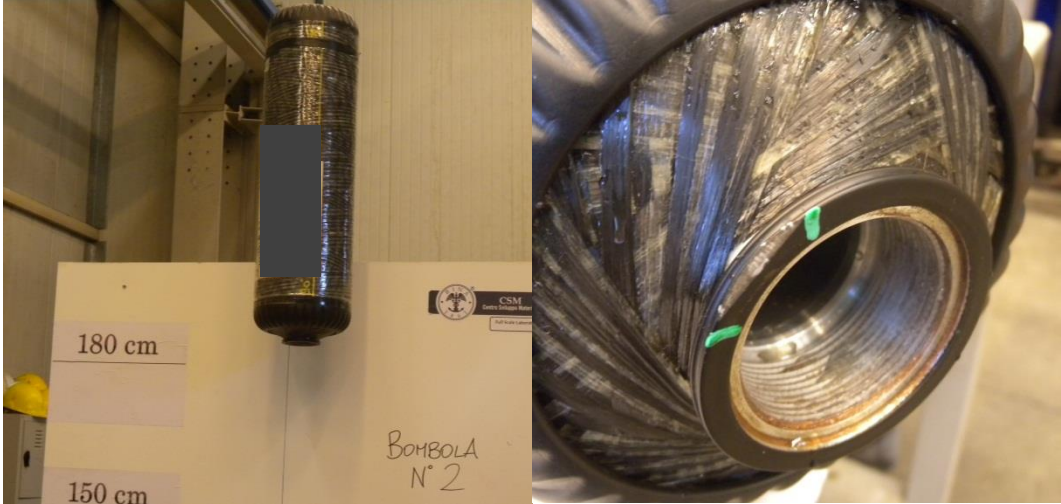
Cylinder 2 was vertically drop tested on both sides. After the test on the valve side, an abrasion of the border of the cylinder connection was observed, as shown in Figure 3-2. The test on the capped side produced an abrasion of the fibers close to the cap, as reported in Figure 3-3.

Figure 3-2: Connection abrasion after vertical drop – Cylinder 2

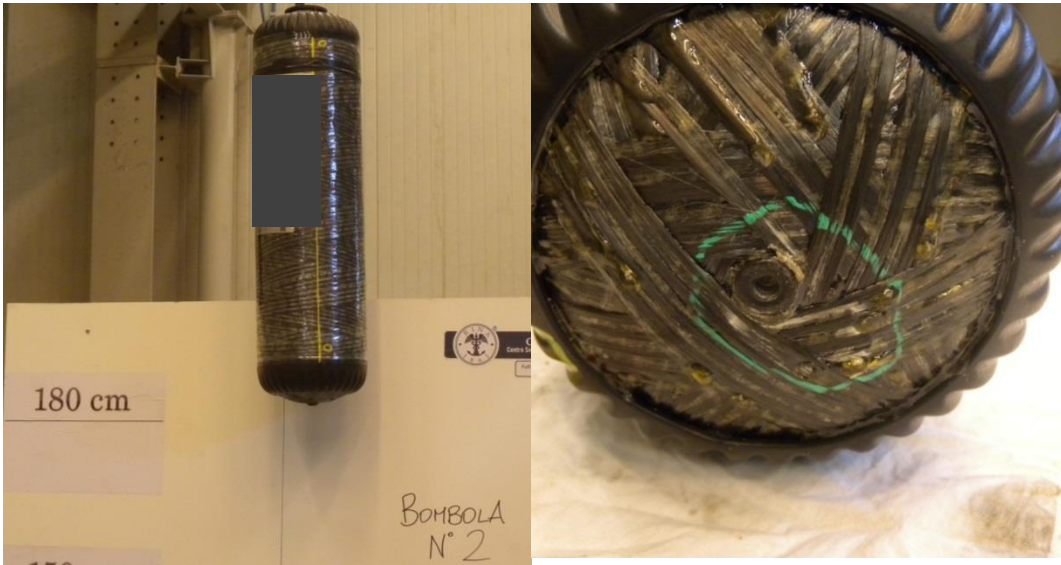
Figure 3-3: Fibers abrasion after vertical drop on capped side – Cylinder 2

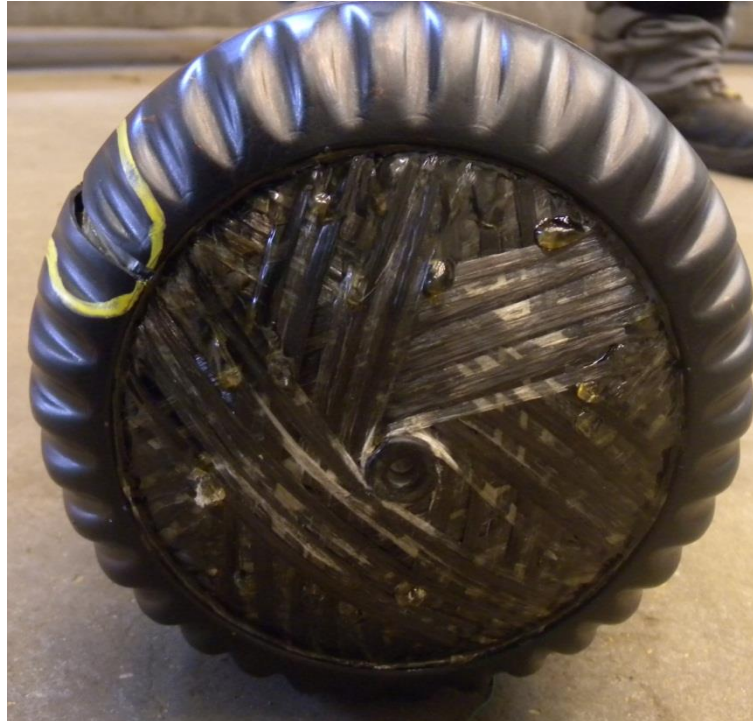
Cylinder 6 was vertically drop tested on both sides (Figure 3-7). The test on the capped side produced an abrasion of the fibers as reported in Figure 3-8; the test on the valve side showed an abrasion of the border of the cylinder connection, as shown in Figure 3-9.

Figure 3-8: Fibers abrasion on the dome after vertical drop, capped side – Cylinder 6

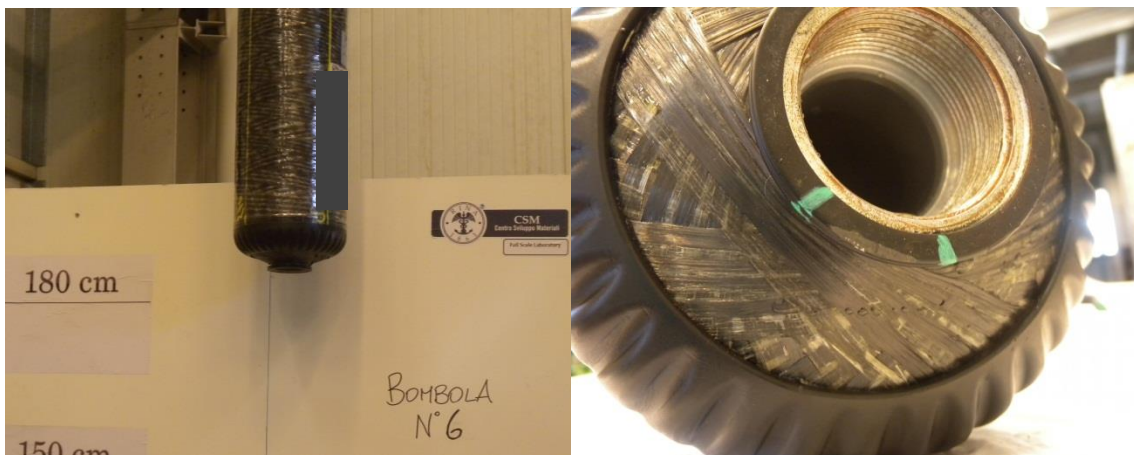
Figure 3-9: Connection abrasion on the valve side after vertical drop – Cylinder 6

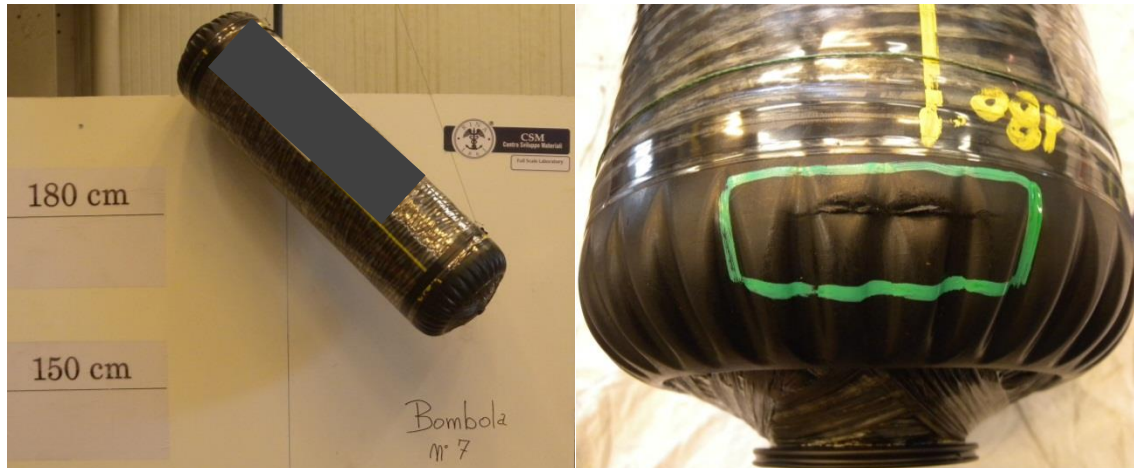
Cylinder 7 was 45° angle drop tested on capped side. Visual inspection after the test showed a damage on the dome of the valve side due to a cylinder rebound (Figure 3-10).

Figure 3-10: Damage after 45° angle drop on the capped side and subsequent rebound – Cylinder 7

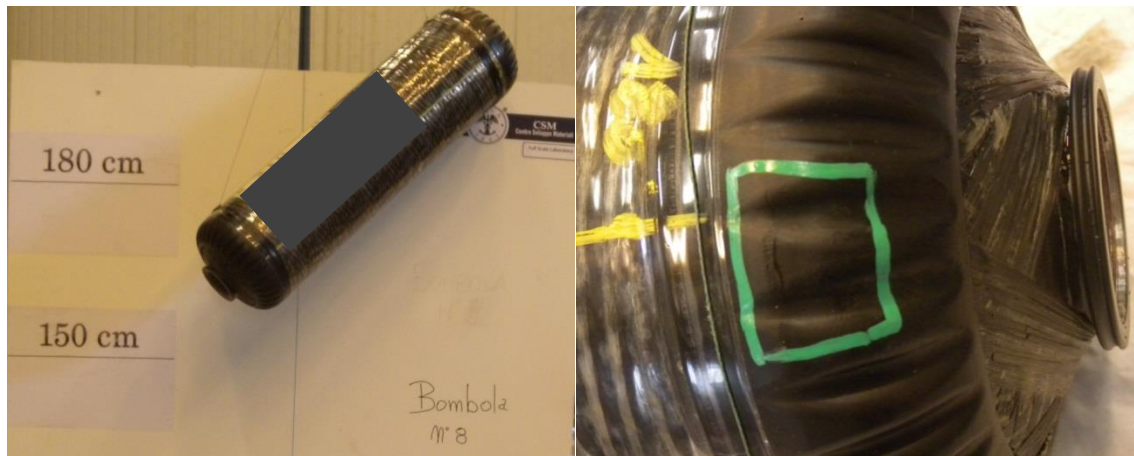
Cylinder 8 was 45° angle drop tested on valve side. Visual inspection after the test showed a damage on the dome of the valve side (Figure 3-11).

Figure 3-11: Damage on the dome after 45° angle drop on the valve side – Cylinder 8

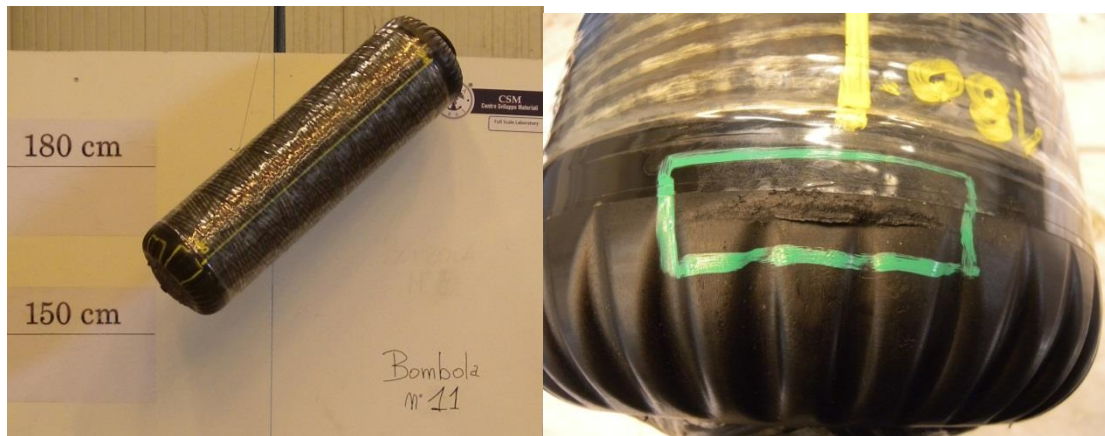
Cylinder 11 was 45° angle drop tested on capped side. Visual inspection after the test showed a damage on the dome of the valve side due to a cylinder rebound (Figure 3-15).

Figure 3-15: Damage after 45° angle drop on the capped side and subsequent rebound – Cylinder 11

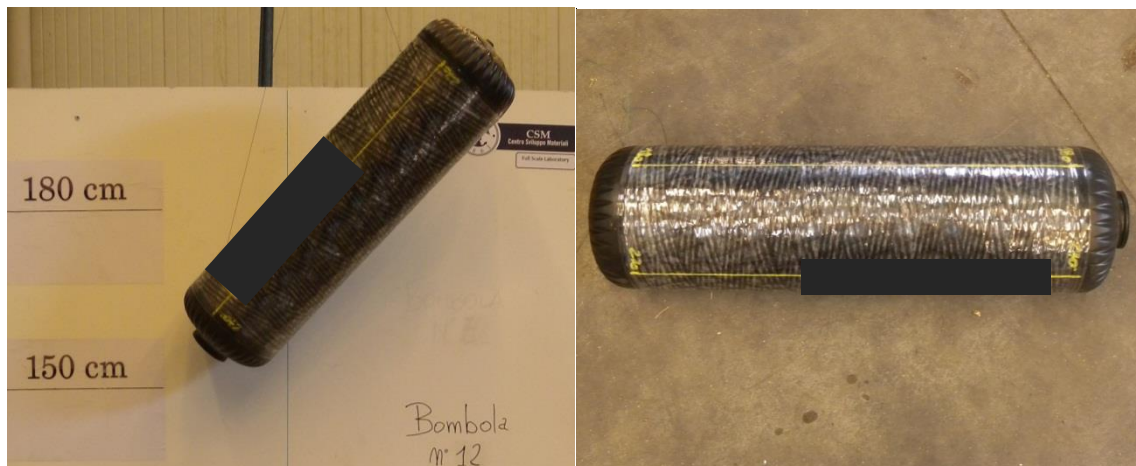
Cylinder 12 was 45° angle drop tested on valve side (Figure 3-16). Visual inspection after the test showed a damage on the dome of the valve side due to a cylinder rebound.

Figure 3-16: 45° angle drop on the valve side – Cylinder 12

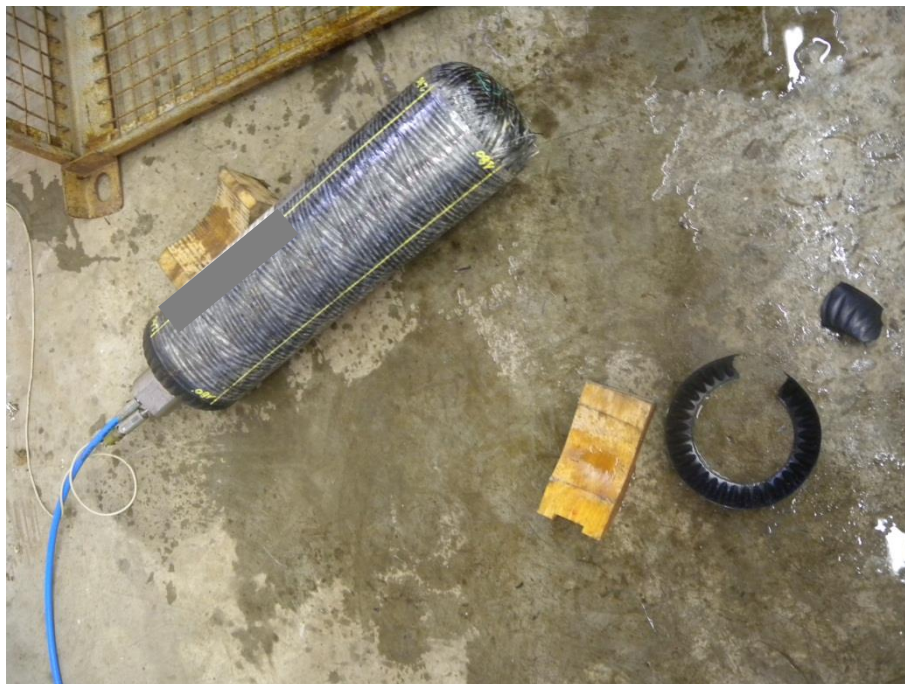
In the cylinder 3 the failure occurred in the dome area on the capped side, as shown in Figure 4-13. This area corresponds to the area where the first impact occurred during the drop test.

Figure 4-13: Cylinder 3 blown up during the second hydraulic test

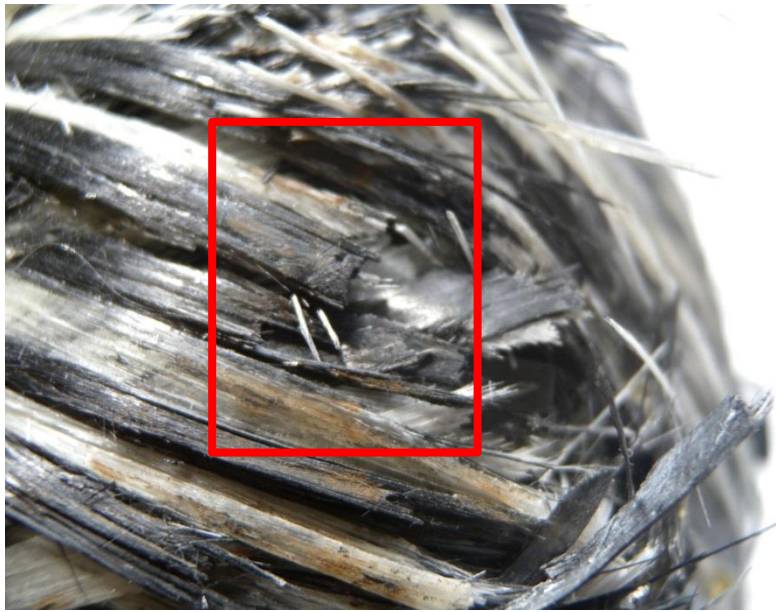
- ✓ in the impact area the fibers are sharply truncated as shown in Figure 4-14;
- ✓ in the area close to the impact the fibers are frayed as shown in Figure 4-15.

Figure 4-14: Detail of sharply truncated fibers after the second hydraulic test- Cylinder 3

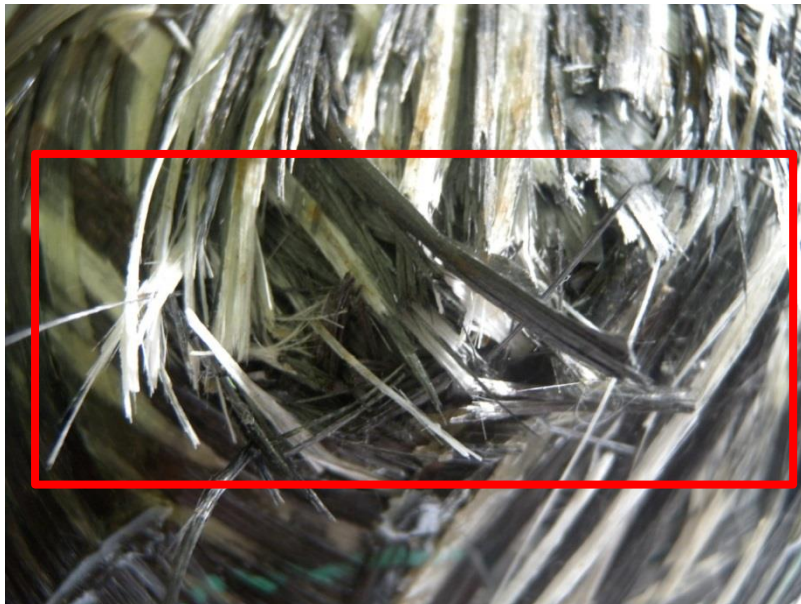
Figure 4-15: Detail of frayed fibers after the second hydraulic test - Cylinder 3

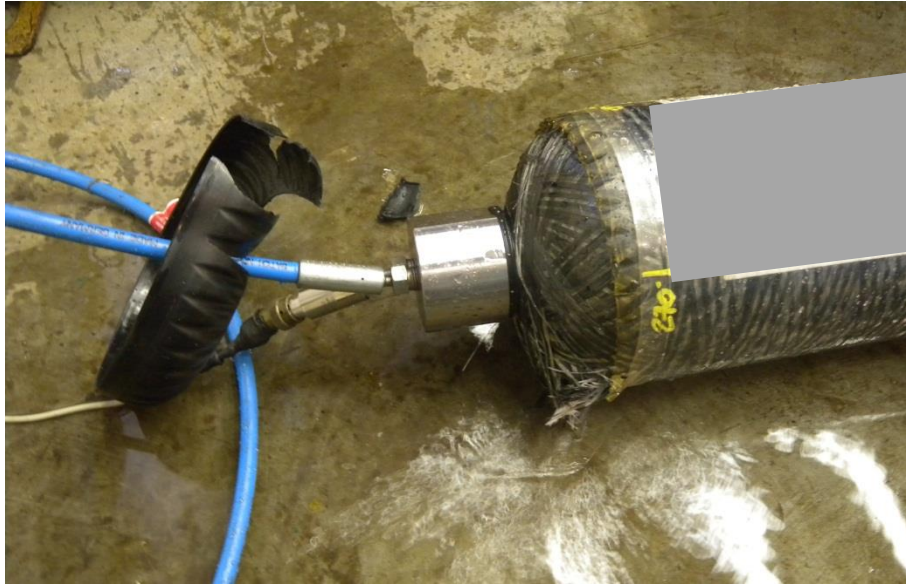
In the cylinder 8 the failure occurred in the dome area on the valve side, as shown in Figure 4-16. This area corresponds to the area where the first impact occurred during the drop test.

Figure 4-16: Cylinder 3 blown up during the second hydraulic test

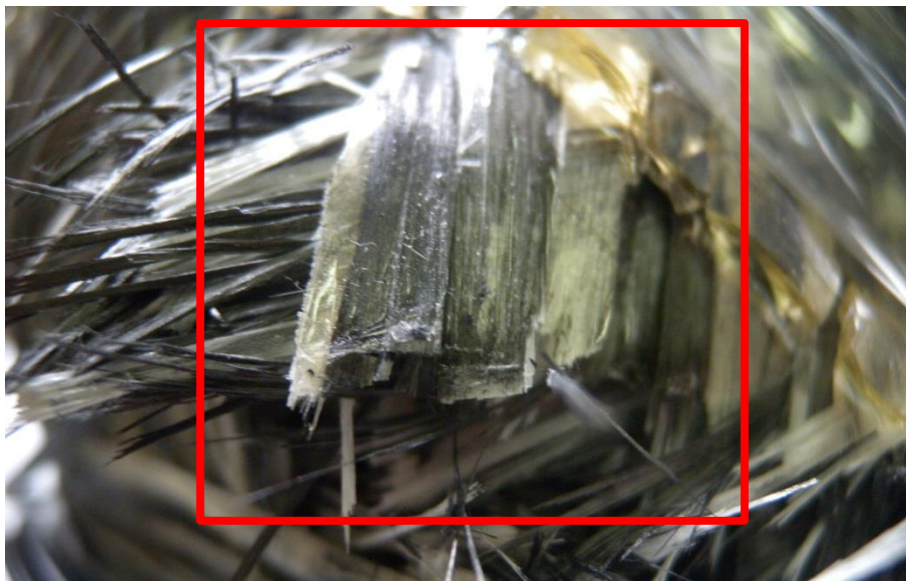
- ✓ in the impact area the fibers are sharply truncated as shown in Figure 4-17;
- ✓ in the area close to the impact the fibers are frayed as shown in Figure 4-18.

Figure 4-17: Detail of sharply truncated fibers after the second hydraulic test- Cylinder 8

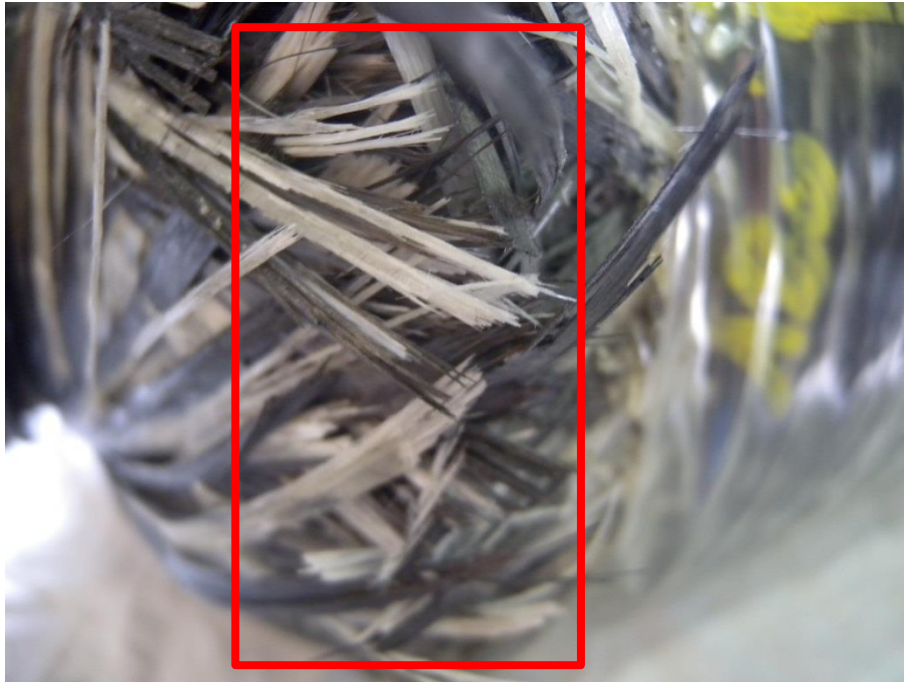
Figure 4-18: Detail of frayed fibers after the second hydraulic test - Cylinder 8

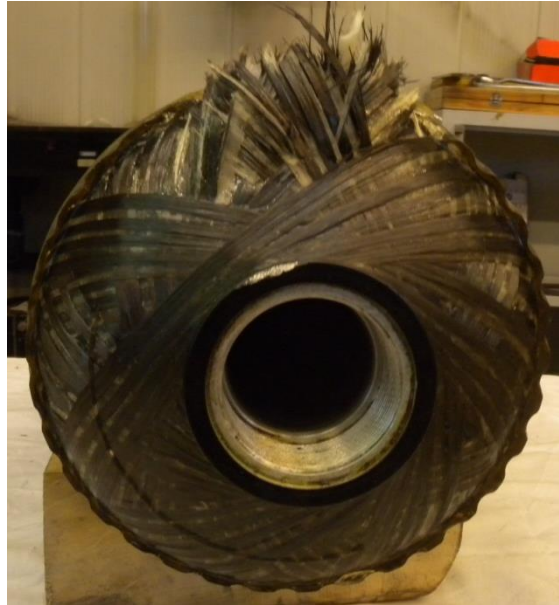
In the cylinder 1 the failure occurred in the dome area on the valve side, as shown in Figure 5-2. This area corresponds to the area where the first impact occurred during the drop test. Failure happened after 1,125 cycles.

Figure 5-2: Cylinder 1 blown up during the fatigue test

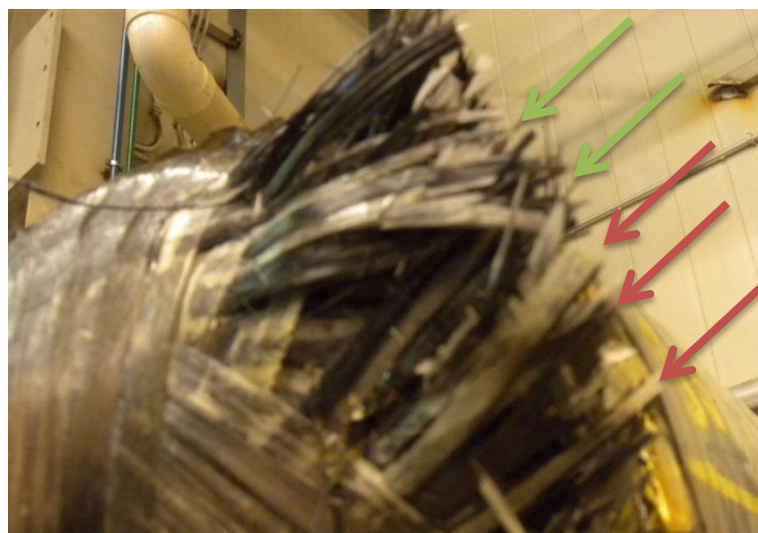
Figure 5-3 shows the two failure mechanisms previously observed. Red arrows indicate the sharply truncated fibers; these fibers are located in the impact area during the drop test (180° generatrix). Close to this area, the green arrows are pointing to the frayed fibers, which have likely been ripped off during the blow up.

Figure 5-3: Cylinder 1 – Details of broken fibers after the fatigue test

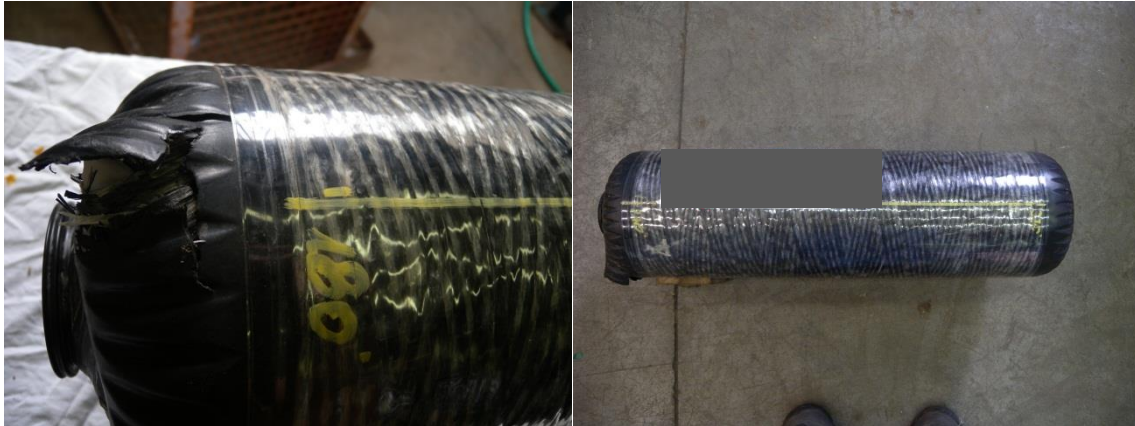
In the cylinder 4 the failure occurred in the dome area on the valve side, as shown in Figure 5-4. This area corresponds to the area where the first impact occurred during the drop test. Failure happened after 615 cycles.

Figure 5-4: Cylinder 4 blown up during the fatigue test

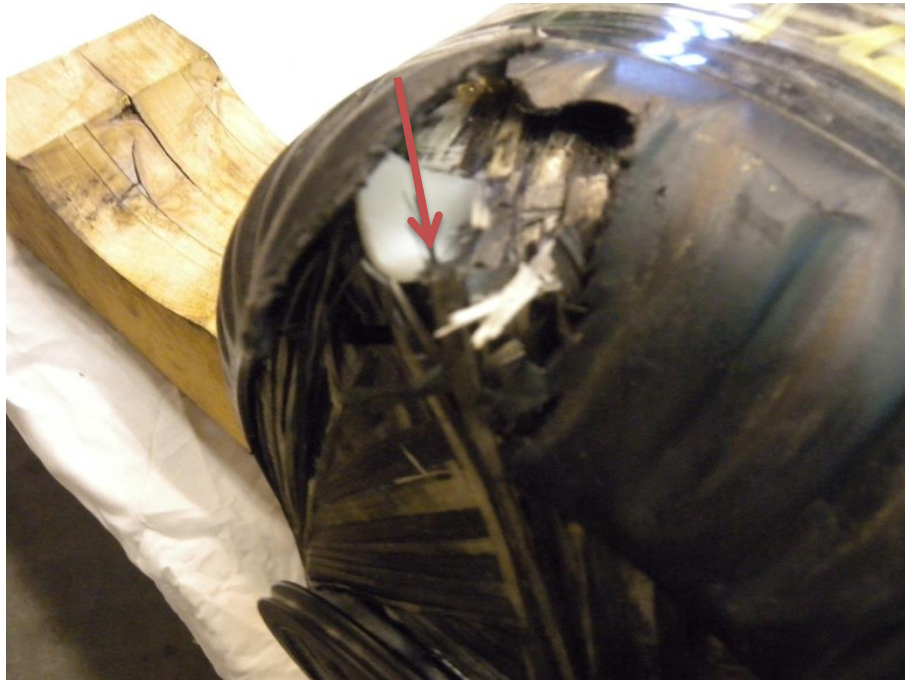
Also in his case it is possible to see the sharply truncated fibers located in the impact area during the drop test (Figure 5-5).

Figure 5-5: Cylinder 4 – Details of broken fibers after the fatigue test

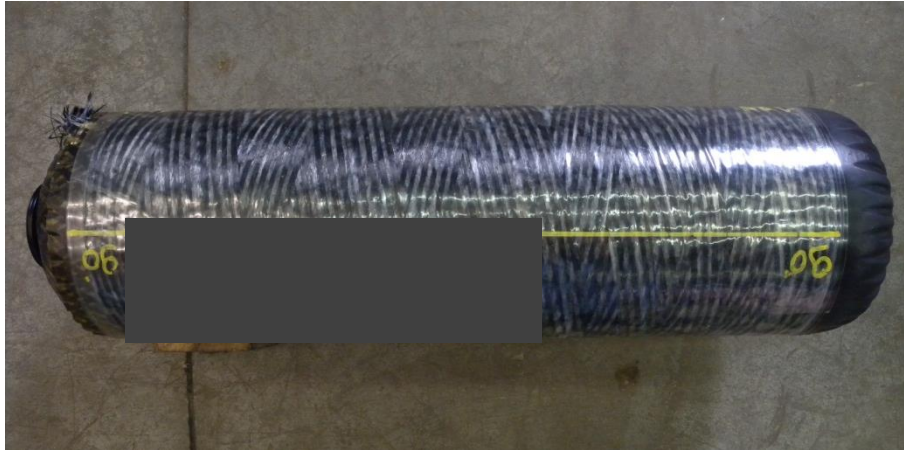
In the cylinder 5 the failure occurred in the dome area on the valve side, as shown in Figure 5-6. This area corresponds to the area where the first impact occurred during the drop test. Failure happened after 120 cycles.

Figure 5-6: Cylinder 5 blown up during the fatigue test

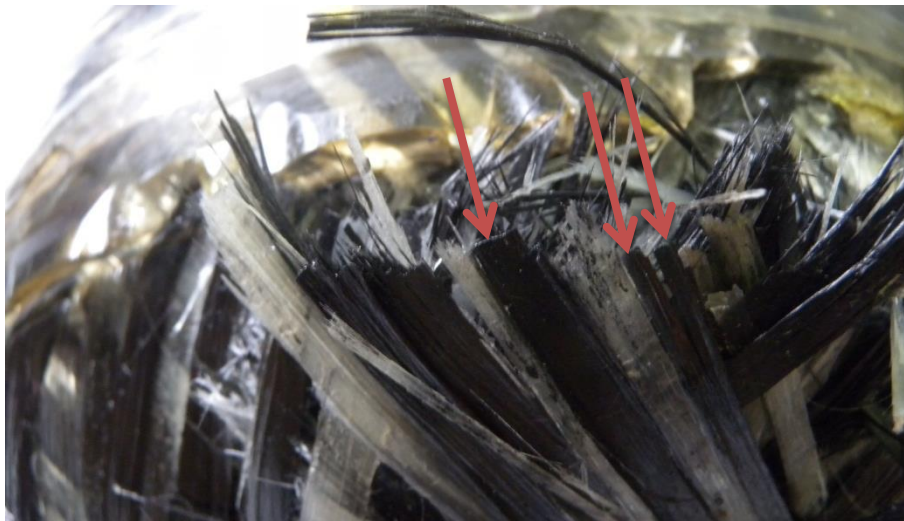
- ✓ in the impact area of the drop test, fibers are sharply truncated (Figure 5-7);
- ✓ in the area close to the impact, fibers are frayed (Figure 5-8).

Figure 5-7: Cylinder 5 – Details of sharply truncated fibers after the fatigue test

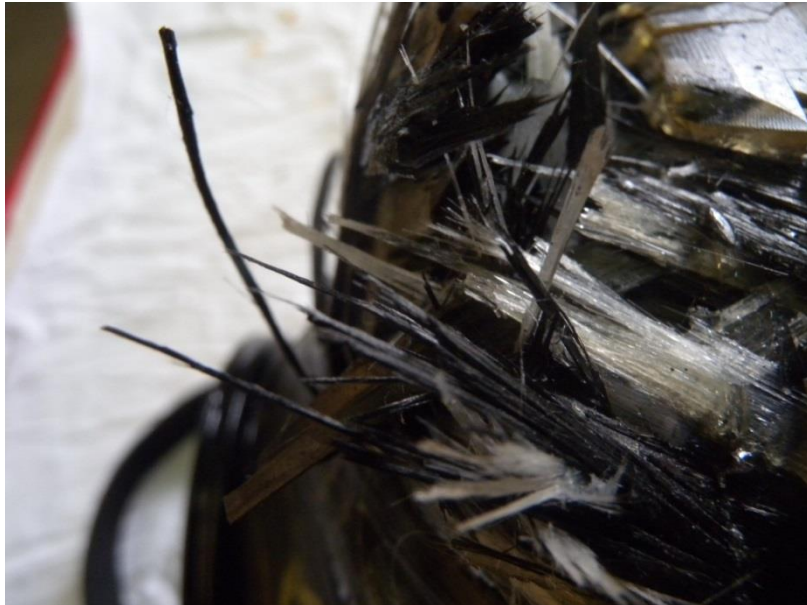
Figure 5-8: Cylinder 5 – Details of frayed fibers after the fatigue test

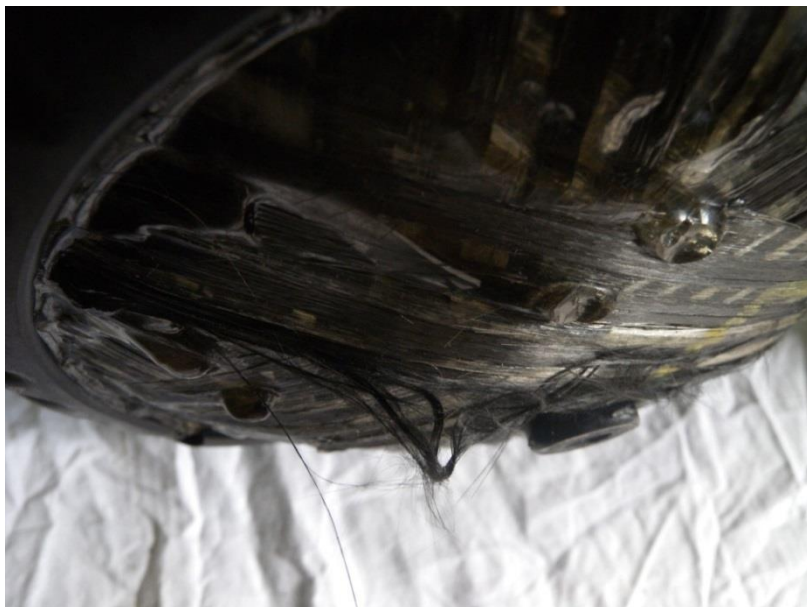
As already reported in Paragraph 1.1, fibers of cylinder 5 in the capped side were observed to be highly damaged during the preliminary visual inspection; nevertheless cylinder 5 did not failed in that area. Final state of the fibers in the capped area, after the fatigue test, is reported in Figure 5-9.

Figure 5-9: Cylinder 5 – Finale state on the fibers after fatigue test in the dome of capped side

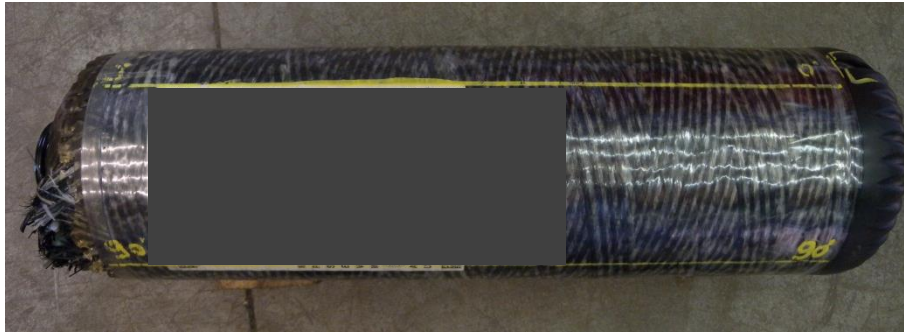
In the cylinder 6 the failure occurred in the dome area on the valve side, along 90° generatrix, as shown in Figure 5-10. This cylinder was vertically drop tested, then it should not be subjected to an impact along the generatrix. Nevertheless, the video of the drop test demonstrates that the cylinder had a strong rebound impact exactly where the failure occurred. Failure happened after 12,515 cycles.

Figure 5-10: Cylinder 6 blown up during the fatigue test

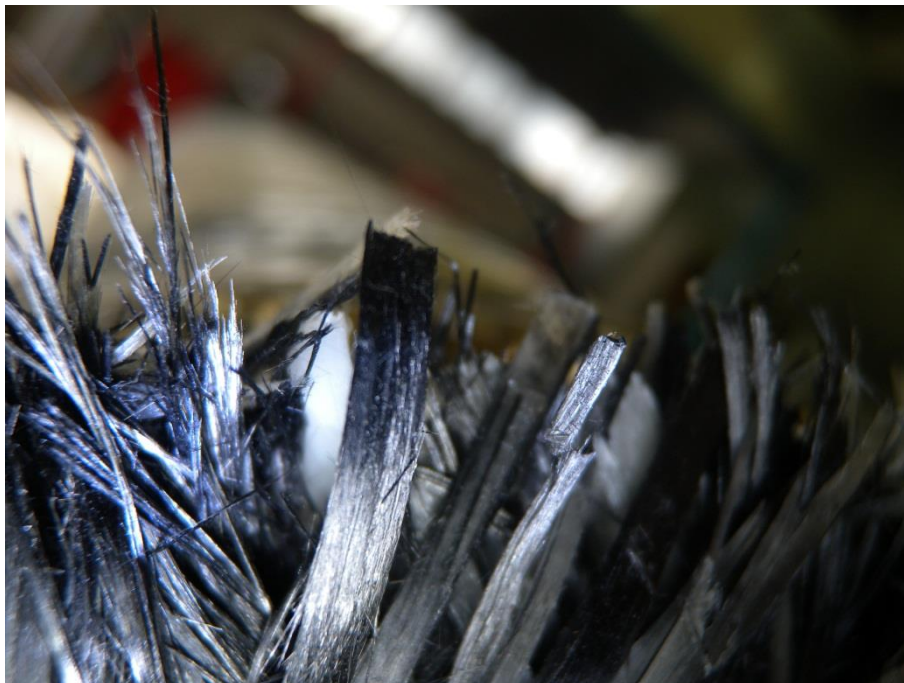
- ✓ in the impact area of the drop test, fibers are sharply truncated (Figure 5-11);
- ✓ in the area close to the impact, fibers are frayed (Figure 5-12).

Figure 5-11: Cylinder 6 – Details of sharply truncated fibers after the fatigue test

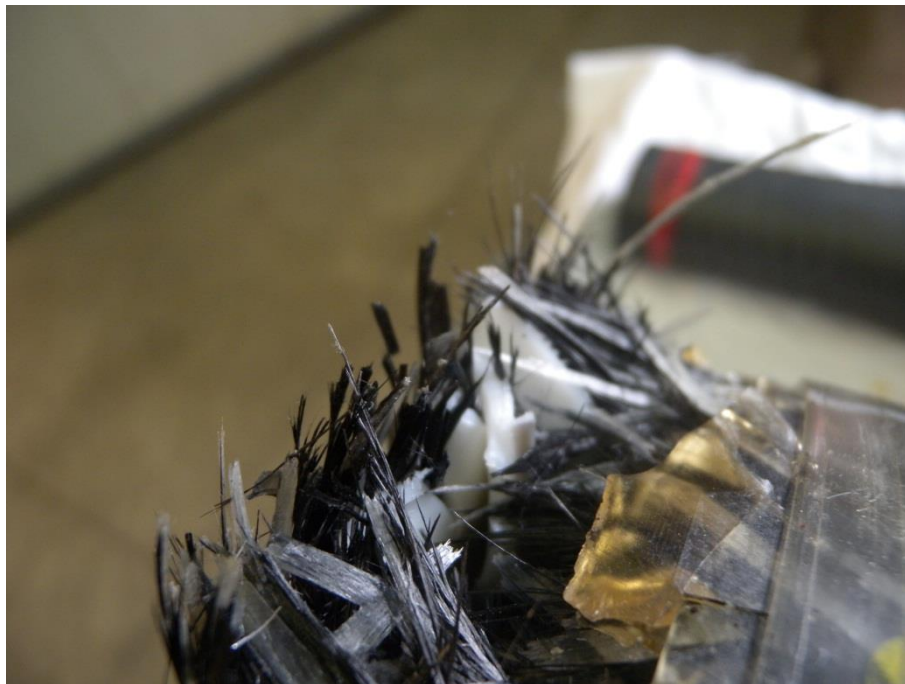
Figure 5-12: Cylinder 6 – Details of frayed fibers after the fatigue test

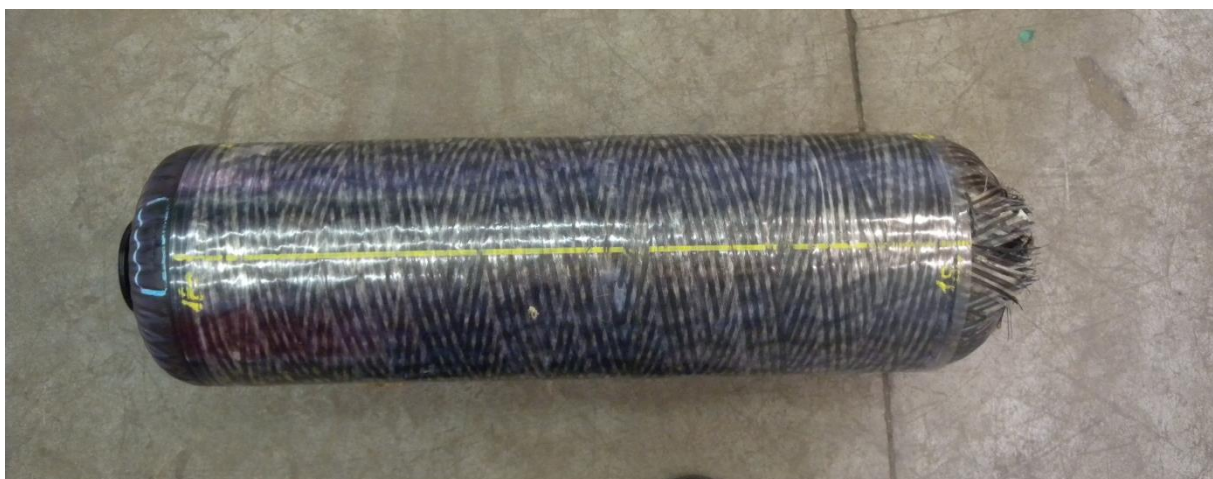
In the cylinder 7 the failure occurred in the dome area on the capped side, as shown in Figure 5-13. This area corresponds to the area where the first impact occurred during the drop test. Failure happened after 2,685 cycles.

Figure 5-13: Cylinder 7 blown up during the fatigue test

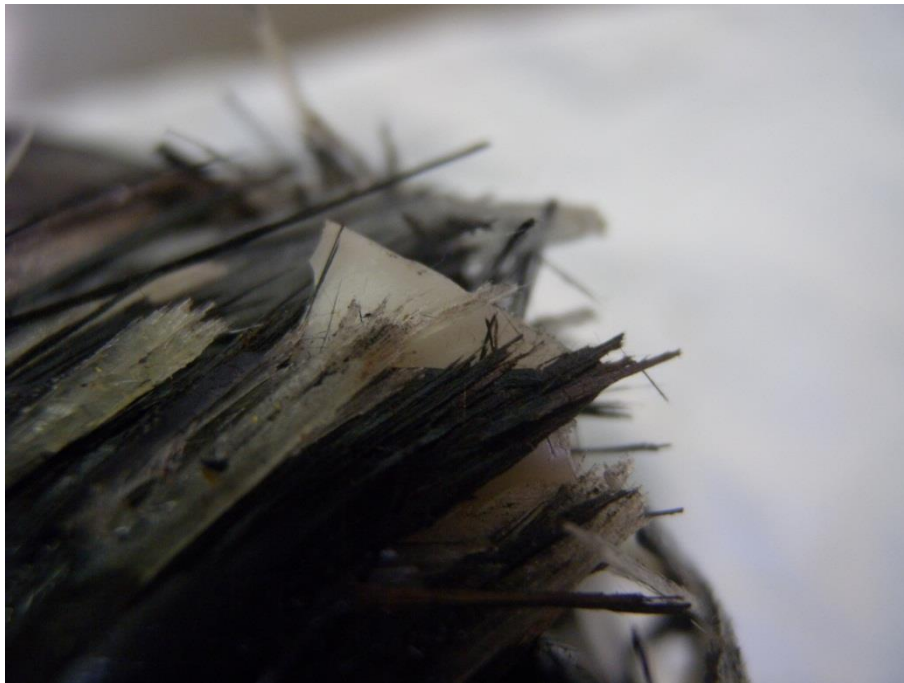
- ✓ in the impact area of the drop test, fibers are sharply truncated (Figure 5-14);
- ✓ in the area close to the impact, fibers are frayed (Figure 5-15).

Figure 5-14: Cylinder 7 – Details of sharply truncated fibers after the fatigue test

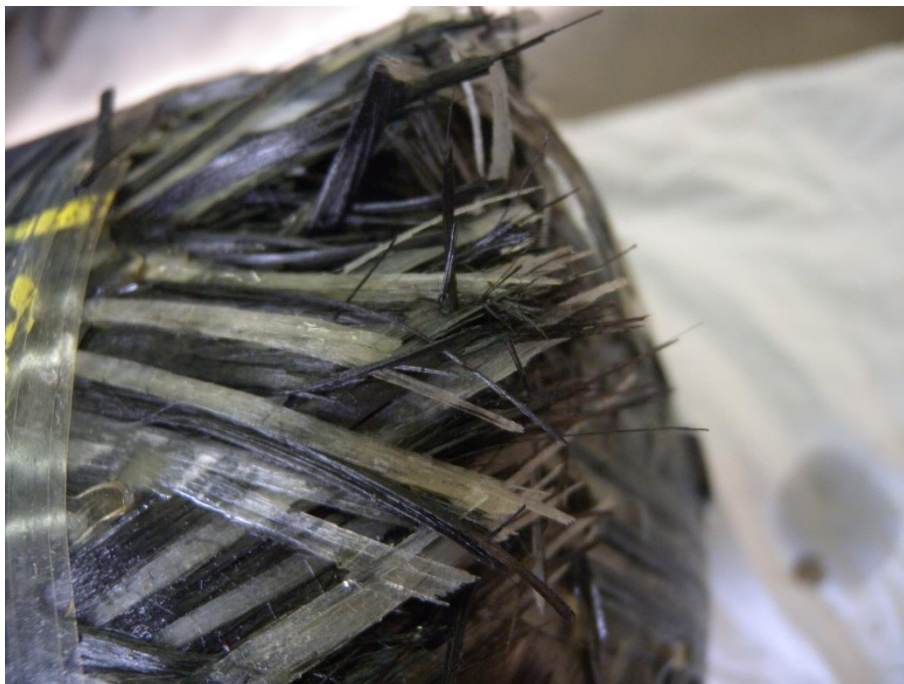
Figure 5-15: Cylinder 7 – Details of frayed fibers after the fatigue test

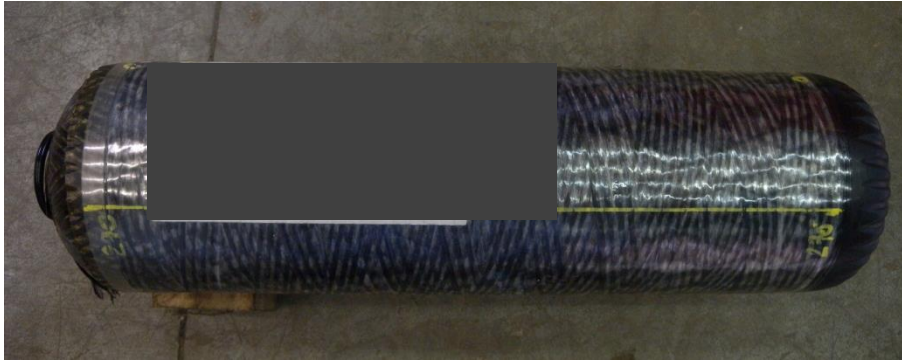
In the cylinder 9 the failure occurred in the dome area on the valve side, as shown in Figure 5-16. This area corresponds to the area where the first impact occurred during the drop test. Failure happened after 190 cycles.

Figure 5-16: Cylinder 9 blown up during the fatigue test

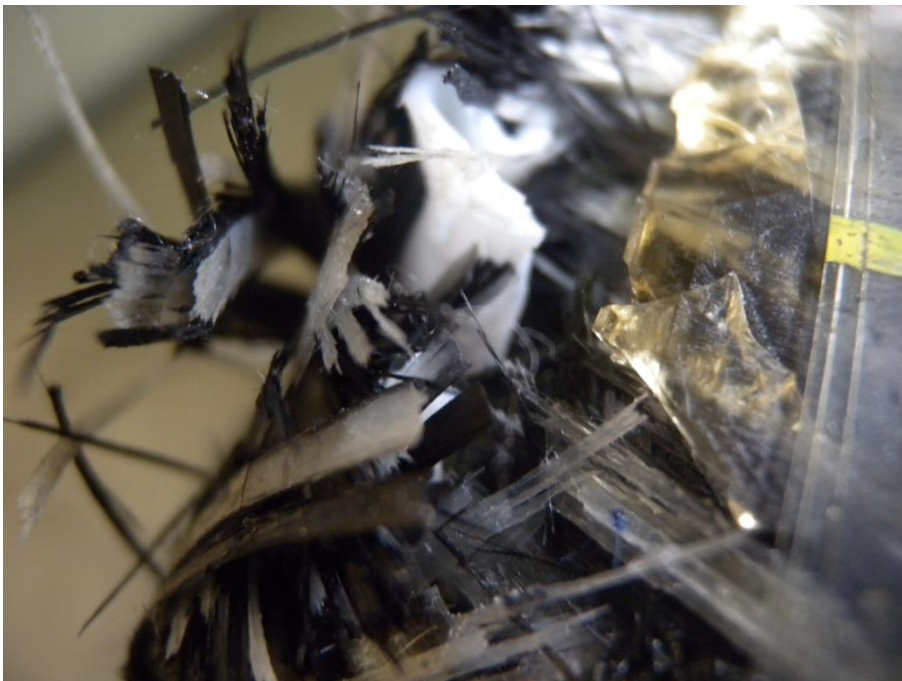
- ✓ in the impact area of the drop test, fibers are sharply truncated (Figure 5-17);
- ✓ in the area close to the impact, fibers are frayed (Figure 5-18).

Figure 5-17: Cylinder 9 – Details of sharply truncated fibers after the fatigue test

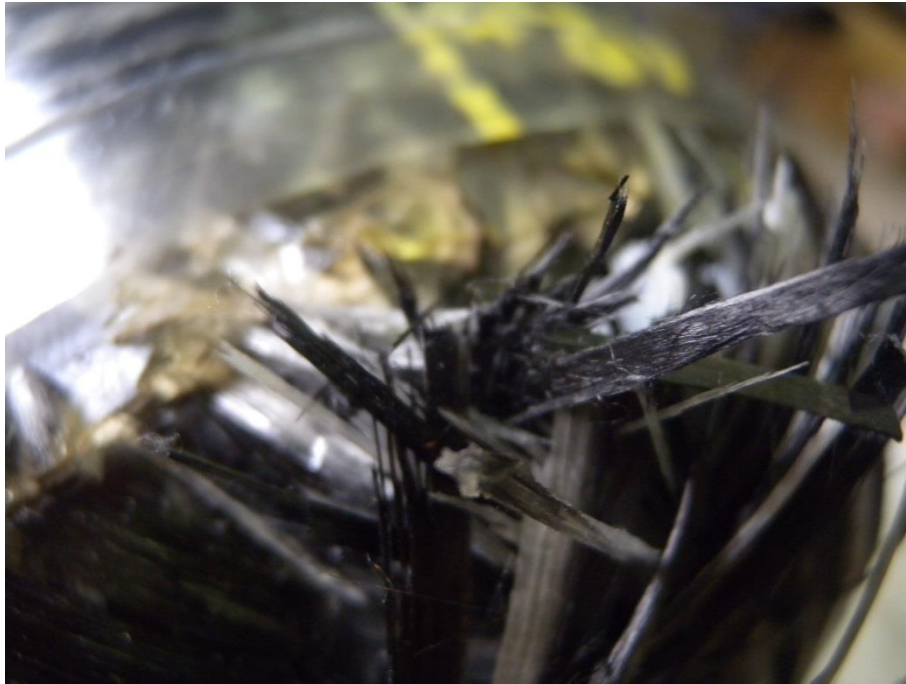
Figure 5-18: Cylinder 9 – Details of frayed fibers after the fatigue test

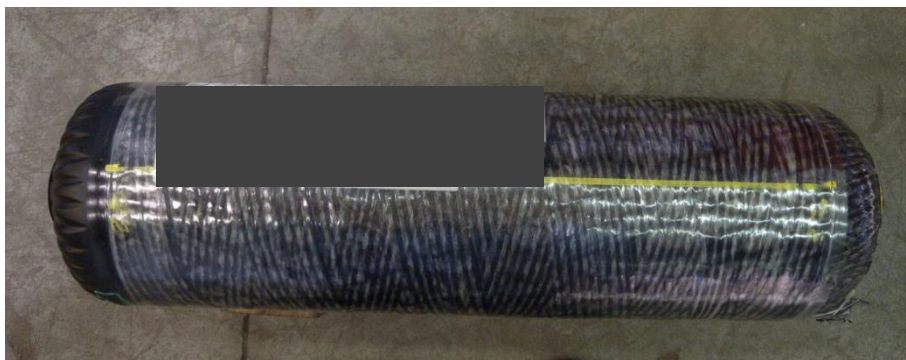
In the cylinder 11 the failure occurred in the dome area on the capped side, as shown in Figure 5-19. This area corresponds to the area where the first impact occurred during the drop test. Failure happened after 709 cycles.

Figure 5-19: Cylinder 11 blown up during the fatigue test

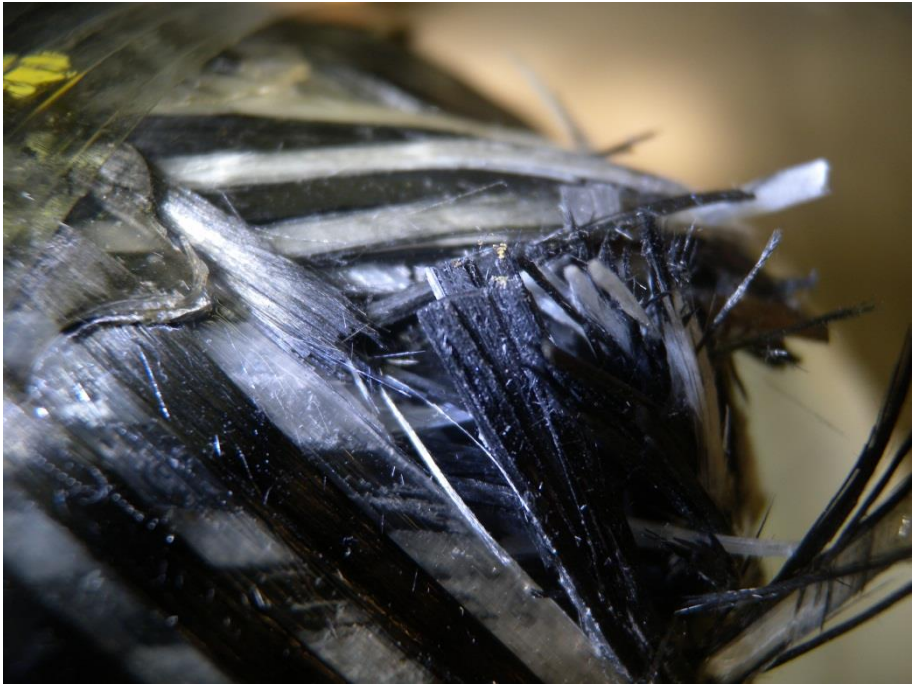
Figure 5-20: Cylinder 11 – Details of sharply truncated fibers after the fatigue test

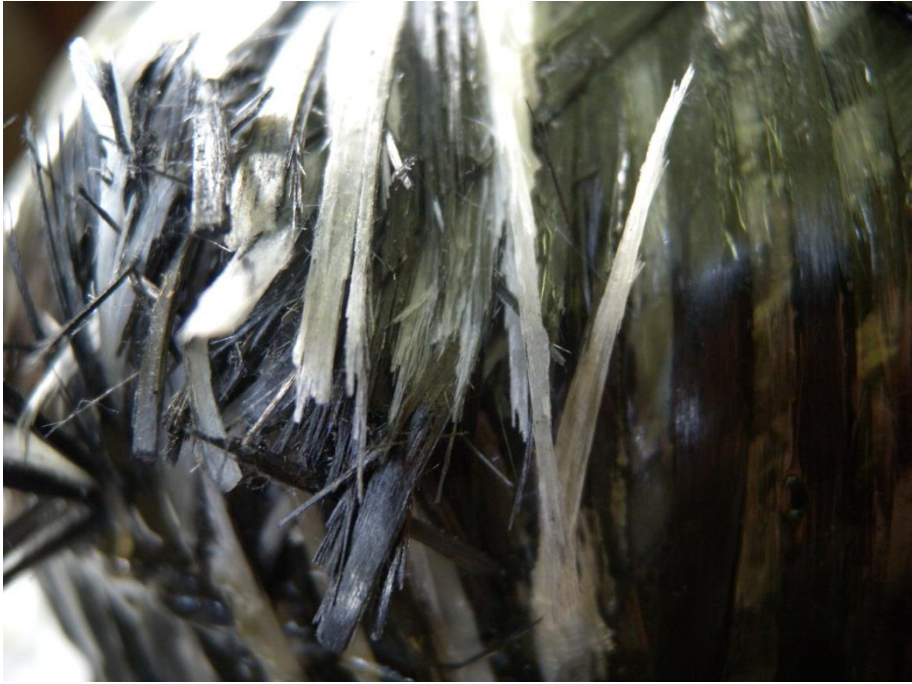
Figure 5-21: Cylinder 11 – Details of frayed fibers after the fatigue test

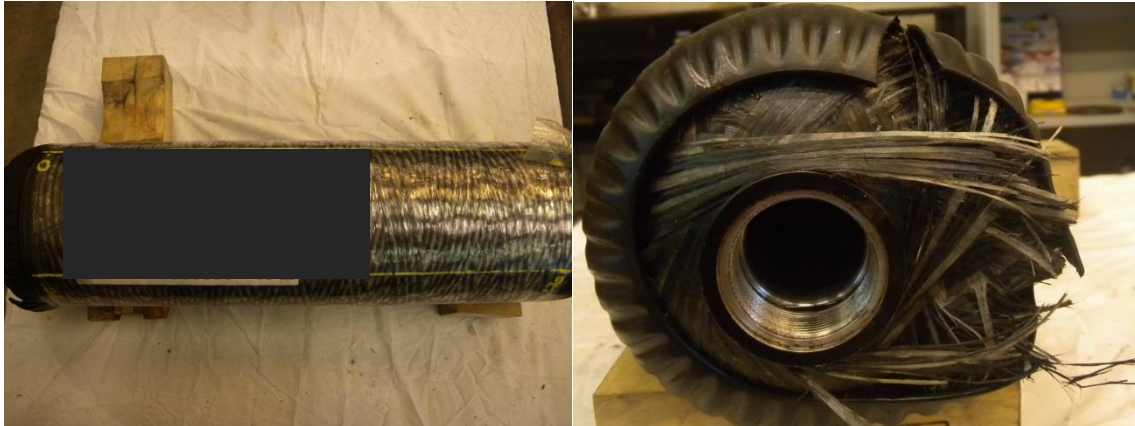
In the cylinder 12 the failure occurred in the dome area on the valve side, as shown in Figure 5-22. This area corresponds to the area where the first impact occurred during the drop test. Failure happened after 5,345 cycles.

Figure 5-22: Cylinder 12 blown up during the fatigue test

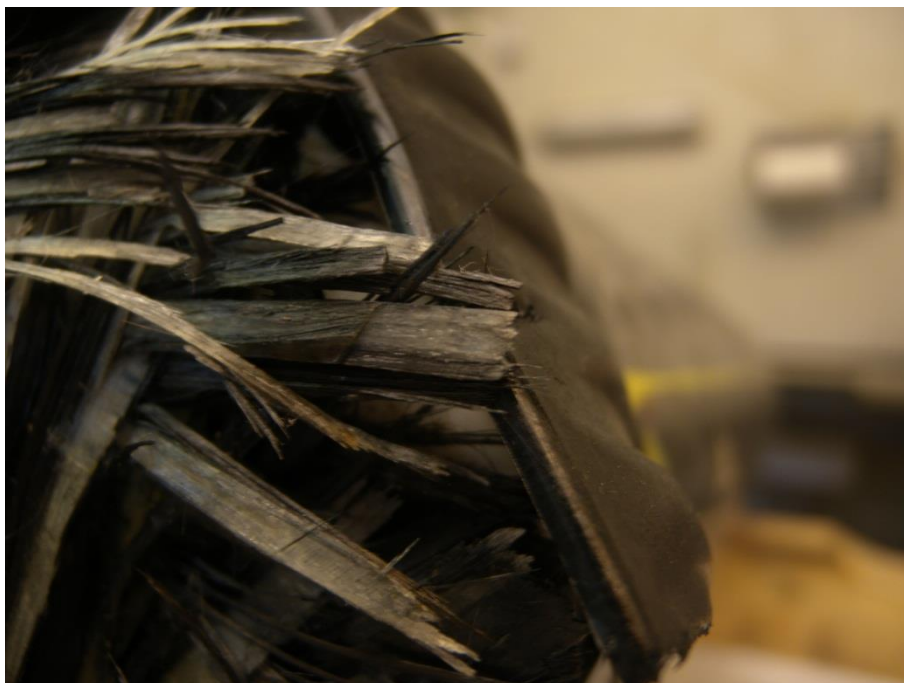
Figure 5-23: Cylinder 12 – Details of sharply truncated fibers after the fatigue test

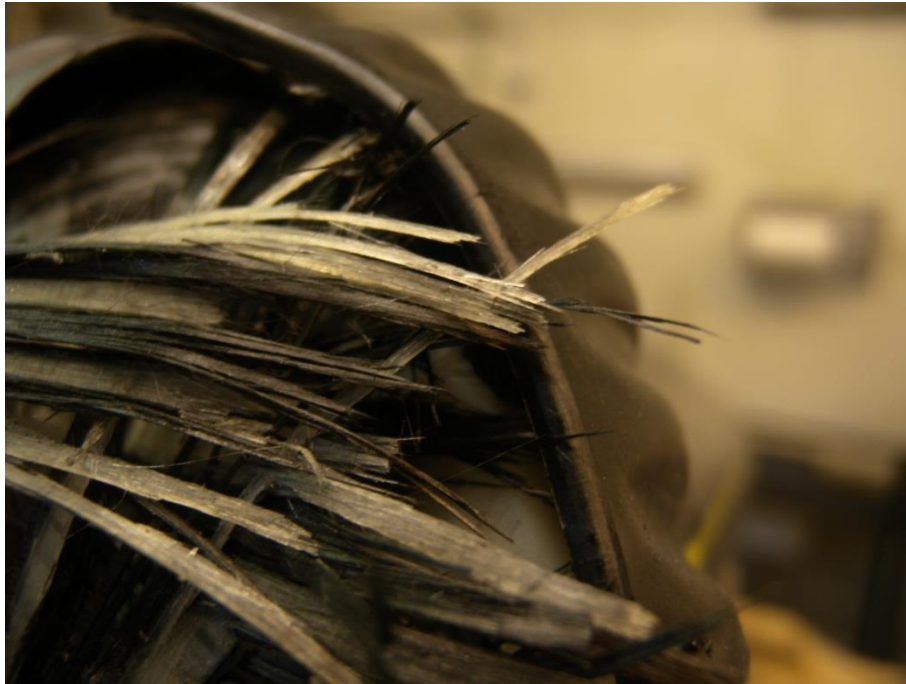
Figure 5-24: Cylinder 12 – Details of frayed fibers after the fatigue test

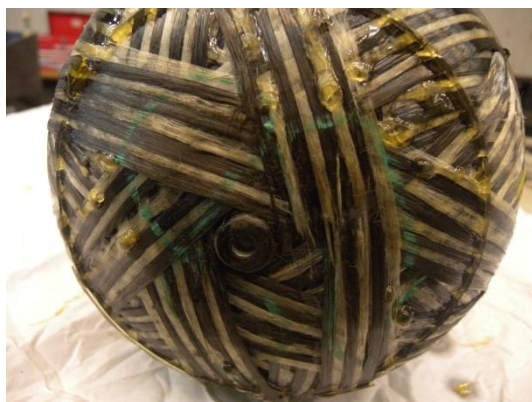
Cylinder 2 has been tested with both sides vertical drops. As shown in Figure 6-7 and Figure 6-8, the cylinder has been highly damaged in the dome area of the capped side.

Figure 6-7: Cylinder 10 – Details of damaged fibres after Vertical drop, capped side
