SFBM S.p.A.

Specific tests on CNG4 cylinders

Provider 2

Doc. No. 19500-R Rev. 2 – March 2018

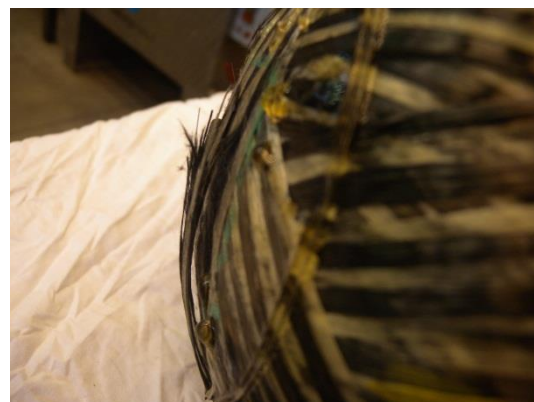
Cylinder 2 has been tested with both sides vertical drops. As shown in Figure 6-7 and Figure 6-8, the cylinder has been highly damaged in the dome area of the capped side.

Figure 6-8: Cylinder 10 – Details of damaged fibres after vertical drop, capped side

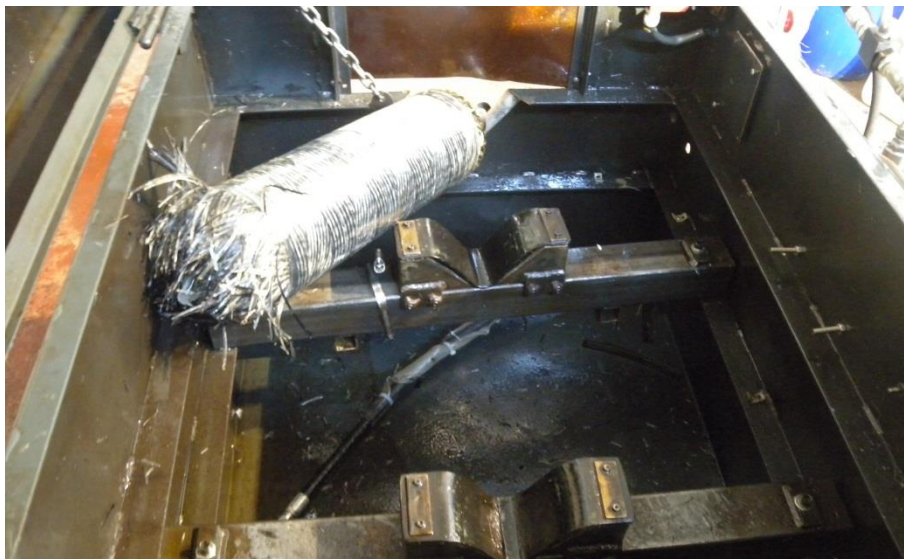
In the cylinder 12 the failure occurred in the dome area on the capped side, as shown in Figure 7-1. Failure happened after 83 cycles.

Figure 7-1: Cylinder 2 blown up during the second fatigue test

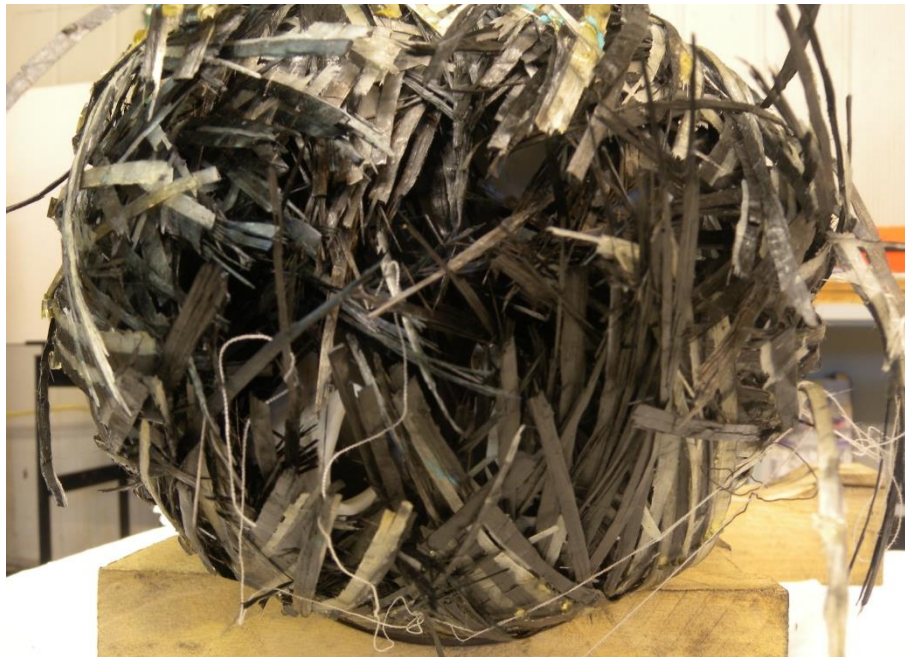
The failure area corresponds to the top of the dome, capped side, as shown in Figure 7-2.

Figure 7-2: Cylinder 2 – Detailed view of the blown up area

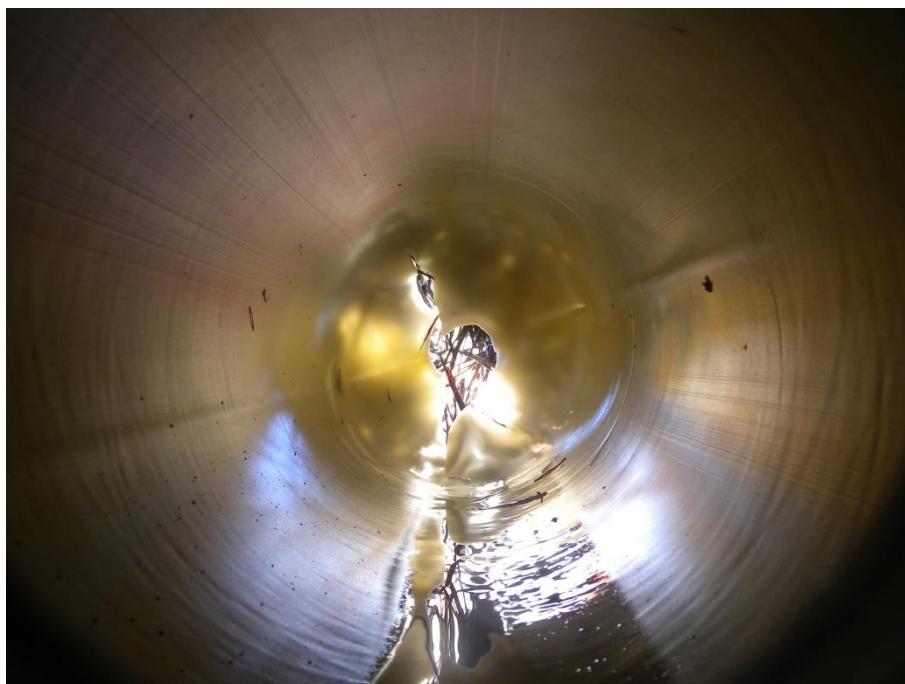
Figure 7-3 reports the inner surface of cylinder 2. It is possible to see that part of the liner at the top of the dome is missing; this kind of damage can be related to the vertical drop.

Figure 7-3: Cylinder 2 – View of the blown up area from inside

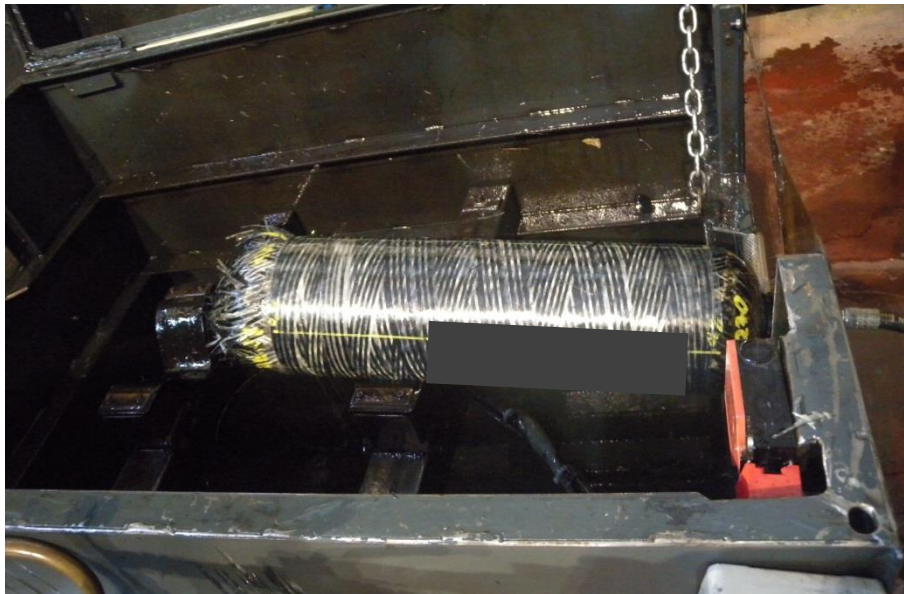
In the cylinder 12 the failure occurred during the first cycle (Figure 7-4) at the top of the dome area on the capped side, as shown in Figure 7-5.

Figure 7-4: Cylinder 10 blown up during the second fatigue test

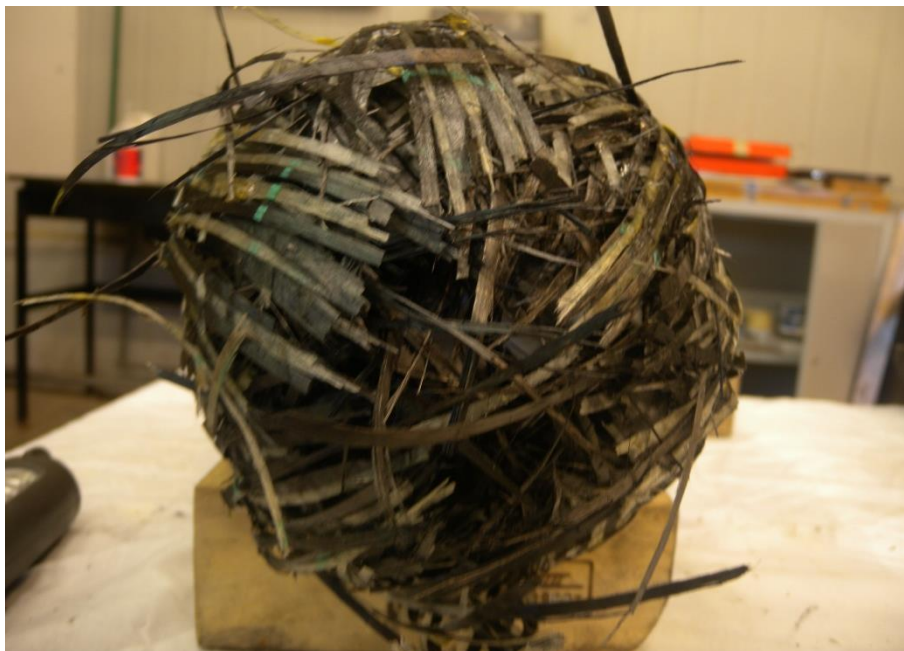
Figure 7-5: Cylinder 10 – Detailed view of the blown up area

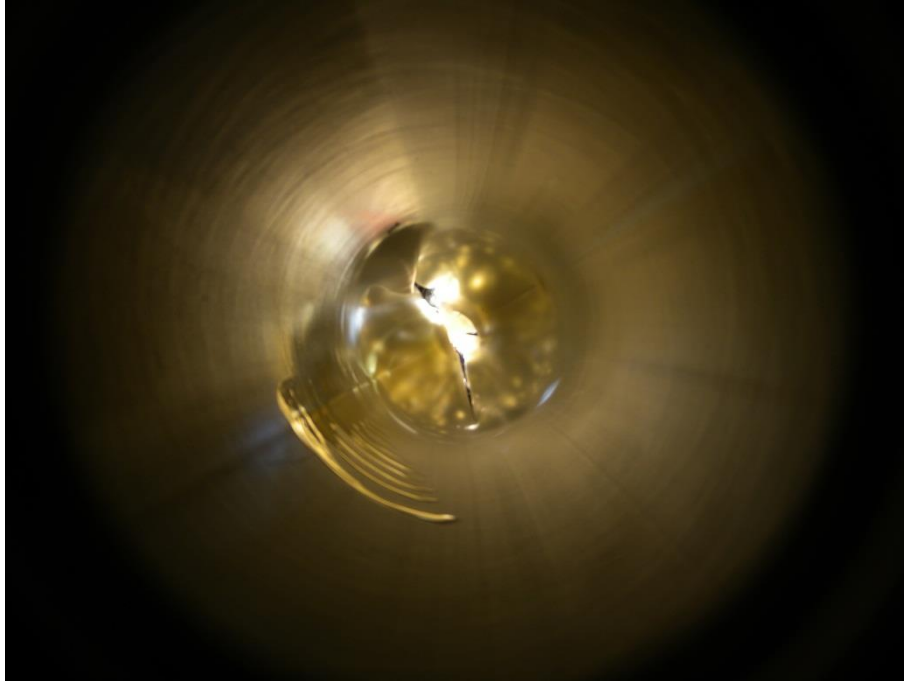
Figure 7-6 reports the inner surface of cylinder 10. It is possible to see that the damage extends to the whole dome. In this case, no part of the liner was missing. This kind of damage can be related to the vertical drop.

Figure 7-6: Cylinder 10 – View of the blown up area from inside

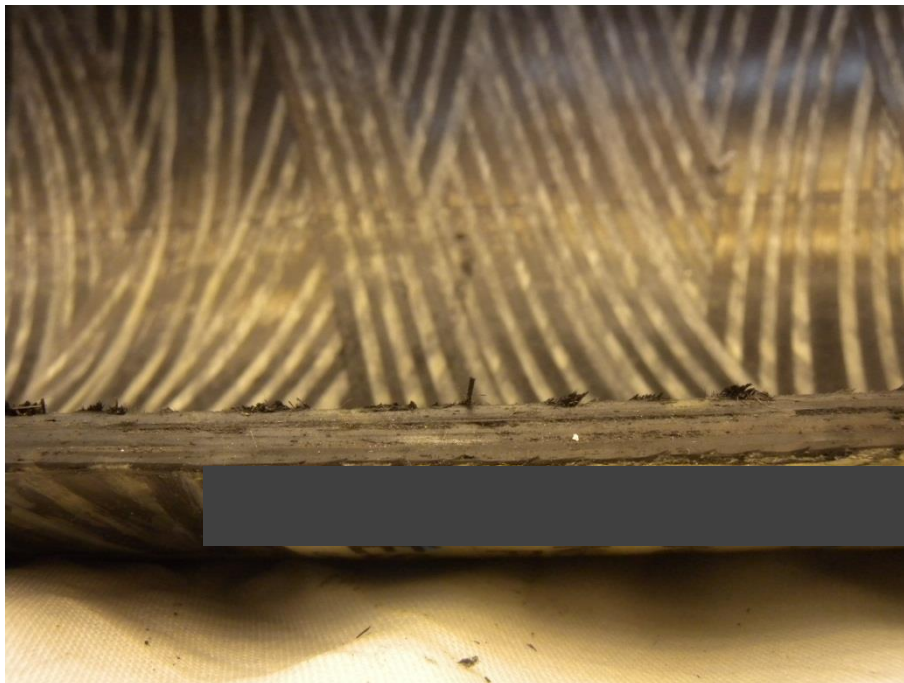
Measurements showed a non-uniform thickness. Particularly in the cylindrical area the composite thickness was constantly of 5 mm (Figure 8-1). In the dome areas, the thickness was higher close to the cylindrical zone and at the top of the dome, whilst a strong thinning was observed in the intermediate zone. In that area, the wall thickness can be lower than 2.5 mm. In some cases, also a lack of superimposition of the fibers was observed (Figure 8-2). In Figure 8-3 a picture of the valve connection area after cutting is presented.

Figure 8-1: Cylinder 7 – View of the cutting along the cylindrical area

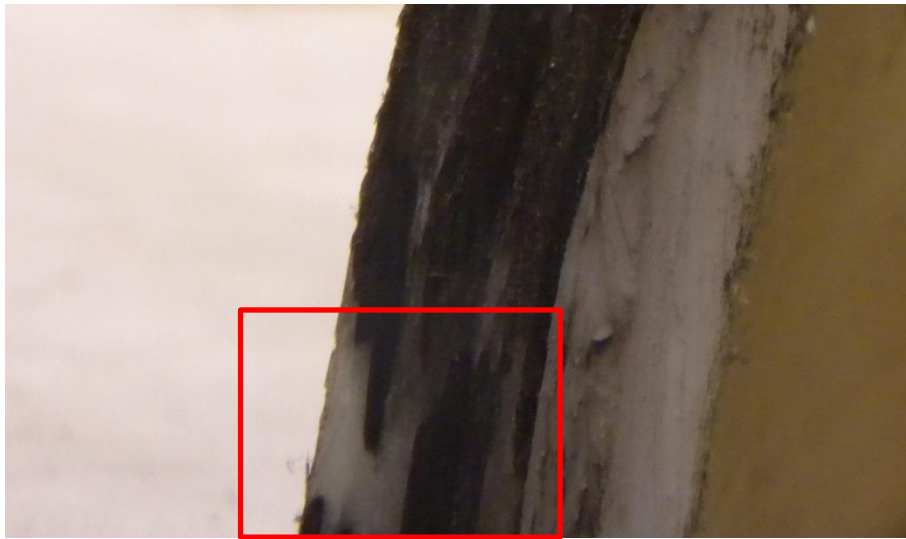
Figure 8-2: Cylinder 7 – Detailed view of the lack of fibers superimposition
