Seat back according to un regulation No. 80

Finnish Safety Investigation Authority has given a recommendation to introduce a change UN Regulation No 80 regarding the structure of the back part of seats for the purpose of making them safer, by adding padding and removing hard protrusions located right in the front of passengers.

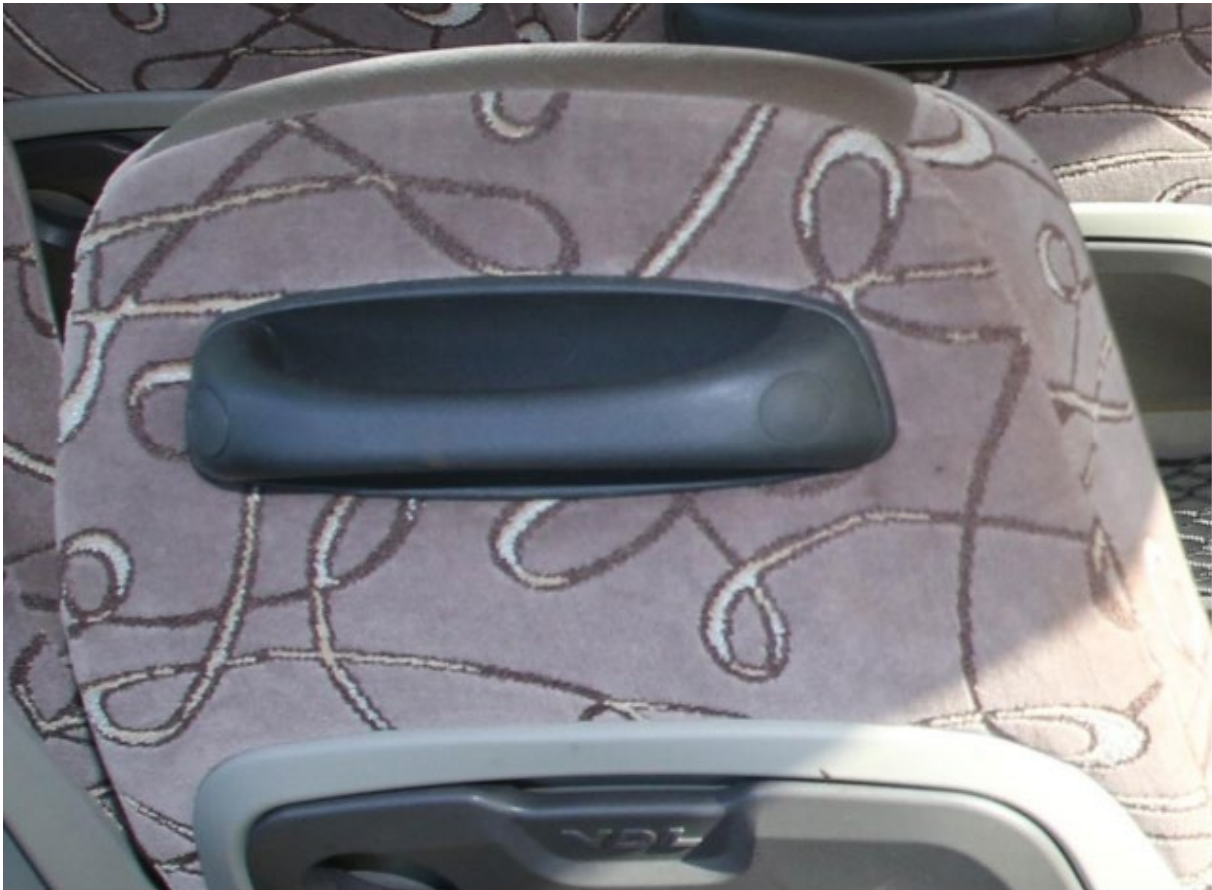
Accident analysis shows that 10 passengers were injured in their face. According to analysis, these injuries happened when passengers hit their face to a rigid handle shown in a picture below.

UN Regulation No 80 in force requires dynamic test according to Appendix 1 Test 2 or Appendix 6 pendulum test to show a conformity of back of a seat. In the Appendix 6, which is linked to UN Regulation No 21, point of impact of the pendulum is not clearly defined. That may cause a situation in which the safety of the handle similar to the one shown in picture is not assessed.

Should the point of impact be defined more clearly?

Should the allowed impulse caused by acceleration be reconsidered?
