Case study: Gas explosions at Pike River coal mine – New Zealand

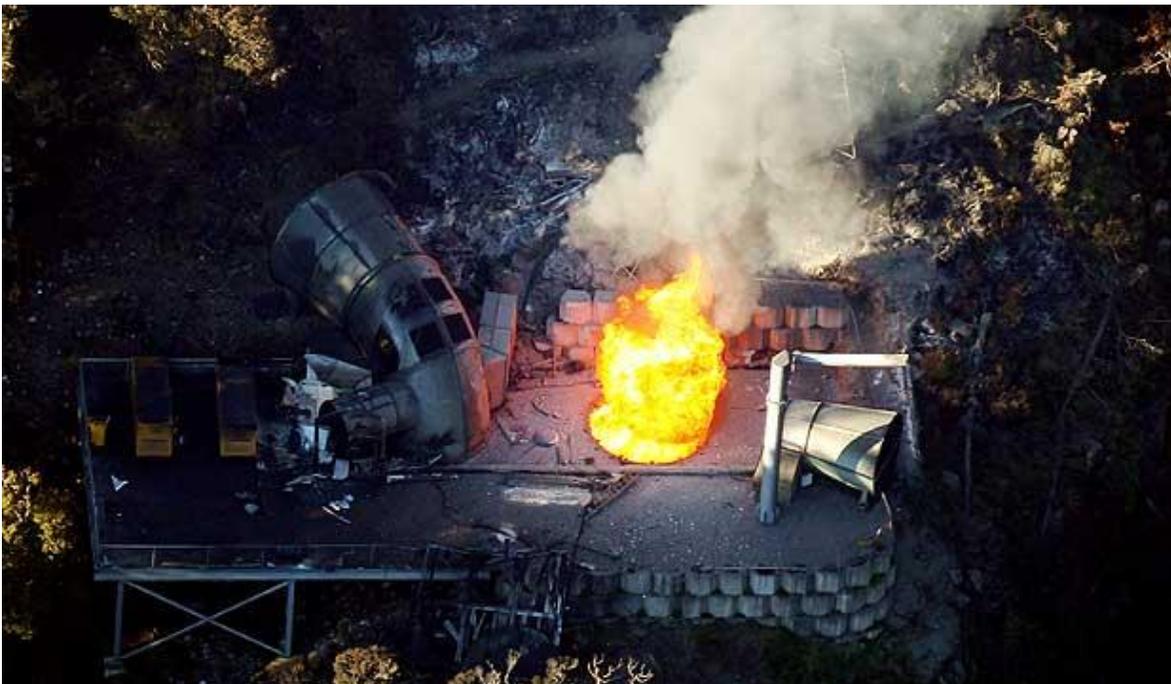
The problem: On 19 November 2010 an explosion occurred. In the ensuing days, three further explosions and a fire occurred (Figure 2) before the mine atmosphere was made inert and the mine sealed. 29 miners were killed.

Figure 2. Fire at the upcast shaft following the third explosion
