**FINLANDS PROPOSAL FOR RULES OF PREVENTION OF FIRE RISK IN BUSES AND COACHES**

## **Incident report**

D 1/2001 Y,  
Shortened Version

# **Bus Fires in Finland during 2001**

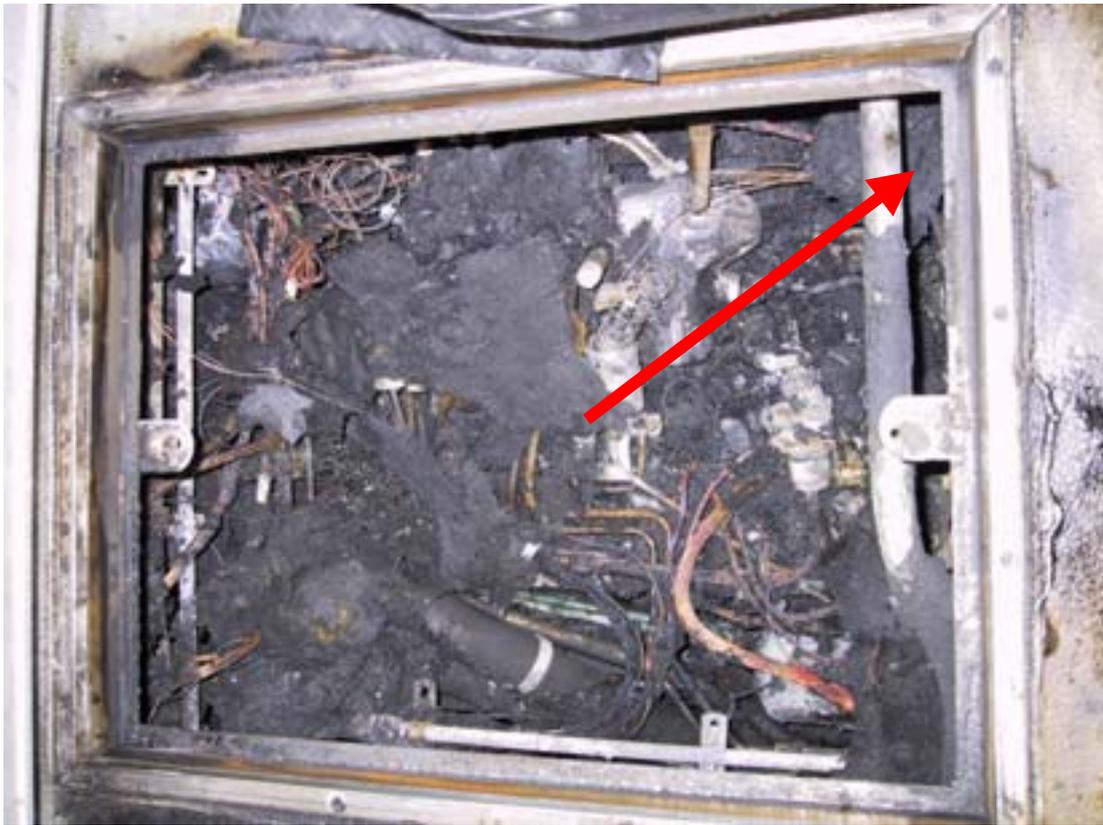
Of the repeated causes of fire that were found in the investigation of the year 2000 one was the abrasion of the battery cable against the hoist bracket of the engine. In 2001 there were still three fires caused by this. In the 2000 report this problem was clearly highlighted so it is surprising that this fault, which can quite easily be repaired, has not disappeared.

Figure 1. Typical damage after the abrasion of the battery cable against the hoist bracket of the engine (Volvo B10B). The arrow points to the location of the short circuit.

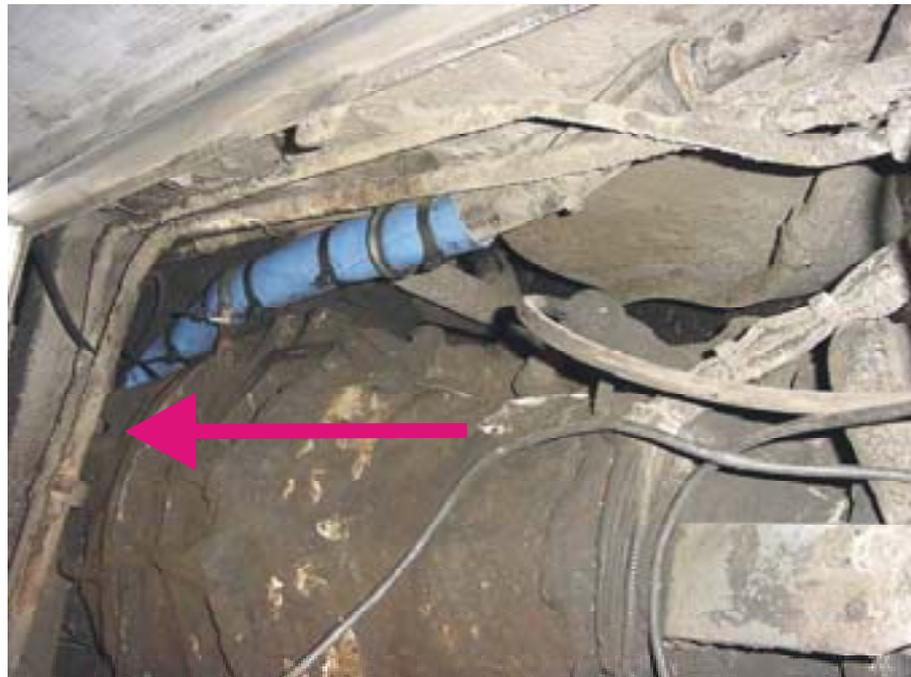
Figure 2. Protection and tightening of the battery cable at the repair shop. The wiring loom has been protected from abrasion with protective tubing and supported well. (Photo : Oy Pohjolan Liikenne Ab)

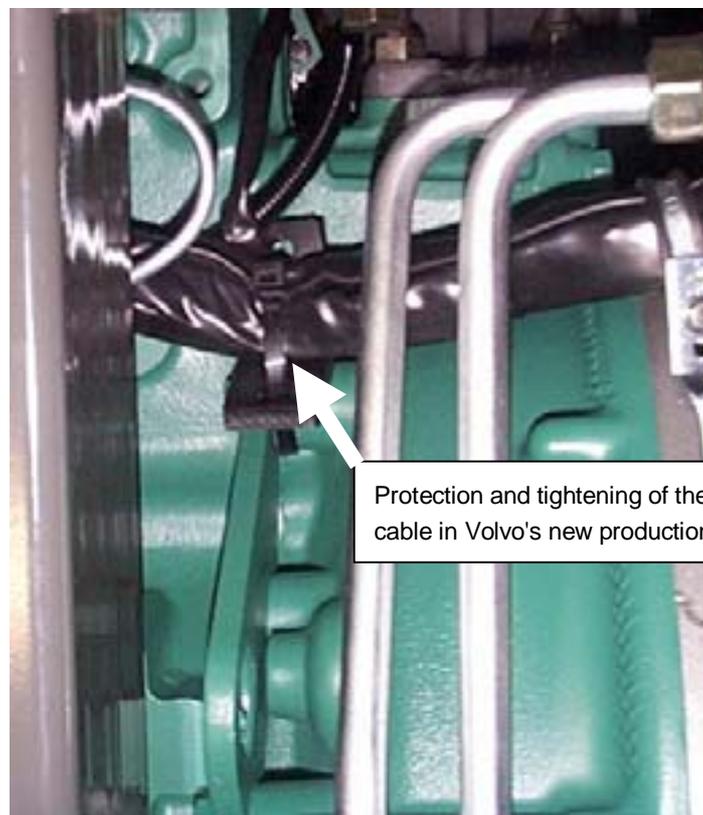
Protection and tightening of the battery cable in Volvo's new production.

Figure 3. The tightening of the cable in Volvo's new production. The hoist bracket is below the tightened cable. (Photo : Volvo Ab)
