# Economic and Social Council

##### Joint Meeting of the RID Committee of Experts and the Working Party on the Transport of Dangerous Goods

### Additional measures after emptying tanks of liquefied gas at very low temperatures

Transmitted by the Government of France<sup>1,2</sup>

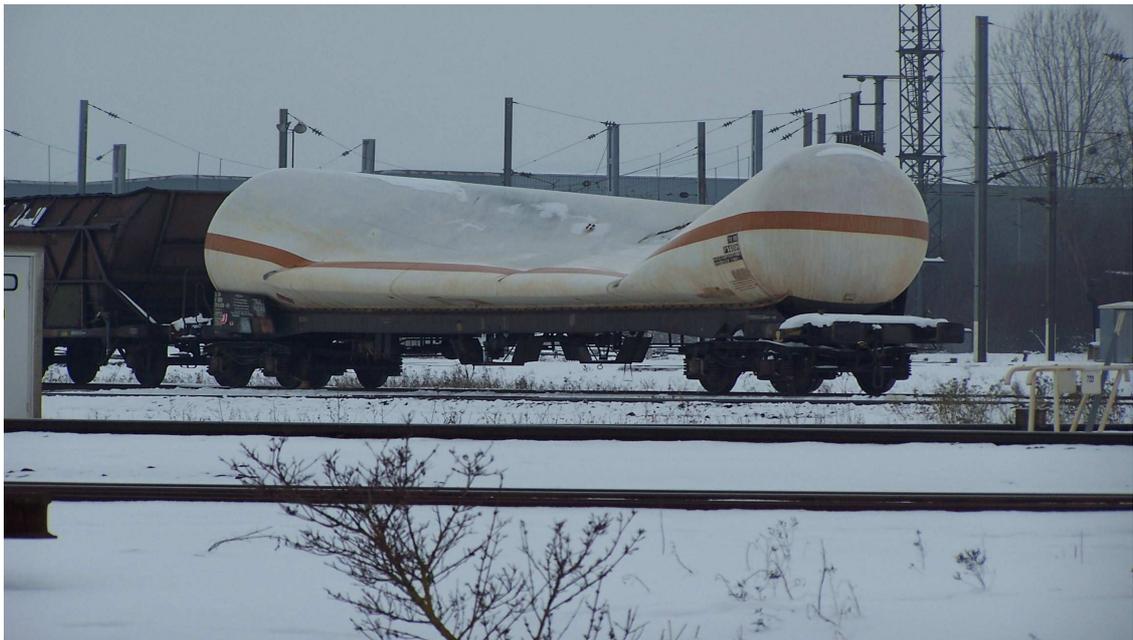
1. An empty unloaded, uncleaned tank-wagon containing residues of butadiene (UN No. 1010) spent some time under low temperature conditions (from the date of unloading, 20 December, to 27 December). The temperature reached a minimum of  $-18^{\circ}\text{C}$  on 27 December.
2. The tank then collapsed due to internal pressure changes probably caused by the liquefaction of butadiene.

3. The remaining mass of the product in the tank was estimated to be 870 kg.
4. The accident caused no major damage (except to the tank itself) because it happened while the wagon was stopped inside a marshalling yard. The consequences could have been much more serious if the tank-wagon had been in service, given that the dimensions of the deformed tank exceeded the rail loading gauge.

5. Add the following new paragraph 4.3.3.3.4 to subsection 4.3.3.3:  
"4.3.3.3.4 In periods when very low temperatures may occur, measures shall be taken during or after unloading to protect tanks transporting liquefied gas against the risk of deformation due to negative internal pressure, by filling them with nitrogen or another inert gas in order to maintain sufficient pressure inside the tank."

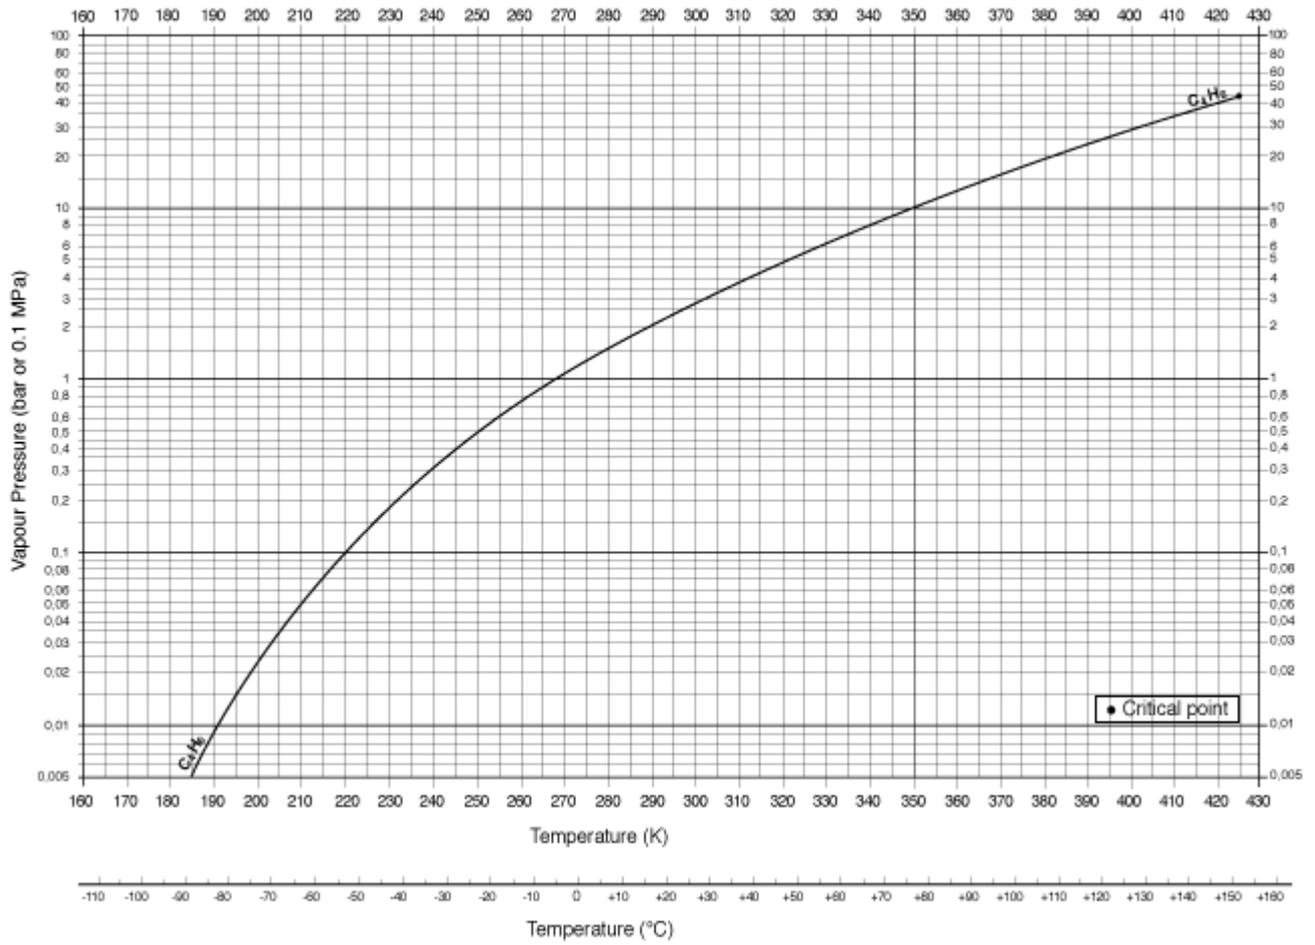
5. The vapour pressure curve of butadiene shows that this type of tank was not designed to withstand the vacuum pressure created at  $-20^{\circ}\text{C}$  (which explains the deformation).
