##### **Joint Meeting of the RID Committee of Experts and the Working Party on the Transport of Dangerous Goods**

### **Accident reporting concerning a collapsed tank-wagon due to depressurisation**

#### **Transmitted by the Government of France**

## INF.31

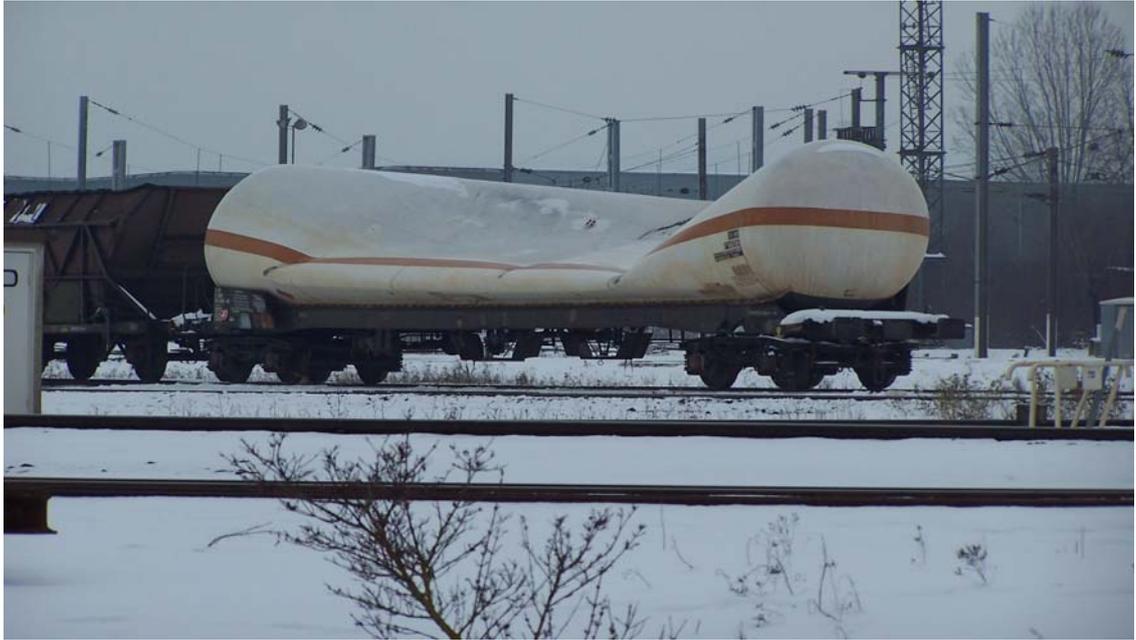
4. An empty unloaded uncleaned tank wagon containing residues of butadiene (UN 1010) spent some time under low temperature conditions (from the date of unloading 20 December to the 27 December). The temperature reached a minimum of -18°C on 27 December.
5. At that moment the tank collapsed due to pressure difference probably caused by the liquefaction of butadiene.

6. The remaining mass of the product in the tank was estimated at 870 kg.
7. The accident did not lead to major damage (except for the tank itself) because at that time the wagon was stopped inside a marshalling yard. But given the fact that the dimensions of the deformed tank exceeded the rail gauge this could have led to more serious consequences in case of a moving tank-wagon on the network.

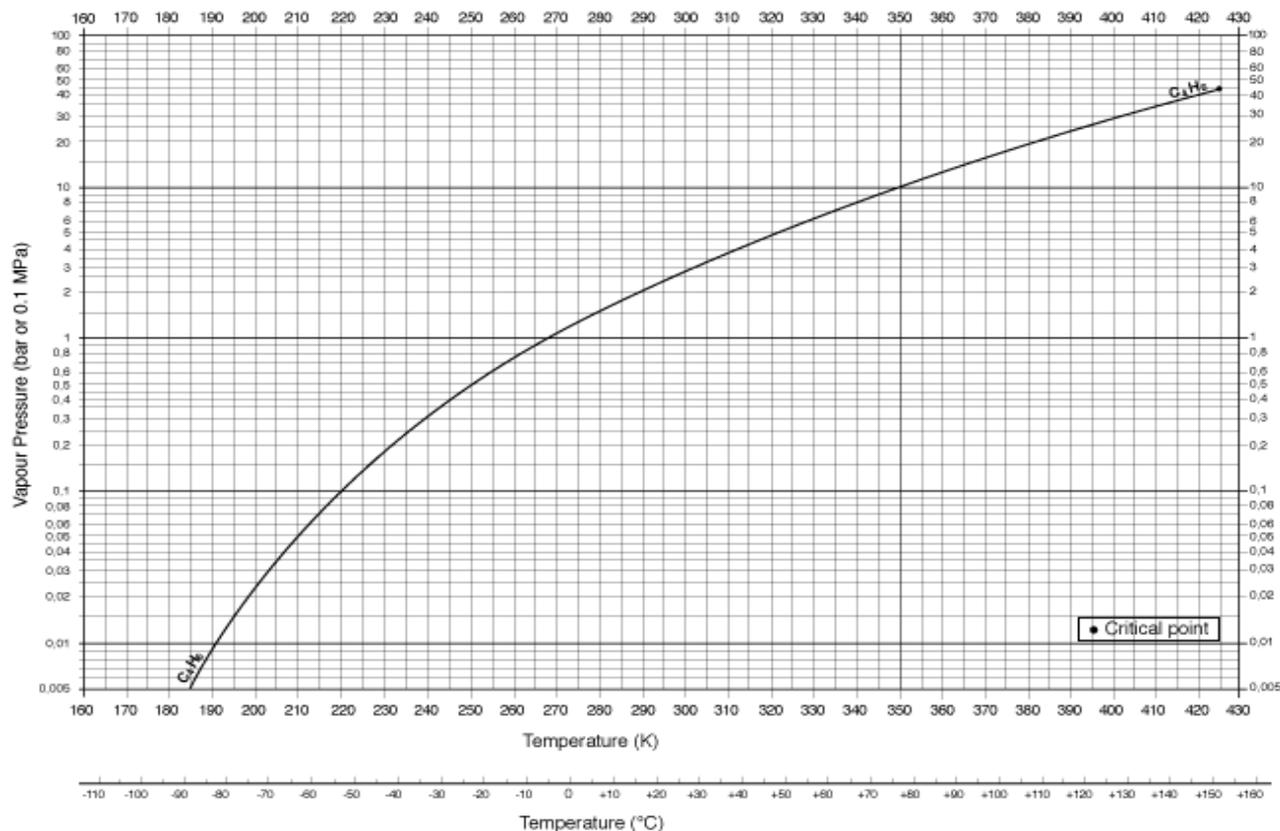
8. The requirements in 6.8.2.1.7 concerning protection against the risk of deformation resulting from a negative internal pressure were modified in 2003.
9. The tank is old but the external design pressure is almost the same as the value defined in 6.8.2.1.7 (0.35 bar instead of 0.4 bar).
10. The pressure/temperature curve of butadiene shows that between -15°C and -20°C the pressure differential reaches the value of the external design pressure of this specific tank (explaining the deformation) but also the value of 0.4 bar defined in 6.8.2.1.7.
