**Additional elements to support the Italian proposal to amend Regulation No. 110 (document ECE/TRANS/WP.29/GRSG/2017/29) on the basis of the results of the Italian research on type CNG4 cylinders**

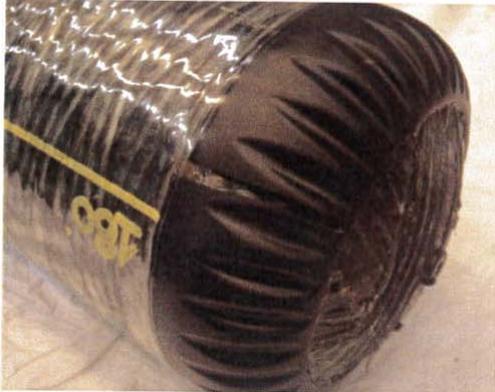
It should be pointed out that **6 of the 12.5 l cylinders evidenced cracks on one of the dome covers**, as shown in the enclosed photos, while still in the packing case, **before any kind of usage**.

Some cylinders showed the protection dome of the capped side damaged. In particular, the damage consisted in a fracture of the dome (from Figure 1-3 to Figure 1-8).

Figure 1-3: Damaged dome – Cylinder 1

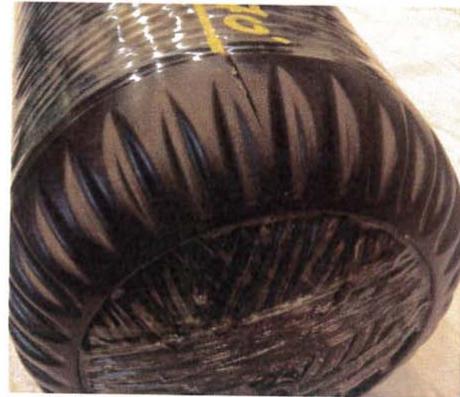
Figure 1-4: Damaged dome – Cylinder 2

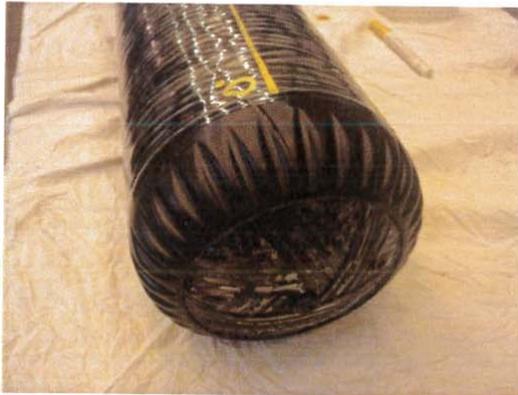
Figure 1-5: Damaged dome – Cylinder 5

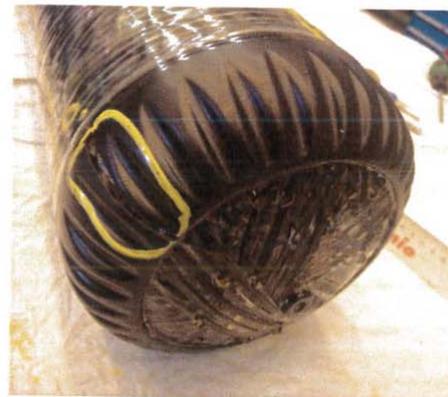
Figure 1-6: Damaged dome – Cylinder 6

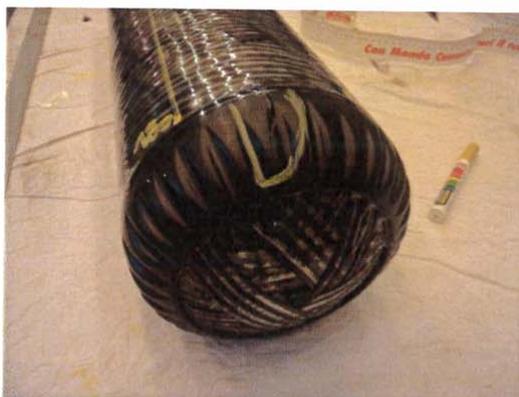
Figure 1-7: Damaged dome – Cylinder 10

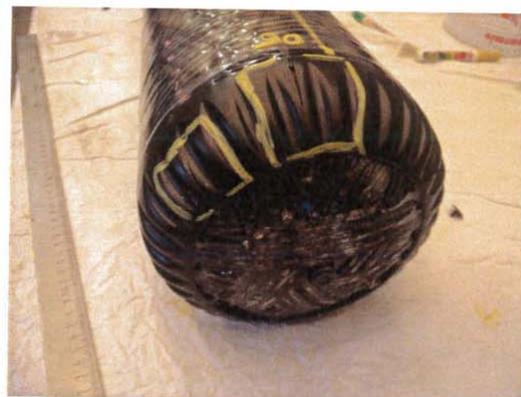
Figure 1-8: Damaged dome – Cylinder 11
