Informal document No. **GRSG-91-7**
(91st GRSG, 17-20 October 2006
agenda item 1.2.5.)

ROLLOVER ACCIDENT WITH EJECTION OF OCCUPANTS

Date: 15.12.2005 early morning, gloom
Place: Pécsdevecser, south Hungary

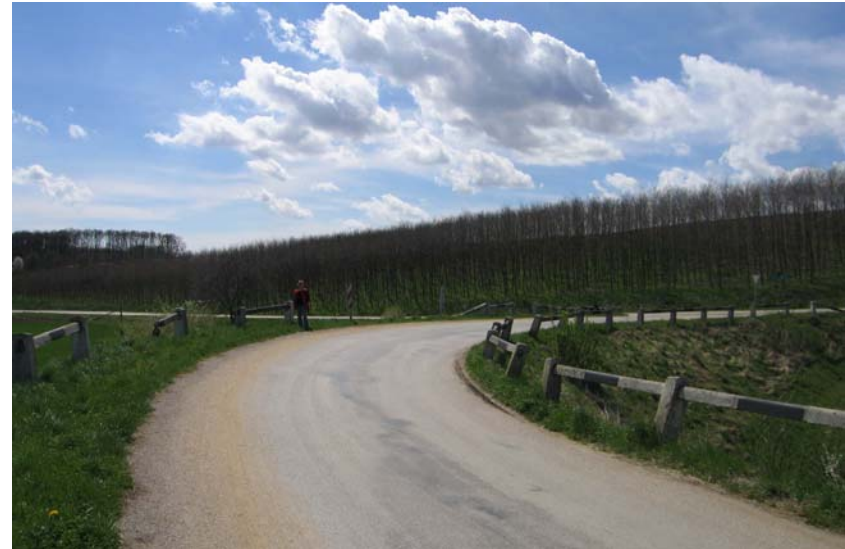
Position „A”

- Narrow hilly road
- 5-10 cm fresh snow on it, it was snowing
- Stone guard on roadside
- The bus drove slightly upwards with a speed of 30-40 km/h
- Sharp right curve (90°)

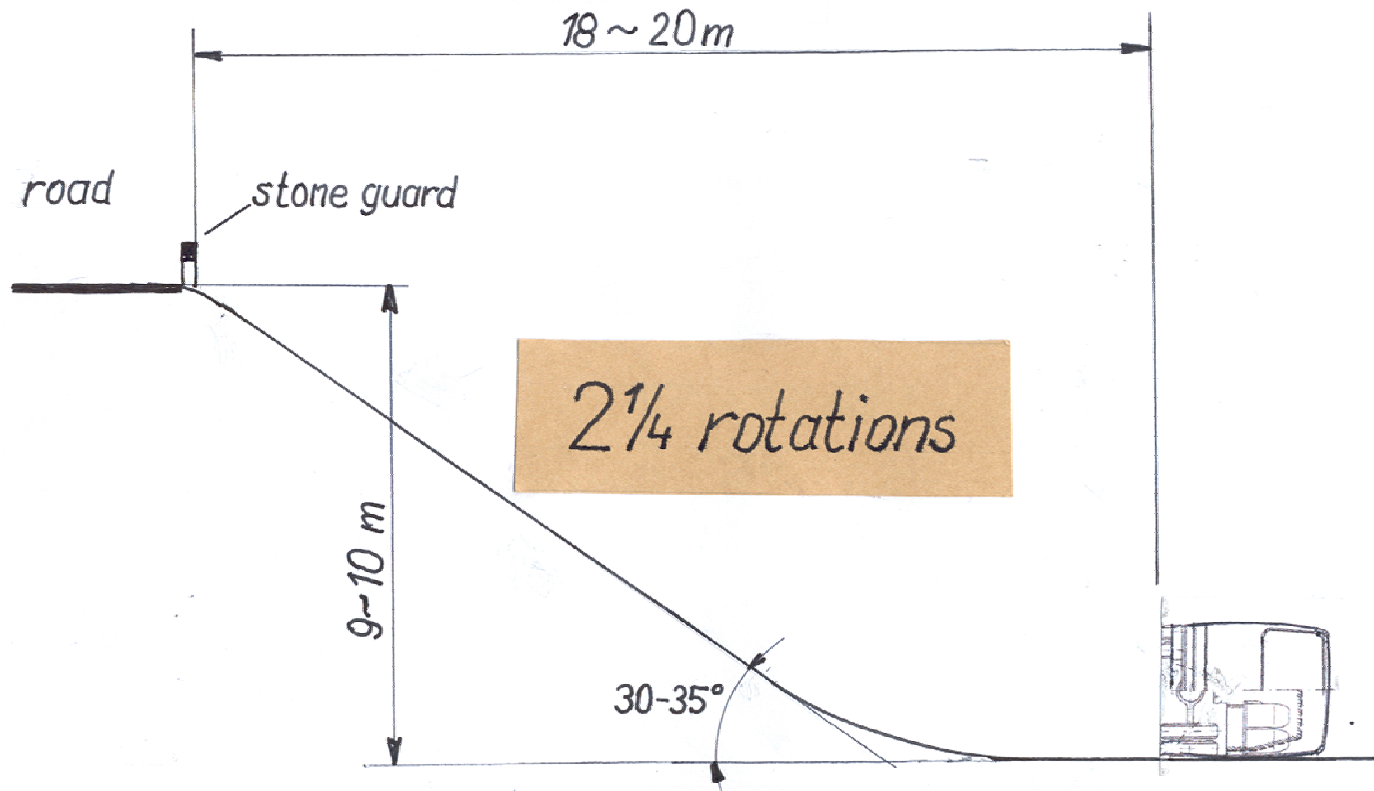
The scene

- Slope with an inclination $\approx 30-35^\circ$ small trees, bushes on the slope
- 5-10 cm snow on the slope
- Soft ground, grass under the snow

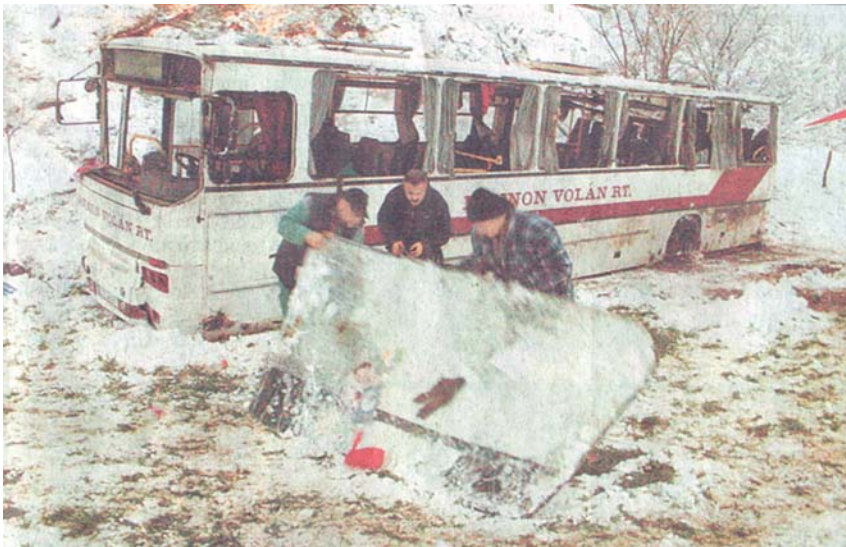
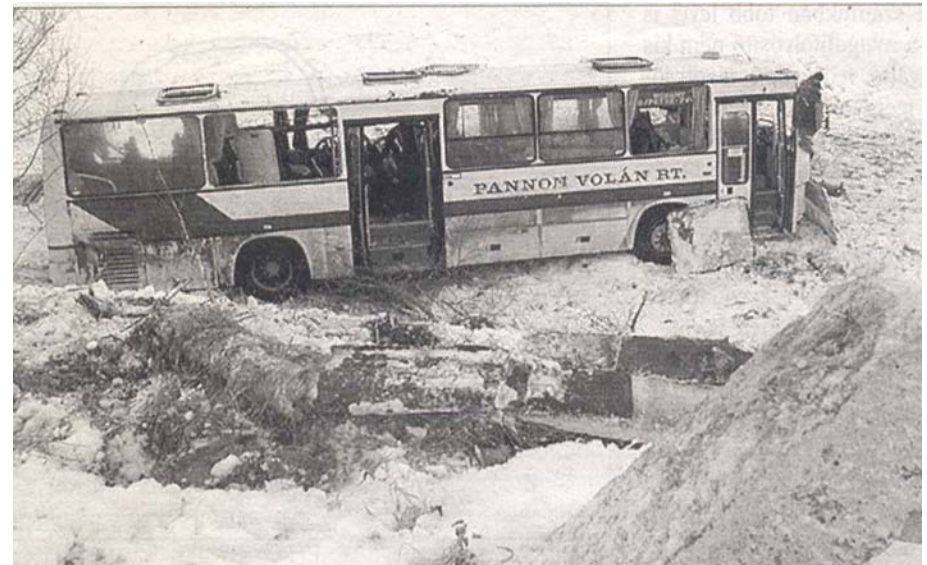
- No considerable deformation on the superstructure
- The survival space remained intact
- Both windscreen and rear window were fallen out without breaking (installation with rubber profile)
- On the left all: side windows were fallen out
- On the right: two side windows were fallen out, 3 remained
