## Flex GT $\alpha$ – Handling and Usage

4<sup>th</sup> Flex TEG Meeting  
April 2<sup>nd</sup>, 2007  
BASt, Bergisch Gladbach

Dipl.-Ing. Dirk-Uwe Gehring  
BGS Böhme & Gehring GmbH

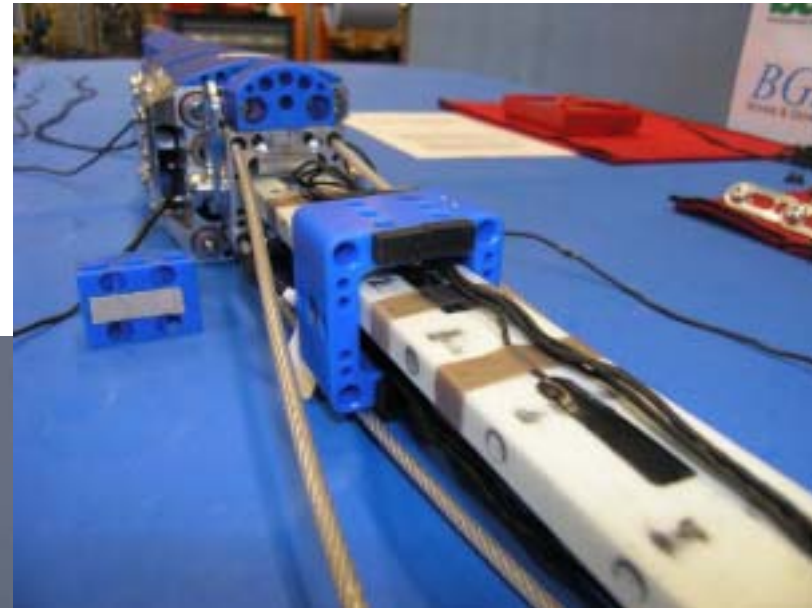
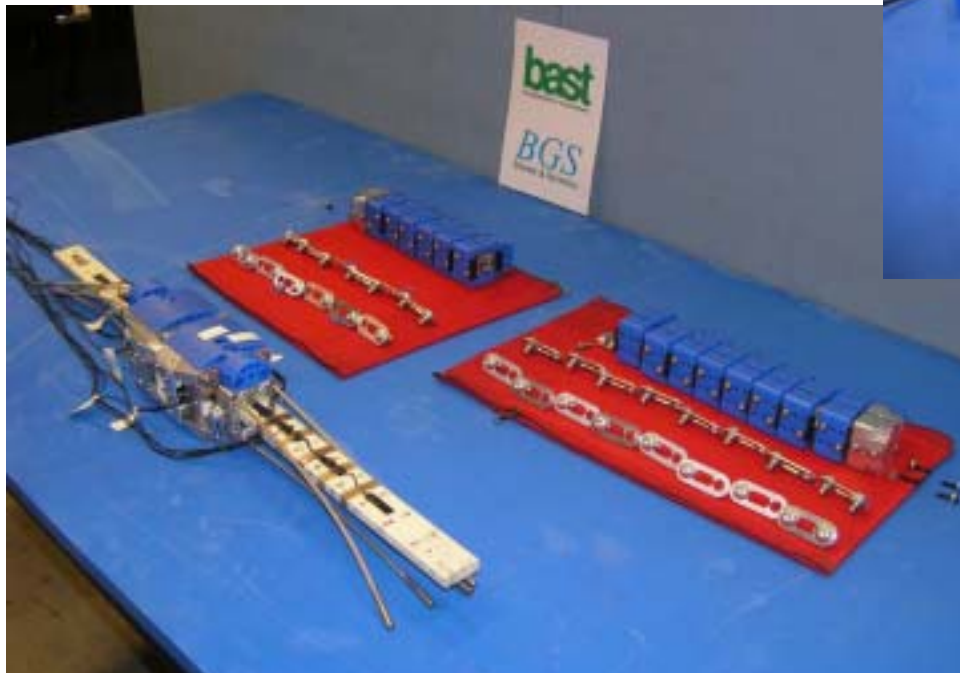
- In case of multiple cable damage the impactor has to be dismantled

- Modification of the cable guiding within the impactor, e.g. integration of the guiding in the tibia and femur segments
- Introduction of a single 17-channel connection cable
- Introduction of a central plug and socket at one end of the impactor in order to be able to replace the connection cable immediately in case of damage
- Rounding of all outer sharp edges of metal parts
- Introduction of a one-piece outer skin with strong zipper
- Improvement of the axial guiding between upper and lower leg
- Replacement of the roller with a linear guiding system to reduce the ACL/PCL-offset at point of first contact
- Certification test to be performed after 3 - 5 impact tests or after severe or unexpected results (to be defined)

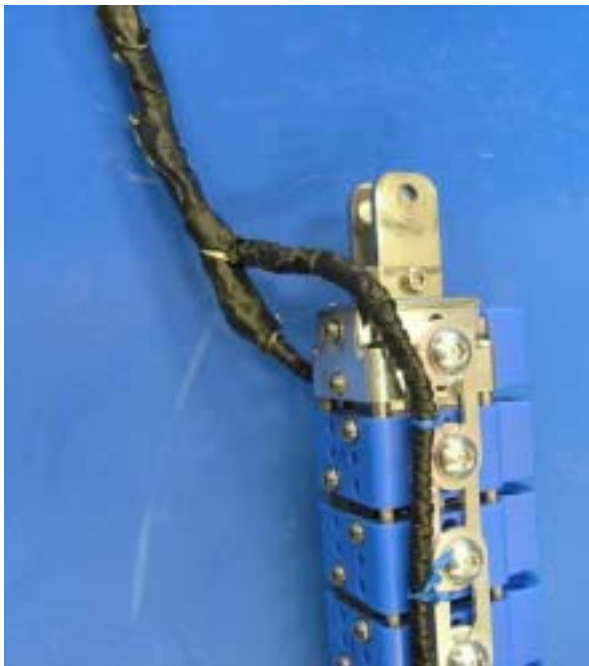
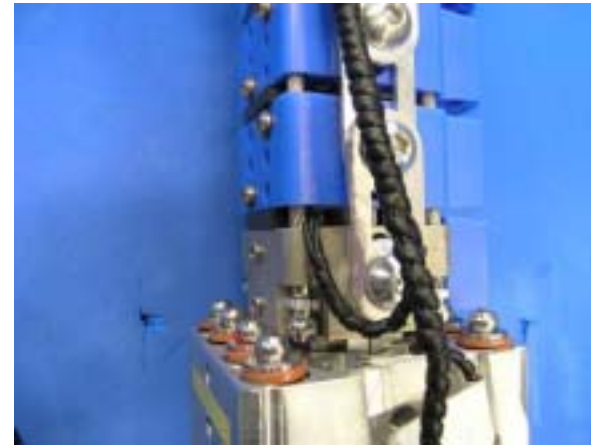
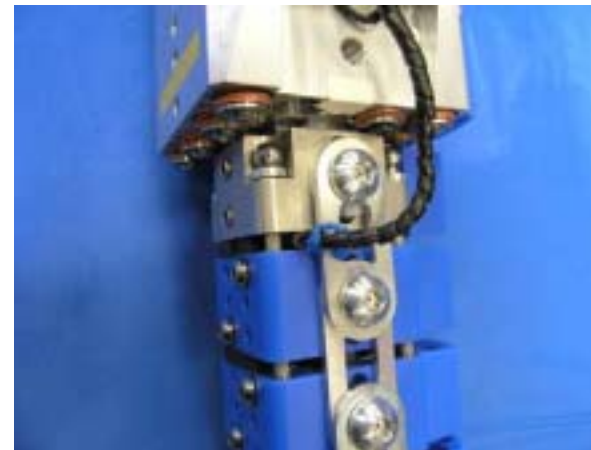
- Cable guiding with sharp angles and around sharp edges
- Cables likely to be damaged near the impactor

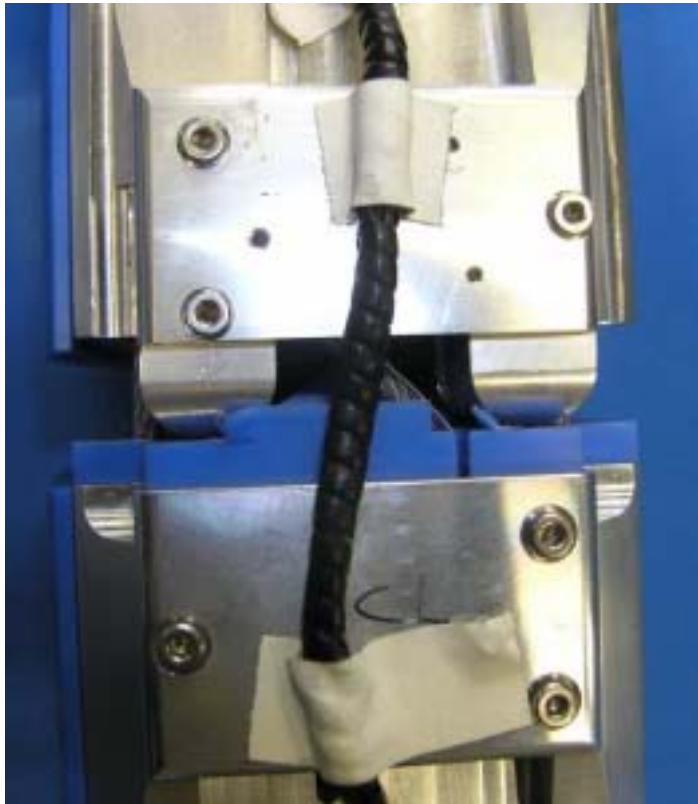
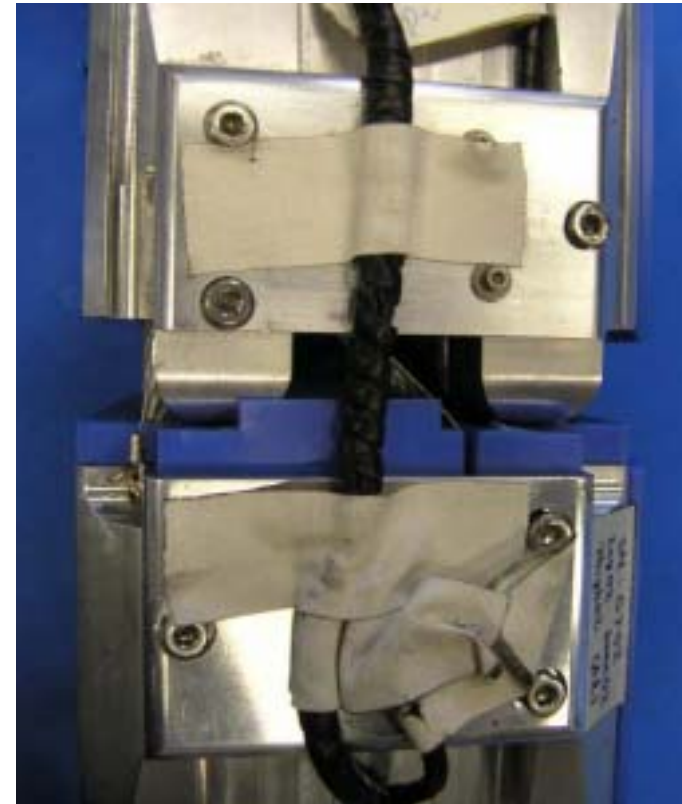
- Broken guidings at tibia surface plate

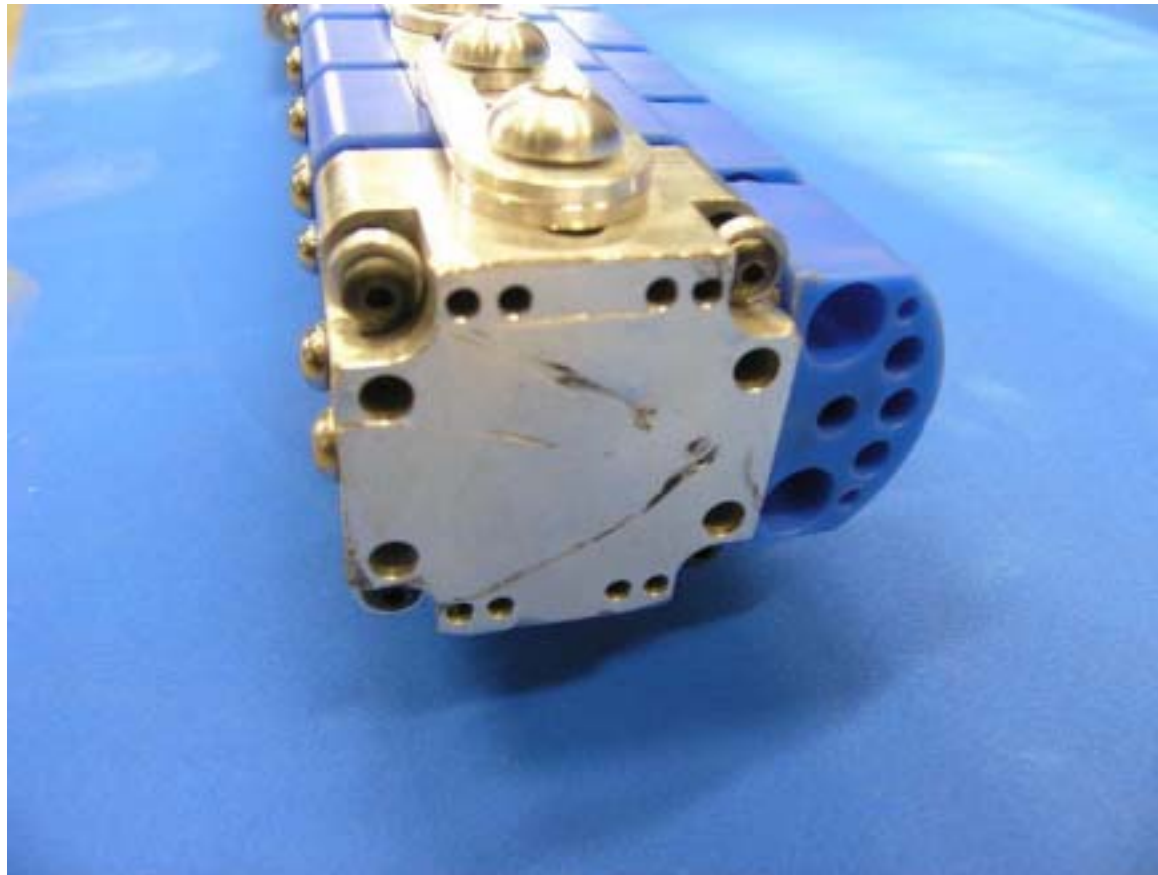
- Scratches at tibia lower end

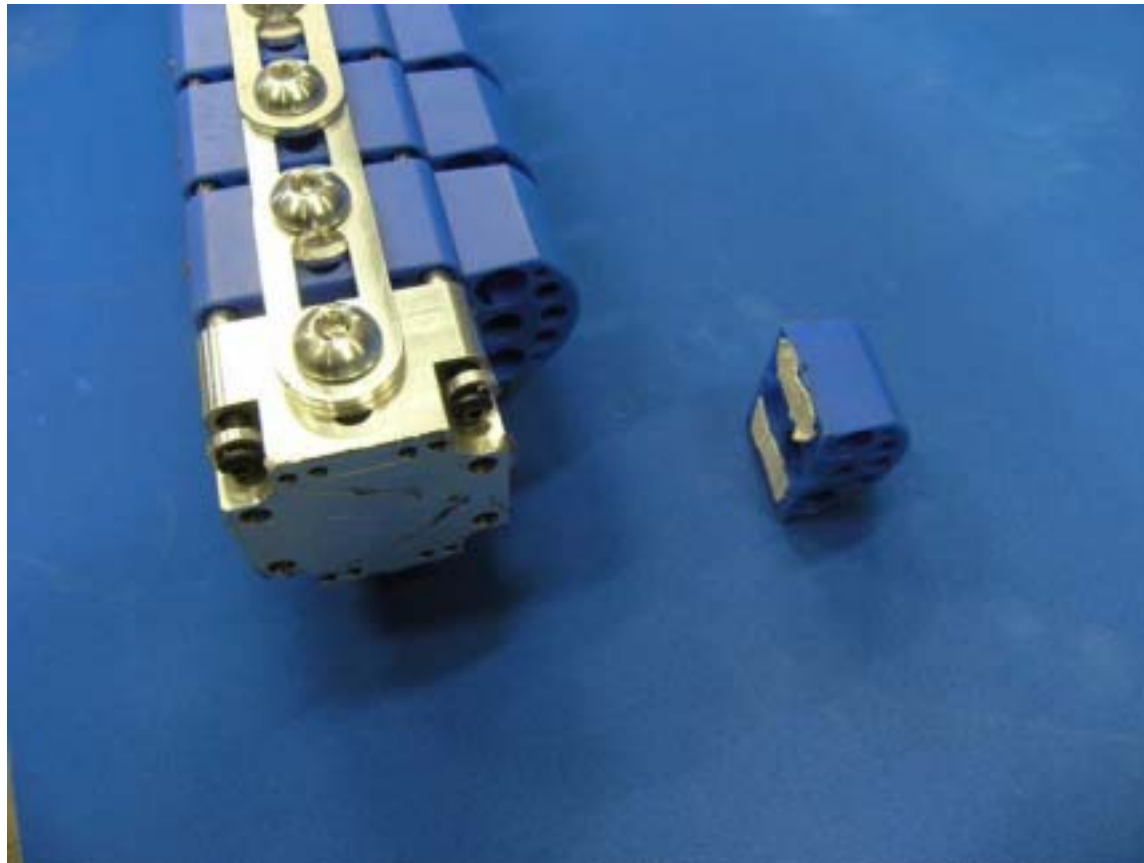
- Separation of lowest segment impact face

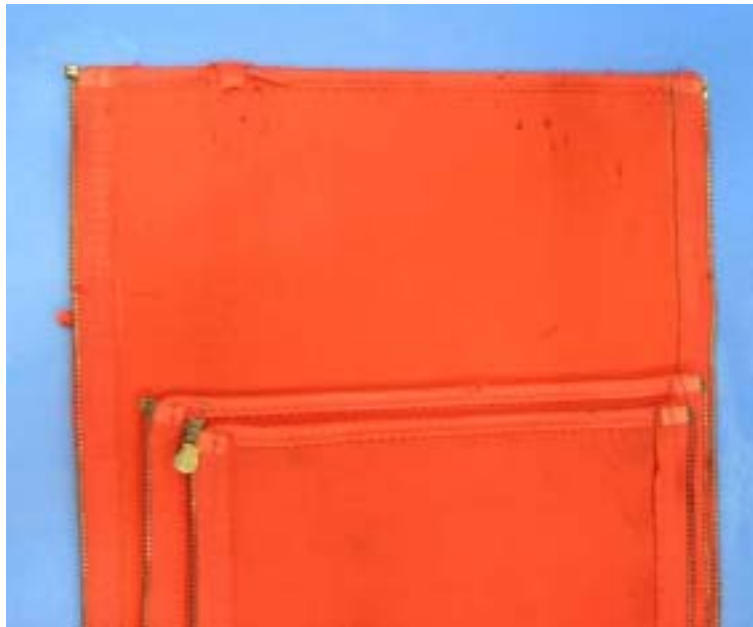
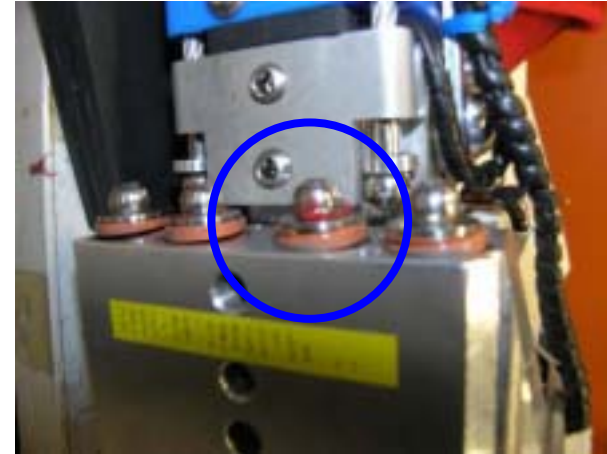
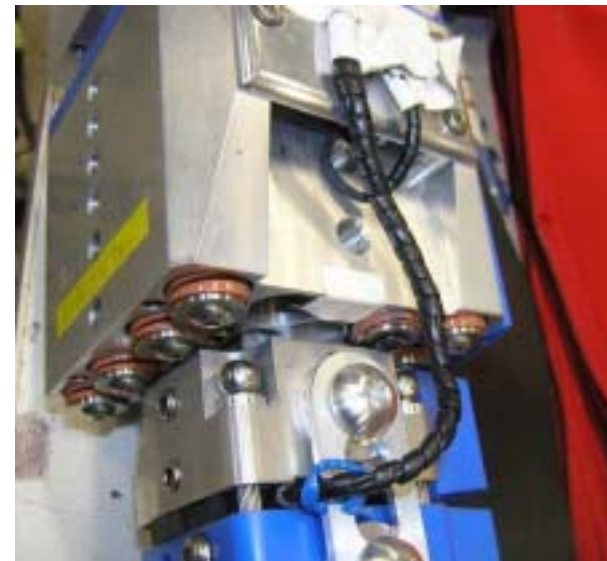
- Neoprene skin:
  - Zippers very sensitive
  - Skin gets caught in spring ends
  - Skin damaged by sharp edges of knee
