**Proposals for amendments to the Regulations annexed to ADN:
other proposals**

Addendum 1 Report inspection interval PO tanks – Tank Assist

Case: Inspection interval
barge's tanks
Propylene Oxide
Report number: 1721004/01
Date: 07th March 2017

Addendum 2 Inspection report and testing on cargo tanks of ex-Chemgas 17 – Manufacturer Siemerink

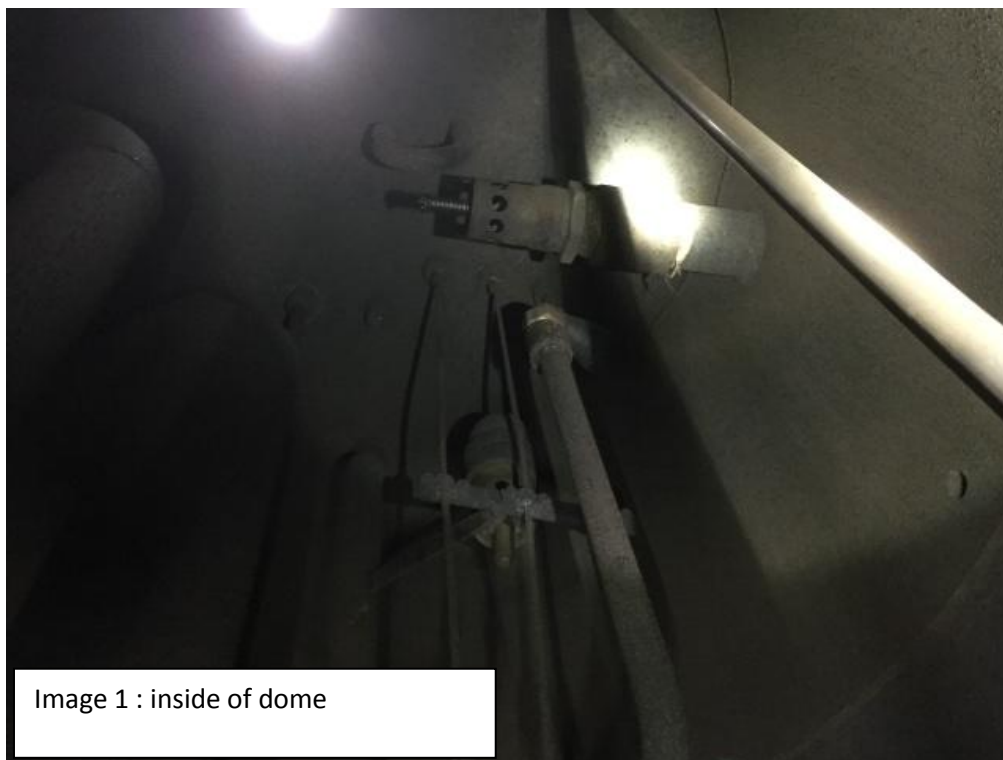
The global inspection of the internal tank surface showed a similar surface condition throughout all the tanks with no sign of degradation of the surface either generally or locally. Please see images 1 through 3

Image 1 : inside of dome

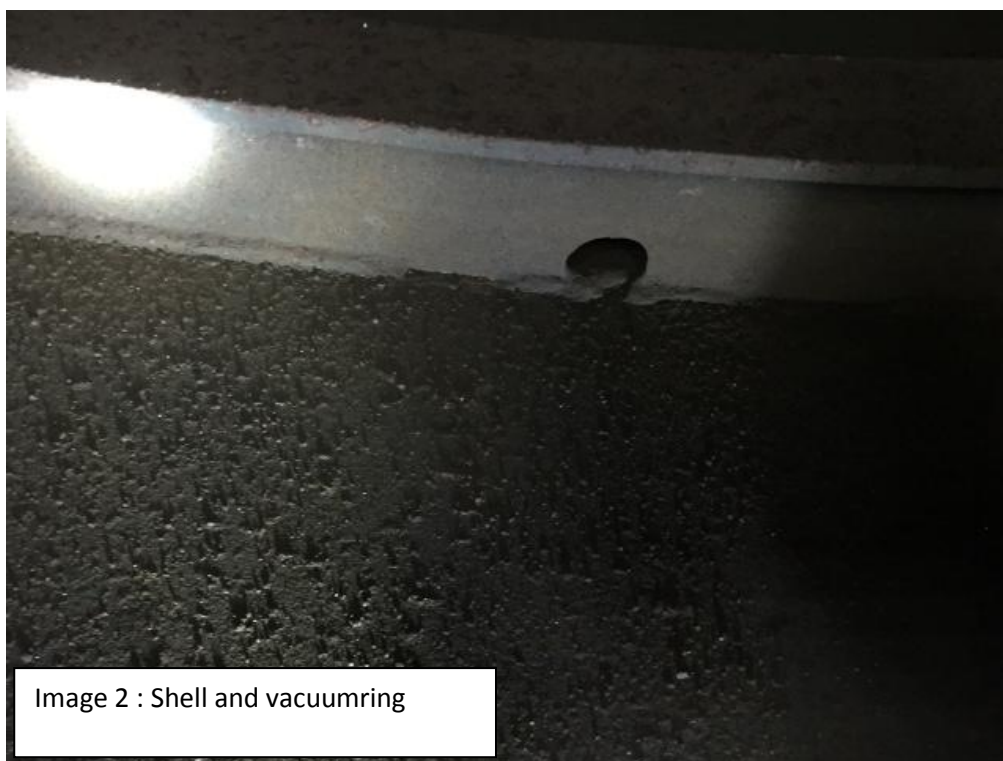
Image 2 : Shell and vacuumring

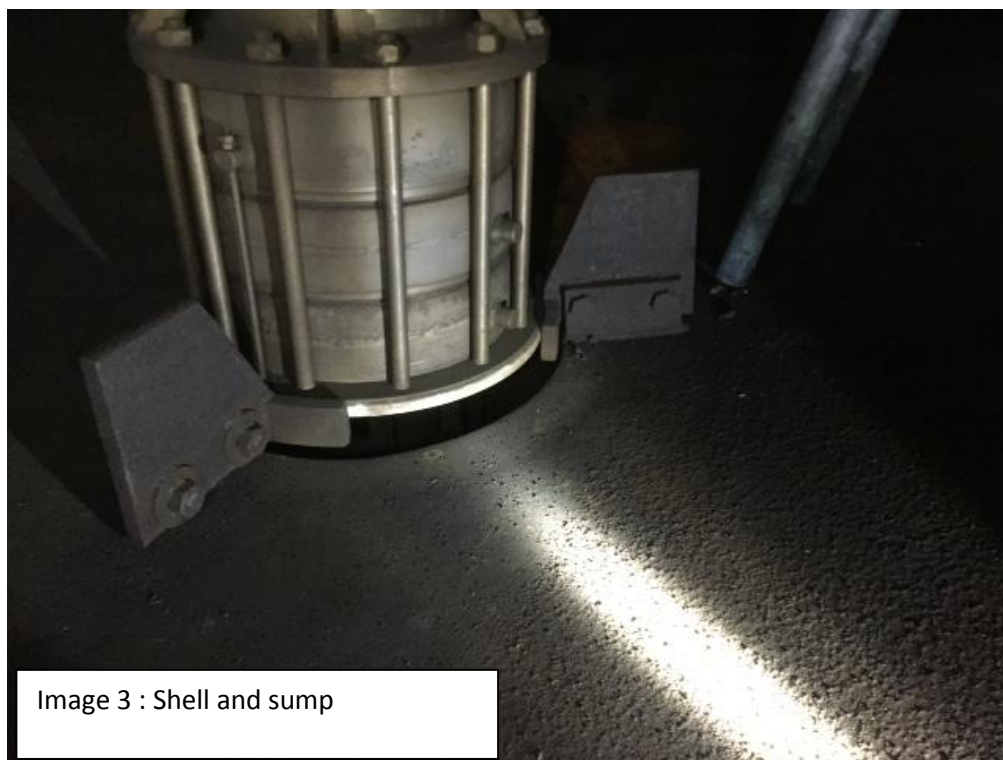
Image 3 : Shell and sump

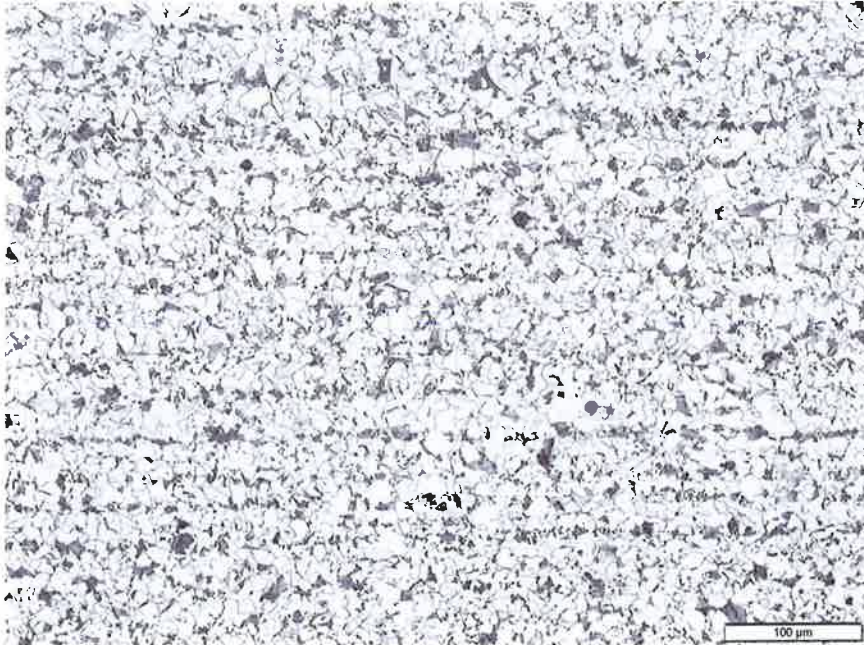
Inner surface

Structure: The microstructure of the inner surface showed a matrix of ferrite with pearlite. No deleterious constituents were observed in the cross-section.

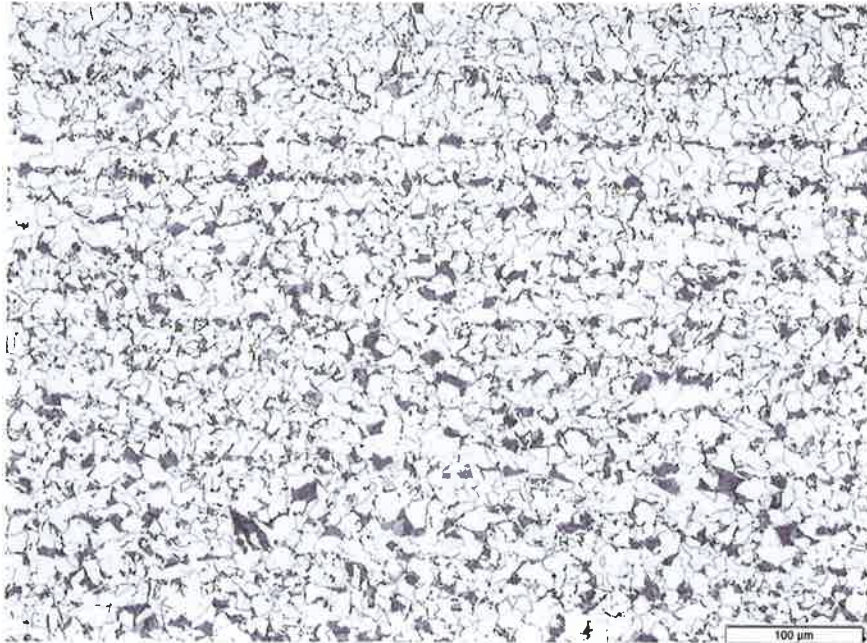
Structure: The microstructure of the outer surface showed a matrix of ferrite with pearlite. No deleterious constituents were observed in the cross-section.

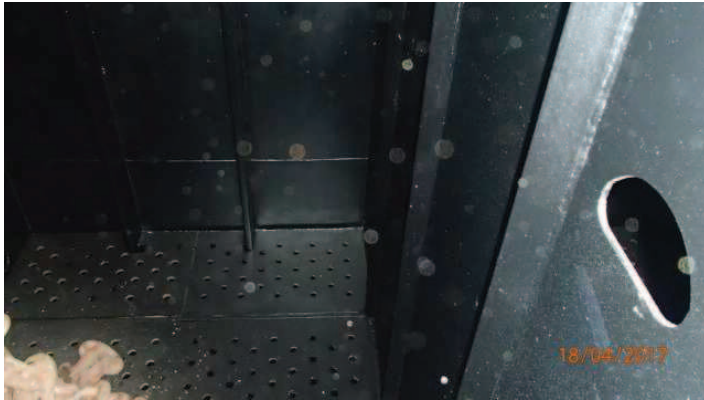
Chainlocker, False Bottom and sides, coating is in good condition

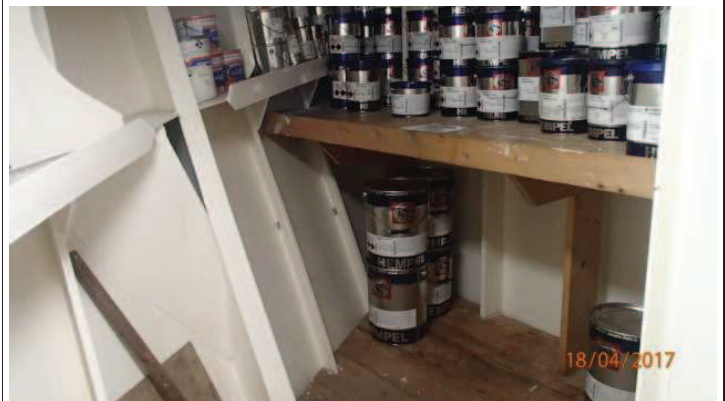
Fore peak, is dry space and nicely coated

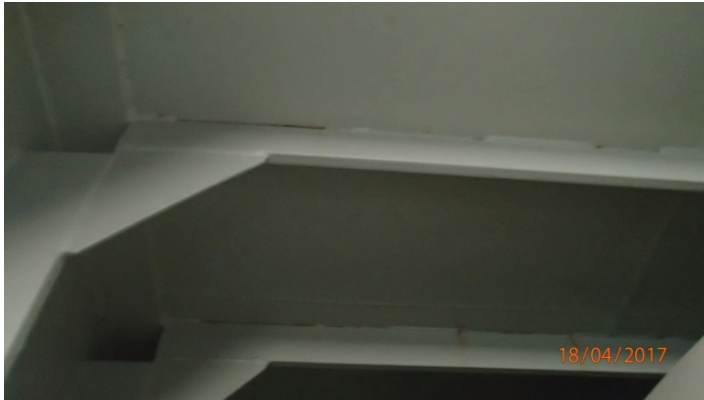
Forward Void space no 1 (Deck head), coating in good condition

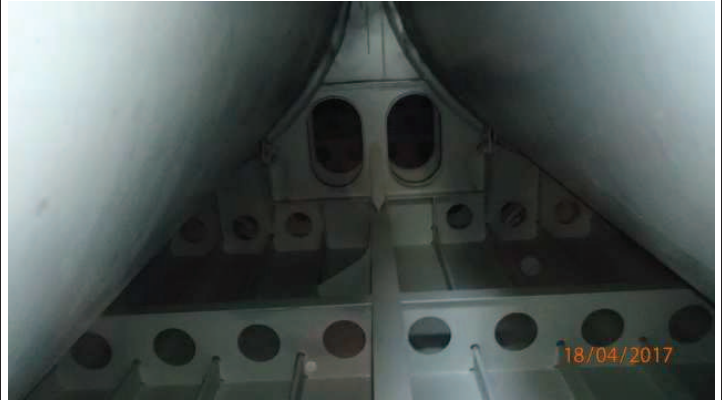
Forward void space no 1 (Tank fundation and bottom plating) very clean

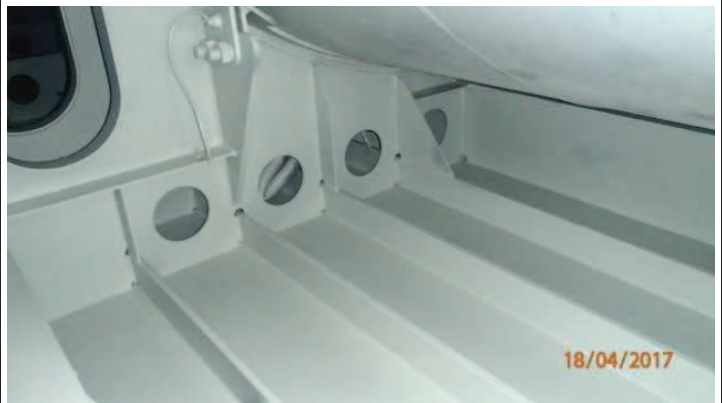
Middle void space (Cargo tank Foundation) very clean and in good condition

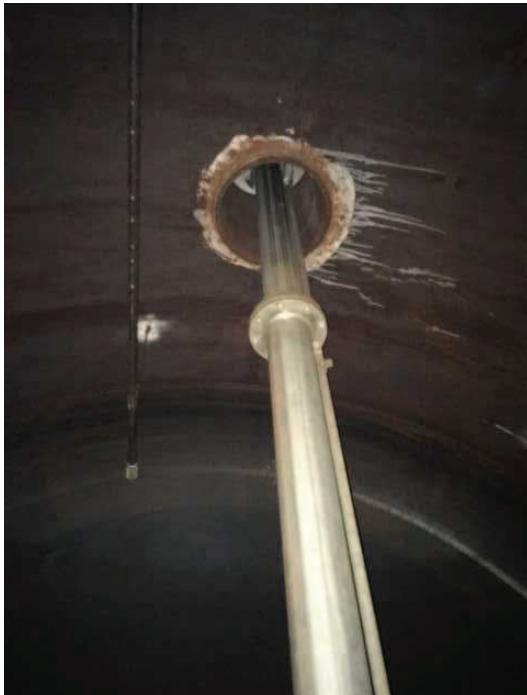
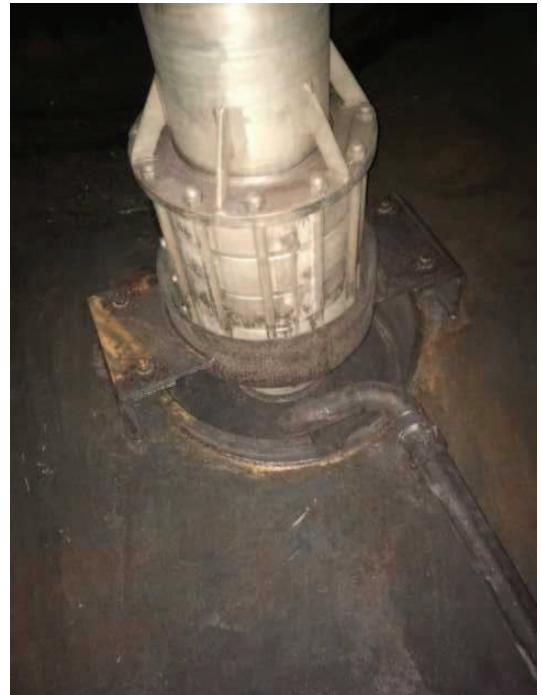
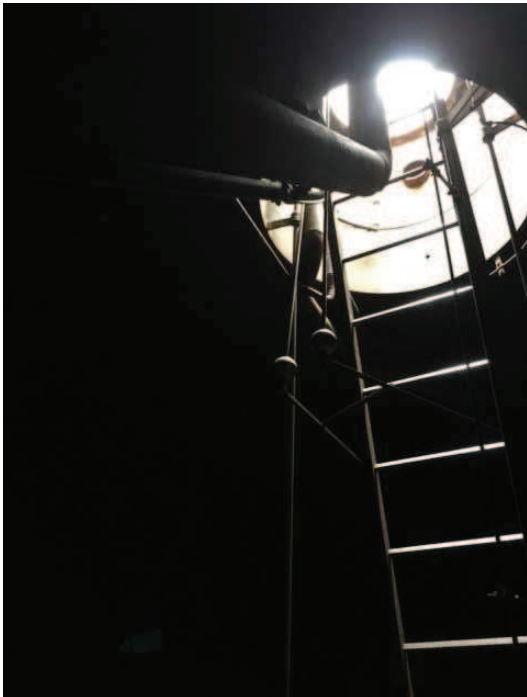
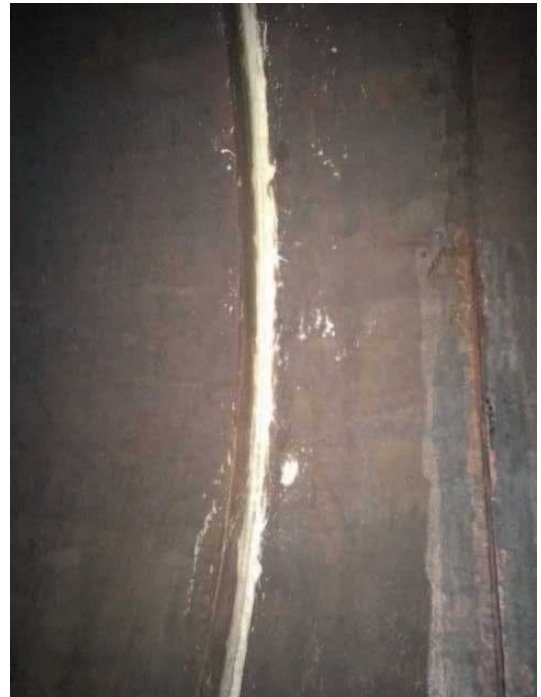
Note; All sediment and mud from the ballast tanks and the void spaces has been removed and all tanks are very clean.
Also the cargo tanks are very clean
