**REPORT FOLLOWING  
TECHNICAL INVESTIGATION  
into the collision (and resulting fire)  
between a coach and a HGV  
that occurred on October 23rd 2015  
on Departmental Road No 17  
near the town of Puisseguin  
(South-West of France)**

**Land Transport Accidents  
Investigations Bureau**

Case n° BEATT-2015-014

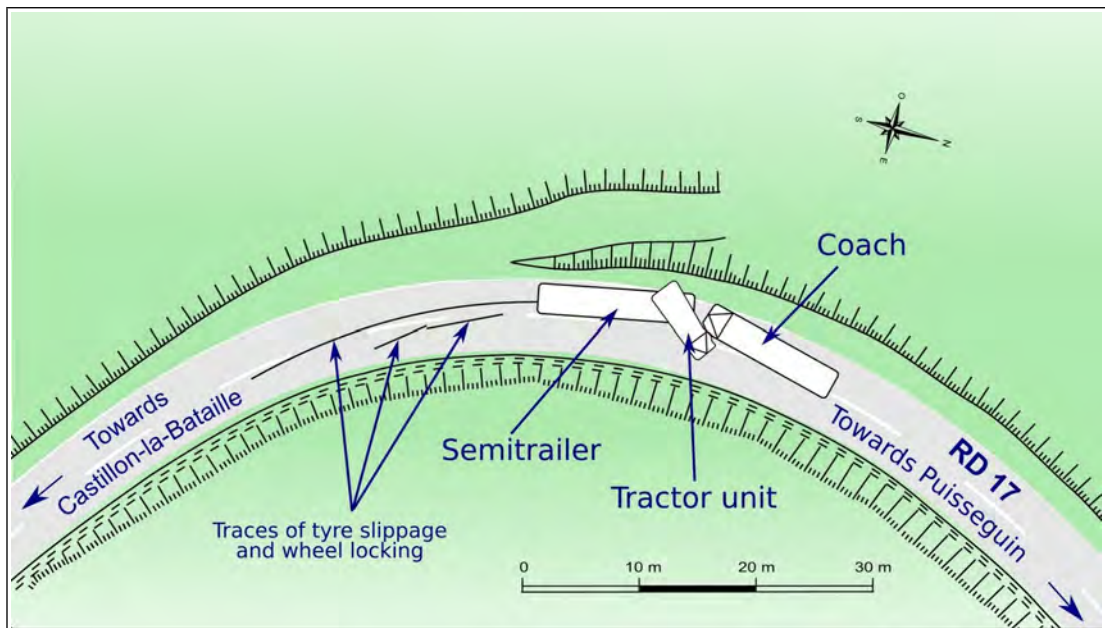
The coach was immobilised on the road along the verge to the right of its lane. The lorry was immobilised in a jack-knife position along the same verge, in the opposite direction, with the front left of the vehicle resting against the front left of the coach.

**Figure 4: Position of the vehicles upon the arrival of emergency services**

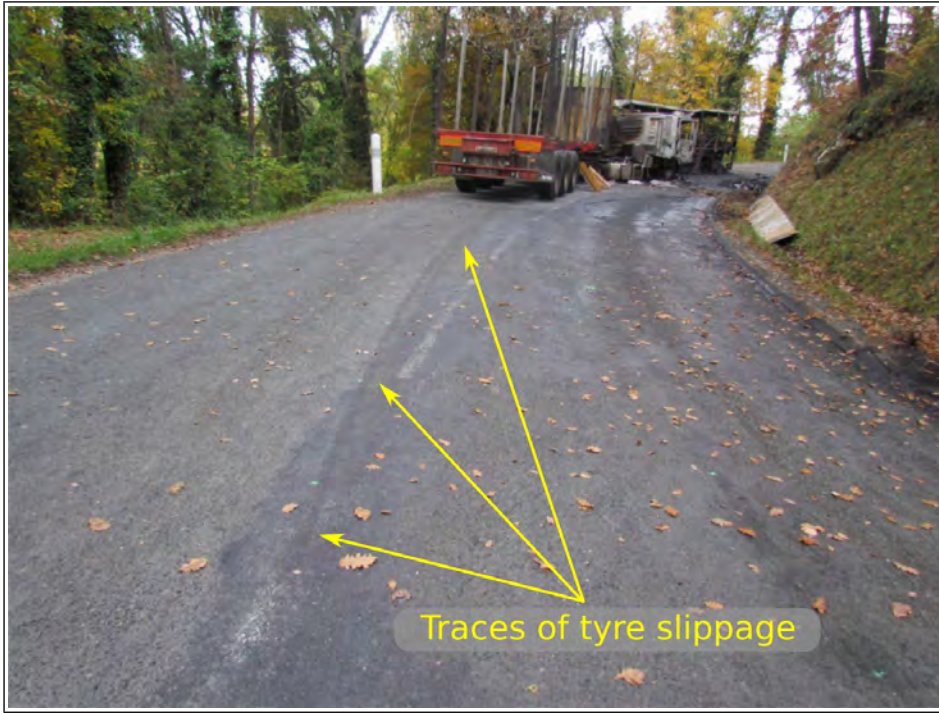
Leading up to the accident, in the direction in which the lorry was travelling, judicial investigators found two types of tyre tracks on the road surface: one caused by tyre slipping and two tracks caused by locked wheels.

**Figure 8: View of the tracks caused by tyre slipping found on the road surface**

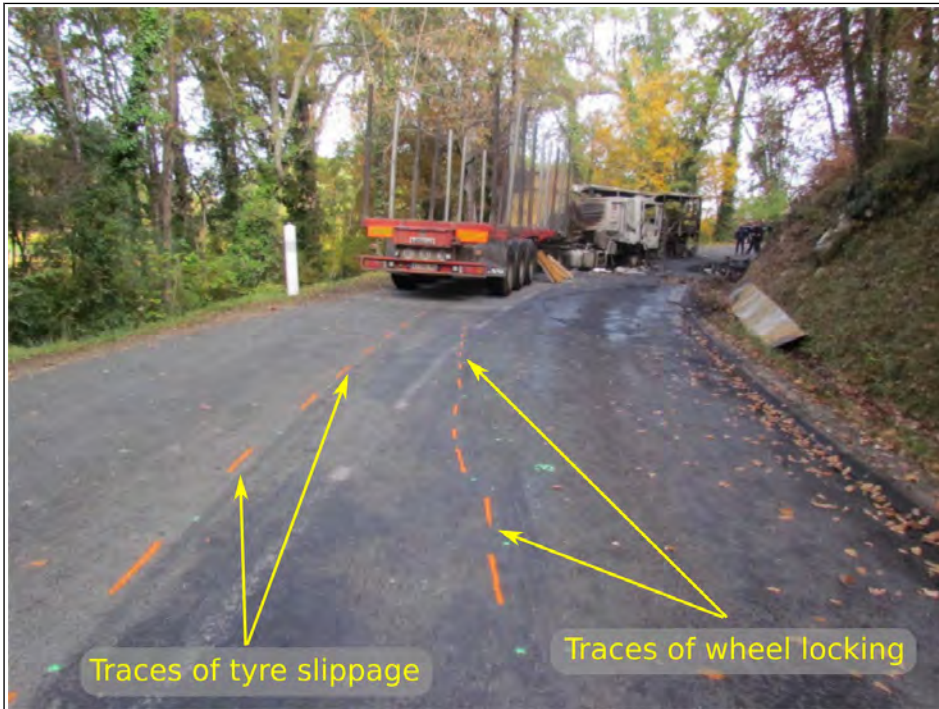
**Figure 9: Close-up view of tracks found on the road surface, highlighted with red paint by judicial investigators**

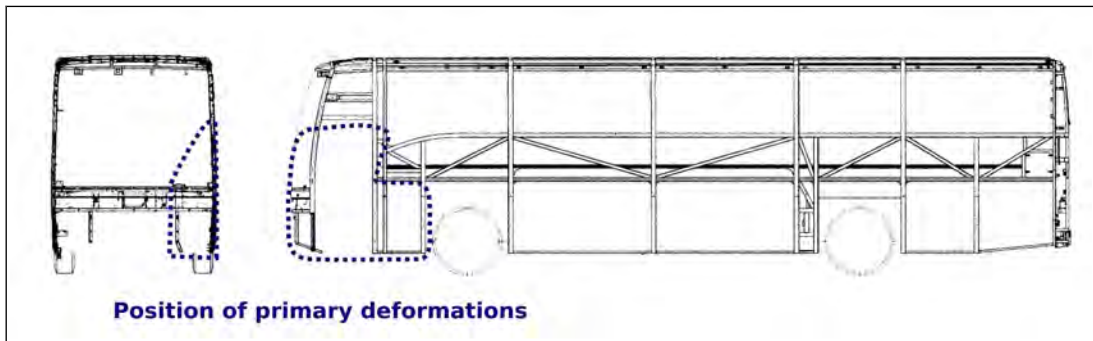
The vehicle suffered a frontal collision with the lorry on its left-hand side, causing its solid structures to be pushed back. The deformations to the vehicle's structure were mostly concentrated in the areas indicated in figures 28 - 31 below.

**Figure 28: Position of areas of structural damage to the coach**

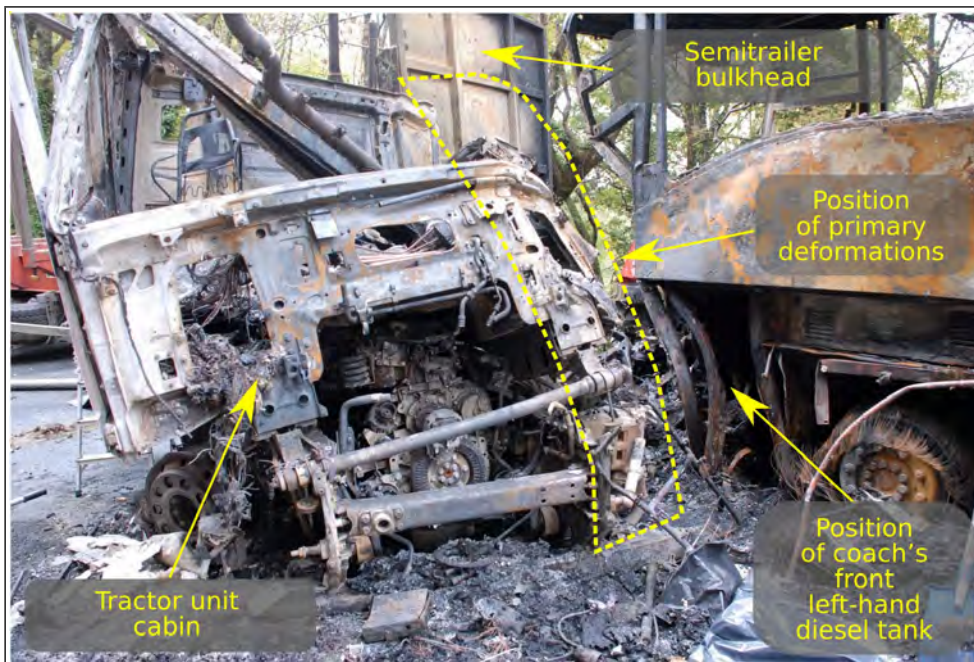
The tractor unit showed signs of localised crushing on its front left-hand corner, with the structures having been collapsed inwards. The driver's cabin was partially collapsed. The left hand side of the cab's rear panel was pressing against the front bulkhead of the semitrailer.

**Figure 57: Front view of the tractor unit involved in the accident**

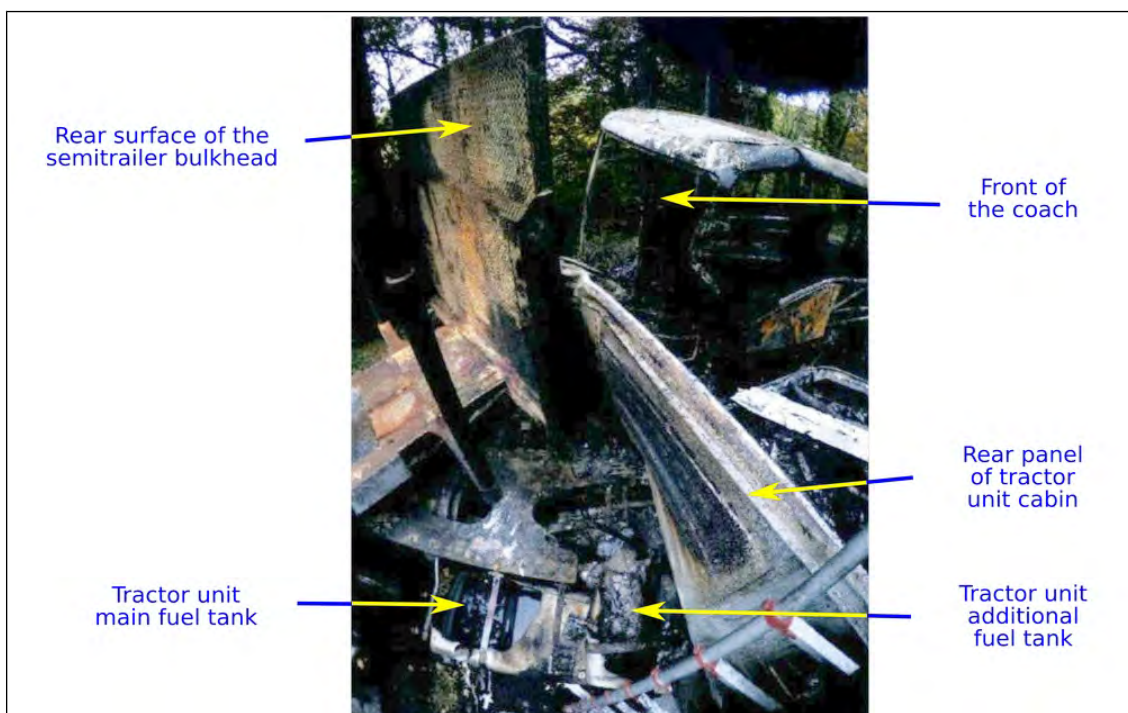
**Figure 58: Rear view of the tractor unit involved in the accident**

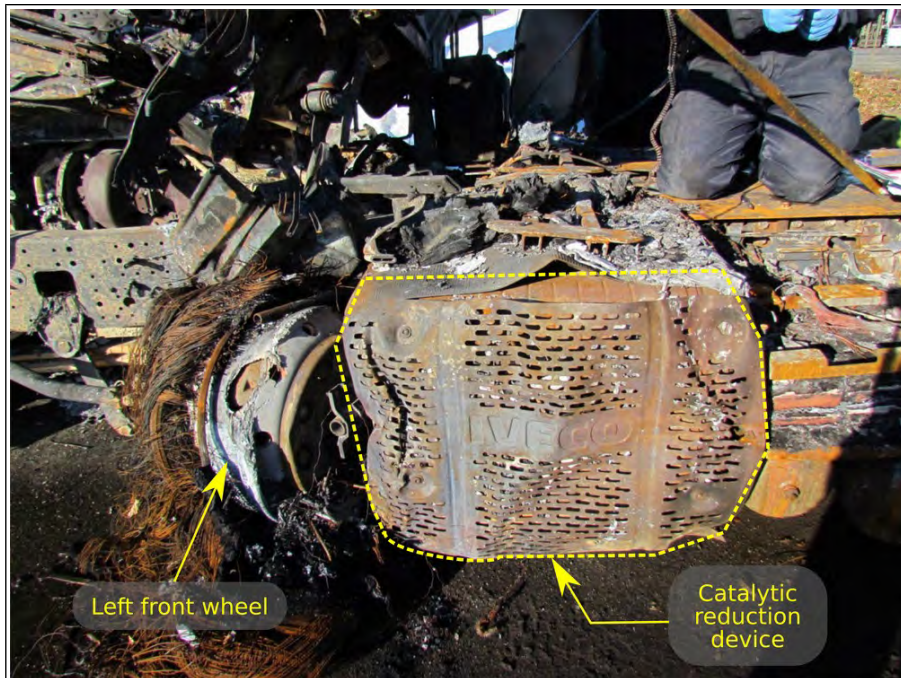
The front left-hand axle was forced back by the impact, and the left front wheel was pushed back against the tractor unit's catalytic reduction system, colliding with and damaging the device.

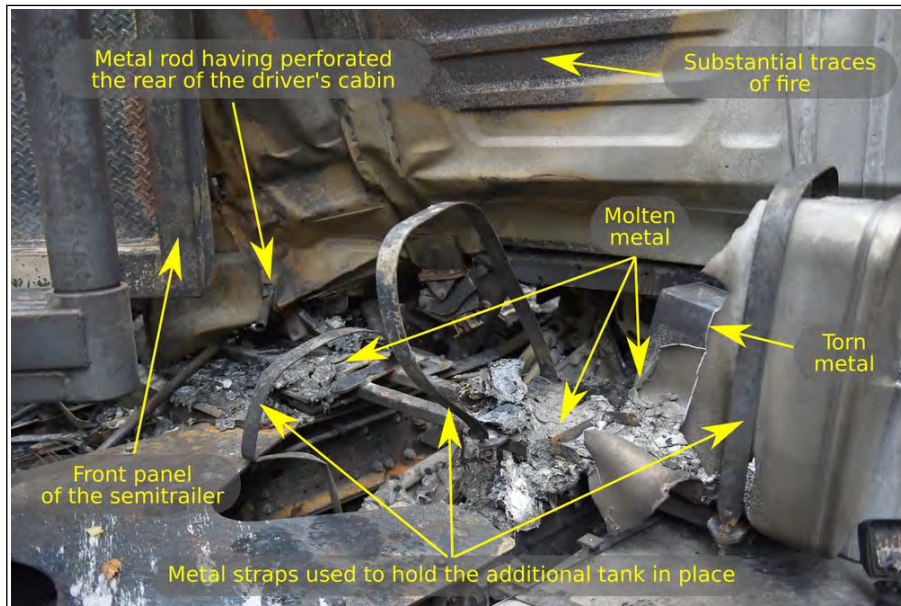
A metal rod, which had been stored in a boot space on the left-hand side of the driver's cab, perforated the rear of the cab; one end of the rod was found where the additional fuel tank had been, in a position that led investigators to surmise that it had partially perforated the tank.

**Figure 63: Close-up view of the additional fuel tank on the tractor unit involved in the accident**

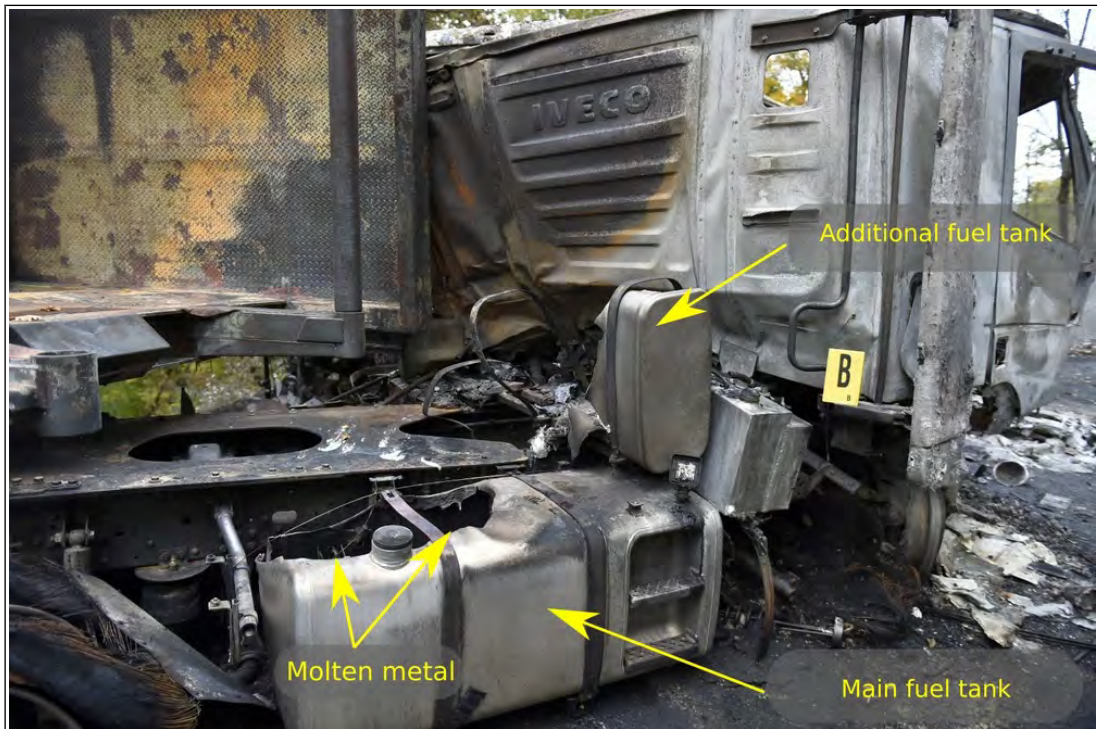
The main fuel tank of the trailer truck was partially melted. It was not located in the direct area of impact. It was not distorted. The damage it suffered is as a result of the fire's thermal radiation.

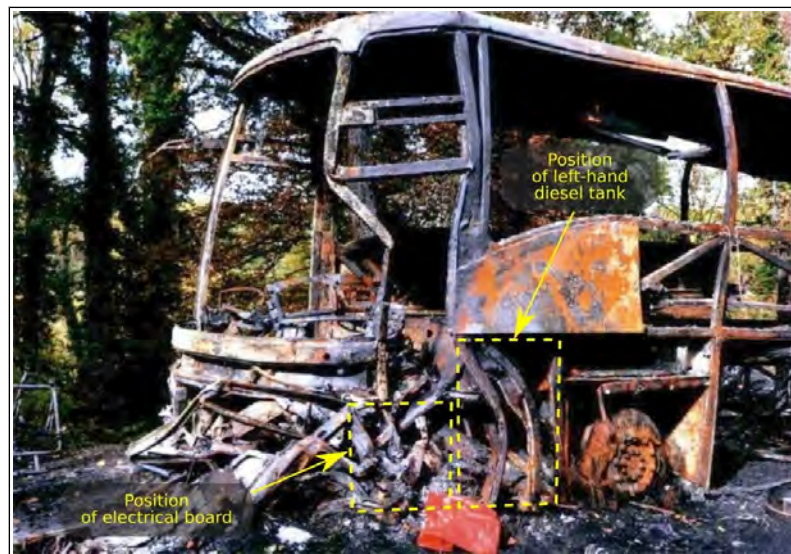
**The left fuel tank of the coach** is made of polyethylene and has been completely burned. There are no usable parts left. This tank was located in the direct area of impact in which the metal structures of the coach which protected it were extensively crushed. It is therefore very probable that this tank did not withstand the impact and that it broke during the collision, releasing its fuel which then spread to the ground.

**Figure 79: View of the left front of the accident-damaged coach**
