REPORT FOLLOWING TECHNICAL INVESTIGATION

**into the collision (and resulting fire)
between a coach and a HGV
that occurred on October 23rd 2015
on Departmental Road No 17
near the town of Puisseguin
(South-West of France)**

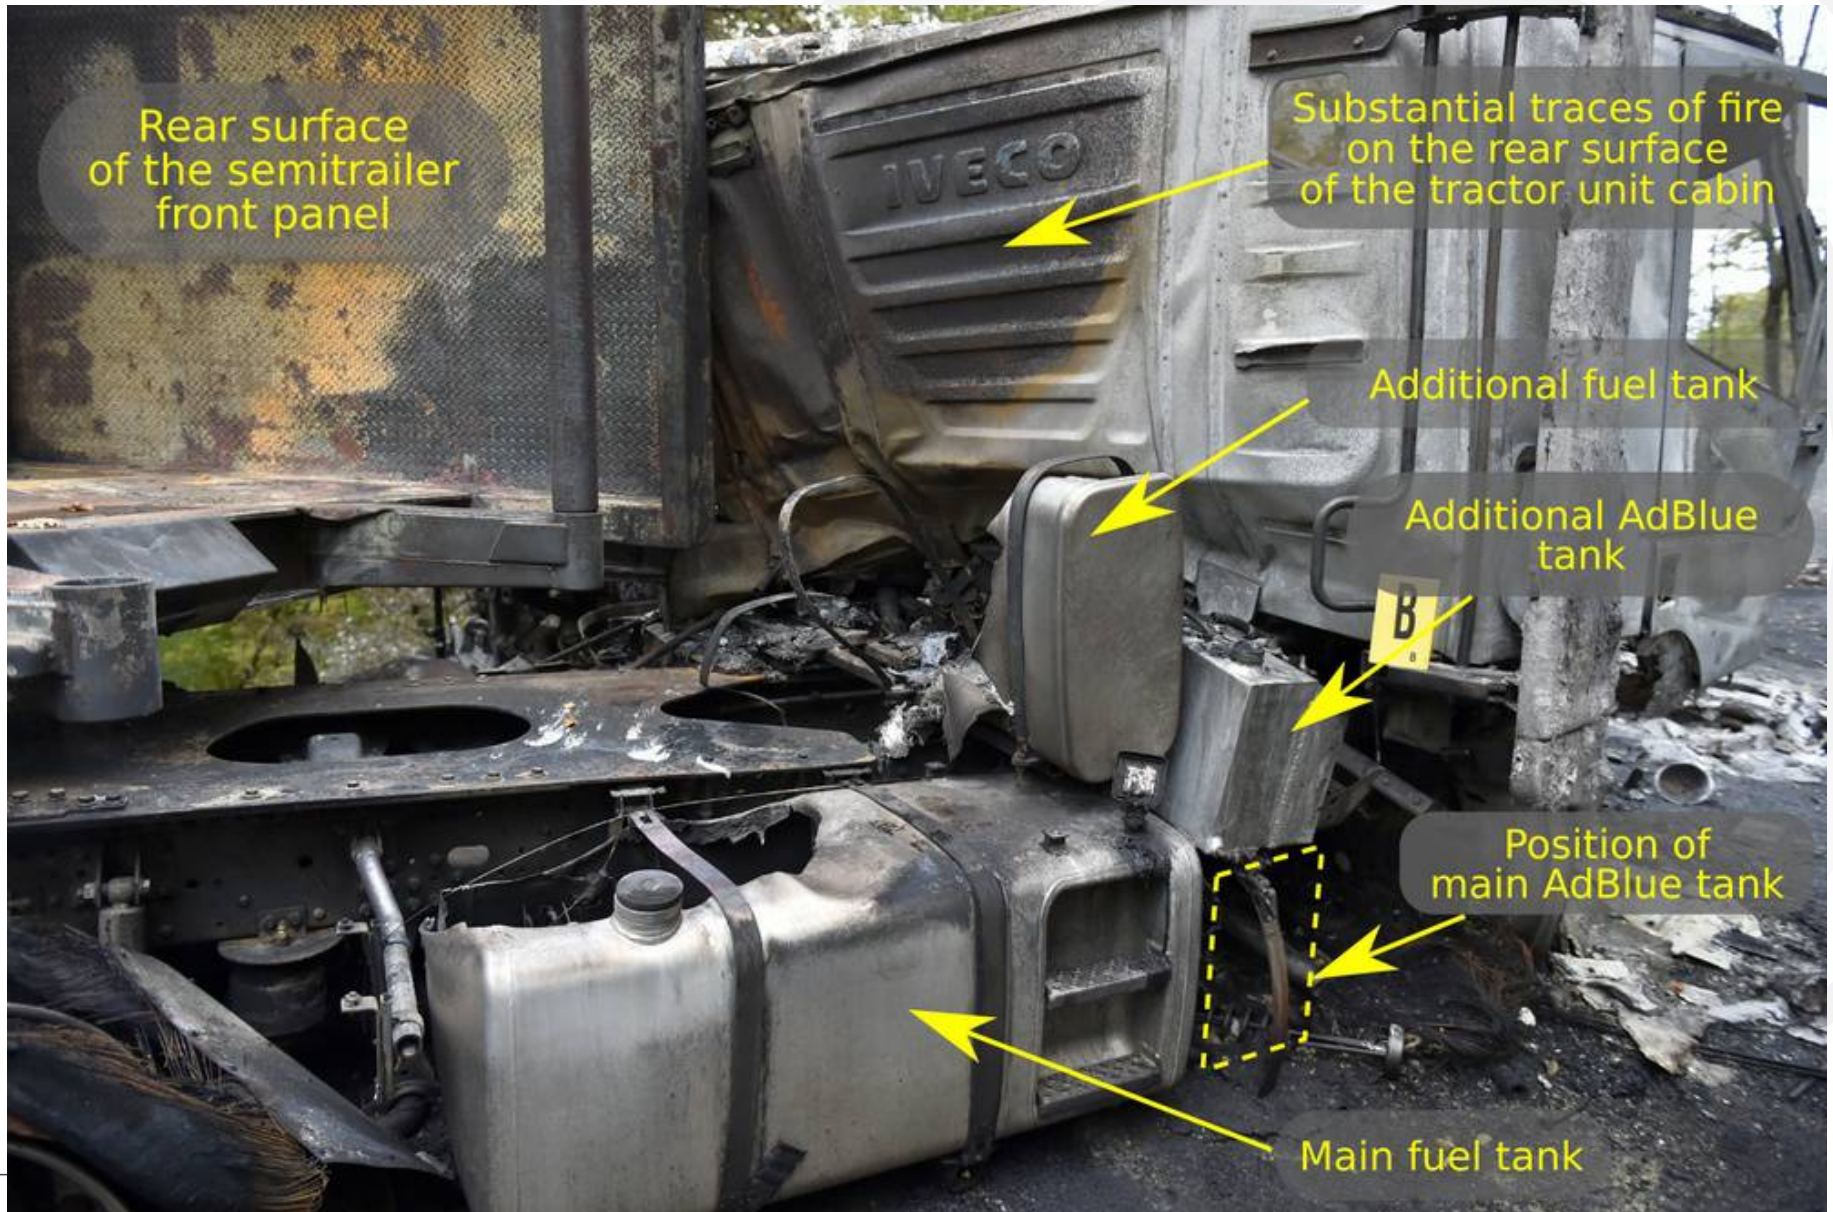
View of the right-hand side of the tractor unit involved in the accident

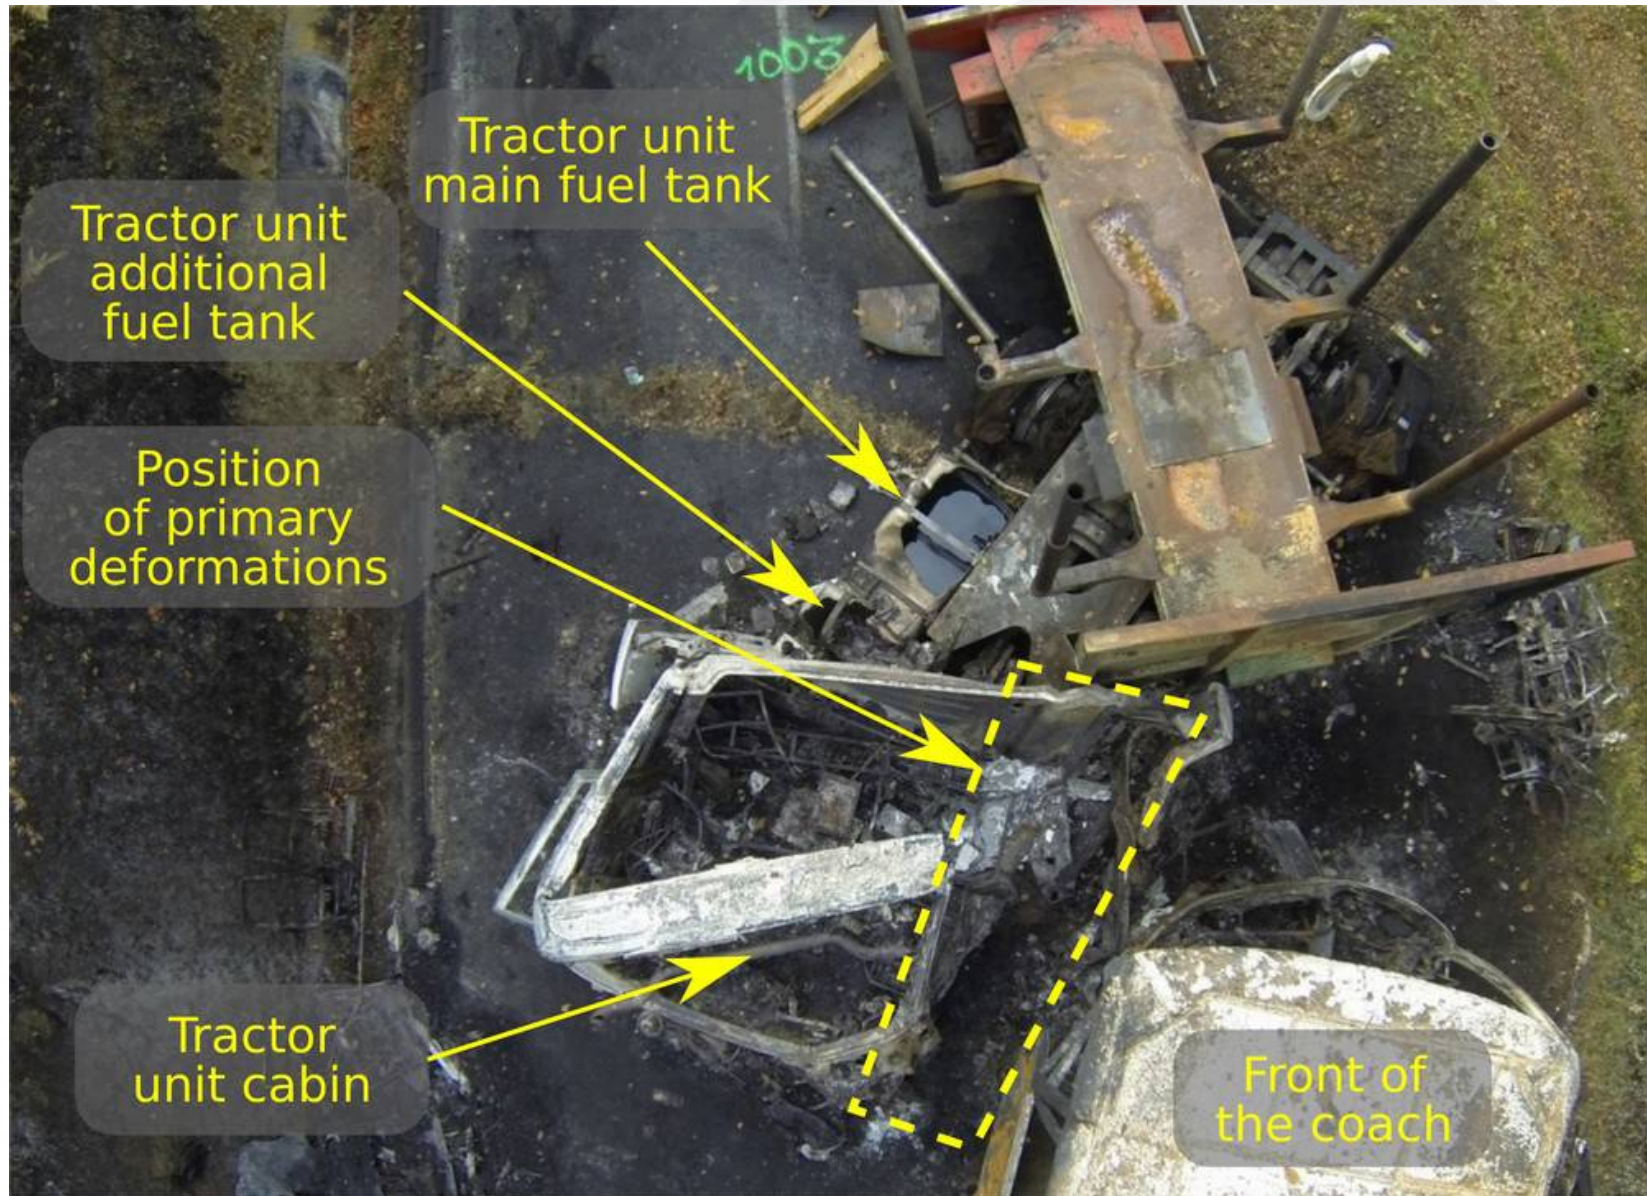
Aerial view of the tractor unit

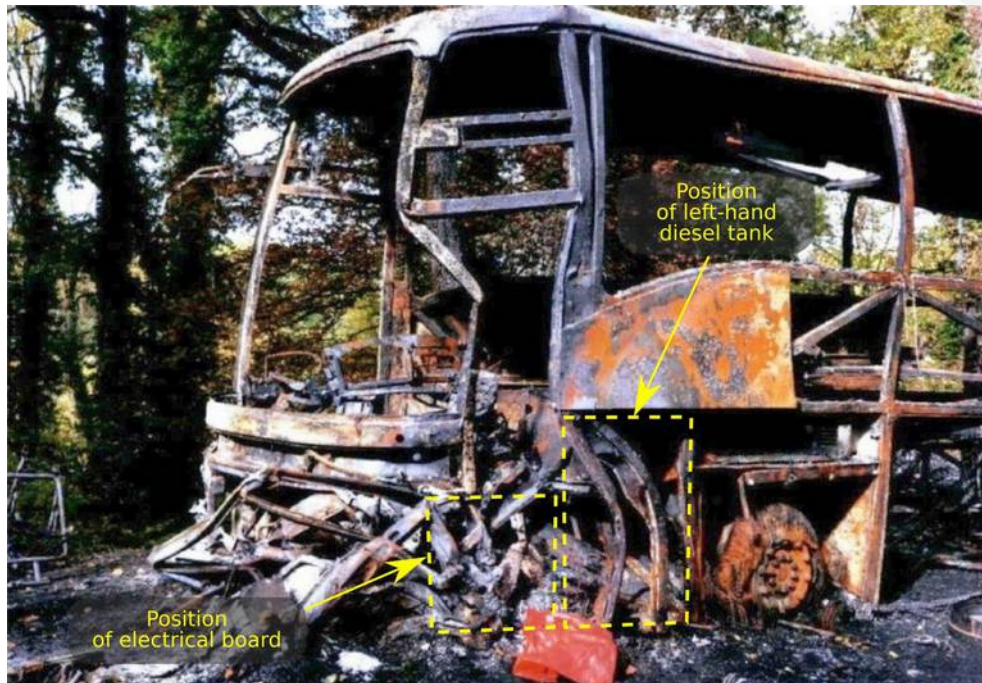
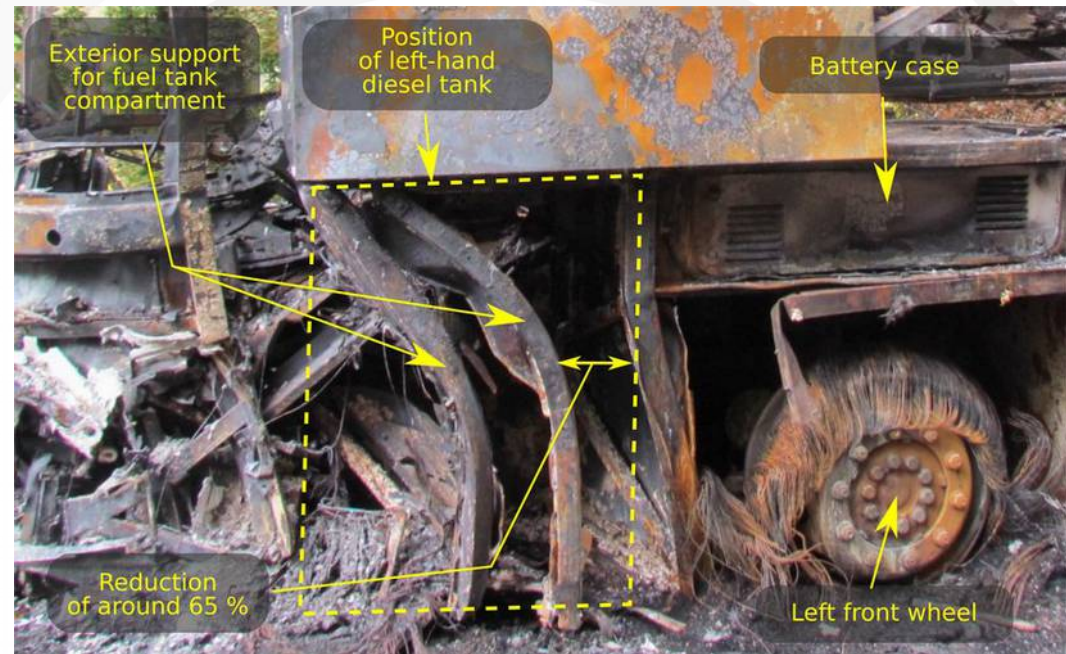
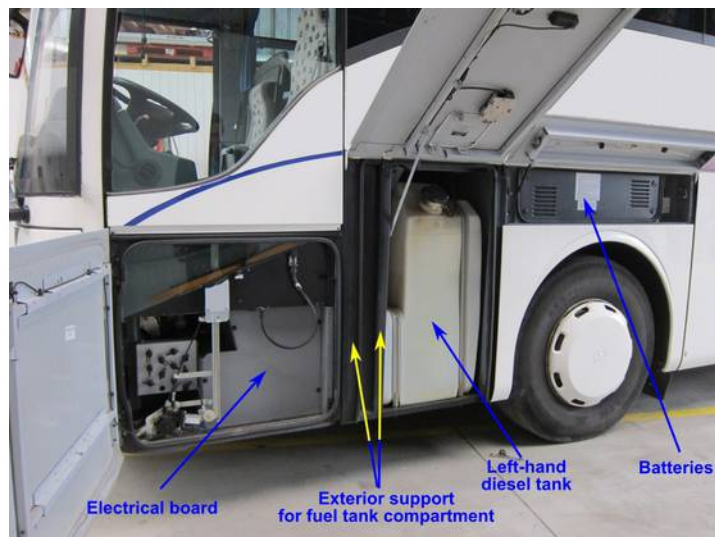
View of the front left-hand side of the coach

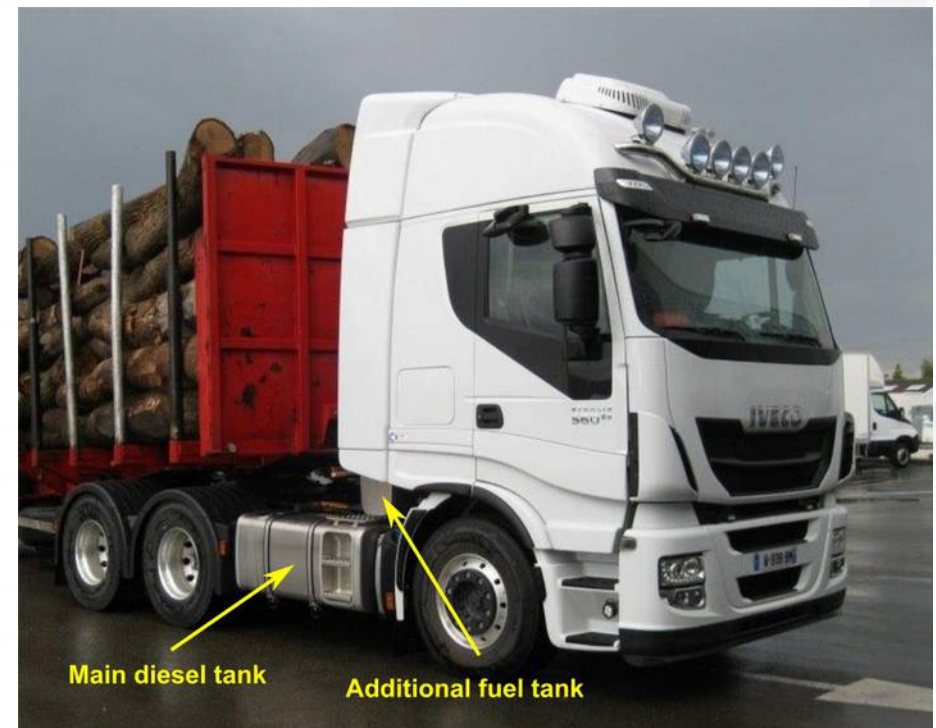
The assessment **did not show any internal failure** in the tractor unit (brought into operation in 2014) **that might have caused it to malfunction** in the moments leading up to the crash.

The expert assessment showed that following its factory release, **the following modifications had especially been made to the tractor unit:**

- addition of **two tanks behind the cab**: one fuel tank and a tank containing an aqueous urea solution (AdBlue®);
- fifth-wheel coupling moved further towards the rear of the vehicle.

Amend Article 13 of the decree of 19 July 1954 relating to the type-approval of motor vehicles in order to add to the list of significant conversions any addition of a tank of fuel of significant capacity not expressly foreseen by the manufacturer of the motor vehicle and update the technical instructions for vehicle inspection accordingly.

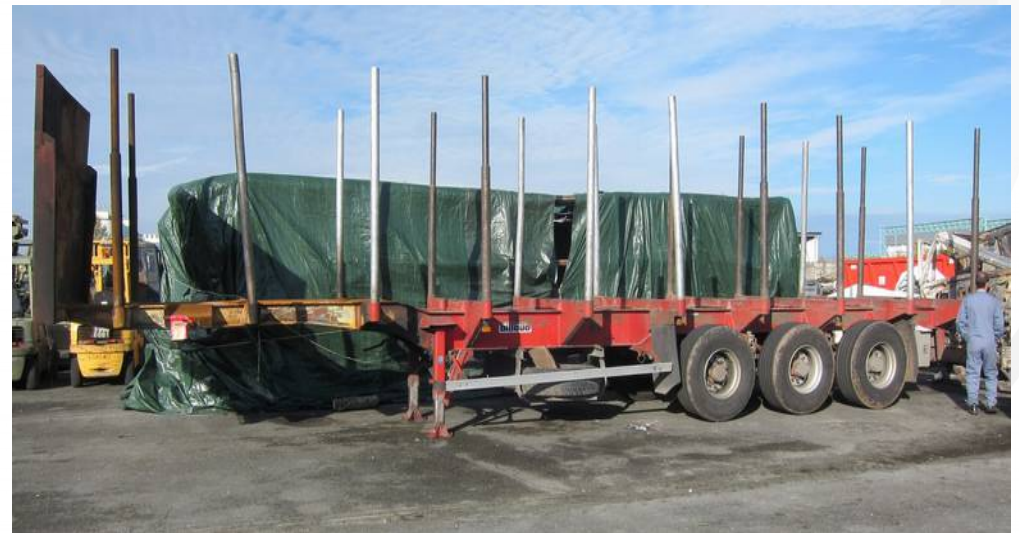
- The examination of its braking system revealed **several defects** (corrosion and cracking of various components, incorrectly connected ABS receptors)
- When the ABS was activated, the trailer was only **able to brake** effectively on **its left-hand side**
- Braking of the right wheels was **weaker** on the third axletree and **stronger** on the first two, causing the wheels to lock

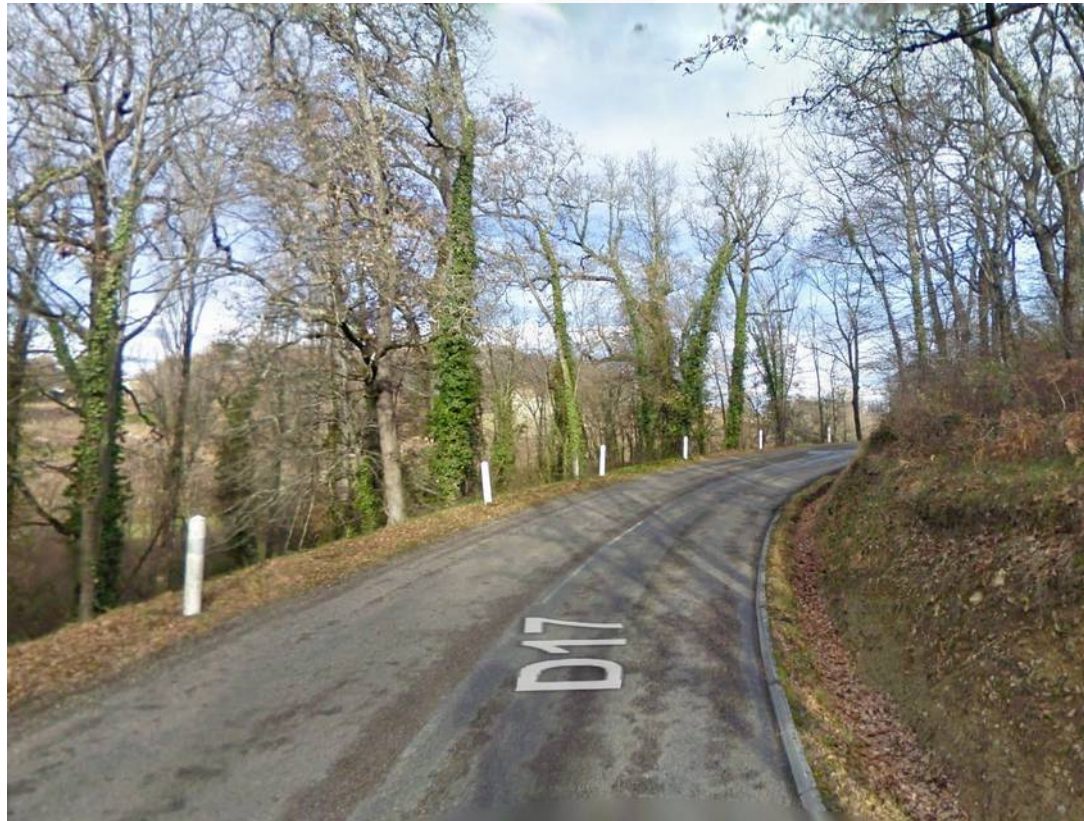
① View of the bend from the position at which the accident occurred, from the direction in which the lorry was travelling

- Road 2x3m wide, without verges
- Visibility reduced by around 40m
- Bends are indicated via warning signs and positional road signs
- Quality of road surface deemed satisfactory

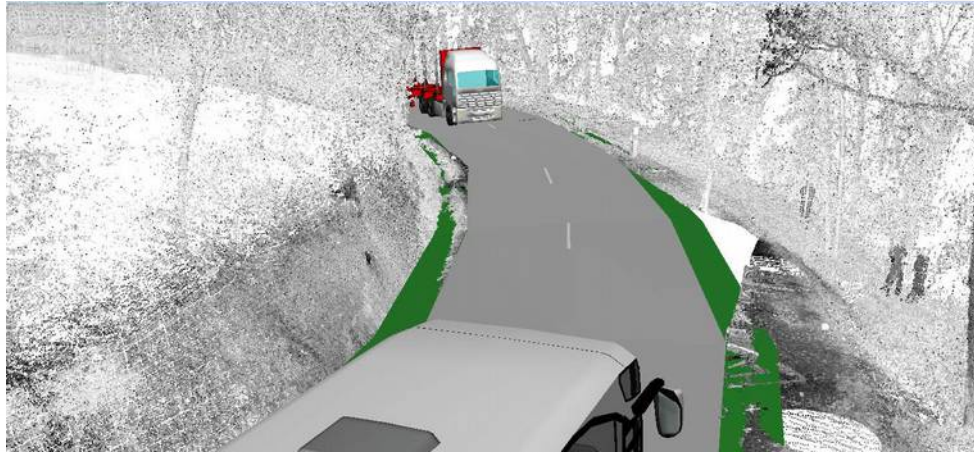
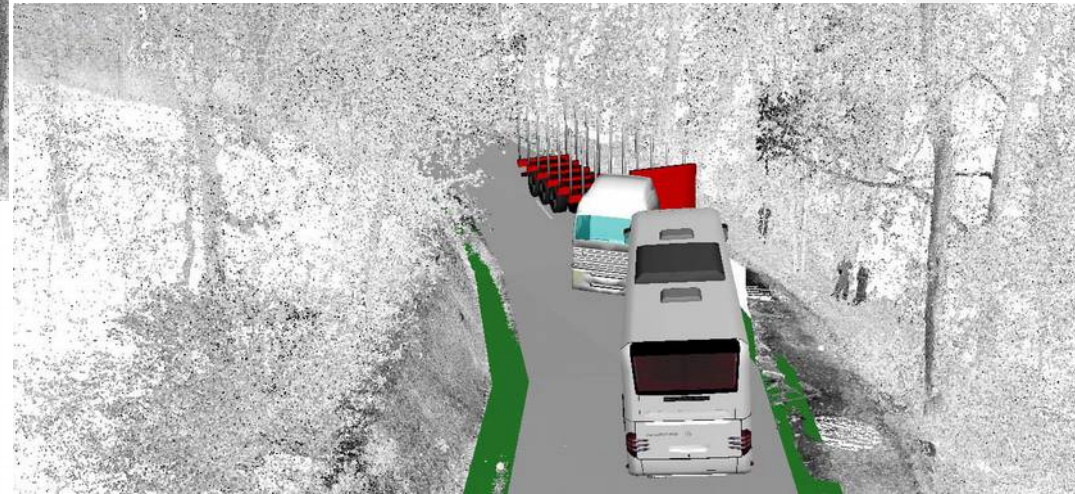
① Kinematic reconstruction of the accident

Position of the vehicles at the moment of impact

Position of the vehicles at 40 m away from each other

The tractor unit entered the bend at an inappropriate speed given the geometry of the road; the left front steerable wheel entered a skid; the vehicle entered the opposite lane, and the driver braked upon seeing the oncoming coach; the defects observed on the trailer's braking system may have led to or exacerbated the jack-knifing of the lorry; the driver was unable to avoid collision with the oncoming coach.

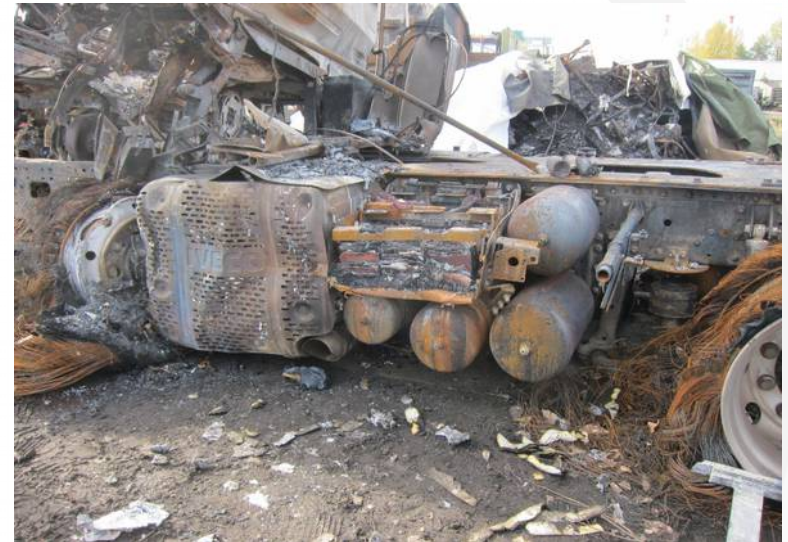
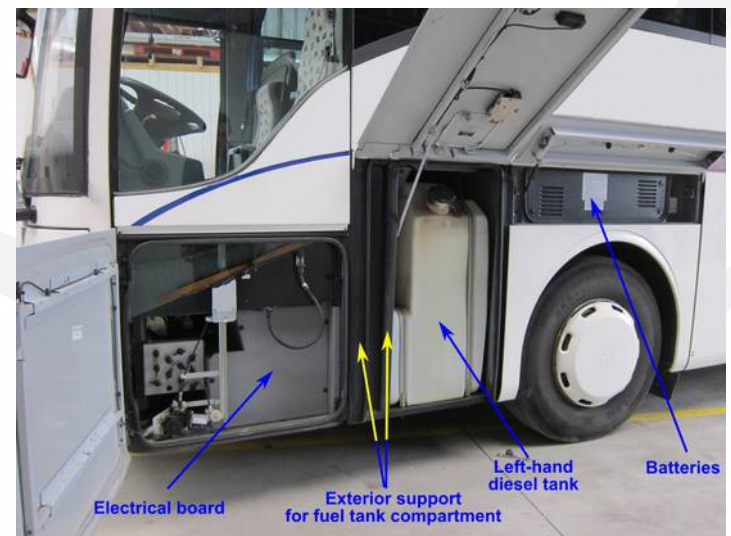
Tractor Unit

- exhaust line: 500°C-600°C
- device to reduce pollutant levels in exhaust gases
- batteries

Coach

- electrical control unit situated in the front left-hand side
- batteries

Friction between metallic elements

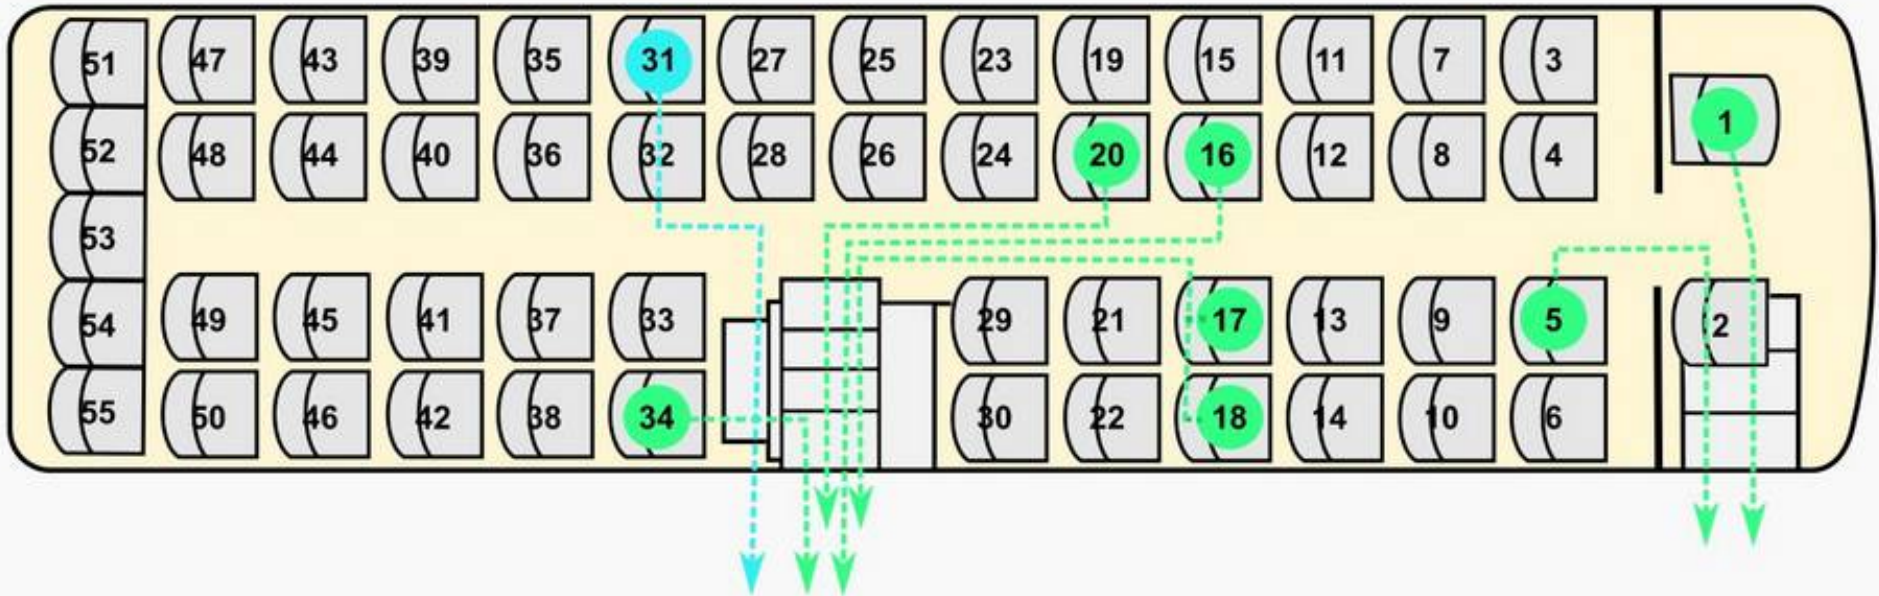
Survivor evacuation routes

Evacuation via a door
-

Evacuation via an emergency exit

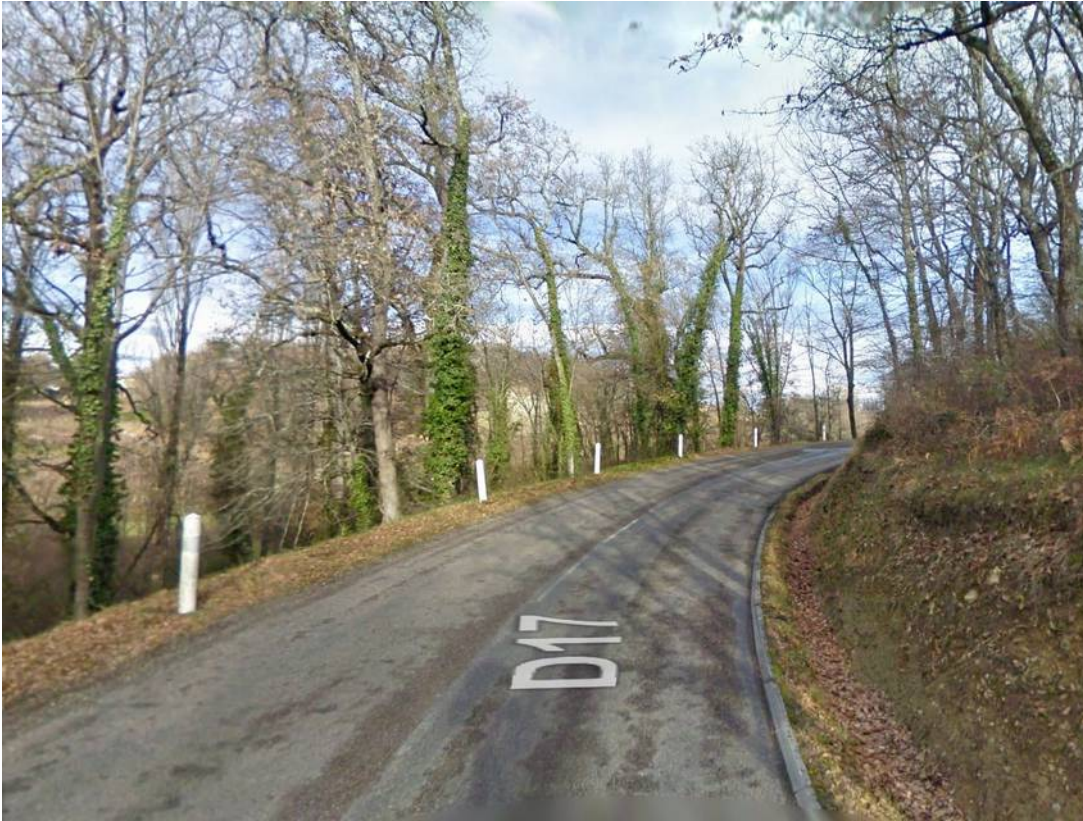
Road signs indicating the bend

Since the accident, multi-chevron warning signs have been erected on the outside of the bend in both directions.

*Without issuing any formal recommendations, the **BEA-TT** has invited the body responsible for the roadway to study the possibility of limiting the maximum speed limit to **50 km/h** for this bend.*
