SFBM S.p.A. Rome, Italy

Specific tests on CNG4 cylinders

Provider 1

Doc. No. 19042-R Rev. 2 – March 2018

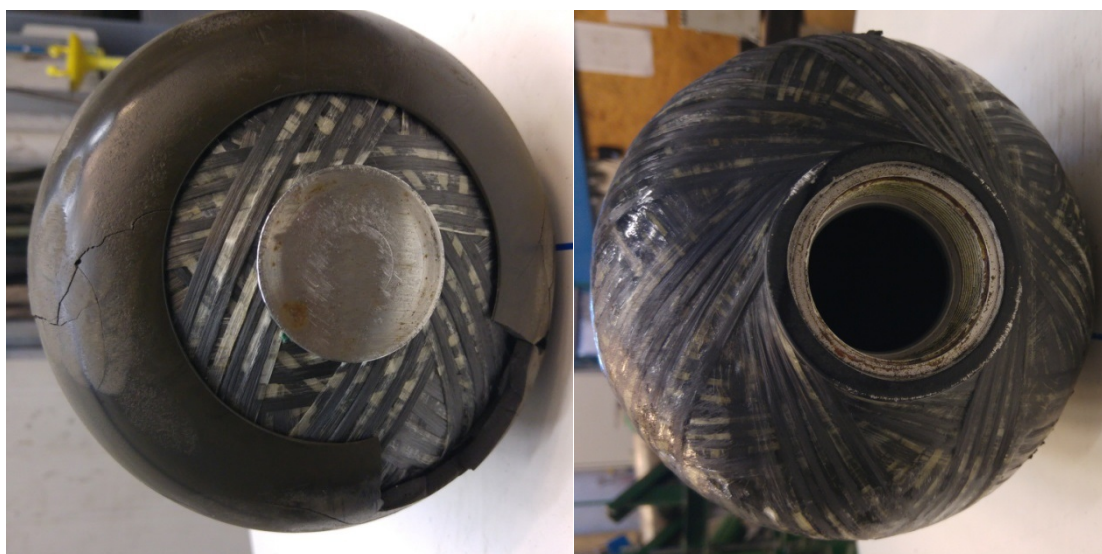
Figure 2-3: Dummy cylinder - Damages on the capped side protective dome after drop tests

The cylinder also showed abrasions and dents on the external resin, but the most evident damage consisted in the diffused discoloration of the impact zone on both domes.

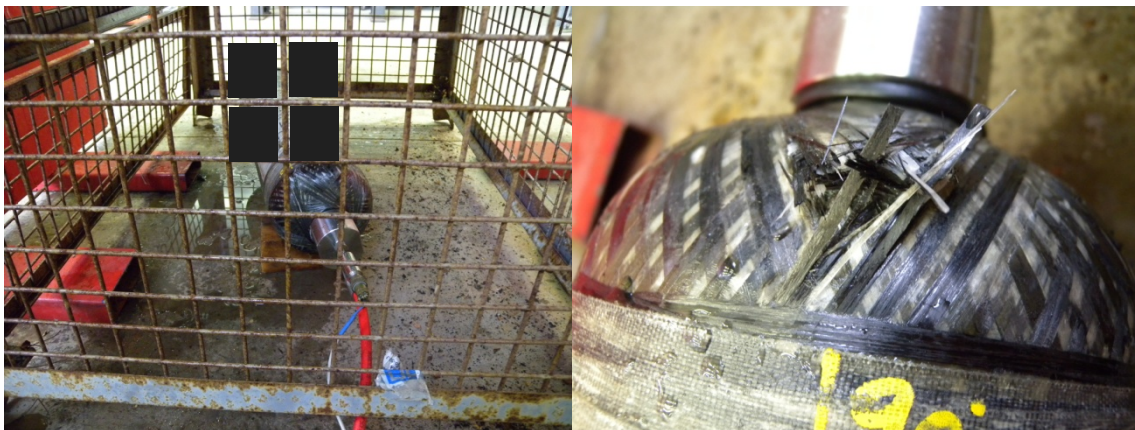
The dummy (spare) cylinder blew up at 150 bar, before achieving the target pressure (300 bar); the failure is put in clear evidence by the pressure collapsing in the plot reported in Figure 2-5.

As shown in Figure 2-6, cylinder failure occurred on the dome at valve side, in correspondence of 90° generatrix. In the failure zone, fibers are at about 30° angle with the longitudinal axis of the cylinder.

Figure 2-6: Dummy cylinder – Failure after the hydraulic test

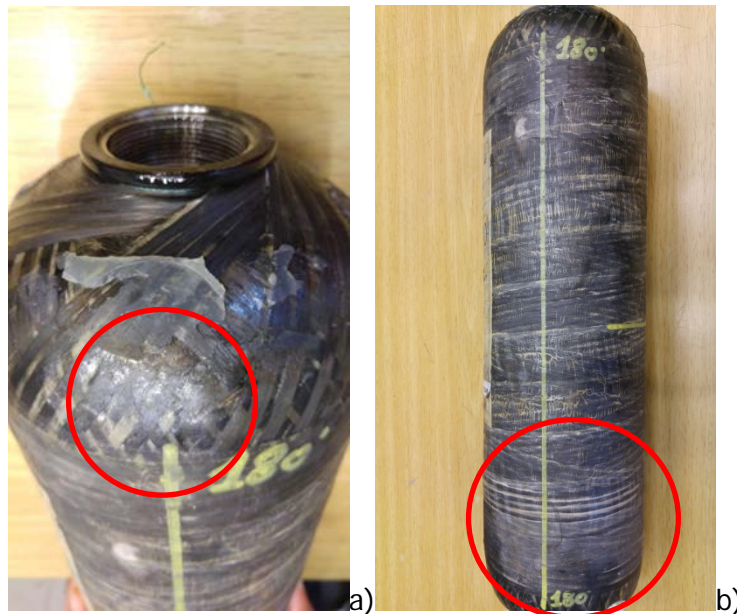
Cylinder 1 failed during the second hydraulic test. Visual inspections put in evidence that the main damages on the cylinder were a strongly discolored area (180°) and the detached fibers close to the valve dome, due to the drop tests. Details of these defects are reported in Figure 4-1.

Figure 4-1: Cylinder 1- Main damages before second hydraulic test:
a) discolored area; b) detached fibers

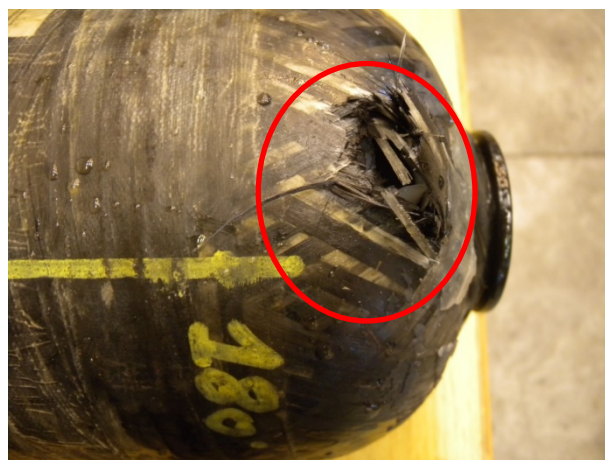
Failure during second hydraulic test occurred, at a pressure of 167 bar, where the discolored area was located, as reported in Figure 4-2.

Figure 4-2: Cylinder 1 – Failure location after second hydraulic test

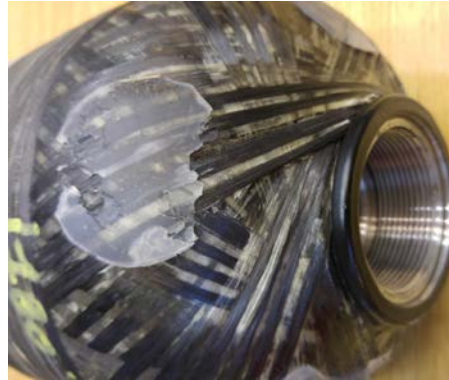
Cylinder 2 passed all of the performed tests, as foreseen by the test program. This cylinder passed two series of vertical drop tests on valve and capped sides. In Figure 4-3 and Figure 4-4 the discolored areas appeared in these zones after the drop tests are reported.

Figure 4-3: Cylinder 2 – Discolored area on valve side

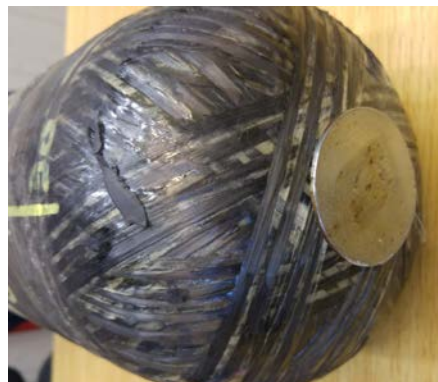
Figure 4-4: Cylinder 2 – Discolored area on capped side

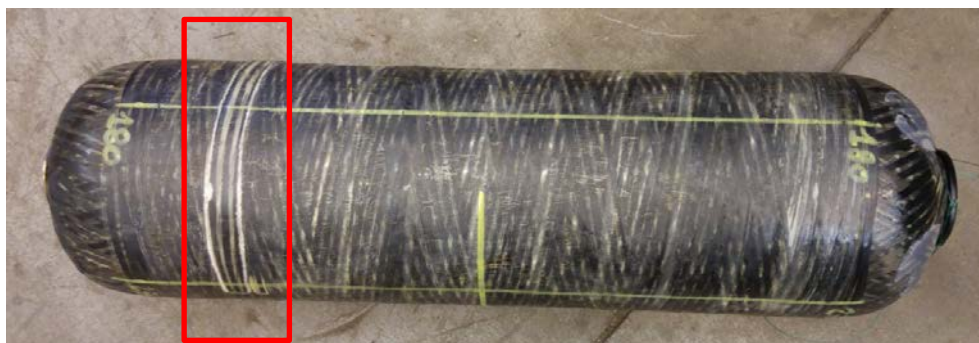
Some unglued fibers observed after the fatigue test are shown in Figure 4-5.

Figure 4-5: Cylinder 2 – Unglued fibers after fatigue test

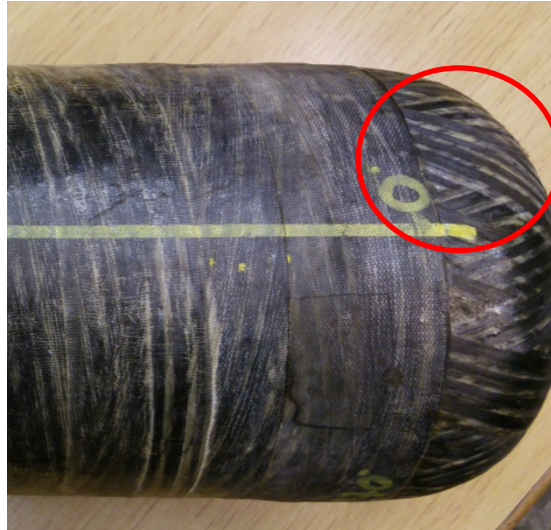
Cylinder 3 failed during the second hydraulic test, at a pressure value of about 229 bar. Visual inspections put in evidence that the main damage on the cylinder was a strongly discolored area (0°) close to the capped dome, due to the drop tests. Details of these damage are reported in Figure 4-6.

Figure 4-6: Cylinder 3 – Discolored area close to capped side (0°)

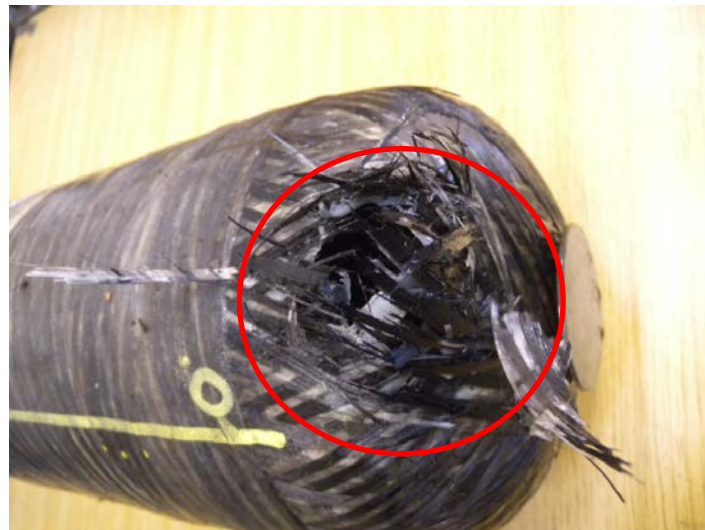
Failure during second hydraulic test occurred where the discolored area was located, as reported in Figure 4-7.

Figure 4-7: Cylinder 3 – Failure location after second hydraulic test

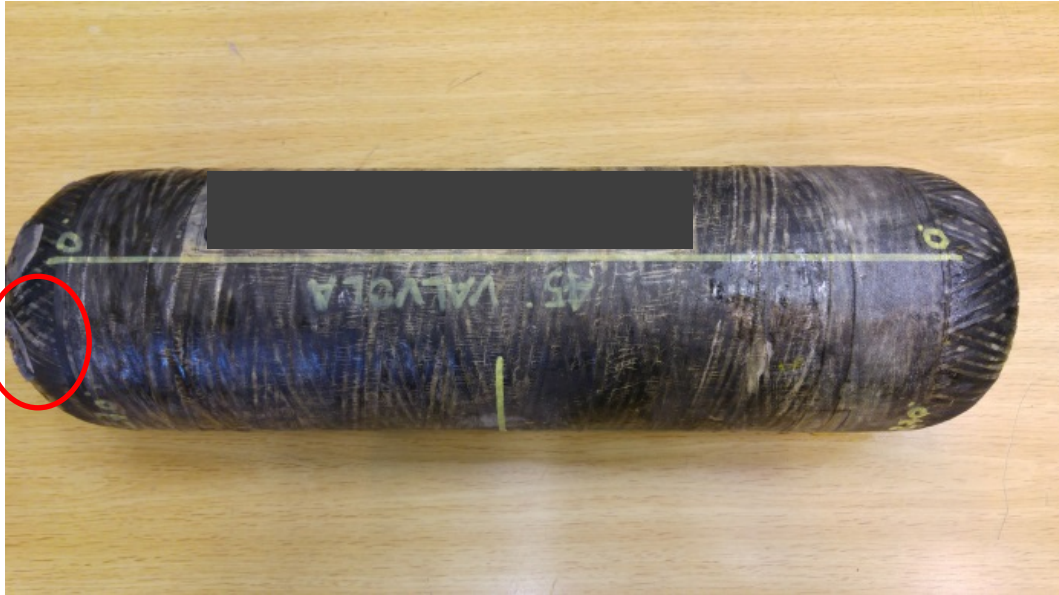
Cylinder 4 failed during the second hydraulic test, at a pressure value of 210 bar. Visual inspections put in evidence that the main damage on the cylinder was a strongly discolored area (0°) close to the valve dome, due to the drop tests. Details of these damage are reported in Figure 4-8.

Figure 4-8: Cylinder 4 – Discolored area close to valve side (0°)

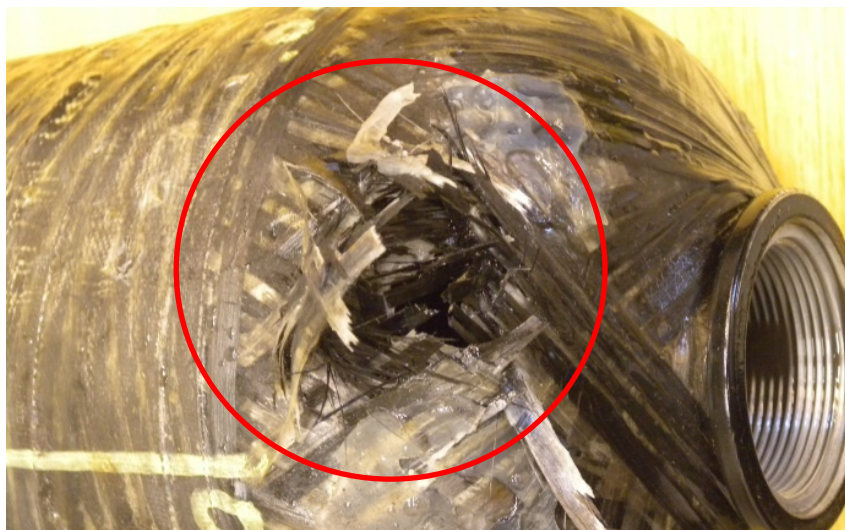
Failure during second hydraulic test occurred where the discolored area was located, as reported in Figure 4-9.

Figure 4-9: Cylinder 4 – Failure location after second hydraulic test

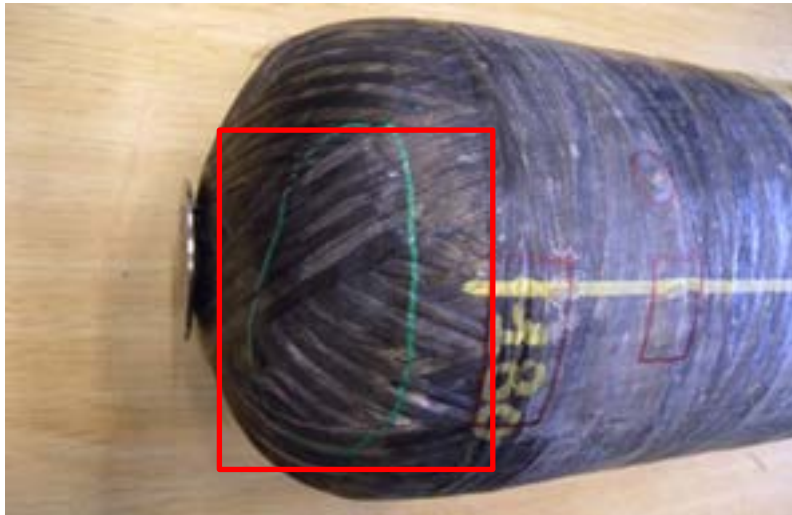
Cylinder 5, as requested by the Client, did not perform the first fatigue test. After the protective domes removal, this cylinder was subjected to a horizontal drop test (on 180° generatrix). The drop test caused a strongly discolored area on the capped dome (Figure 4-10). The subsequent hydraulic test at 300 bar did not cause any other damage.

Figure 4-10: Cylinder 5 – Discolored area close to capped side (180°)

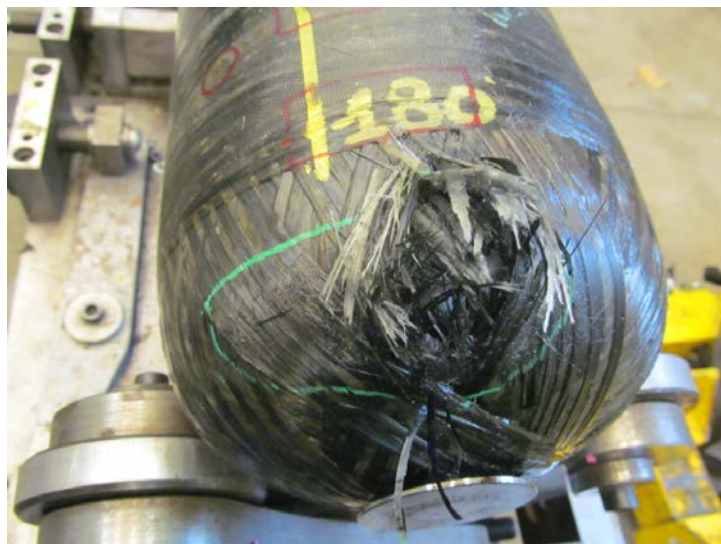
Failure occurred during the second fatigue test, after 375 cycles, where the discolored area was located, as reported in Figure 4-11.

Figure 4-11: Cylinder 5 – Failure location after second fatigue test

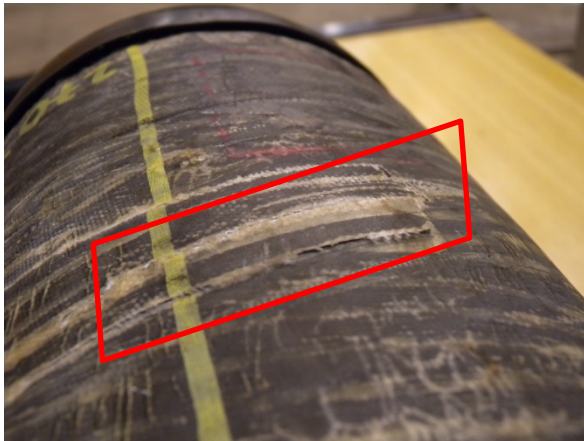
Cylinder 6, failed during the second fatigue test, after 390 cycles. Visual inspections before this test put in evidence two main damages: the first one consisted in some unglued fibers observed after the first fatigue test (Figure 4-12); the second was a strongly discolored area close to the capped side (Figure 4-13). It is worthwhile to remember that the cylinder started creaking at 250 bar during the second hydraulic test.

Figure 4-12: Cylinder 6 – Unglued fibers

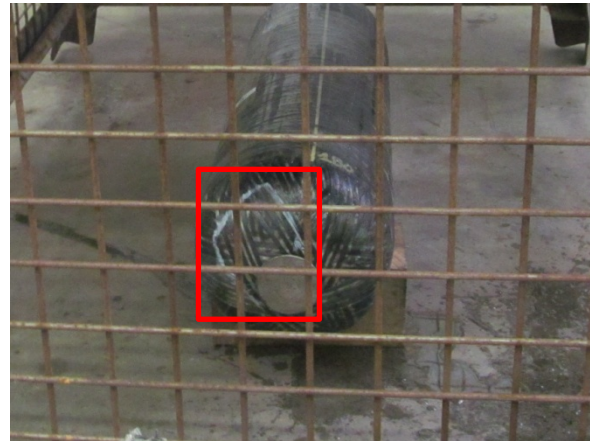
Figure 4-13: Cylinder 6 – Discolored area

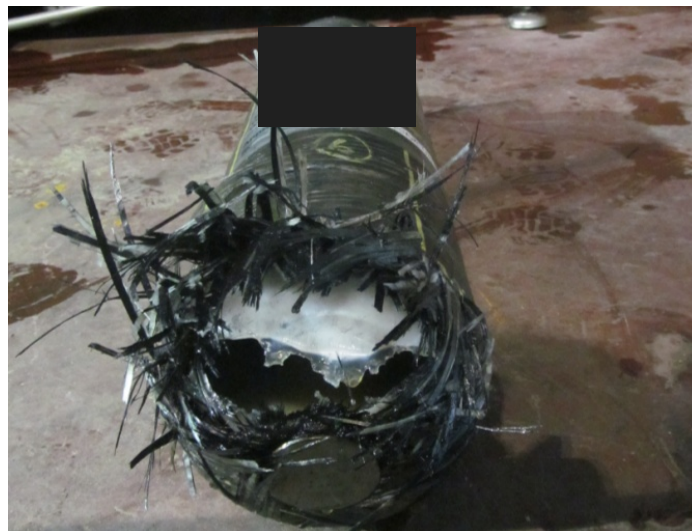
Failure occurred during the second fatigue test where the discolored area was located, as reported in Figure 4-14.

Figure 4-14: Cylinder 6 – Failure location after second fatigue test

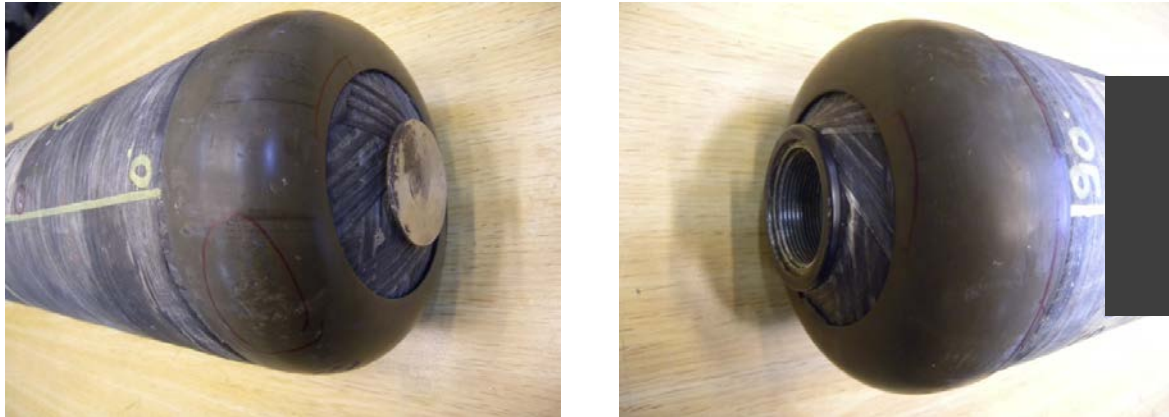
Cylinder 7 is the only one where it was not possible to correlate the impact area of the drop test (45° angle, on the capped dome) and the failure zone. The cylinder also did not show any damage after the drop test but it was the only one to fail after the first fatigue test. Probably the removal of the protective domes after the first drop test could have revealed a possible damage. The state of both protective domes after the drop test is reported in Figure 4-15.

Figure 4-15: Cylinder 7 – Protective domes after the first drop test

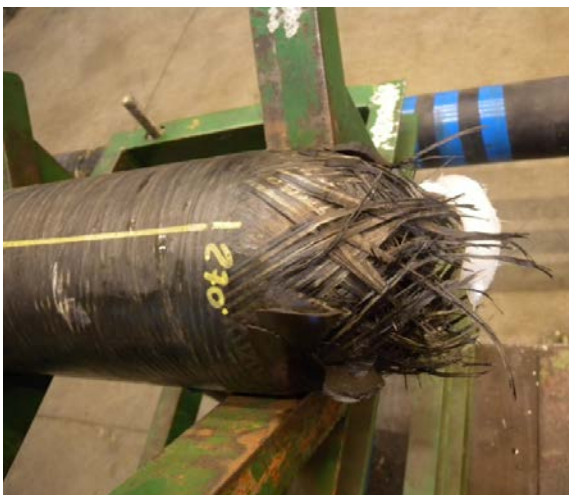
Failure occurred during the first fatigue test, after 12,935 cycles and at 250 bar. In this case the failure consisted in the full ejection/separation of the valve connector from the cylinder (Figure 4-16 and Figure 4-17). Such an event did not occur in any other cylinder and could be likely referred to a pre-existing defect covered by the protective dome.

Figure 4-16: Cylinder 7 – Failure after first fatigue test

As far as cylinder 7 is concerned, the failure cannot be related to any kind of damage observed after the drop test. Failure occurred during the first fatigue test, when the protective domes were still on. This case suggests the opportunity to remove the protective domes from the very beginning, in order to be able to perform a more accurate visual inspection.

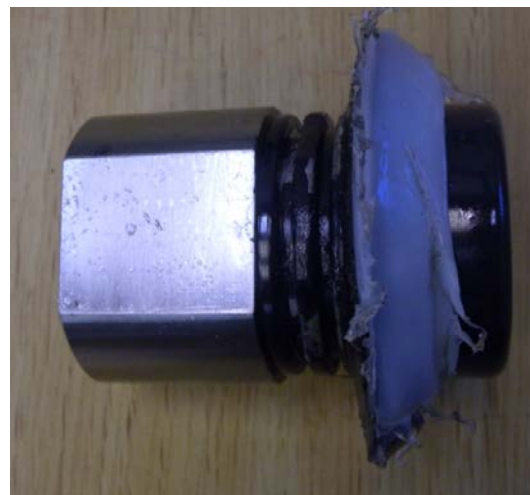
Figure 4-17: Cylinder 7 – Valve connector

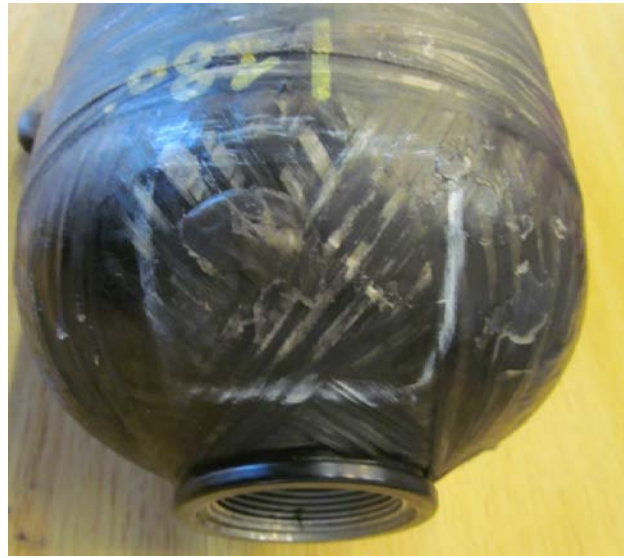
Cylinder 8 failed during the second hydraulic test. Visual inspection before this test showed a strongly discolored area in the valve side dome, at 180°, caused by the drop test performed at 45° angle. Pictures of the drop test and of the damaged area are reported in Figure 4-18 and Figure 4-19.

Figure 4-19: Cylinder 8 – Damaged area

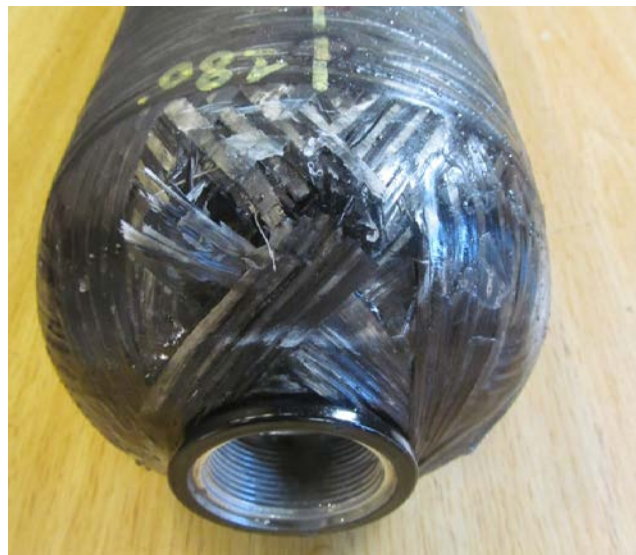
Failure occurred in correspondence of the discolored area, at 171 bar, as shown in Figure 4-20.

Figure 4-20: Cylinder 8 – Failure location after second hydraulic test

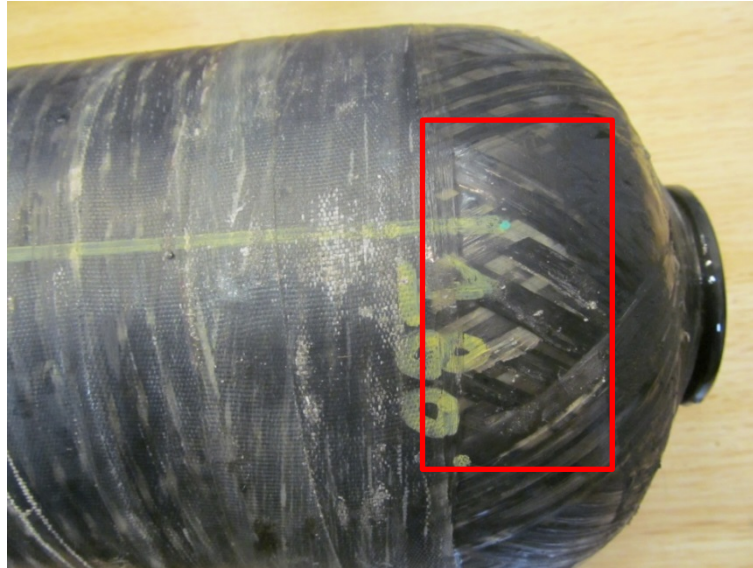
Cylinder 9 failed during the second hydraulic test. Visual inspection before this test showed a strongly discolored area in the valve side dome, at 180°, caused by the horizontal drop test performed on 180° generatrix (Figure 4-21).

Figure 4-21: Cylinder 9 – Discolored area close to valve capped side (180°)

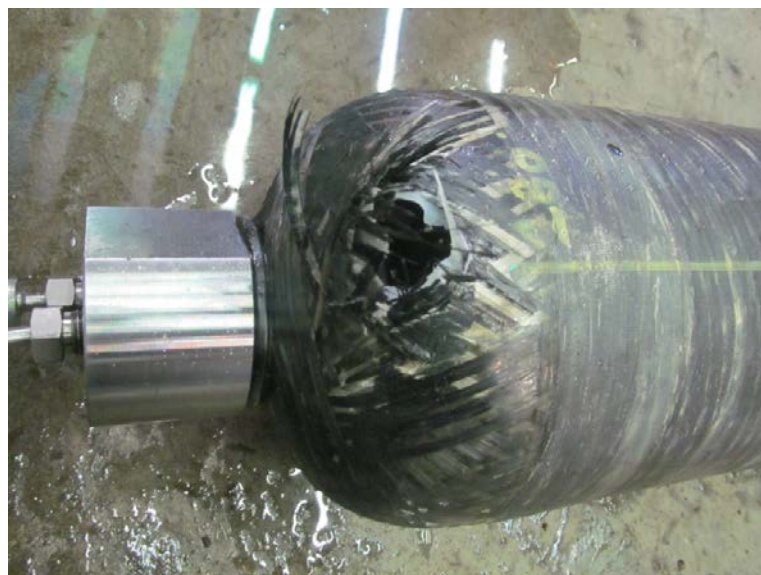
Failure occurred in correspondence of the discolored area, at 240 bar, as shown in Figure 4-22.

Figure 4-22: Cylinder 9 – Failure location after second hydraulic test

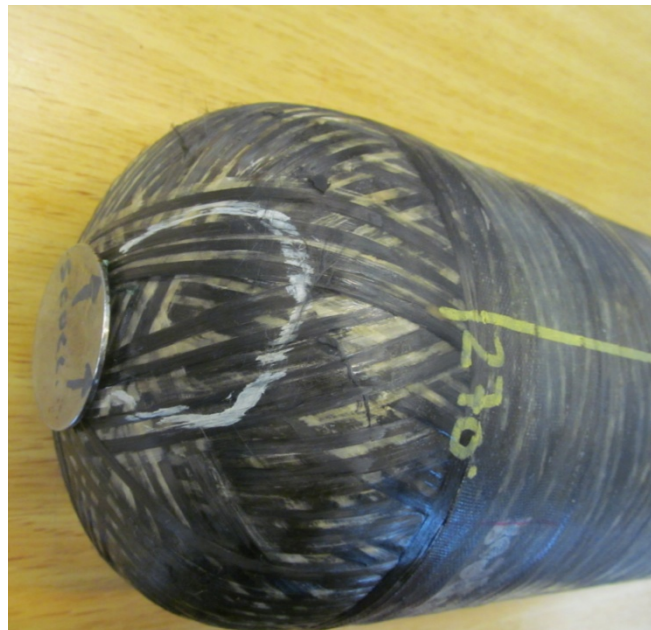
Figure 4-24: Cylinder 10 – Strongly discolored area after drop test

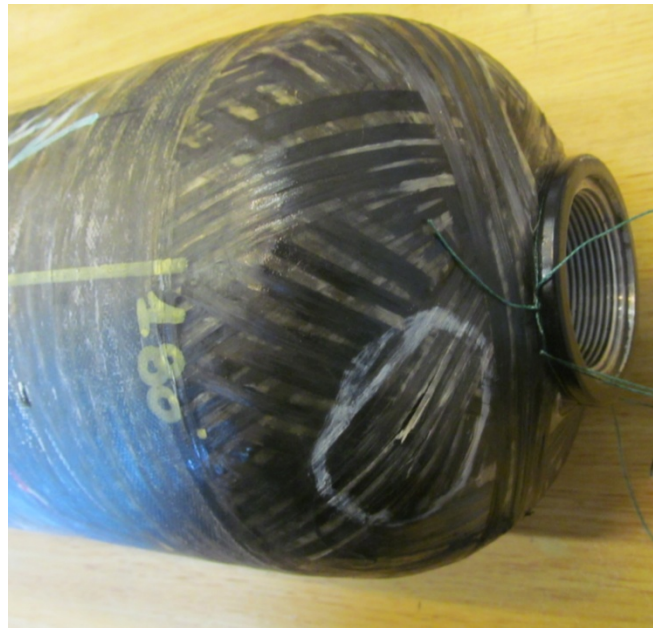
Figure 4-25: Cylinder 10 – Broken fibers on the valve dome

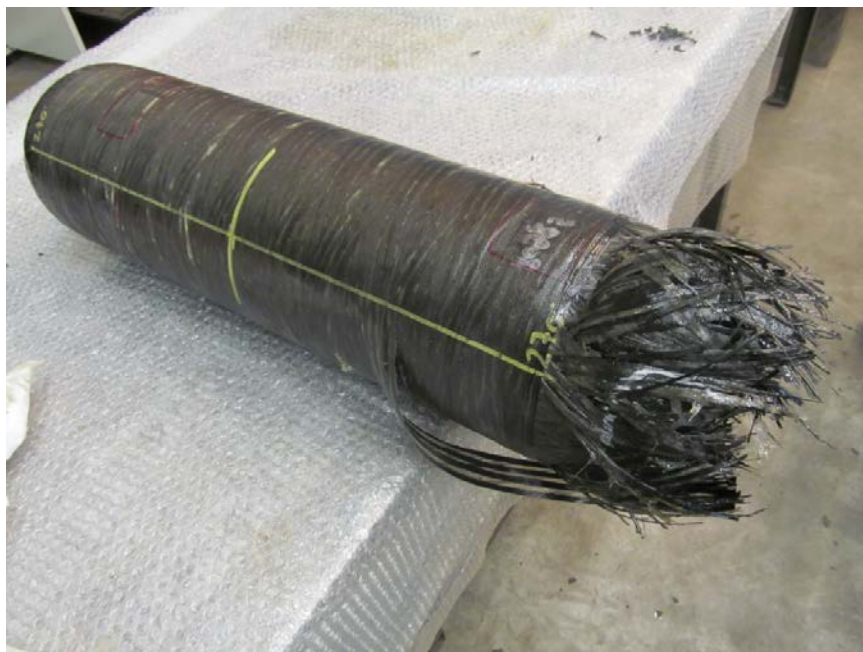
Also in this case, the discolored area of the capped dome confirmed to be the most severe damage. Failure occurred in that area after 975 cycles of the second fatigue test (Figure 4-26).

Figure 4-26: Cylinder 10 – Failure location after second fatigue test

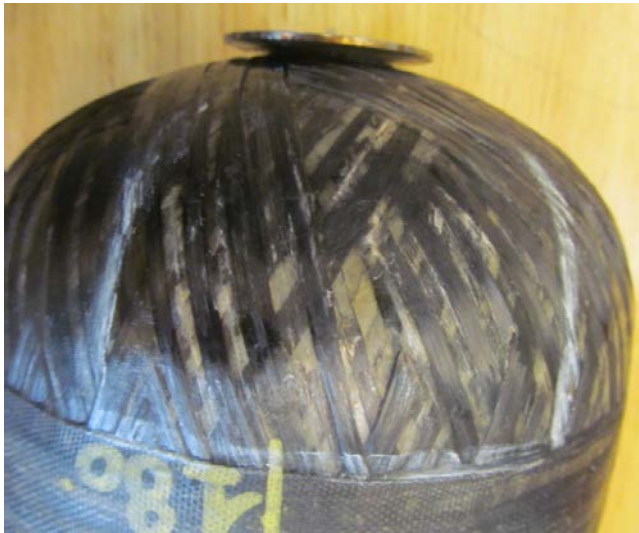
Cylinder 11 failed during the second hydraulic test. Visual inspection before this test showed a strongly discolored area in the capped side dome, at 180°, caused by the drop test performed at 45° angle. A second discolored area, due to a rebound impact, was observed on the valve side dome. Pictures of the damaged areas are reported in Figure 4-27 and Figure 4-28.

Figure 4-27: Cylinder 11 – Damaged area capped side

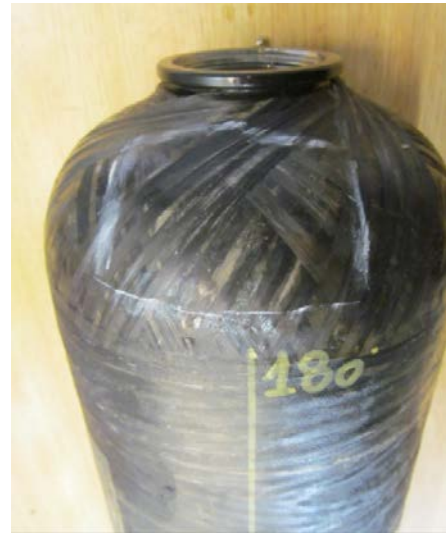
Figure 4-28: Cylinder 11 – Damaged area valve side

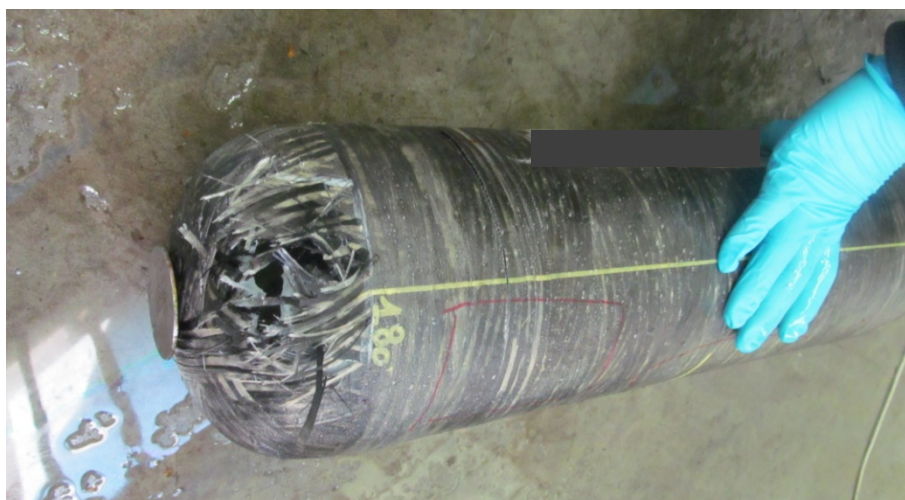
Failure occurred in correspondence of the discolored area on the capped dome, at 250 bar, as shown in Figure 4-29.

Figure 4-29: Cylinder 11 – Failure location after second hydraulic test

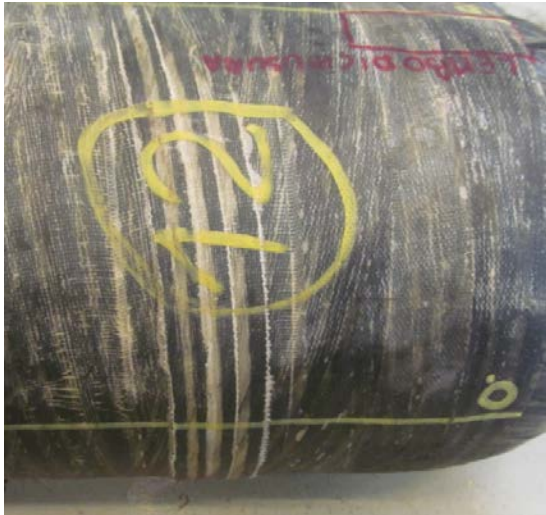
Cylinder 12 failed during the second hydraulic test. Visual inspection before this test showed two main damages: some unglued fibers (Figure 4-30), observed after the first fatigue test, and a strongly discolored area (Figure 4-31) in the capped side dome, at 180°, caused by the drop test performed at 45° angle.

Figure 4-30: Cylinder 12 – Unglued fibers

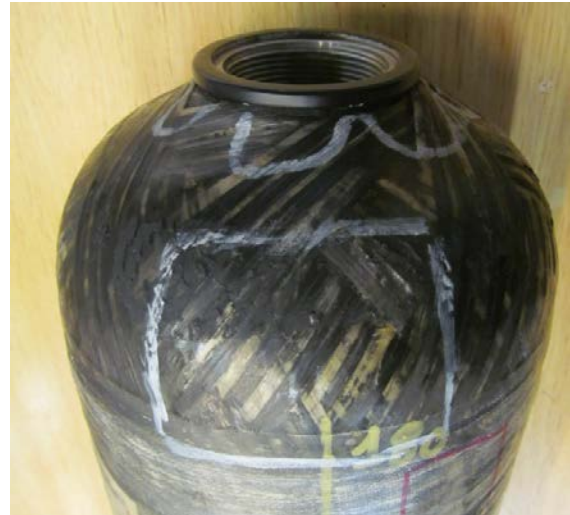
Figure 4-31: Cylinder 12 – Damaged area valve side

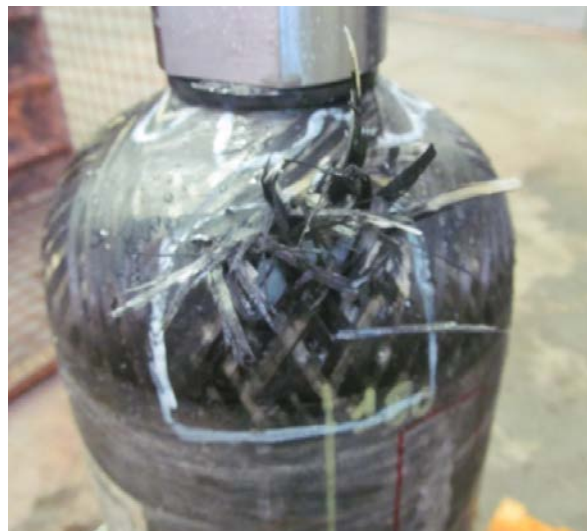
Failure occurred in correspondence of the discolored area on the capped dome, at 170 bar, as shown in Figure 4-32.

Figure 4-32: Cylinder 12 – Failure location after second hydraulic test
