Lower level of double deck buses and coaches. Extended justification

1. This document is strongly related to the proposal given in the doc. ECE/TRANS/WP.29/GRSG/2010/2. After the discussion of this document GRSG requested some further evidences that the lower level (LL) of double deck (DD) buses can be considered as rigid part, therefore no test is required on it, the residual space (RS) should not be checked. This would result a much simpler, cheaper approval test and clear, unified calculation approval methods (quasi-static calculation and dynamic computer simulation)

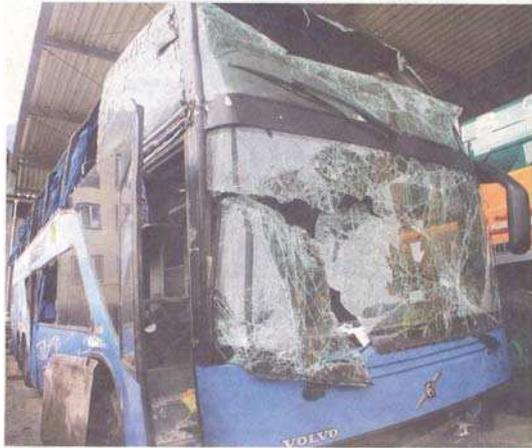
Slight deformation on the upper level (intact RS); rigid LL

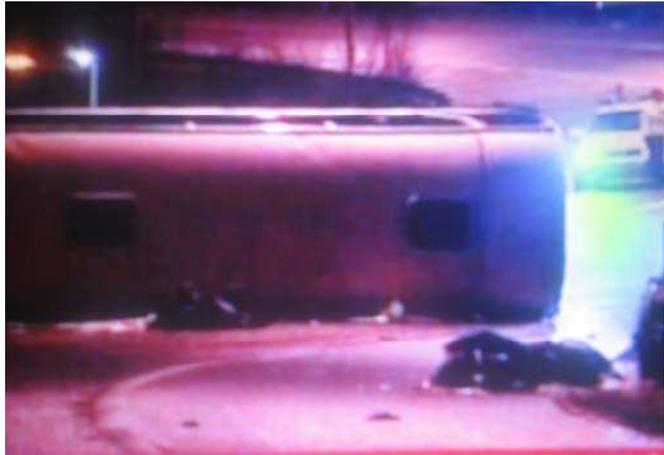
No significant deformation on the UL, rigid LL

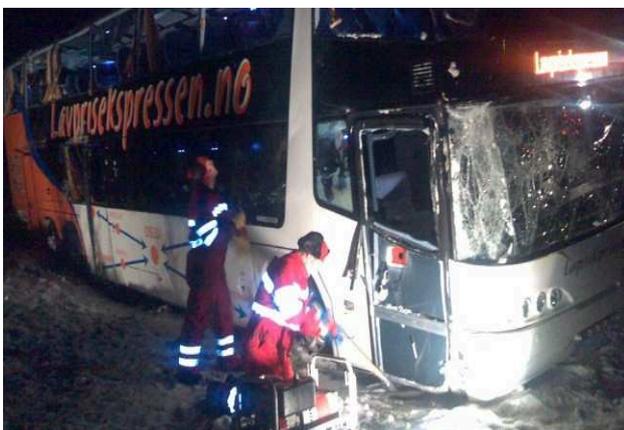
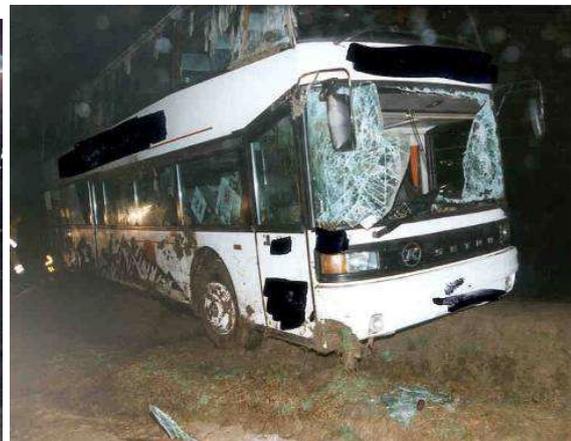
No significant deformation on the UL, rigid LL

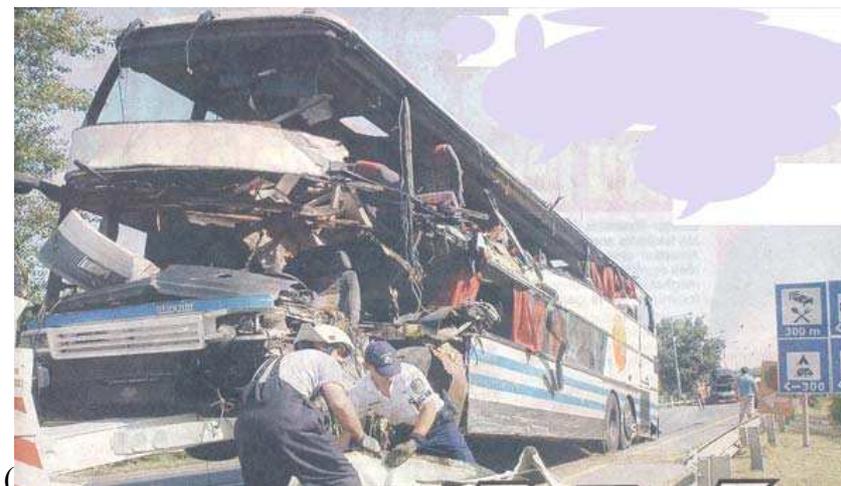
Slight deformation on the UL, Rigid LL

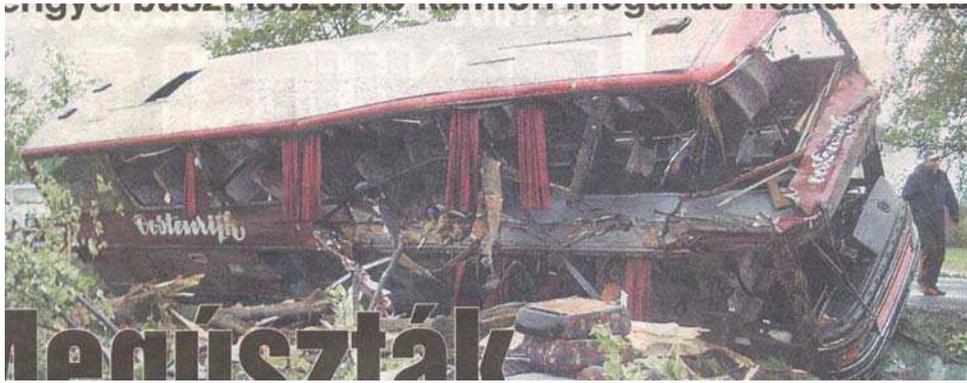
Considerable deformation on the front part of UL, rigid LL

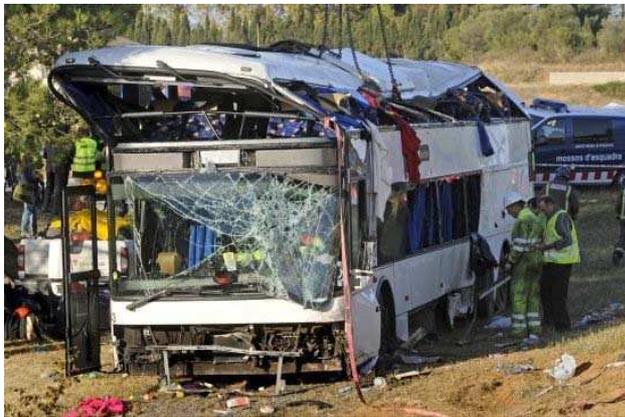
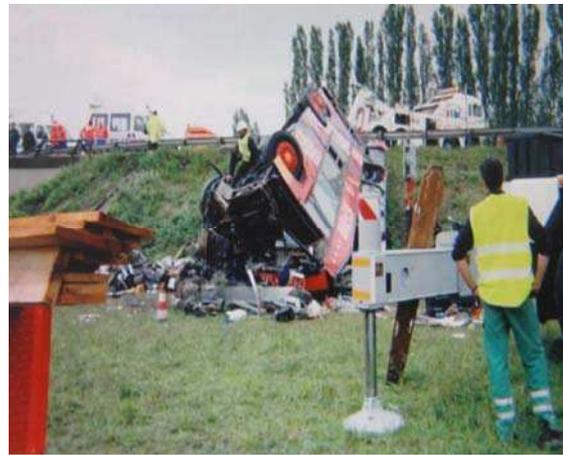
Collapsed UL, the RS disappeared.

Rigid LL

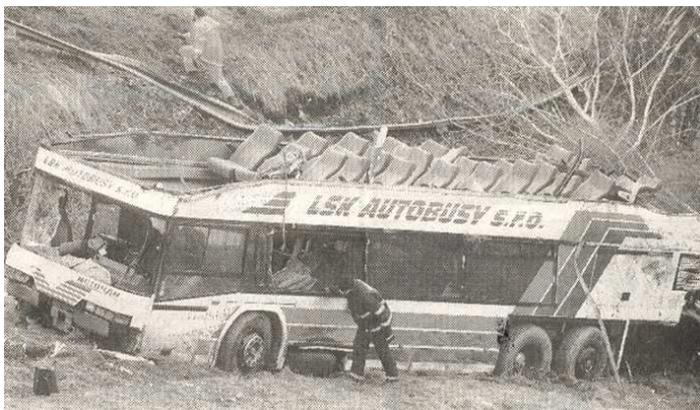
RS disappeared; UL collapsed

Rigid LL

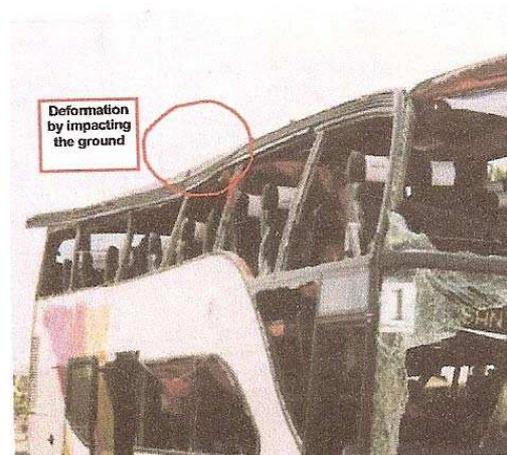
Considerable deformation on the UL

Rigid LL

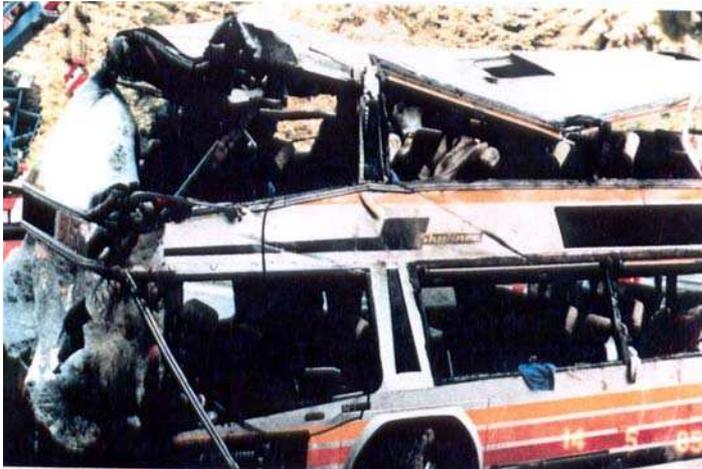
Considerable deformation on UL, rigid LL

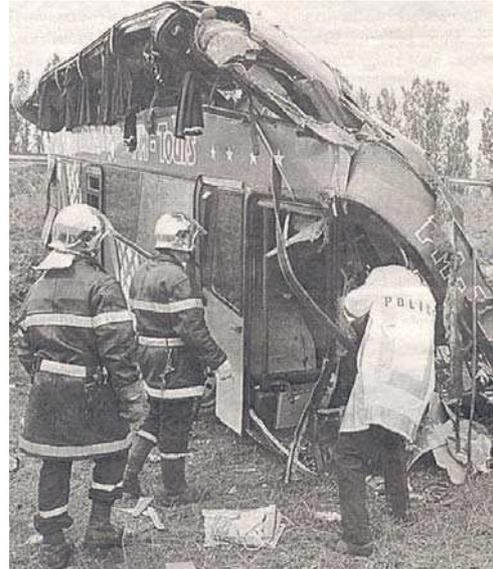
One side collapse on the UL; rigid LL, but severe damage on the driver's cab due to a frontal collision with a car
