Informal document No. GRSG-99-26  
(99th GRSG, 19-22 October 2010  
agenda item 2)

# BEHAVIOUR OF THE LOWER LEVEL (DECK) OF DOUBLE-DECK VEHICLES IN ROLLOVER

Dr. Matolcsy Mátyás  
delegate of Hungary

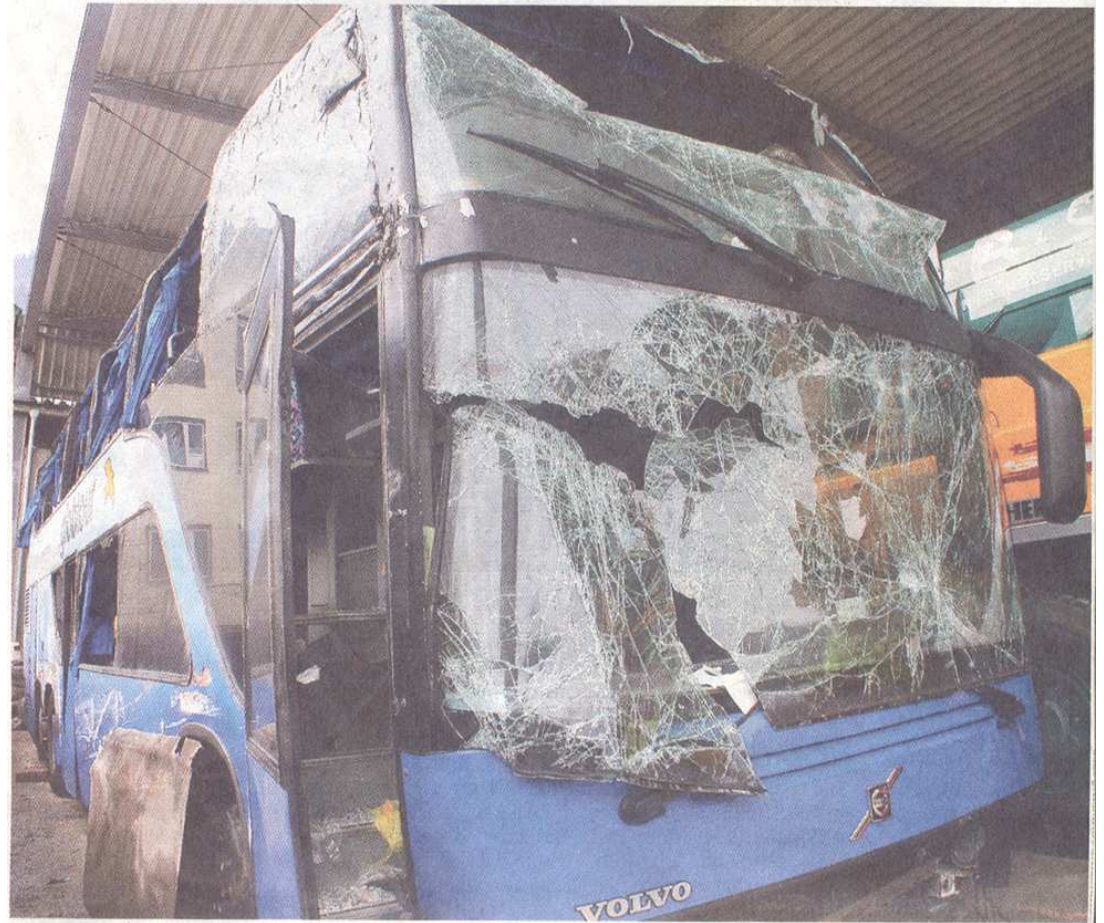
Tip over at an exit of a tunnel  
(The left wheels run up a rising  
concrete barrier)

- No significant, but slight deformation on the UL
- Residual space (RS) remained intact
- Rigid LL

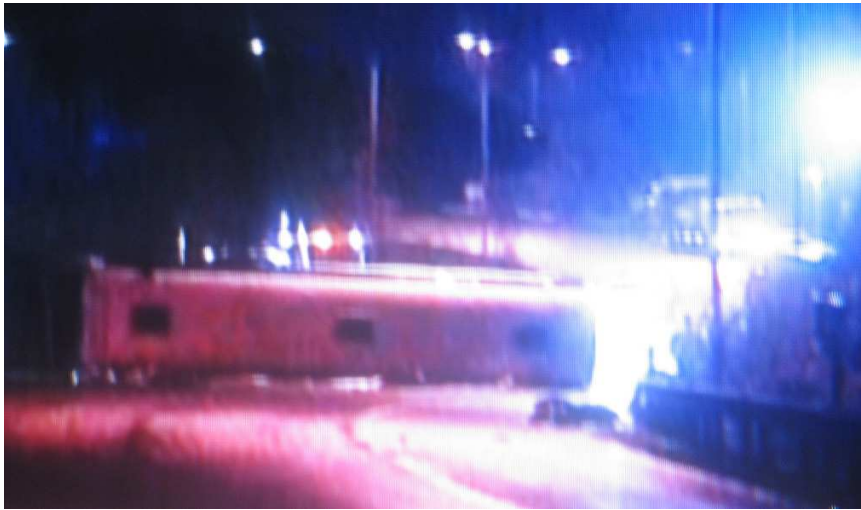
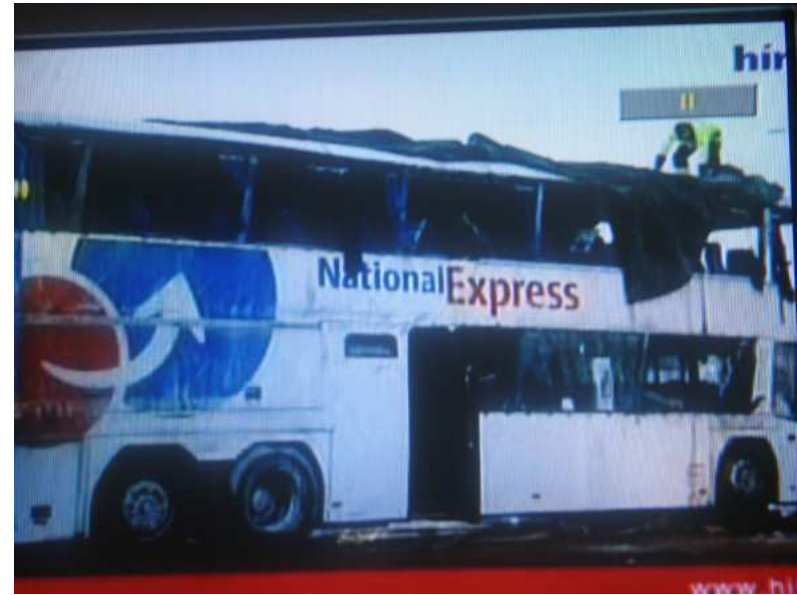
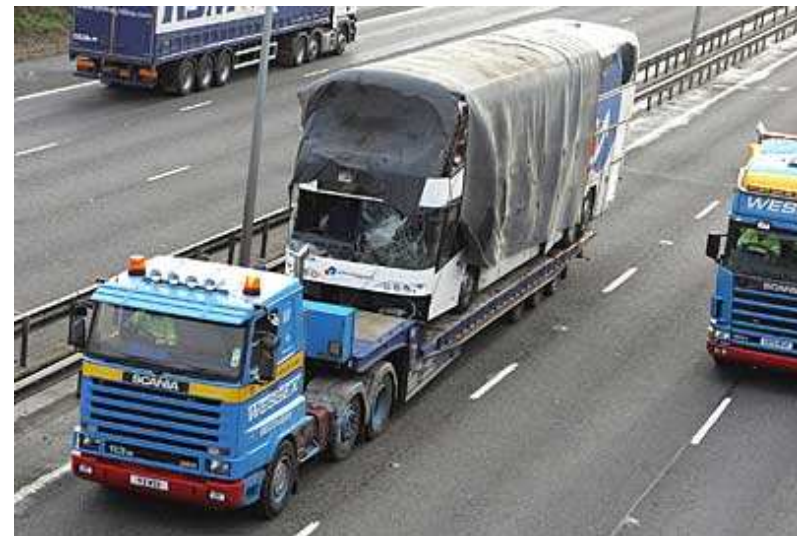
Tip over on a flat road

- No significant deformation on the UL
- RS remained intact
- Rigid LL

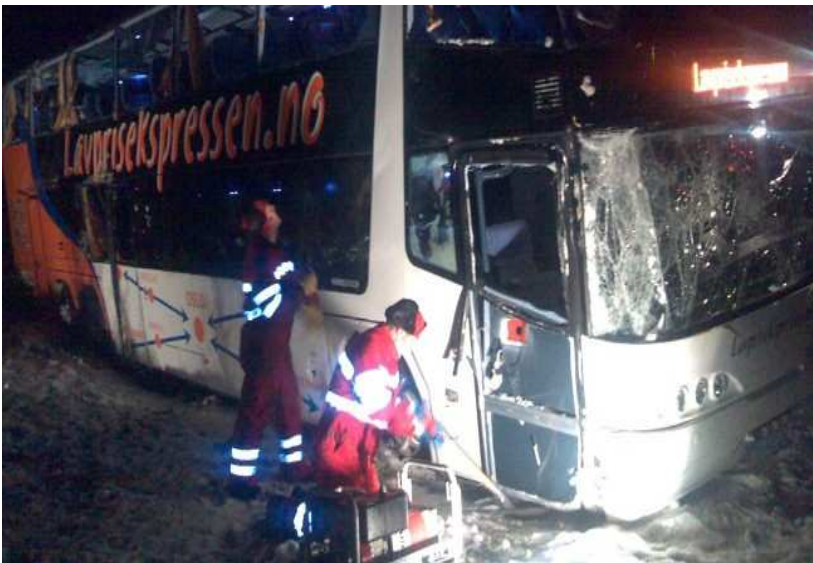
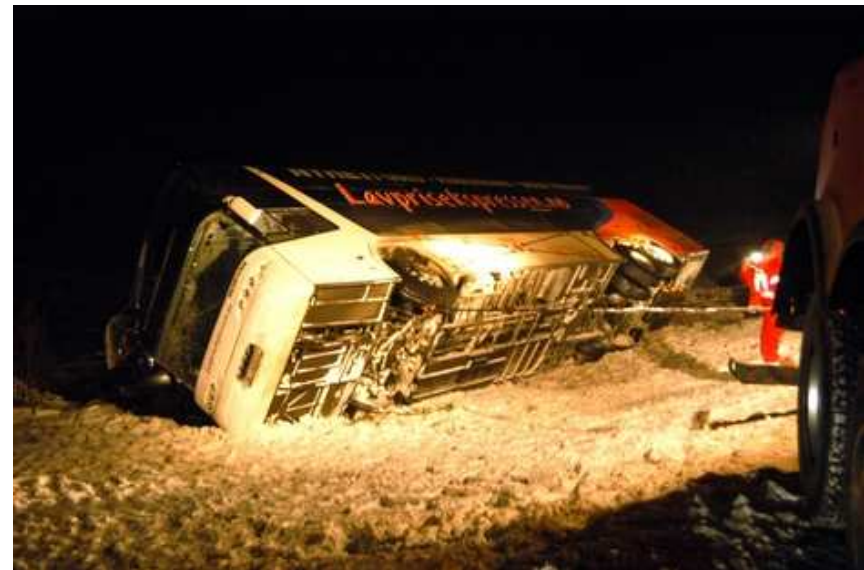
Flat road, flat snowy ground

- No significant deformation on the UL,
- intact RS
- Rigid LL

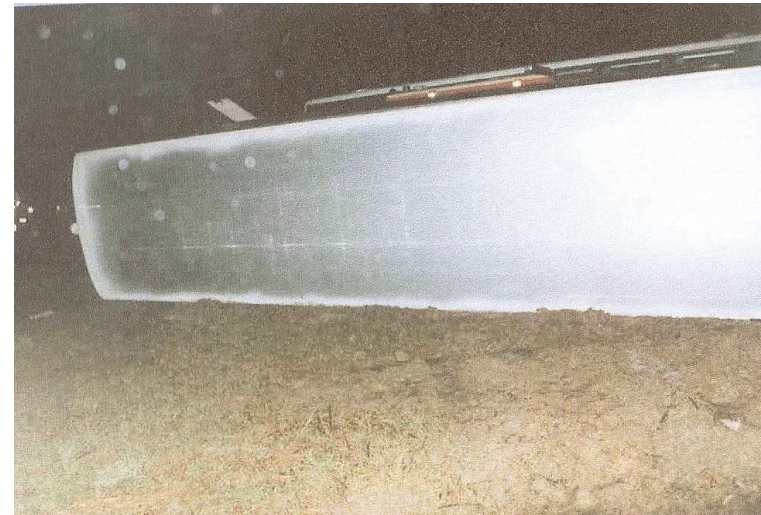
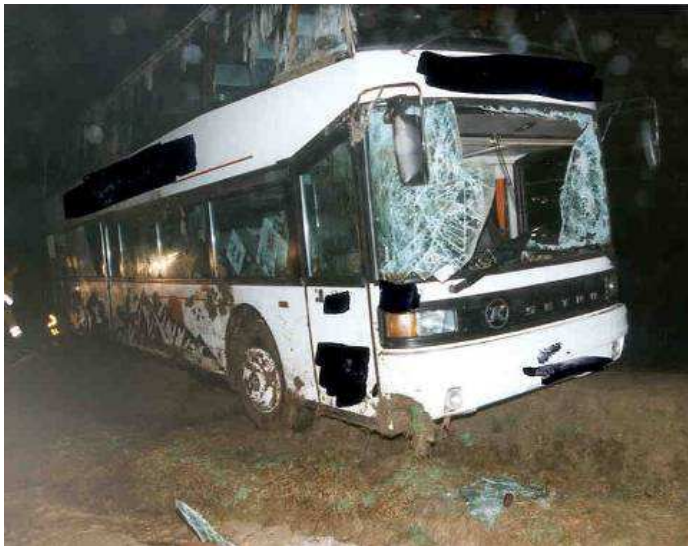
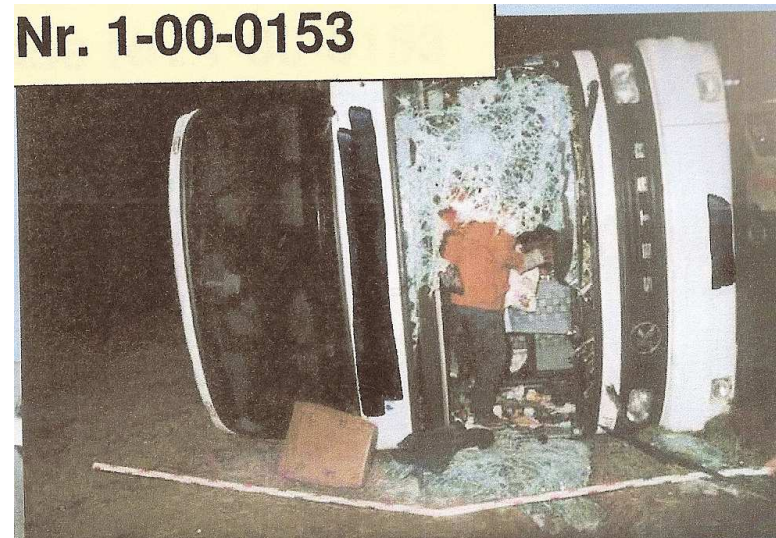
Nr. 1-00-0153

Flat, soft grassy ground

- No significant deformation on the UL
- Rigid LL

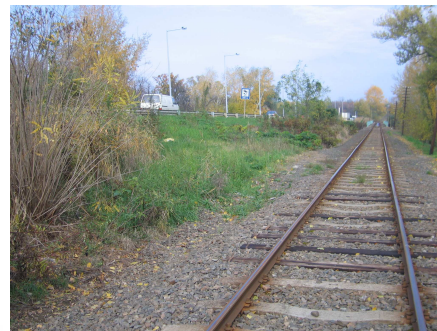
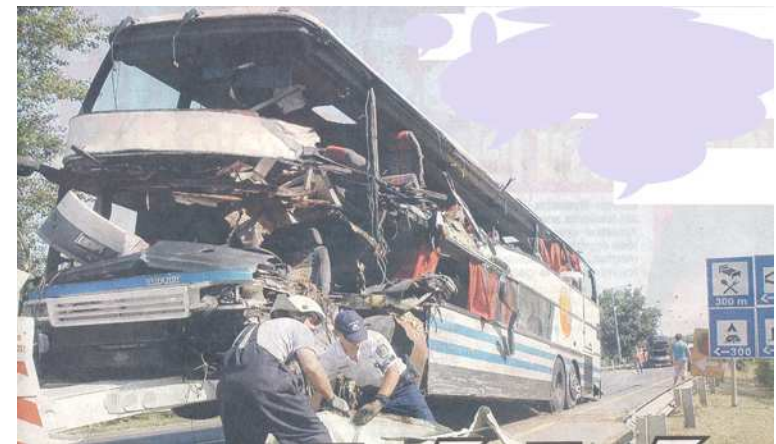
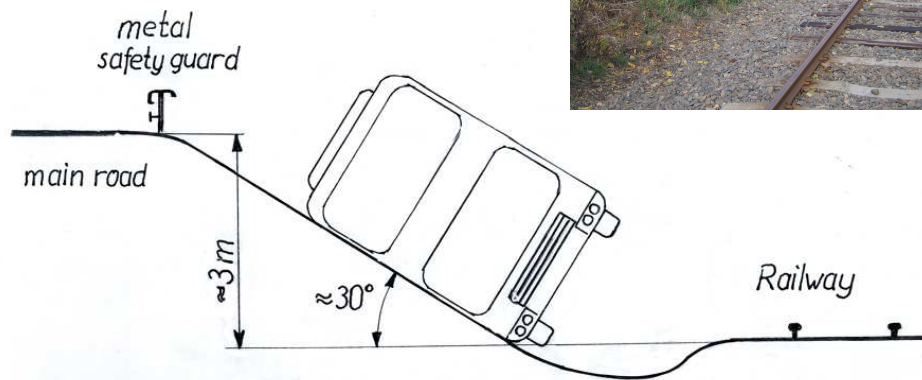
After a severe frontal collision (on the driver's cab) the bus run down on the slope and a railway embankment turned it back onto the slope.

- Slight deformation on the UL
- RS remained intact
- Rigid LL (deformation only as the result of the frontal impact)

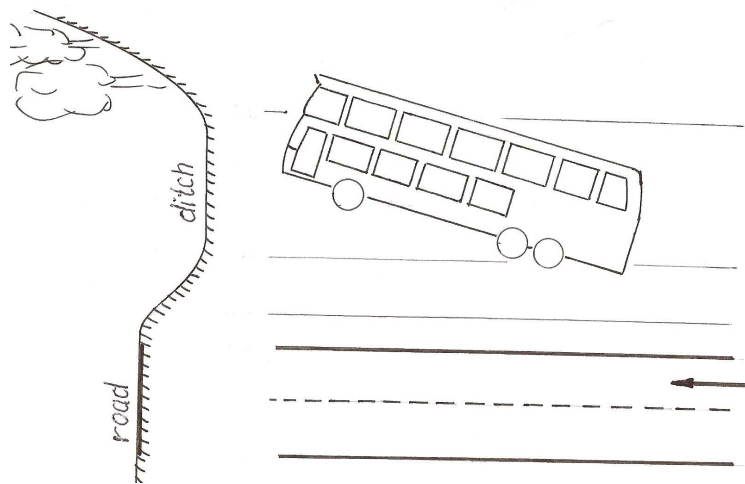
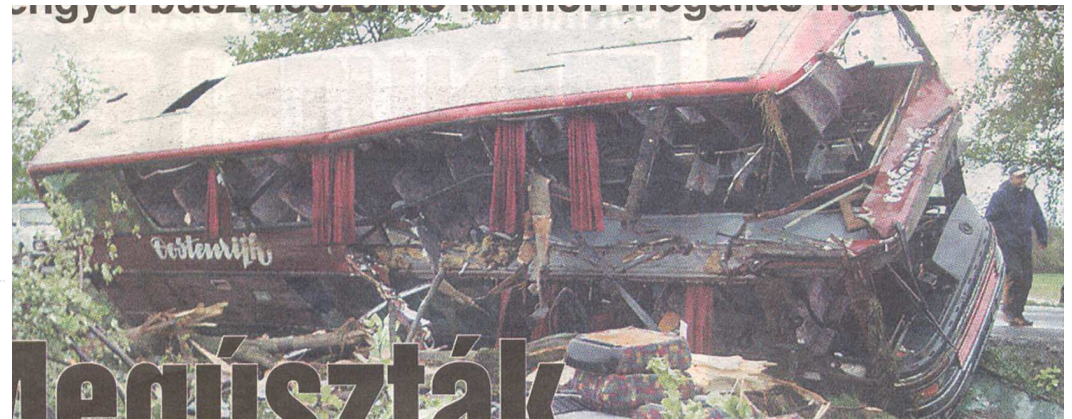
The bus turned into a ditch having an inclining elevated other side

- Considerable deformation on the front half of the UL
- Possible intrusions into the RS on the UL
- Rigid LL

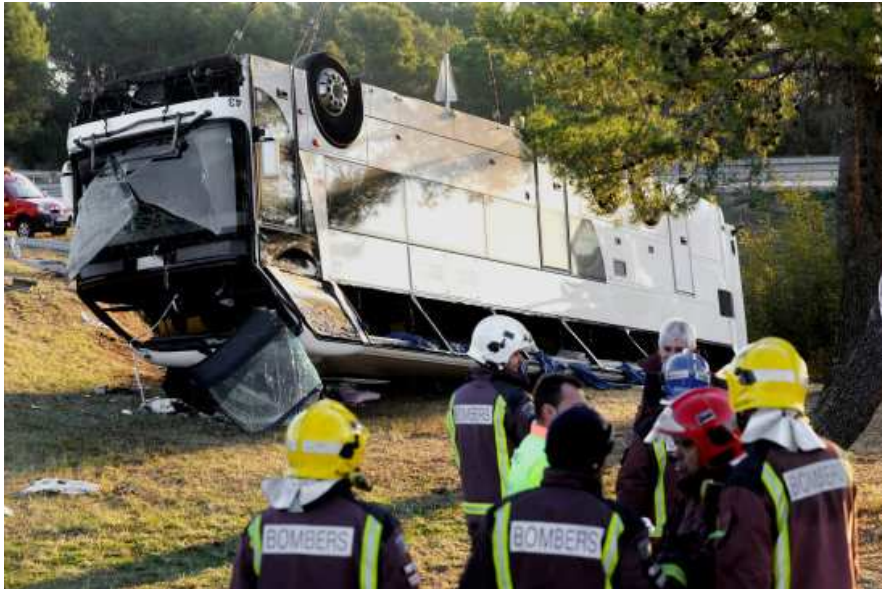
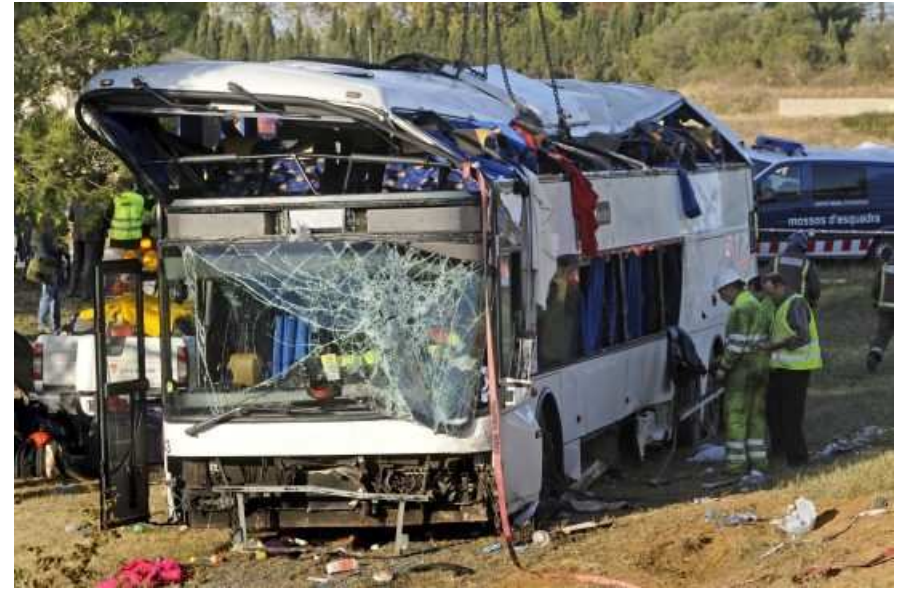
- The UL collapsed
- RS disappeared on the UL
- Rigid LL

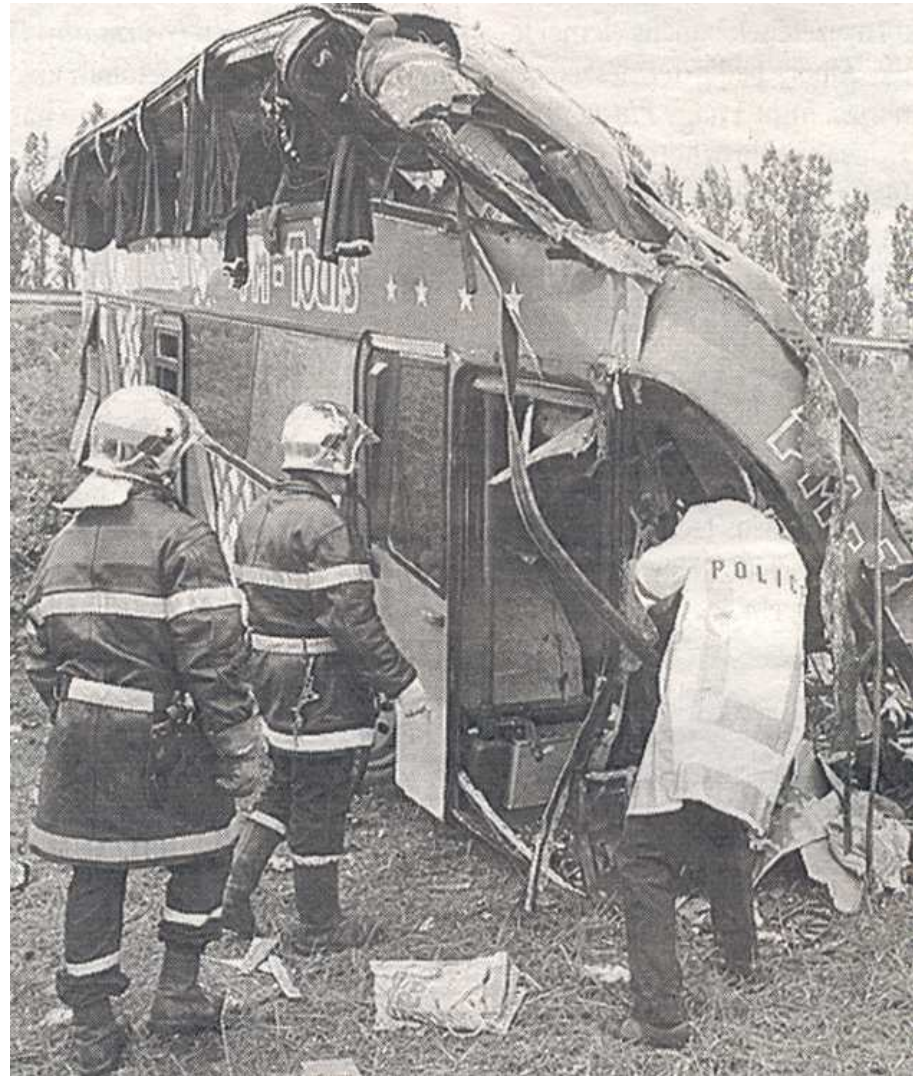
After a frontal collision on the driver's cab side, the bus rolled down on a slope

- Asymmetrically collapsed UL
- RS strongly damaged
- No structural deformation on LL except due to the frontal collision

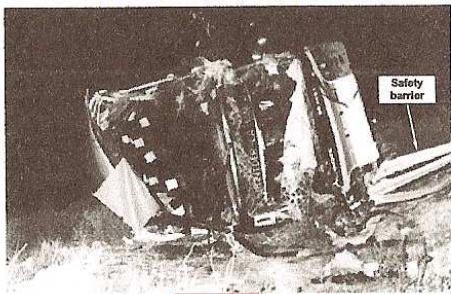
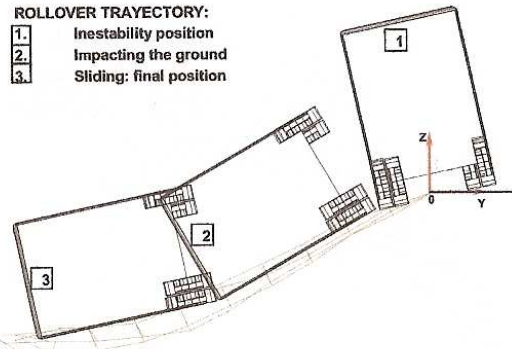
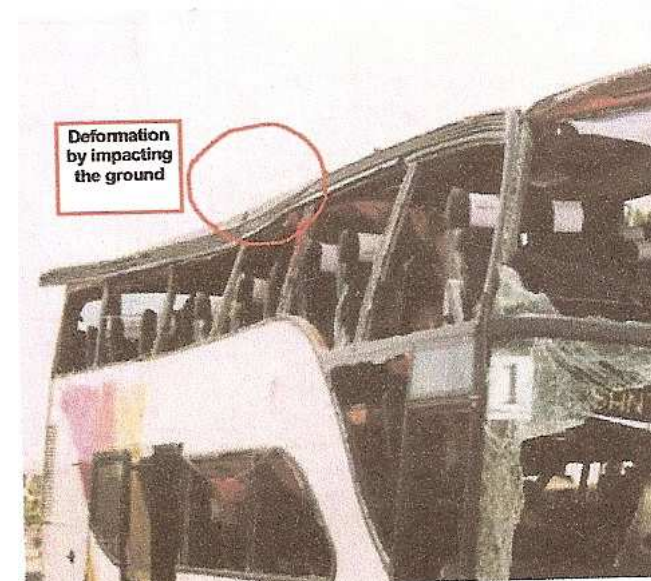
- 1.- **FIRST COLLISION:** Fronto-lateral impact against the coach
- 2.- **SECOND IMPACT:** Against the safety barrier
- 3.- **FINAL COLLISION:** Off-Road rollover

- ### ROLLOVER TRAYECTORY:
1. Instability position
  2. Impacting the ground
  3. Sliding: final position

Deformation by impacting the ground

After a frontal collision on the driver's cab the bus rolled down... on a slope

- Considerable deformation on the UL
- Possible intrusion into the RS on the UL
- Rigid LL

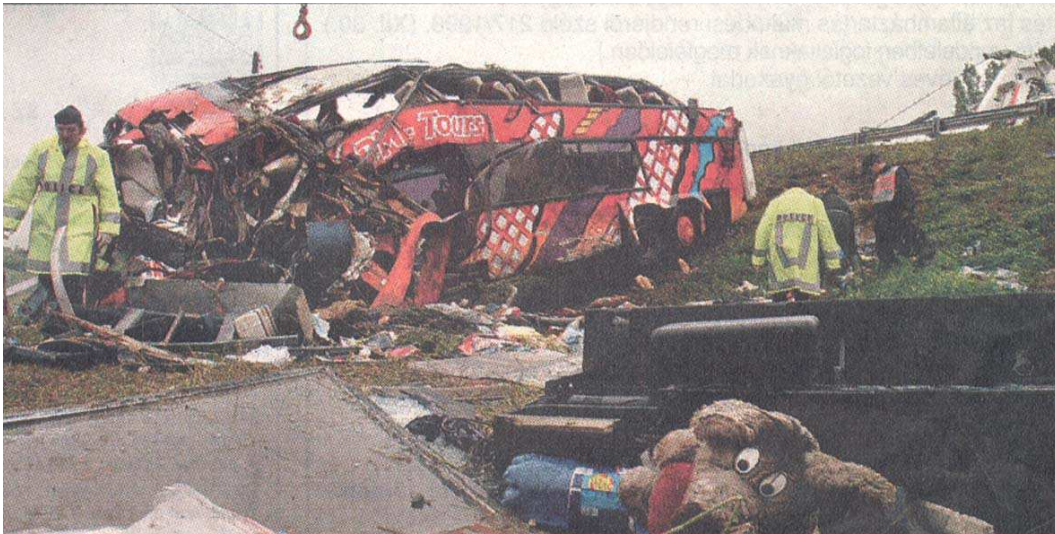
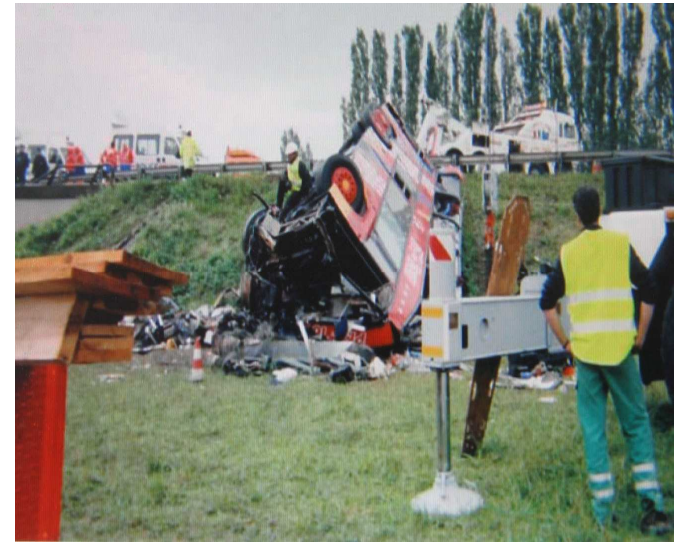
After a severe frontal collision on the driver's cab, the bus rolled down on a slope.

- The UL collapsed
- RS disappeared on the UL
- Rigid LL (deformation only due to the frontal collision)

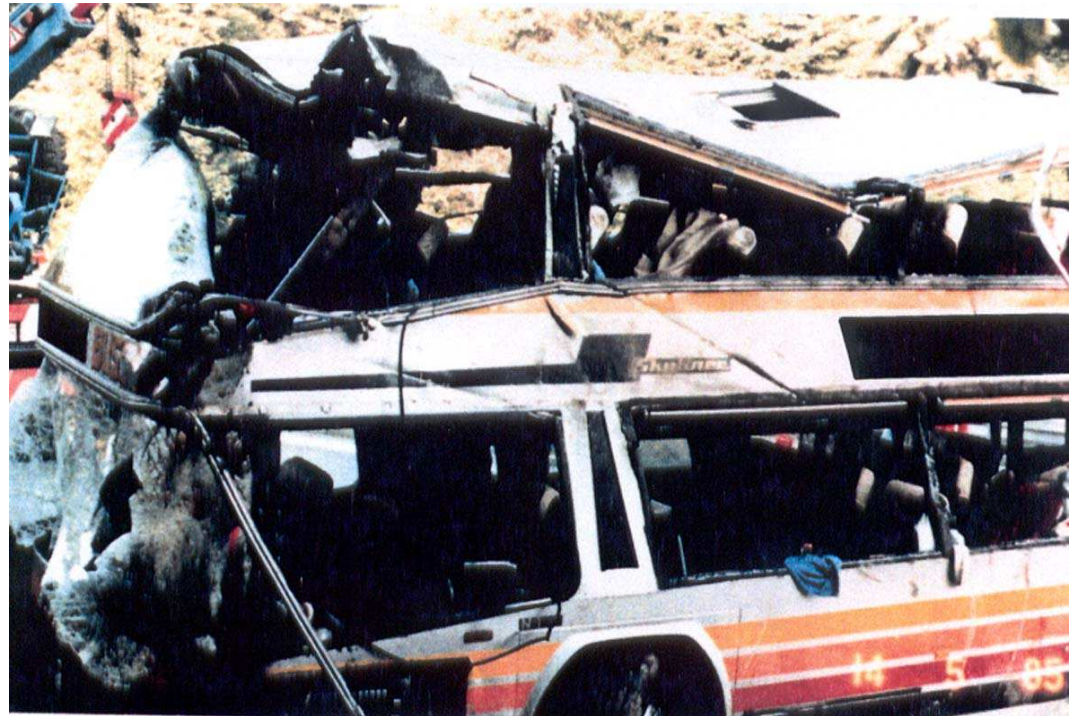
- Severe, locally concentrated deformation on the UL
- Harmed RS on the UL
- Rigid LL

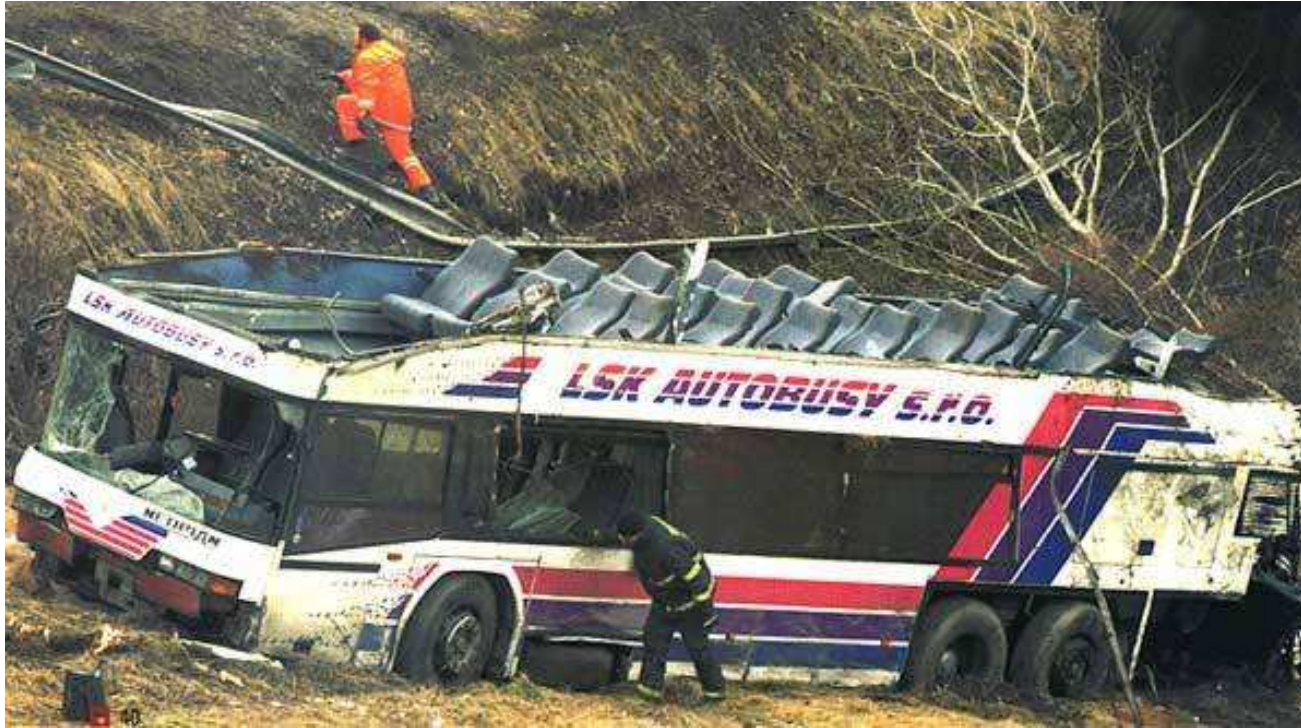
- The UL collapsed (Firemen cut it down to rescue the passengers)
- RS disappeared on the UL
- Rigid LL
