WS-4-6

# Update: Recent Australian Pole Side Impact Tests with WorldSID 50<sup>th</sup>

# Summary of Tests

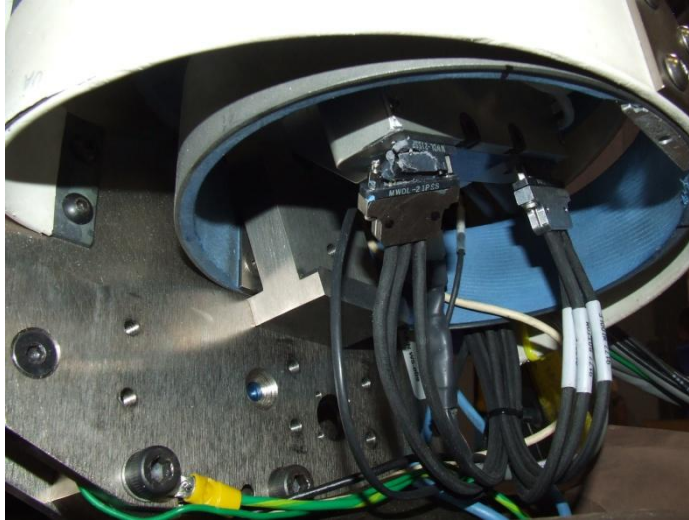
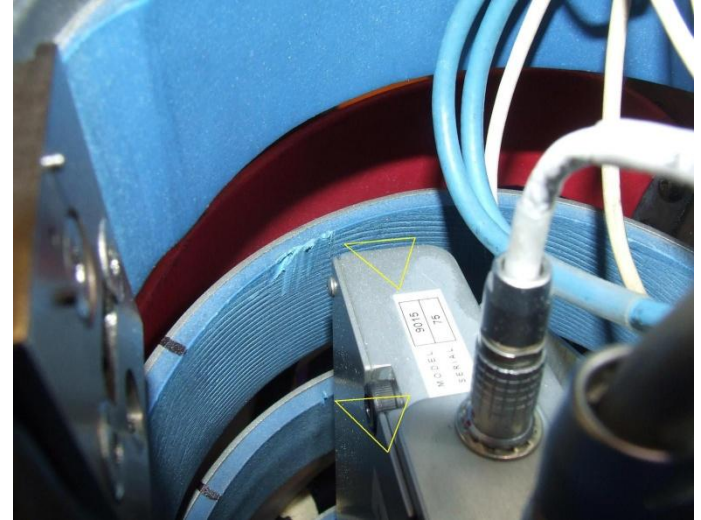
- Ribeye controller sensor cable connector damage. No internal damage to controller processor board. Field repair successfully performed by test facility.
- Interaction of non-struck side rib damping material with the ribeye controller.
