Report on Tests with the Flexible Pedestrian Legform Impactors Flex GT α and Flex GT

July 2nd , 2007
Bergisch Gladbach
Germany

Dipl.-Ing. Dirk-Uwe Gehring
BGS Böhme & Gehring GmbH

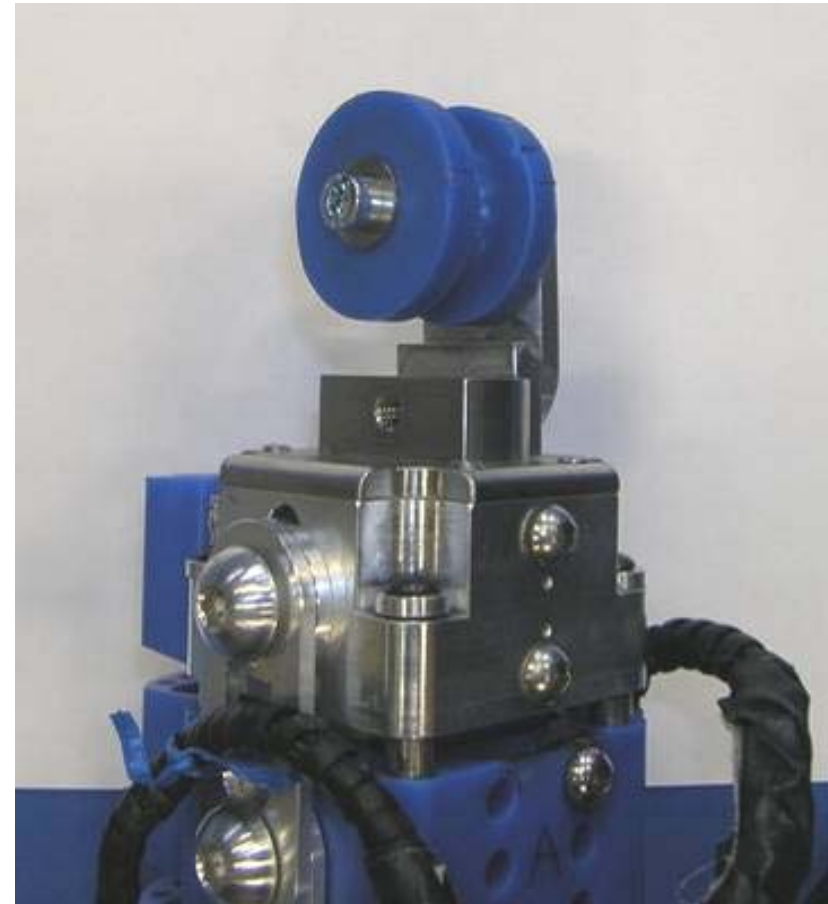
Support Roller Flex GT α

- No guiding during acceleration phase
- Impactor rotation about z-axis possible
- Likely to be damaged during test

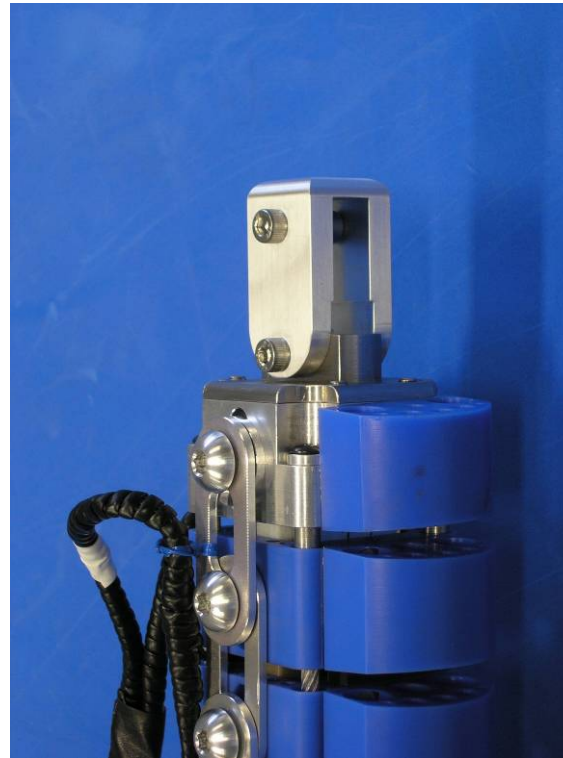
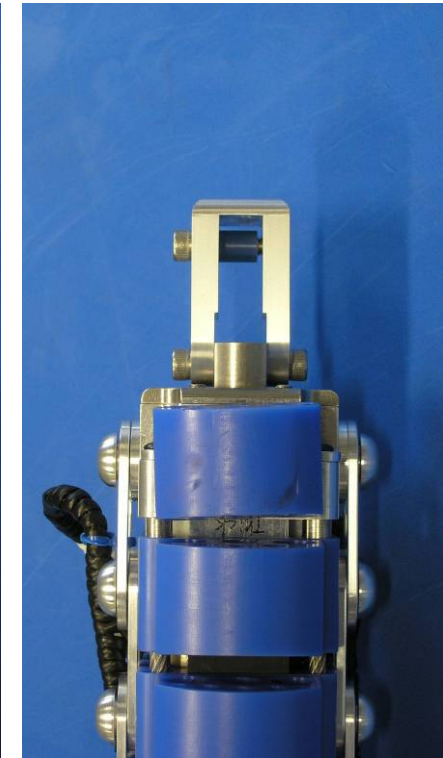
Support Roller Flex GT

- Guided support
- No impactor rotation around vertical axis possible during acceleration phase
- Strong bracket
- Protected roller

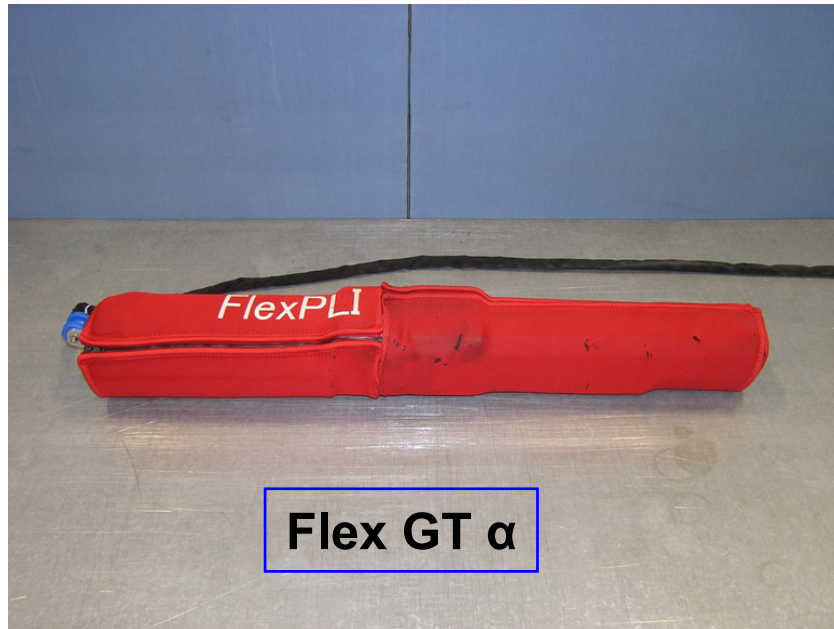
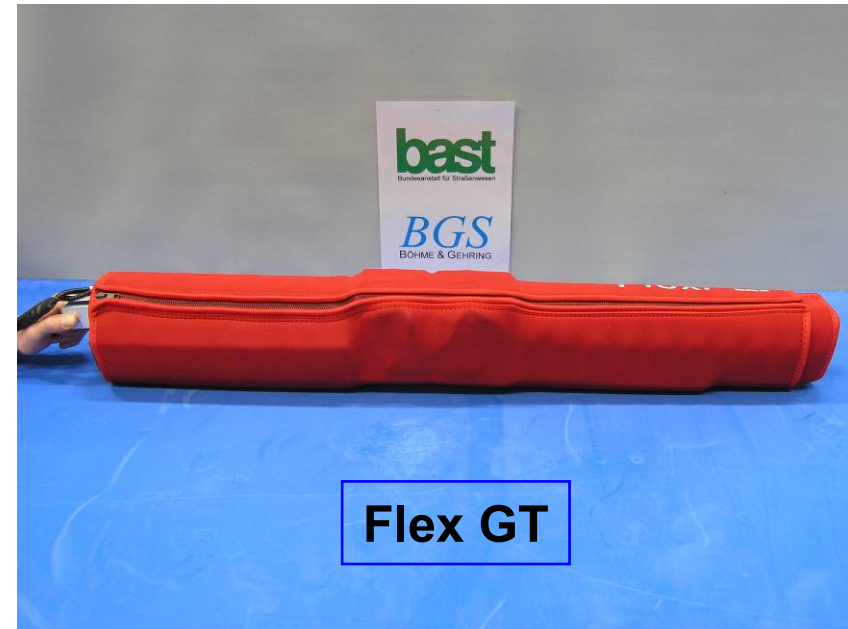
Outer Flesh

Change from two pieces to a continuous, one-piece outer flesh

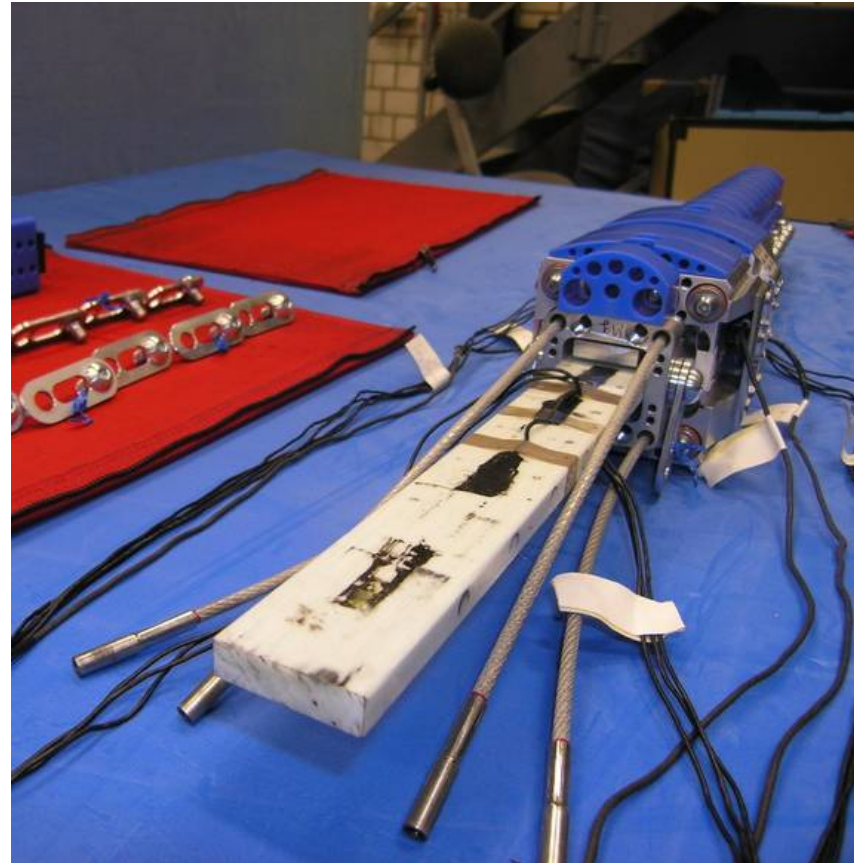
Bone Cores

- Improvement of production
- Reduction of thickness (- 0.5 mm)
- “Bending characteristic comparable”
- Additional parts also modified to avoid any play
 - Tibia and femur segment openings
 - Bone clamping devices in knee part

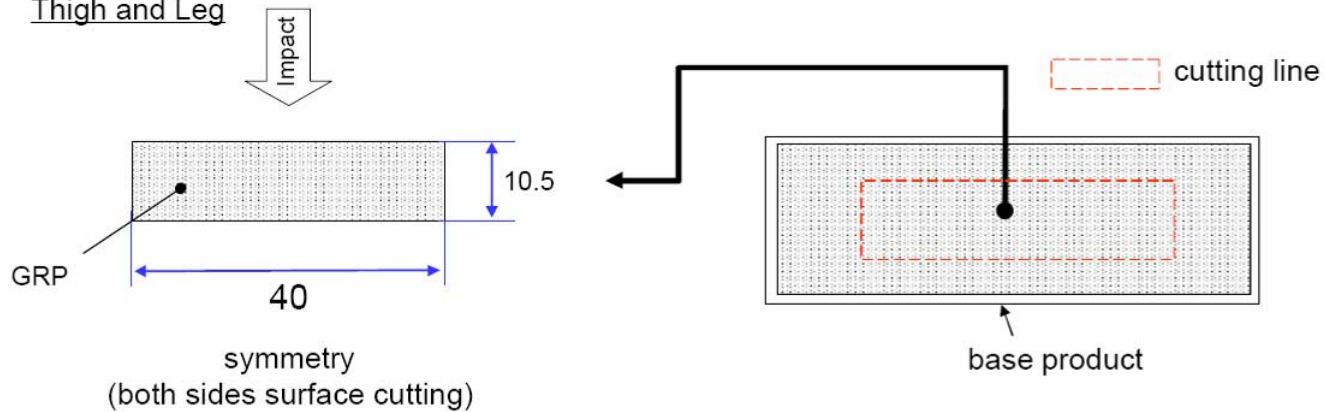
Detailed Explanation (Flex-GT)

How to make

Flex-GT (t=10.5 mm)

Thigh and Leg

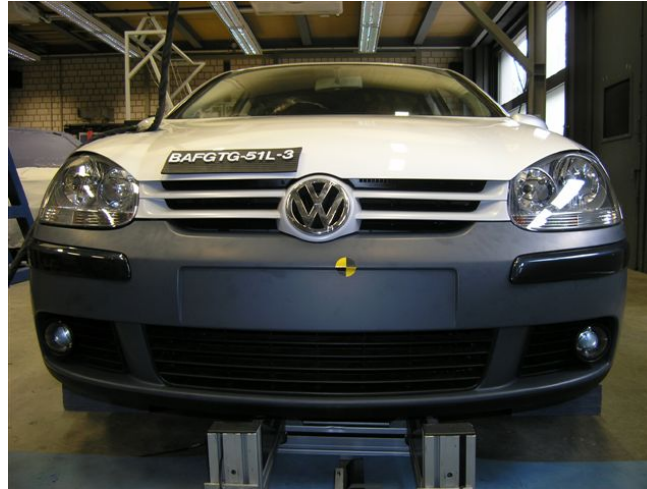
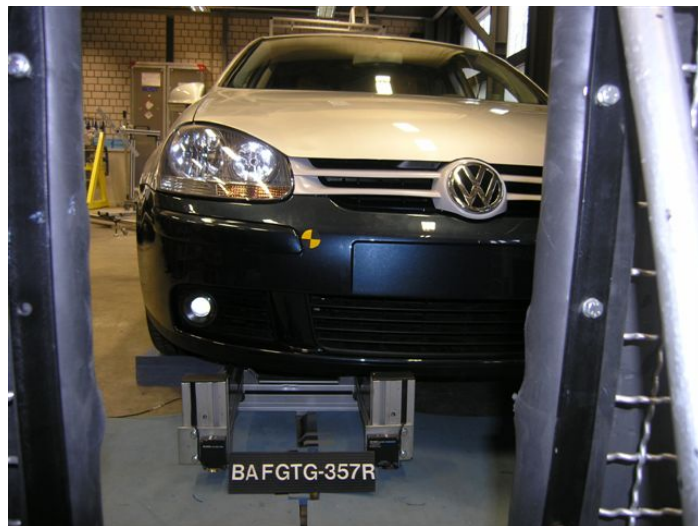
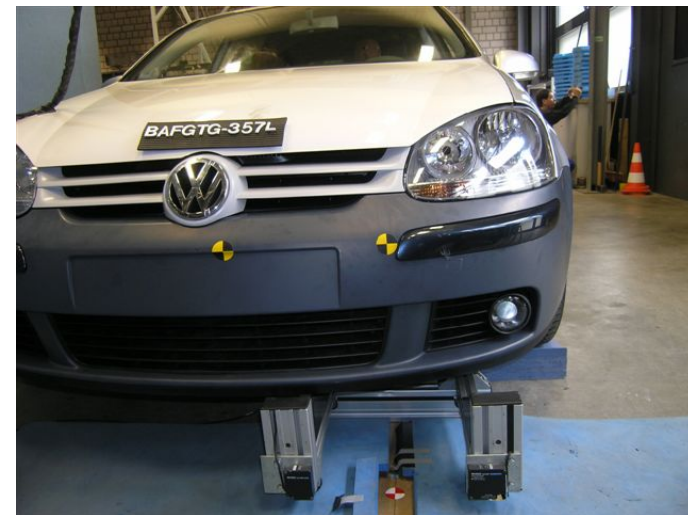
Tests with Golf (2)

Y= 51 mm

Y= -357 mm

Y= 357 mm

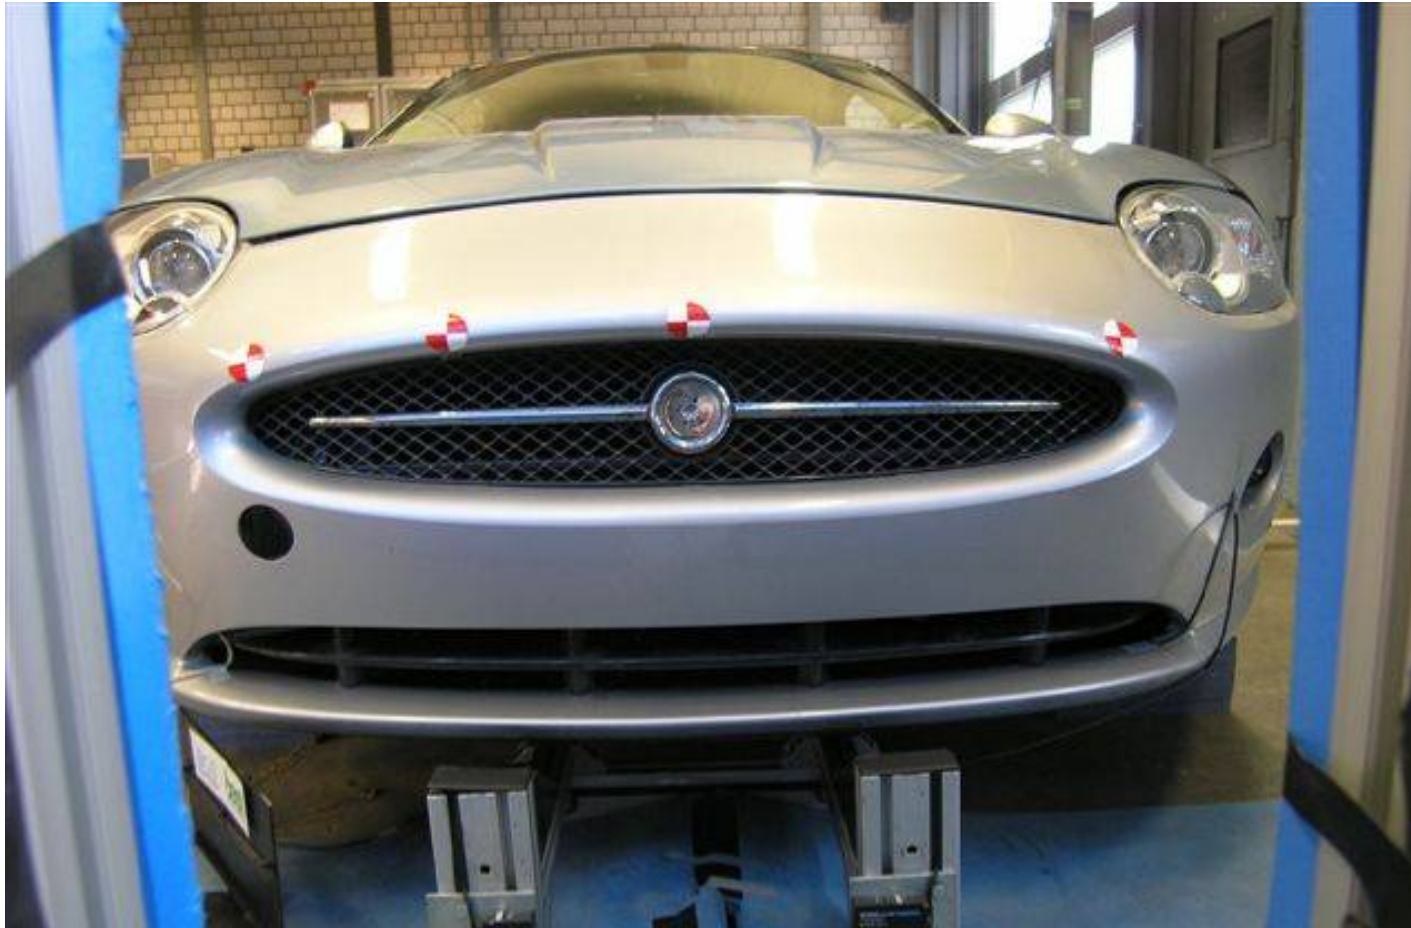
Tests with XK (3)

Y= -420 mm

Y= -220 mm

Y= 0 mm

Y= 420 mm

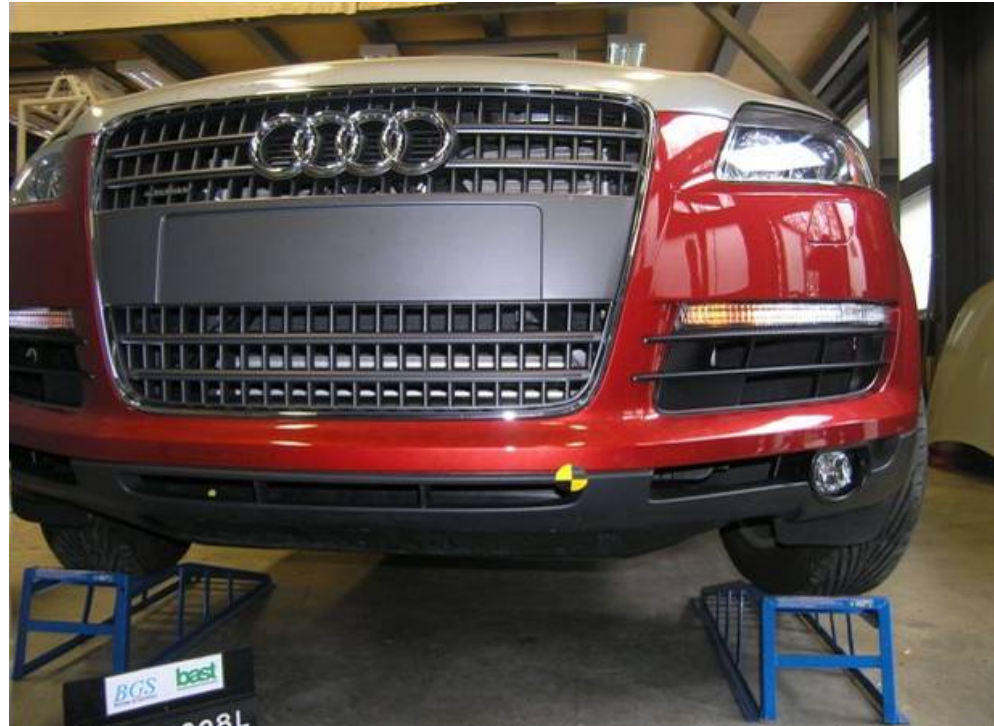
Tests with Q7 (2)

- For these tests, the vehicle was lifted up to achieve a Lower Bumper Reference Line of 501 mm

Y= 298 mm

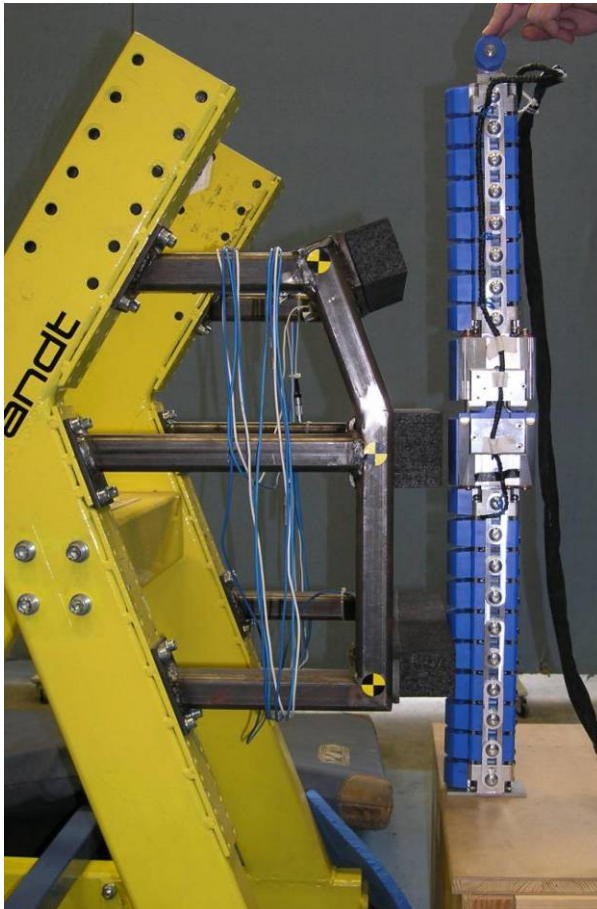
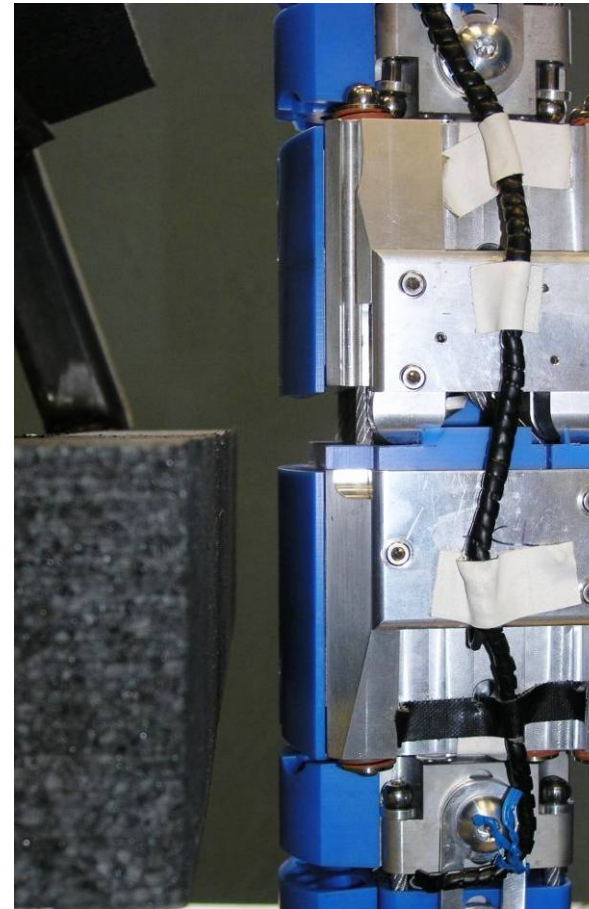
Tests with Test Rig (3)

Impact height 0 mm: Centre of knee in line with upper edge of second foam piece

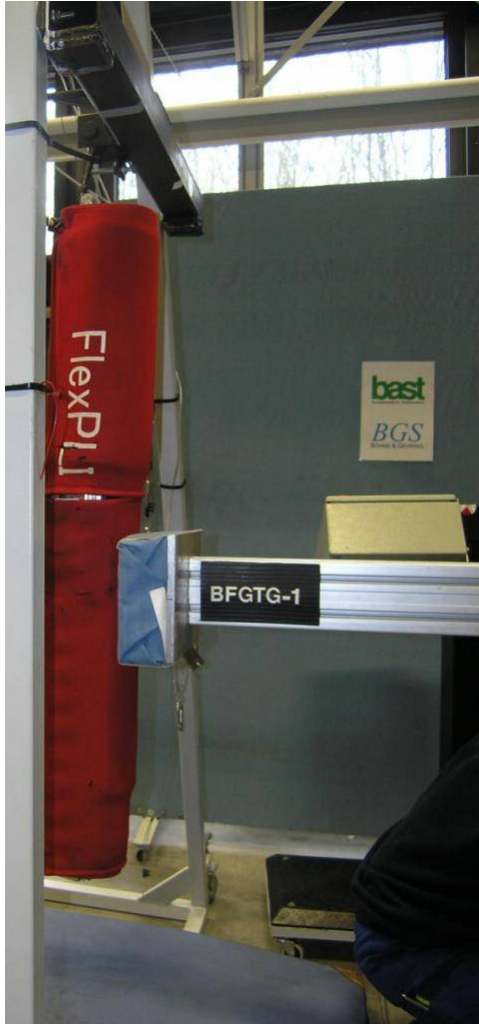
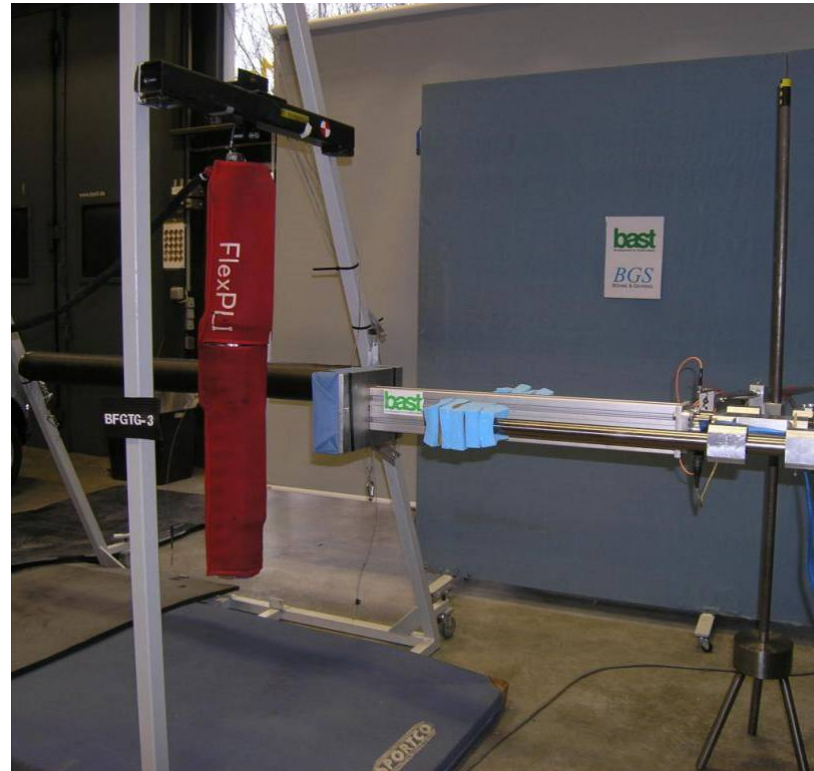
Inverse Tests (2)

Impact height: Upper edge of aluminium honeycomb in line with centre of knee

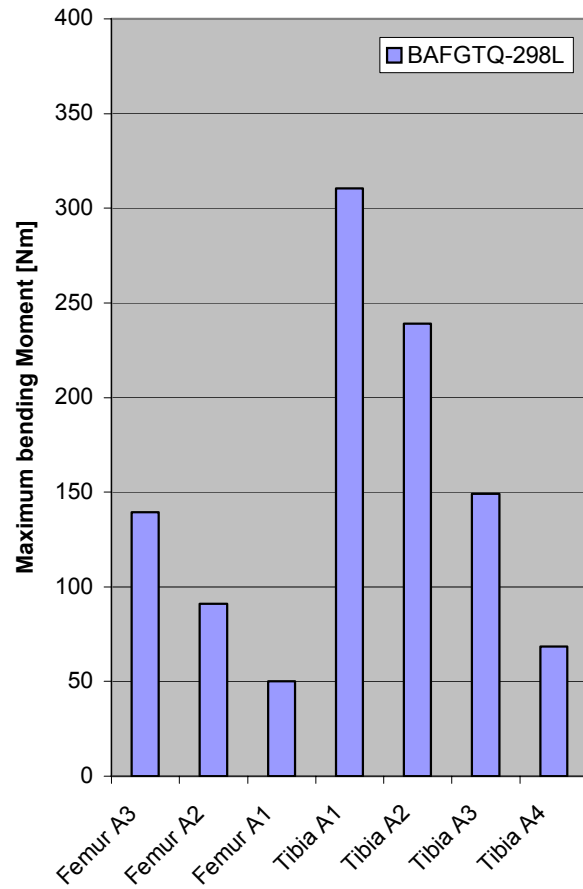
Audi Q7 Bending Moments

LBRL=501 mm

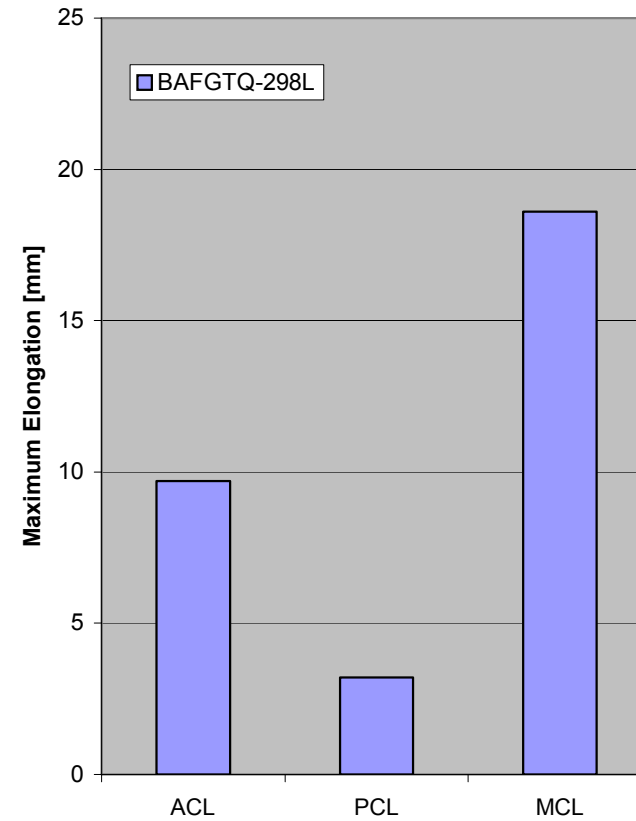
Audi Q7 Elongations

LBRL=501 mm

- WG 17 Legform Impactor
 - Max. Acceleration: -85,9 g
 - Max. Bending angle: 17,9°
 - Max. Shear Displacement: 2,7 mm
- WG 17 Upper Legform Impactor
 - Max Bending Moment: 347,9 Nm
 - Max. Sum of Forces: 6,23 kN

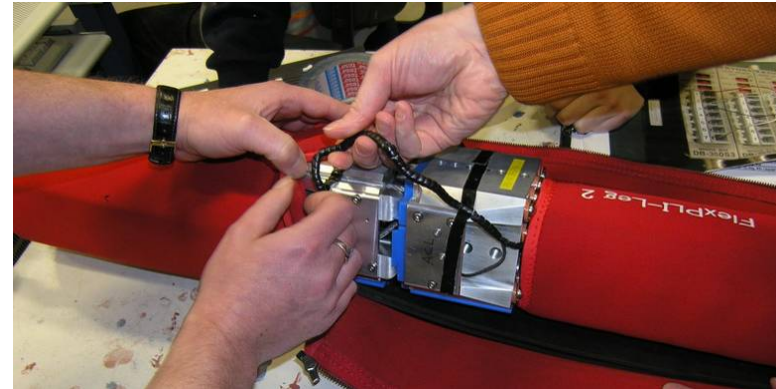
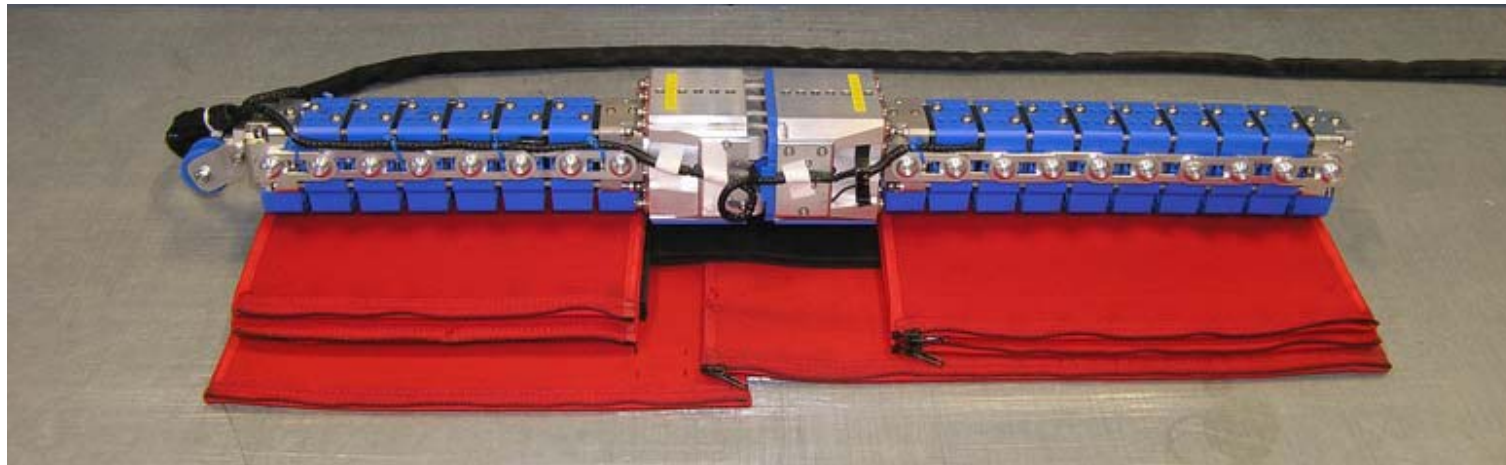
Inspection after test

- Visual inspection of the impactor components and the cabling

Impactor shown on photographs is Flex GT α

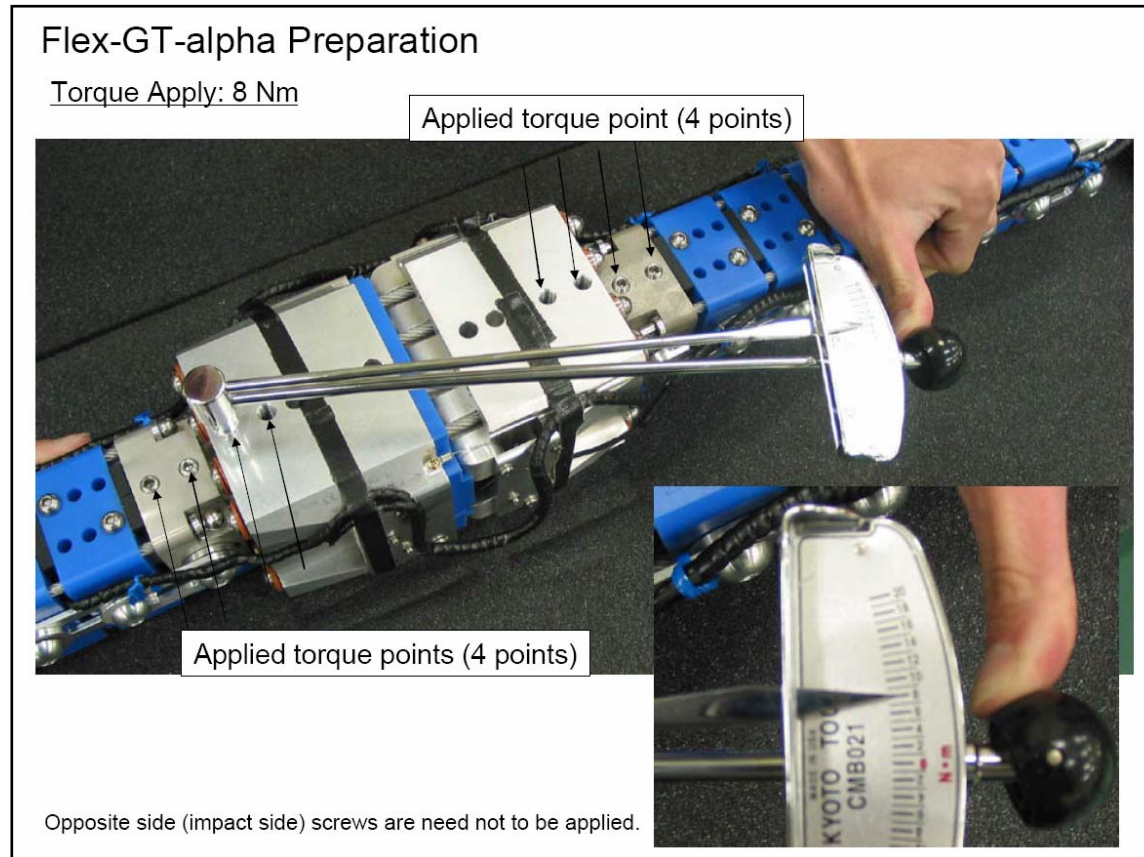
- Verification of the torque of 8 screws

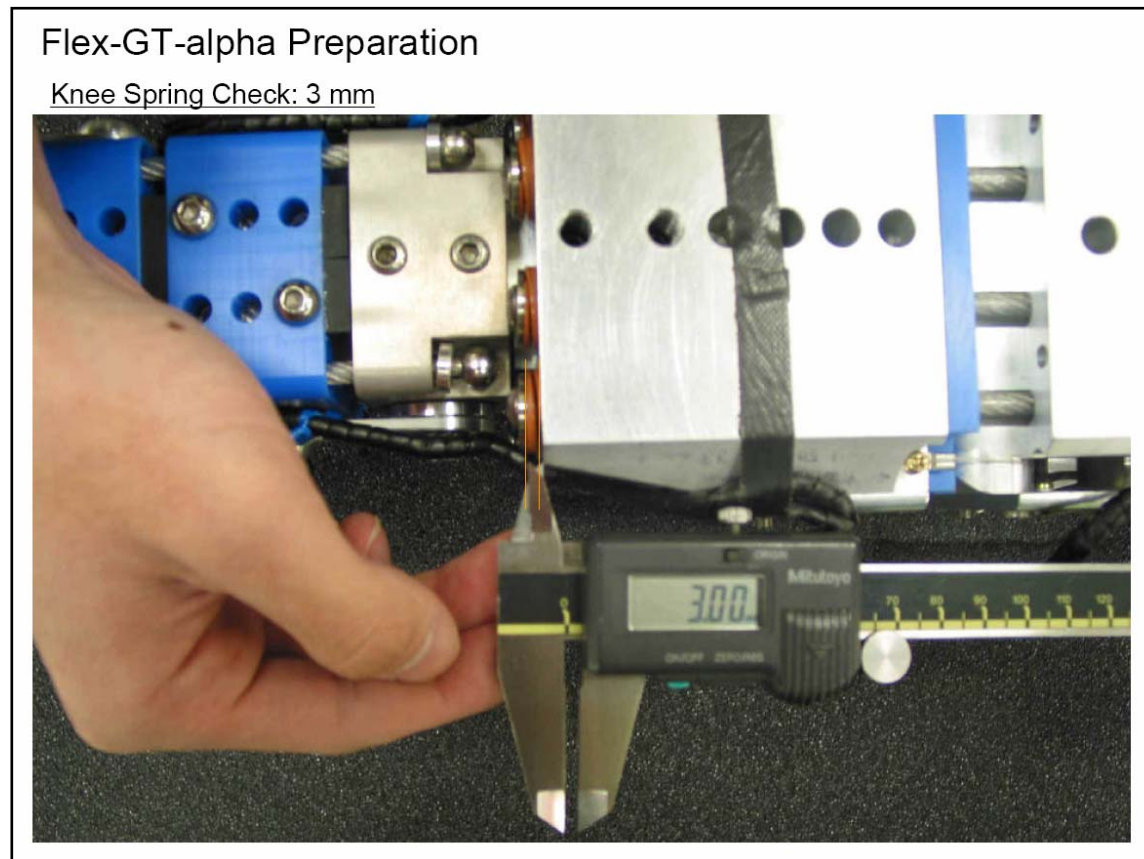
- Check of the length of the 20 knee spring ends

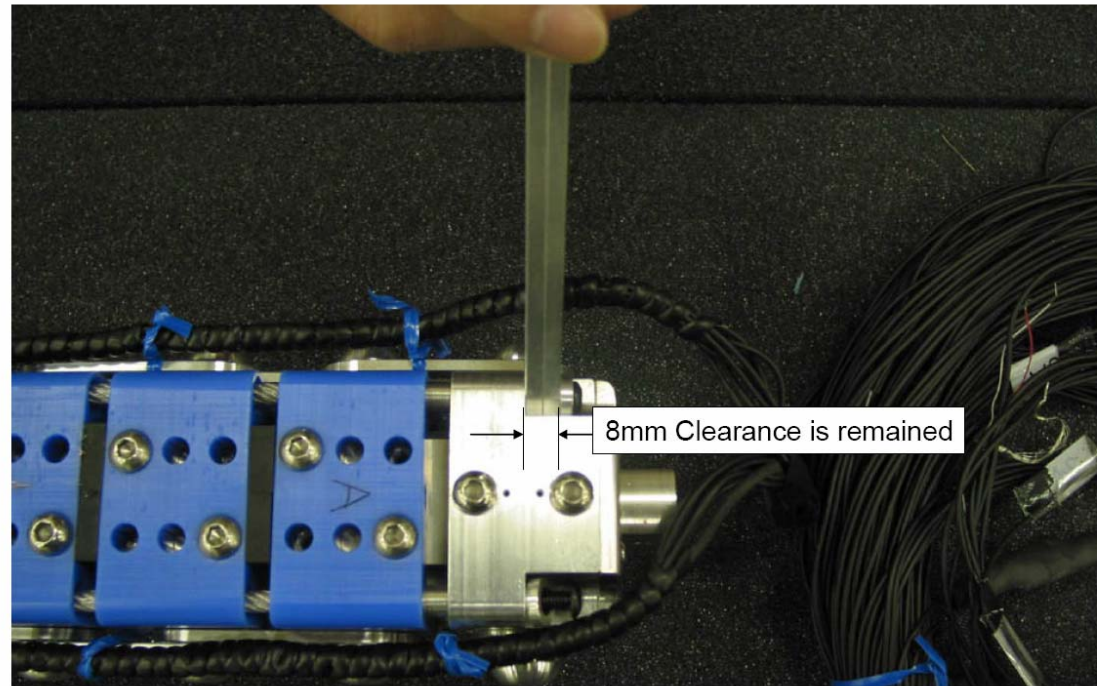
- Check of the length of the 4 upper leg bending stopper cable ends

Bending Stopper Cable Clearance Check (Thigh): 8 mm

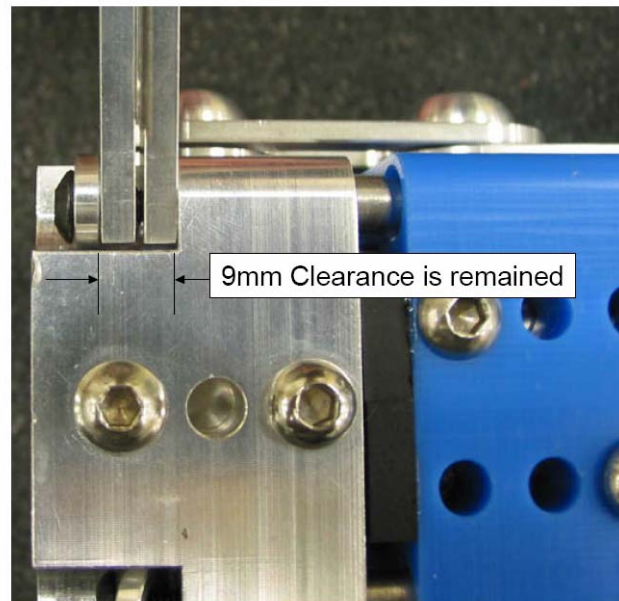
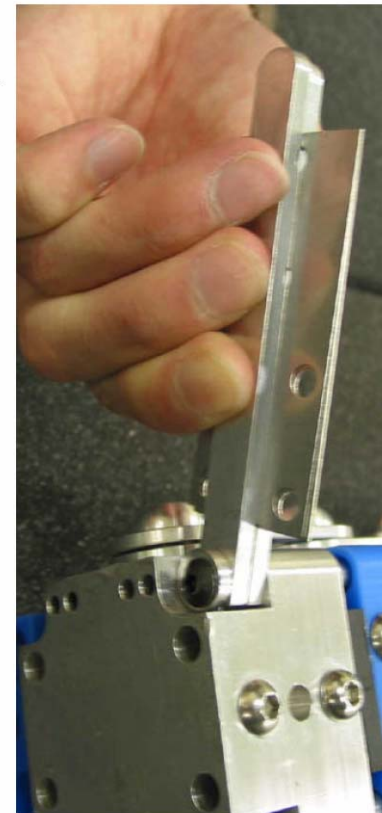
- Check of the length of the 4 lower leg bending stopper cable ends

Bending Stopper Cable Clearance Check (Leg): 9 mm

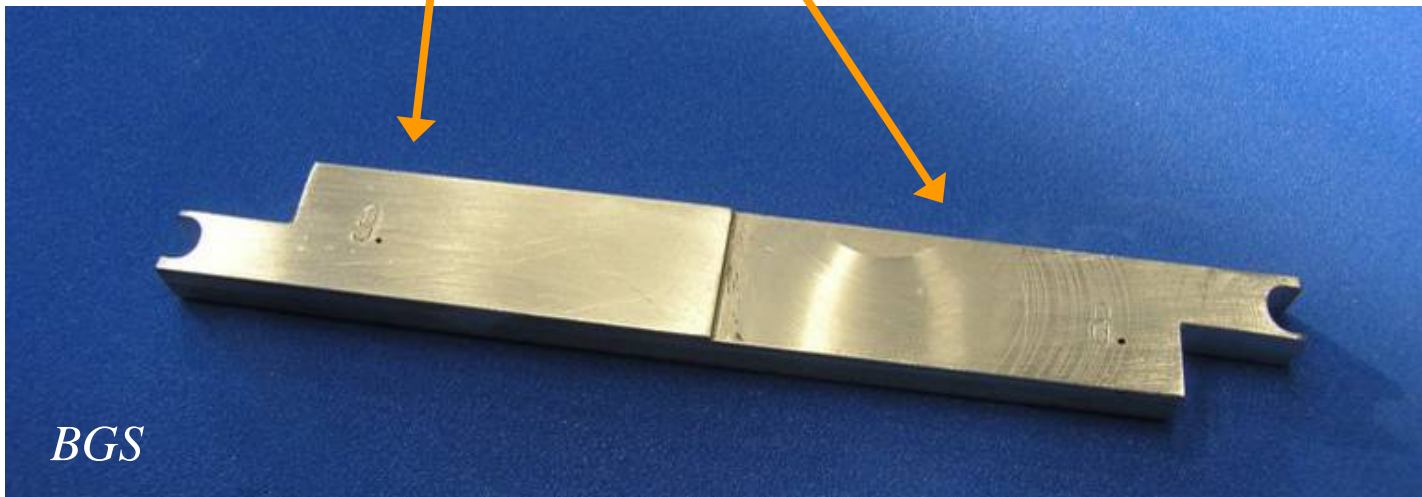
- New tool for cable clearance checks:
 - Thicknesses: 9 mm and 8 mm

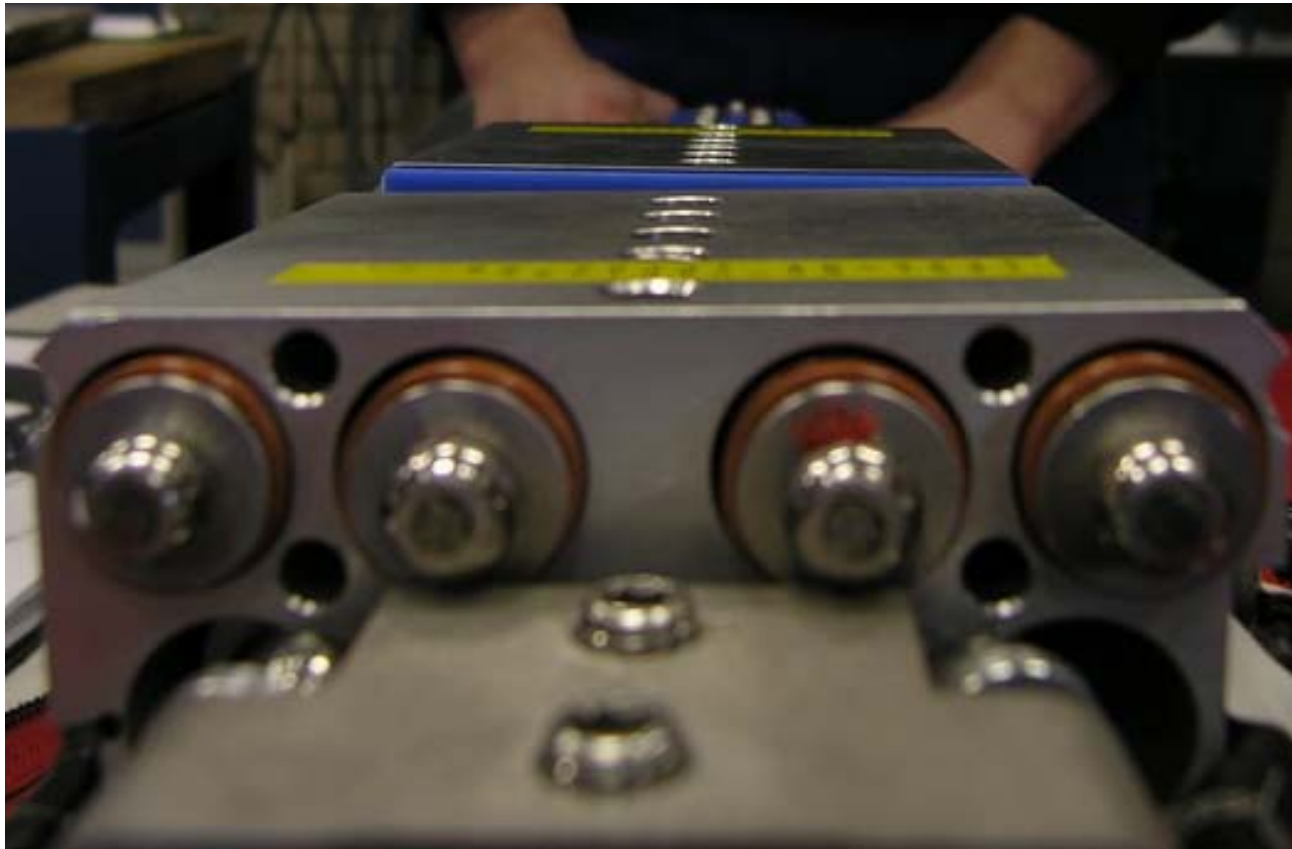
- Check for distortion

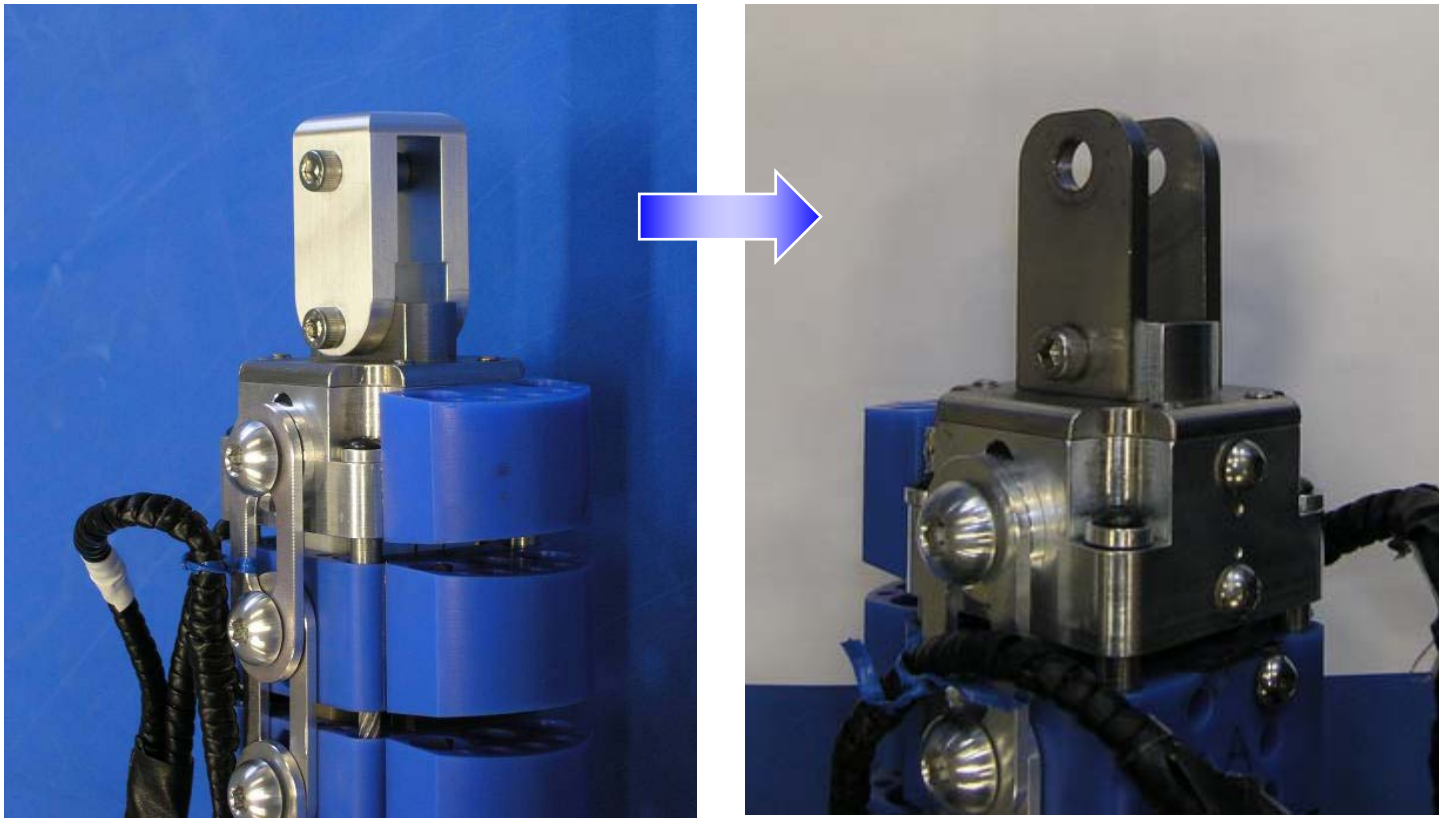
- Change from roller bracket to mounting bars

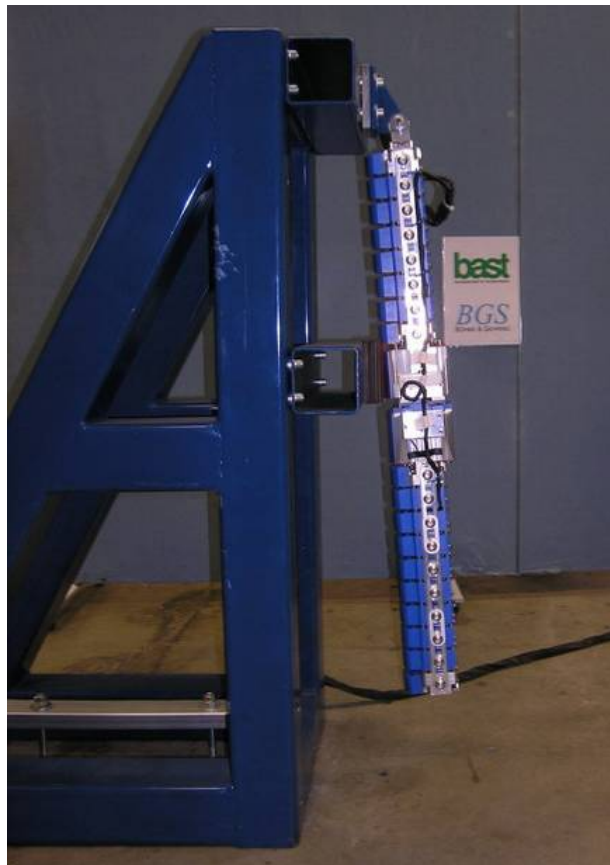
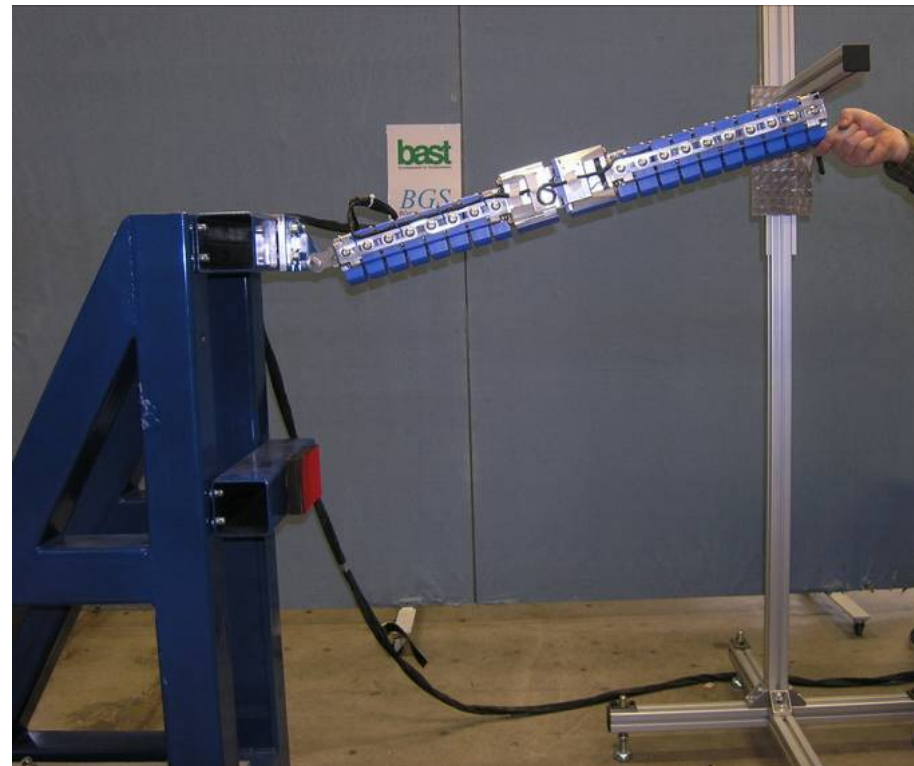
Certification

- Mount to the certification rig, zero the offsets, lift up the impactor to +15° and release

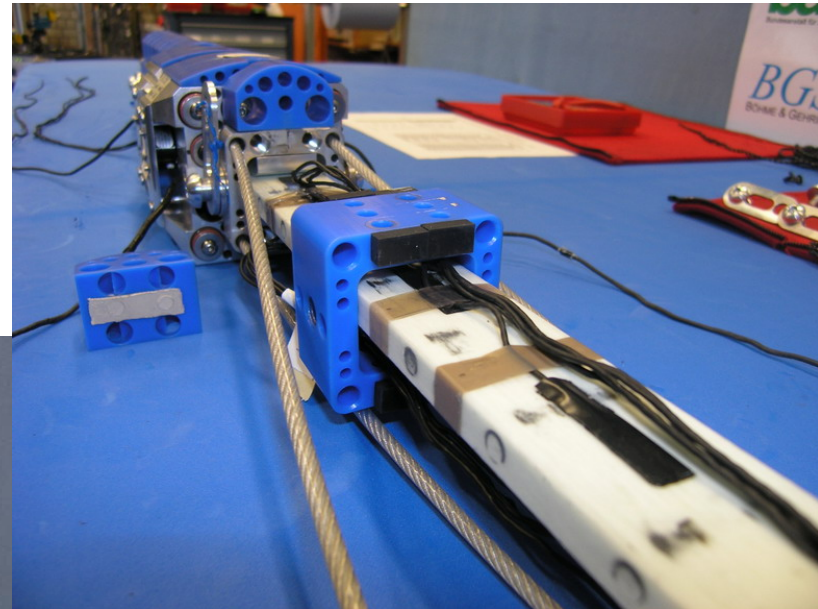
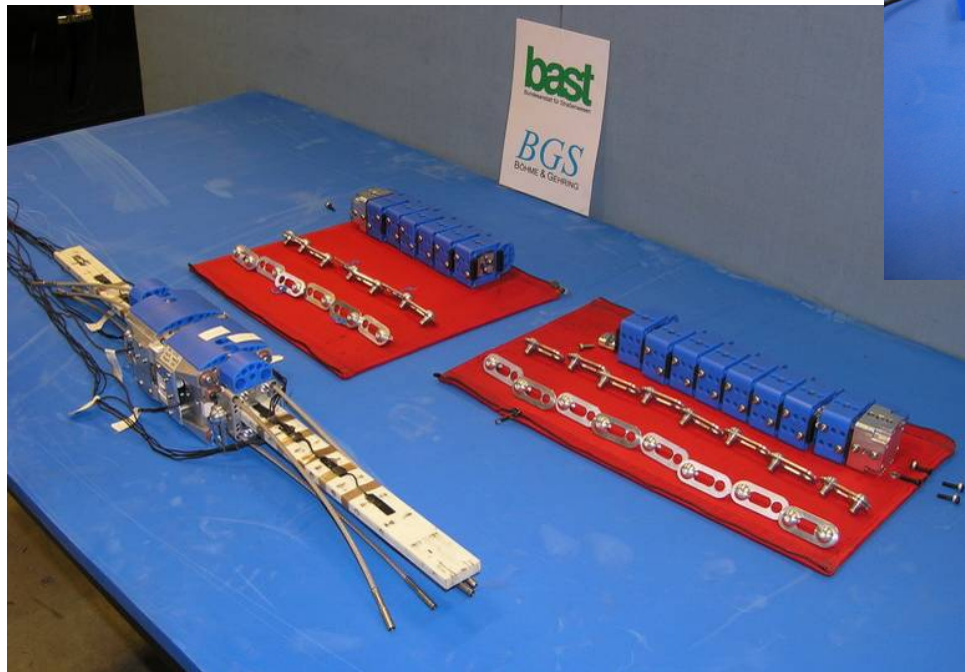
Particularities: Wiring

- In case of multiple cable damage the impactor has to be dismantled

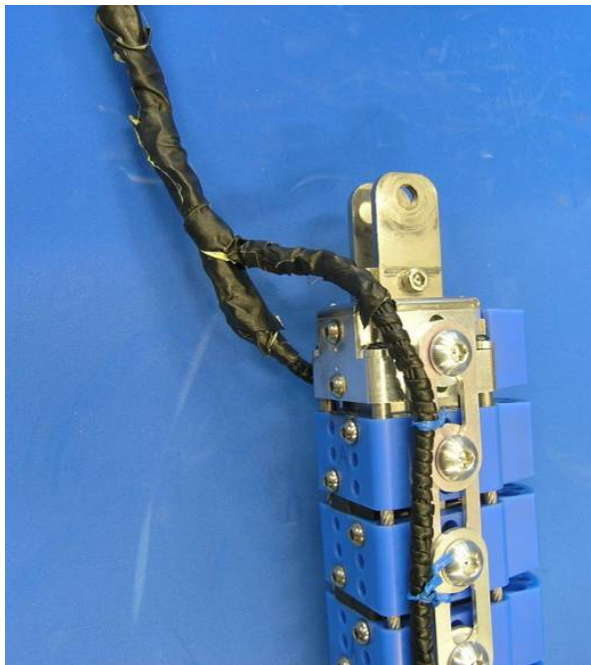
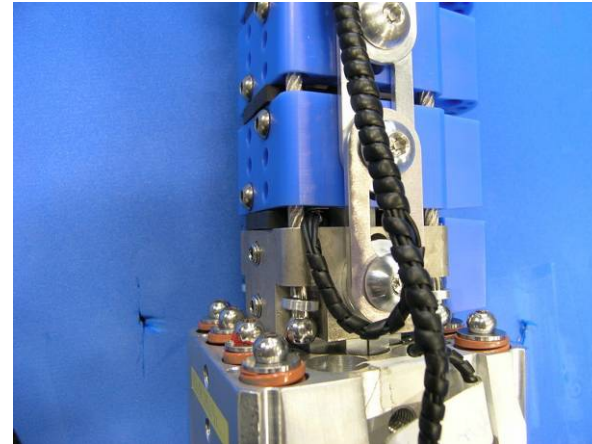
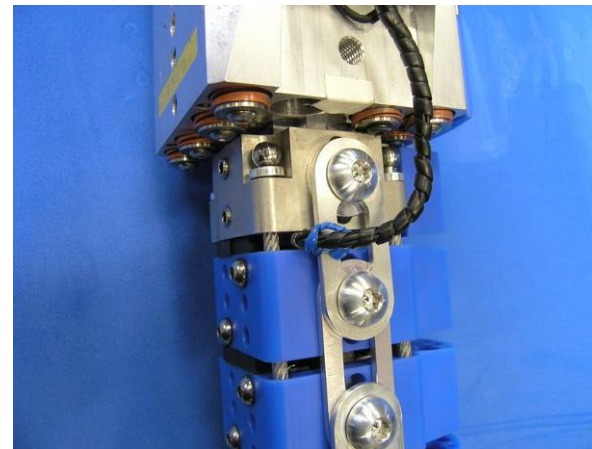
Particularities: Wiring

- Cable guiding with sharp angles and around sharp edges
- Cables likely to be damaged near the impactor

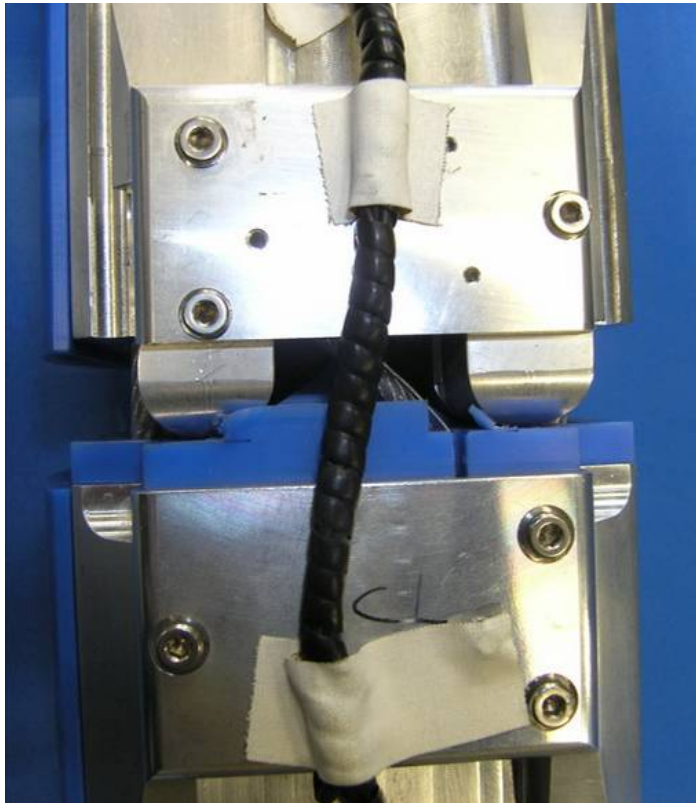
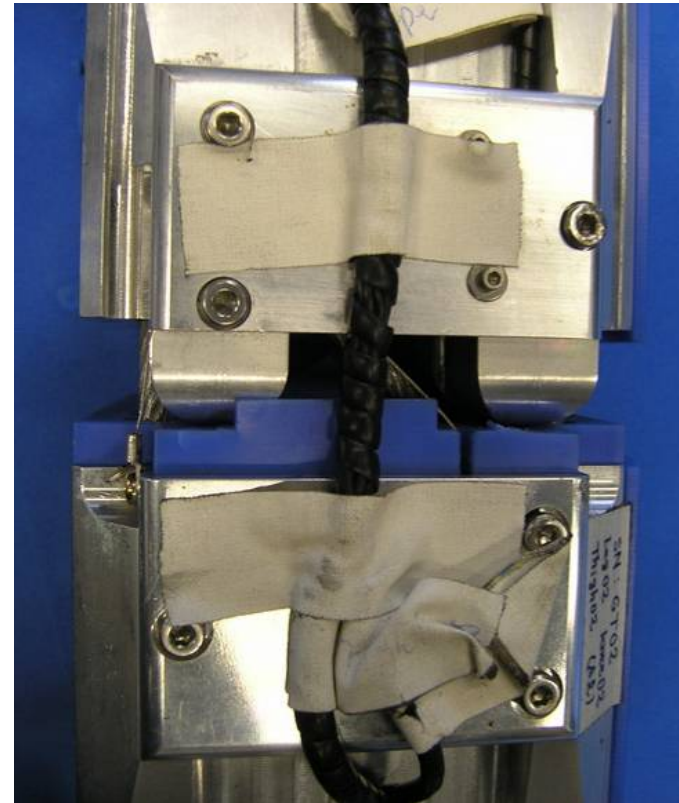
Particularities: Defects

- Broken guidings at tibia surface plate
