Report on Tests with the Flexible Pedestrian Legform Impactors Flex GT α and Flex GT

July 2nd , 2007
Bergisch Gladbach
Germany

Dipl.-Ing. Dirk-Uwe Gehring
BGS Böhme & Gehring GmbH

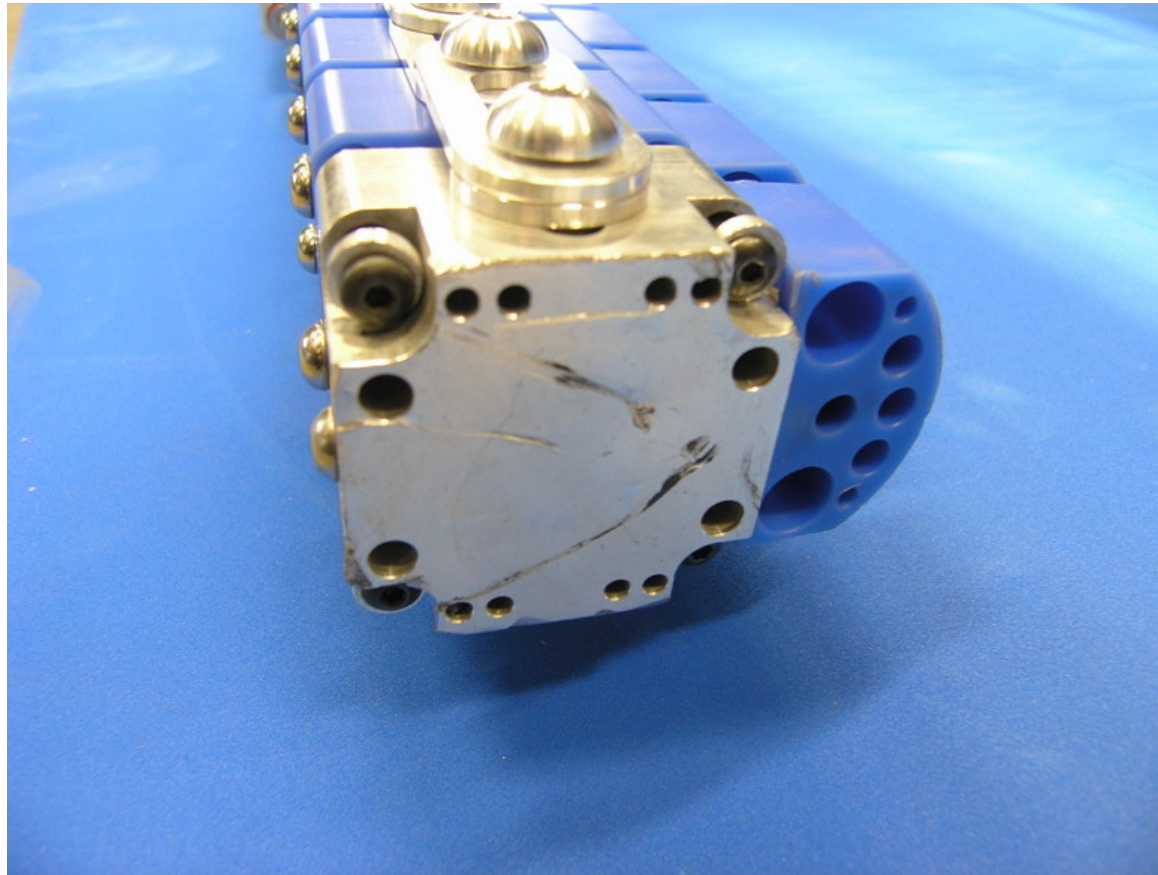
Particularities: Defects

- Scratches at tibia lower end

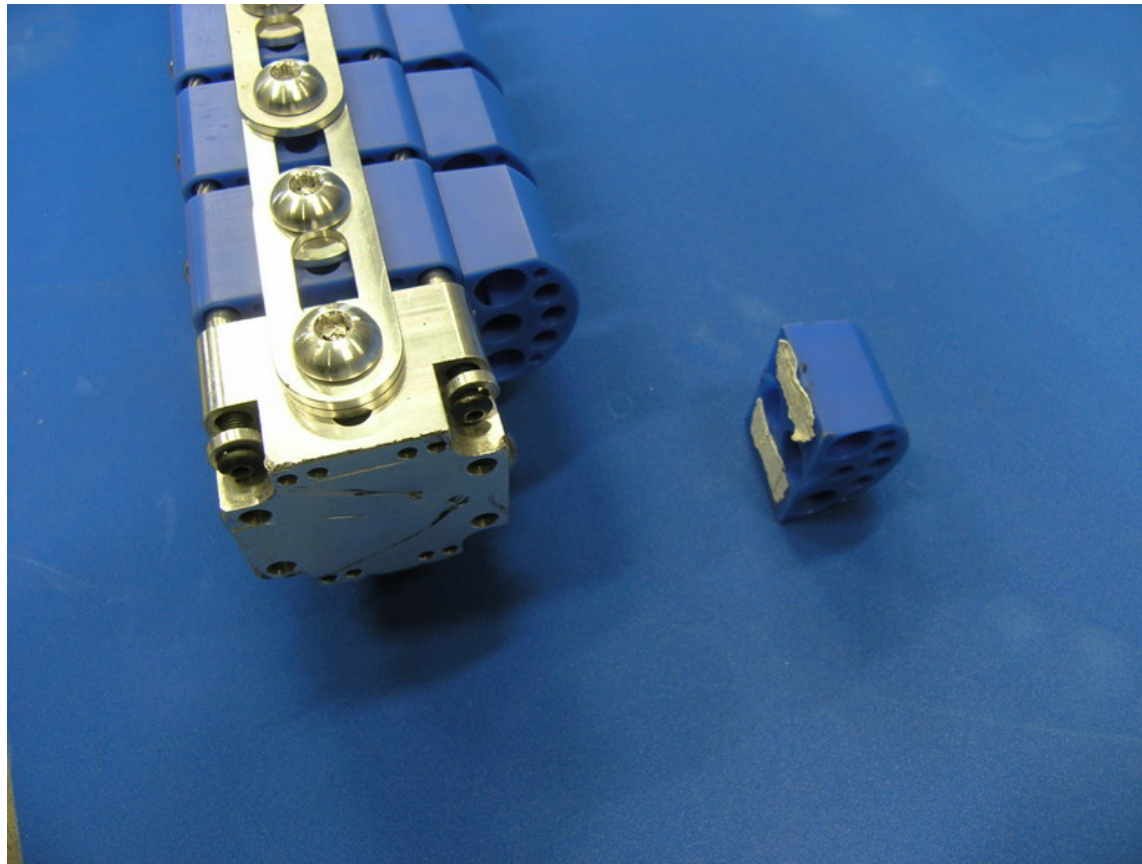
Particularities: Defects

- Separation of lowest segment impact face

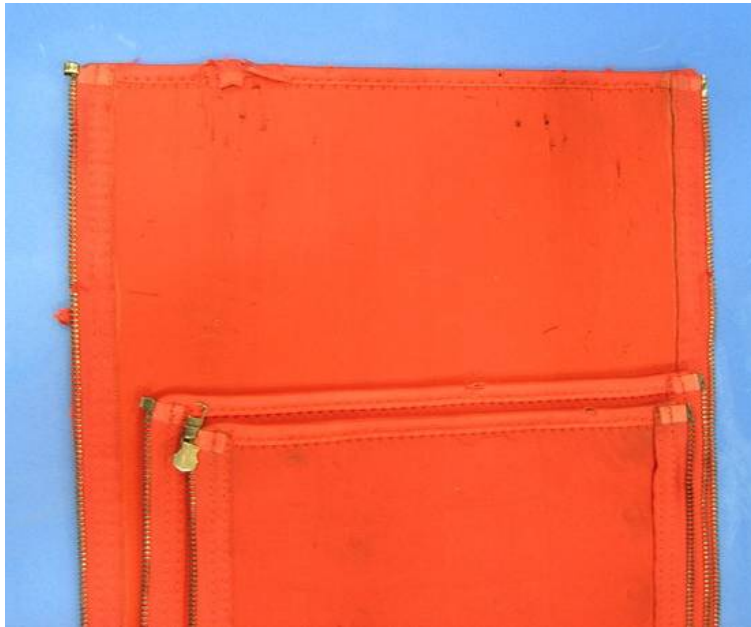
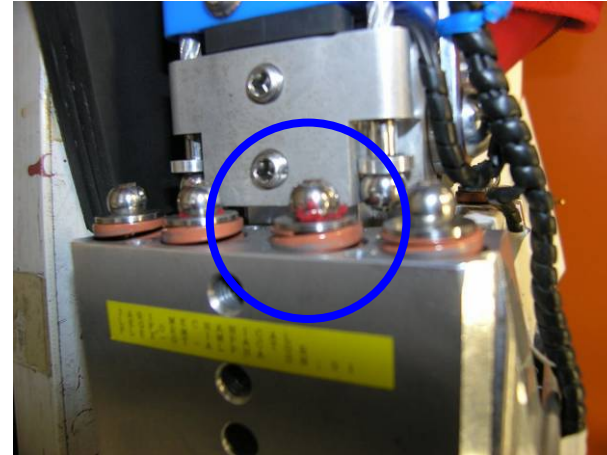
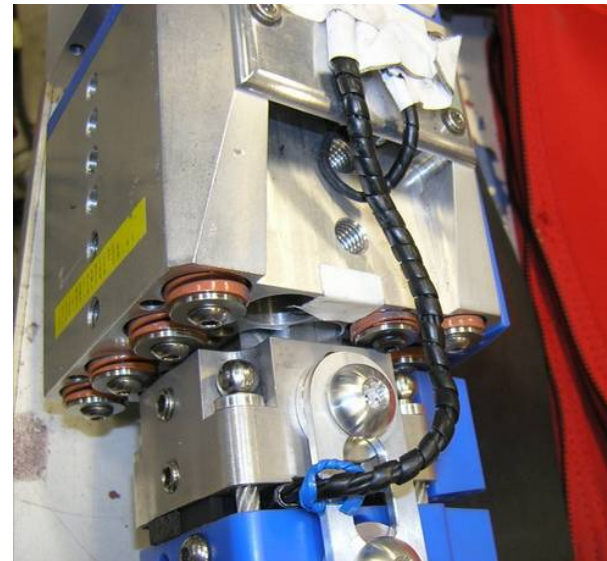
Particularities: Defects

- Neoprene skin:
 - Zippers very sensitive
 - Skin gets caught in spring ends
 - Skin damaged by sharp edges of knee
