#### **Localized Fire Protection Considerations**

Matt Coons – Senior Regulatory Development Engineer, Road Safety Directorate, Transport Canada

#### **Localized Fire Studies**

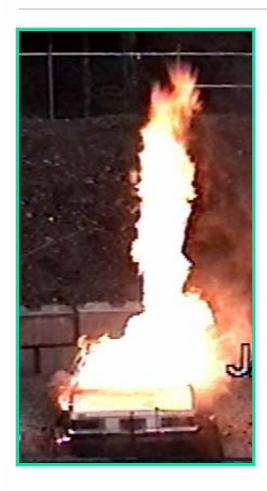
H2 release from burning vehicle

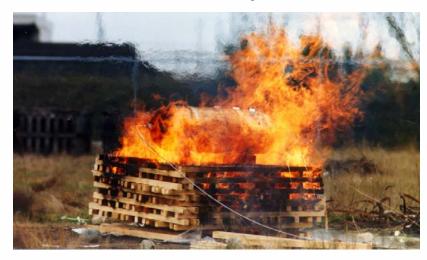
Bonfire test of tank using LPG burner

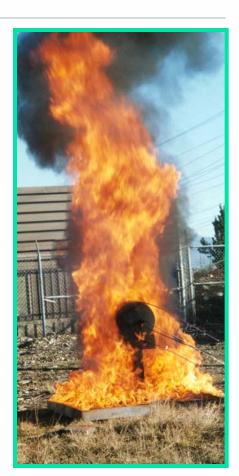
Wood bonfire test of tank

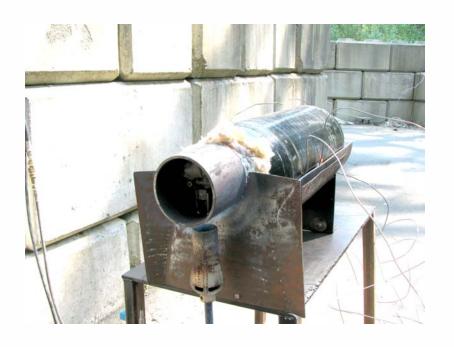
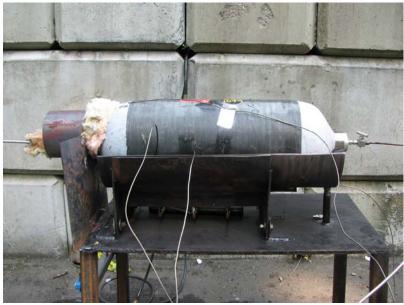
## **Hot Plate Design – Test**

- Need a repeatable method that achieves and maintains certain constant temperatures within a given time
- "Hot plate" test method developed
  - Tank centre sits in contact with a curved steel "cradle" (high temperature)
  - One tank end sits in contact with separate steel "cradle" (medium temperature)
  - Opposite tank end in open air (low temperature)
- Central cradle heated by oxy-LPG flame & end cradle heated by separate LPG torch
  - Oxy-LPG required to heat steel to 800°C within 8 minutes

- Steel cradle provides temperature control vs use of open flames or hot gases
  - Hot gas temperatures easily affected by thermal mass of tank
  - Temperature control +/- 5°C has been demonstrated
  - Keeps the temperature away from the ends
- Valve/PRD end can be tested in either medium temp or low temp position
- Hot plate" not only method that can be used any test method that meets the temperature/time profile is acceptable
  - The temperature/time profile assures consistent test results between Test Labs

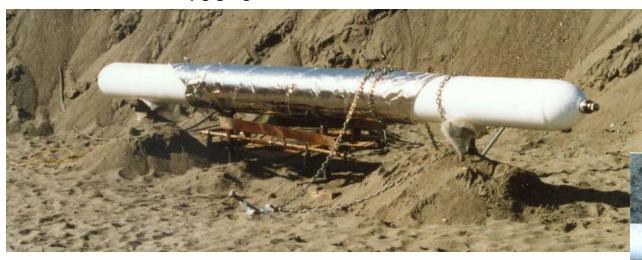
## Bonfire Test of Thermal Protective Coatings (illustrates fire protection method without PRDs)

- 1994 study performed by Powertech on 6m long CNG cylinder
  - 6 mm thick aluminum oxide wrap 1.65m long fire
  - 45 minutes in fire, composite temperature only reached 100°C

Set-up for bonfire test using LPG burner

Illustrates heat discolouration to wrap
