# GM Biorid Fx Data Issue Final Results

Report to GTR/TEG

April 28, 2010

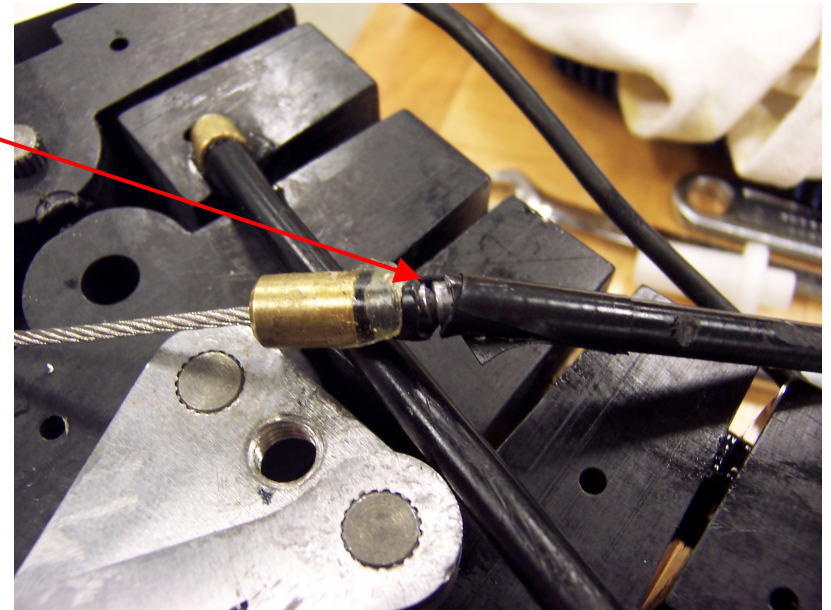
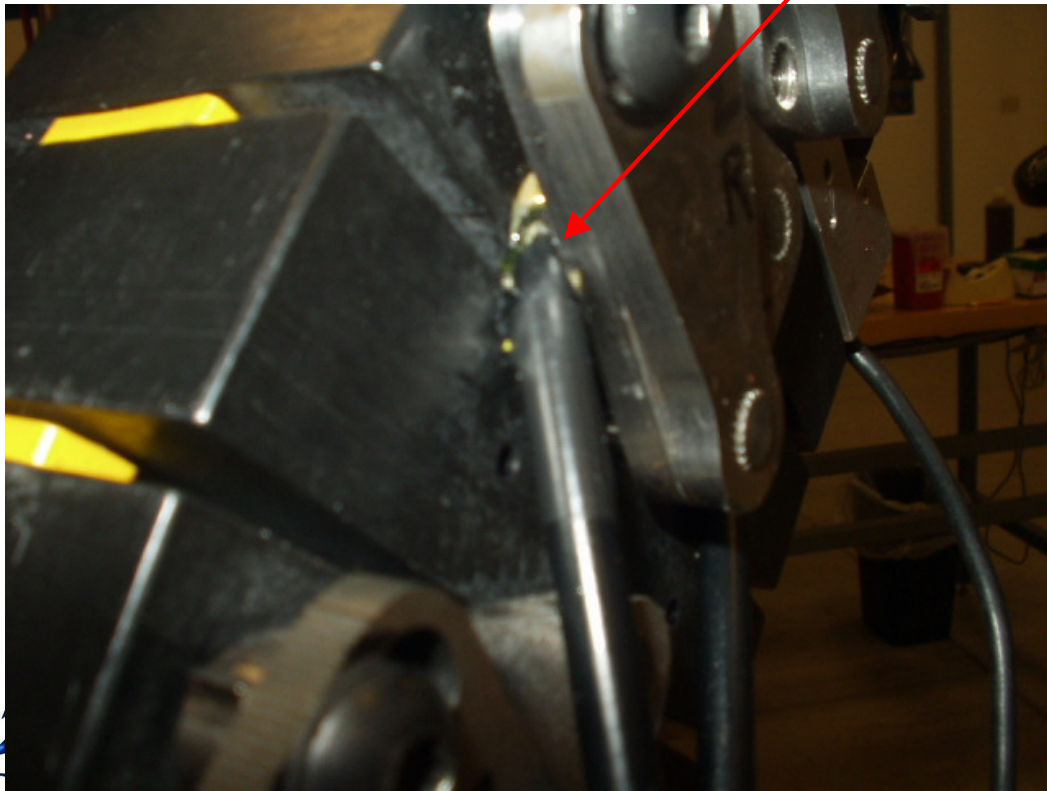
- Loose damper & washer out of place (at GM)
- Damper missing oil (refilled & checked)
- Rear muscle tension cable sheath damaged
  - Replaced cable/sheath & added notch to washer plate

**Muscle substitute cable sheath damage.**

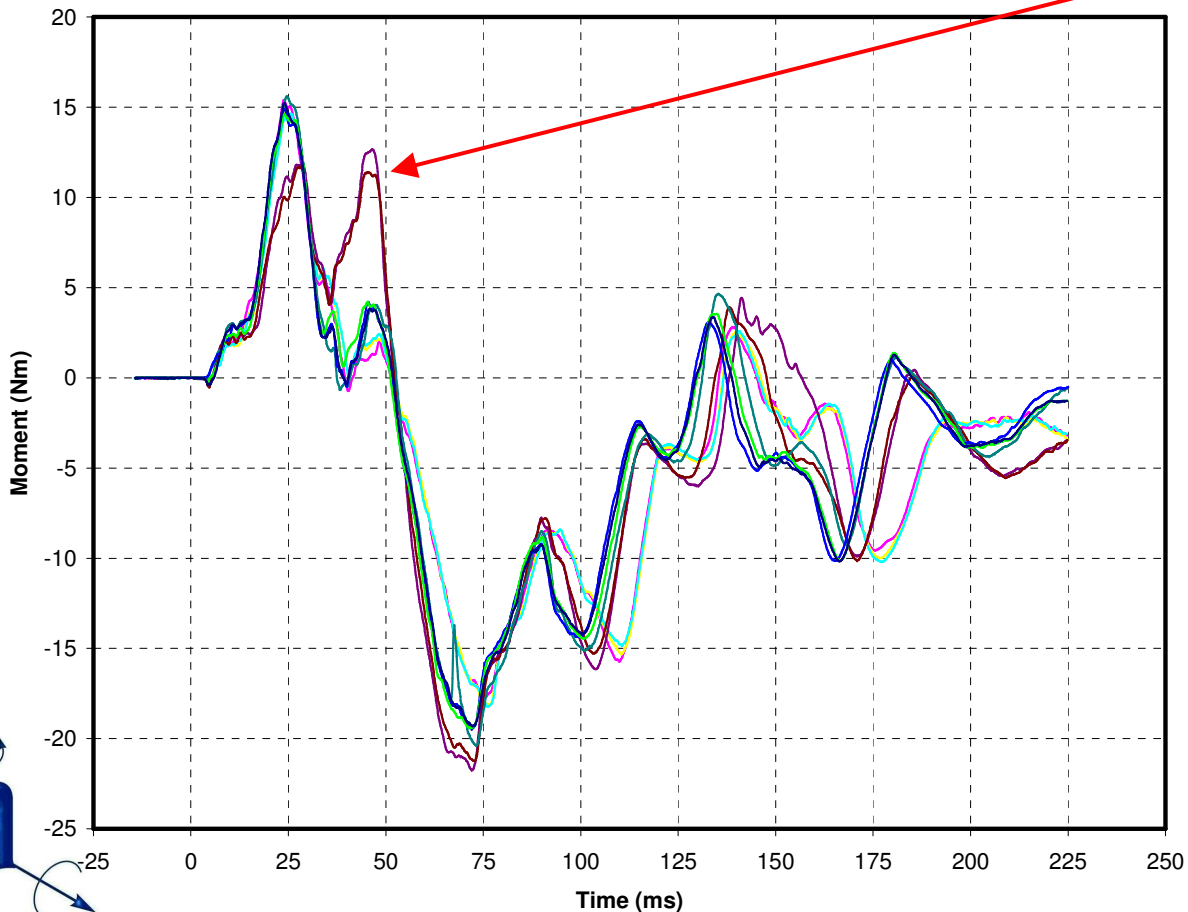
Upper Neck Moment MY

- Did NOT fix positive Fx problem
- Removed double peak in certification test My

Something repaired changed performance. We will be investigating this further.

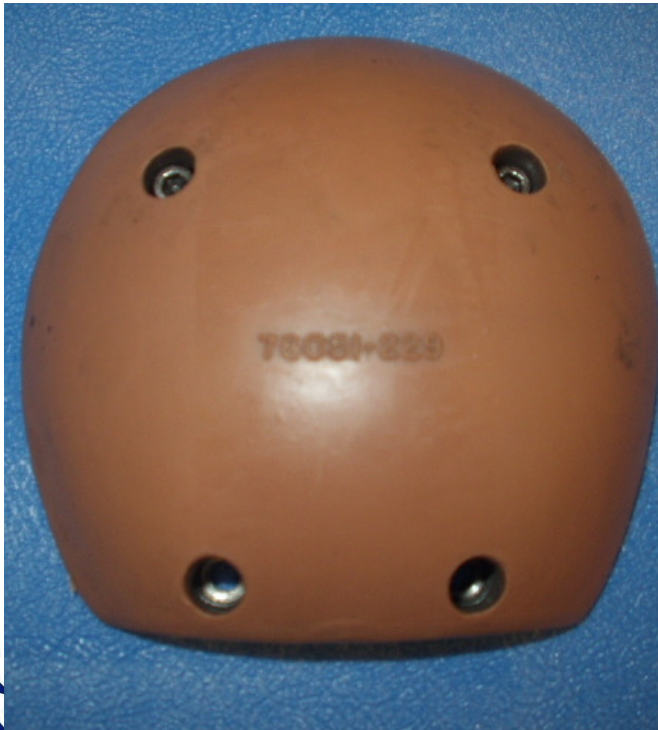
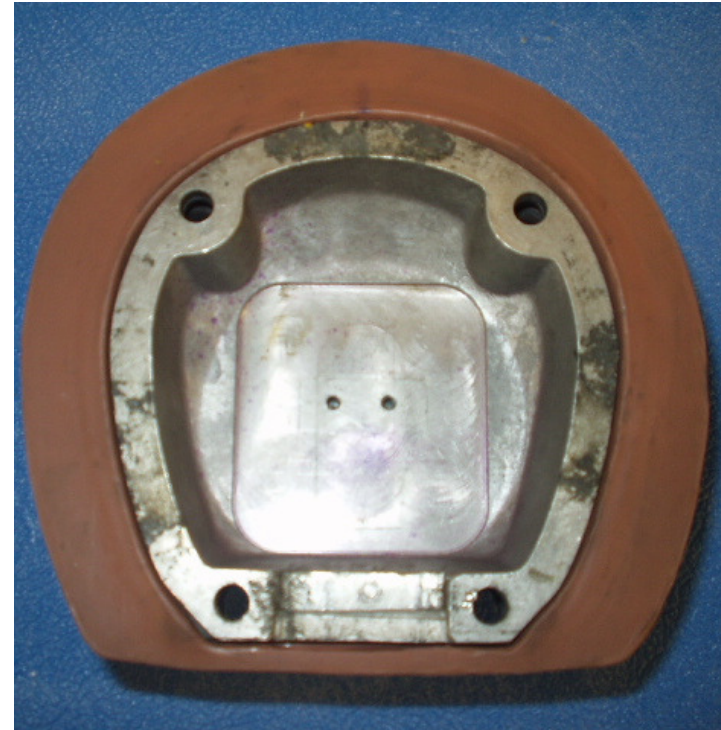
- A close examination of dummy after last return found incorrect skull cap on dummy
  - This cap is a special FTSS Hybrid III 50<sup>th</sup> cap

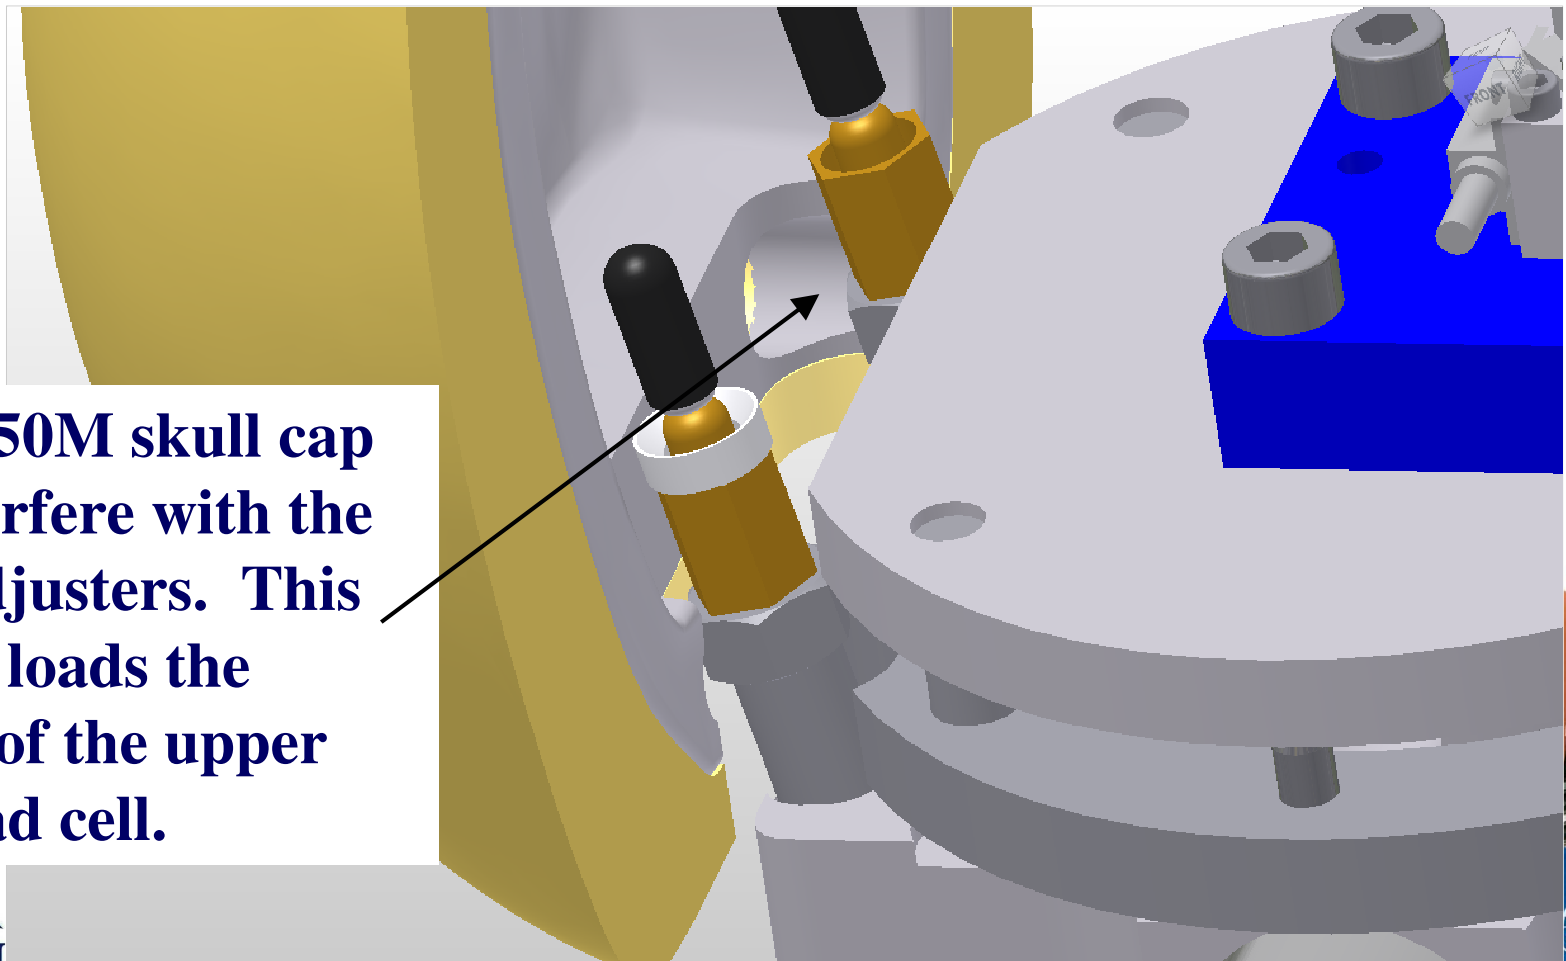
- Biorid cap has clearance for cable adjustors

**A H-III50M skull cap will interfere with the cable adjustors. This directly loads the bottom of the upper neck load cell.**

- Error proof head
  - Add pin to skull and hole in cap
    - Could easily retrofit existing heads & caps
  - Use new head design for cable exit
    - Possible longer term solution
- Technical bulletin to users about problem
  - Which solution?

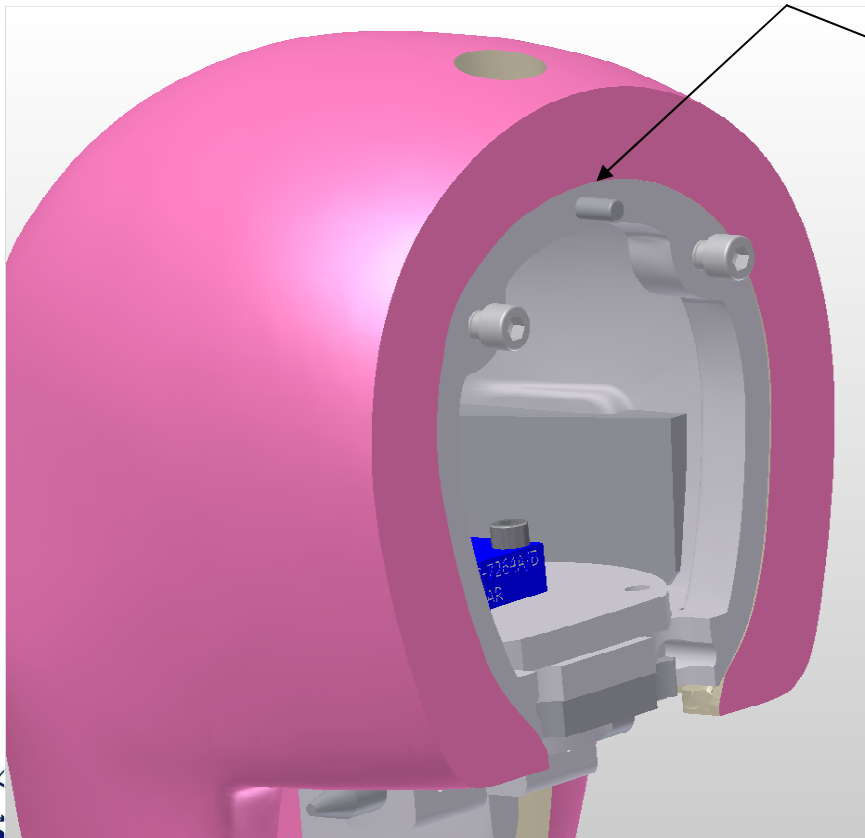
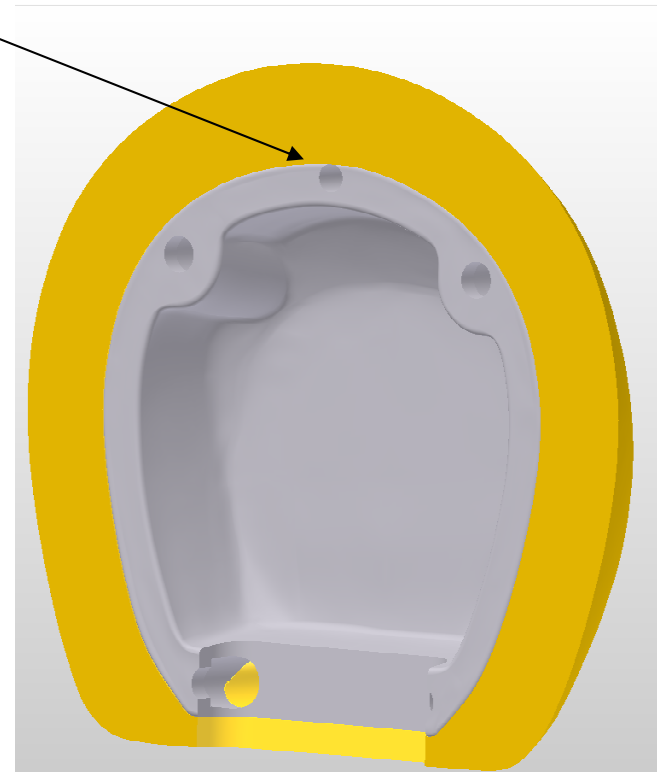
- Pin in skull & hole in cap to error proof
  - Can easily modify existing parts

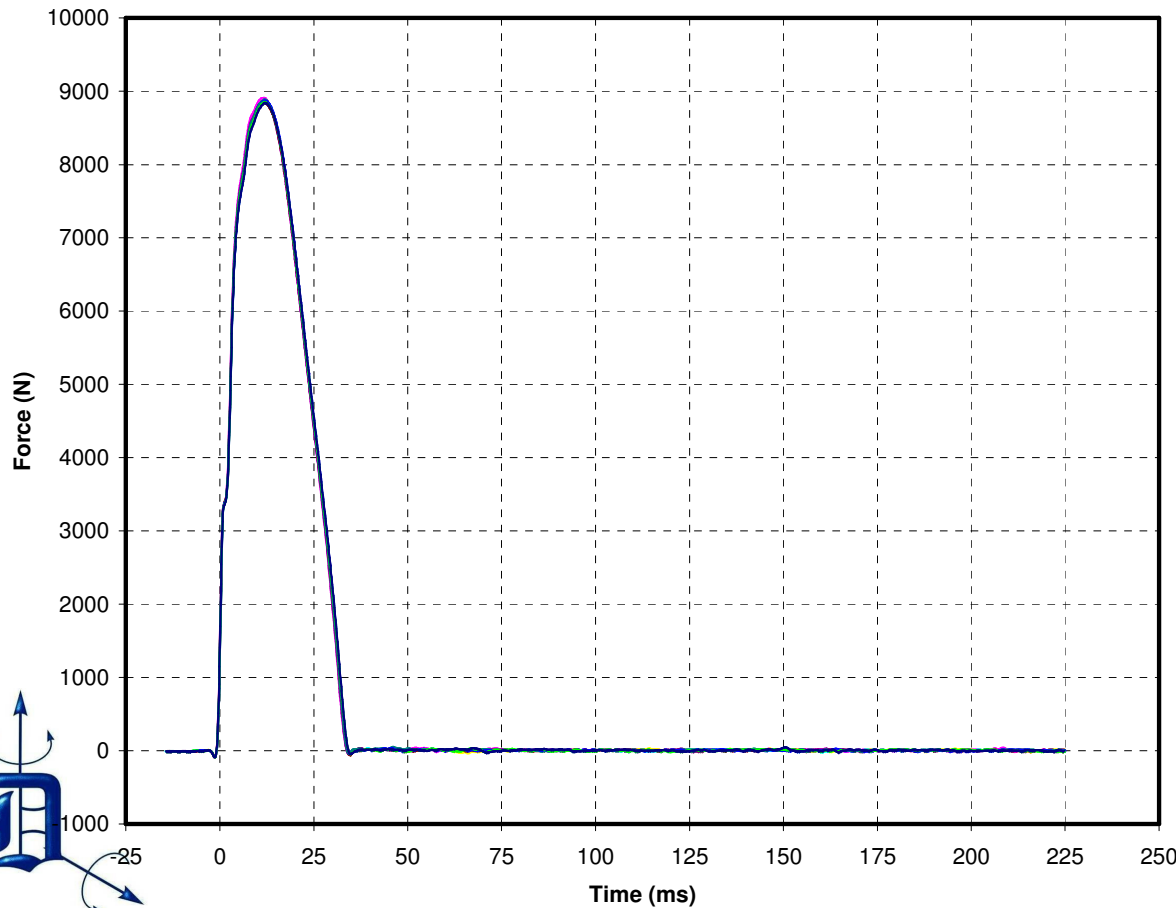
Pendulum Force

## mini-sled w/o headrest test

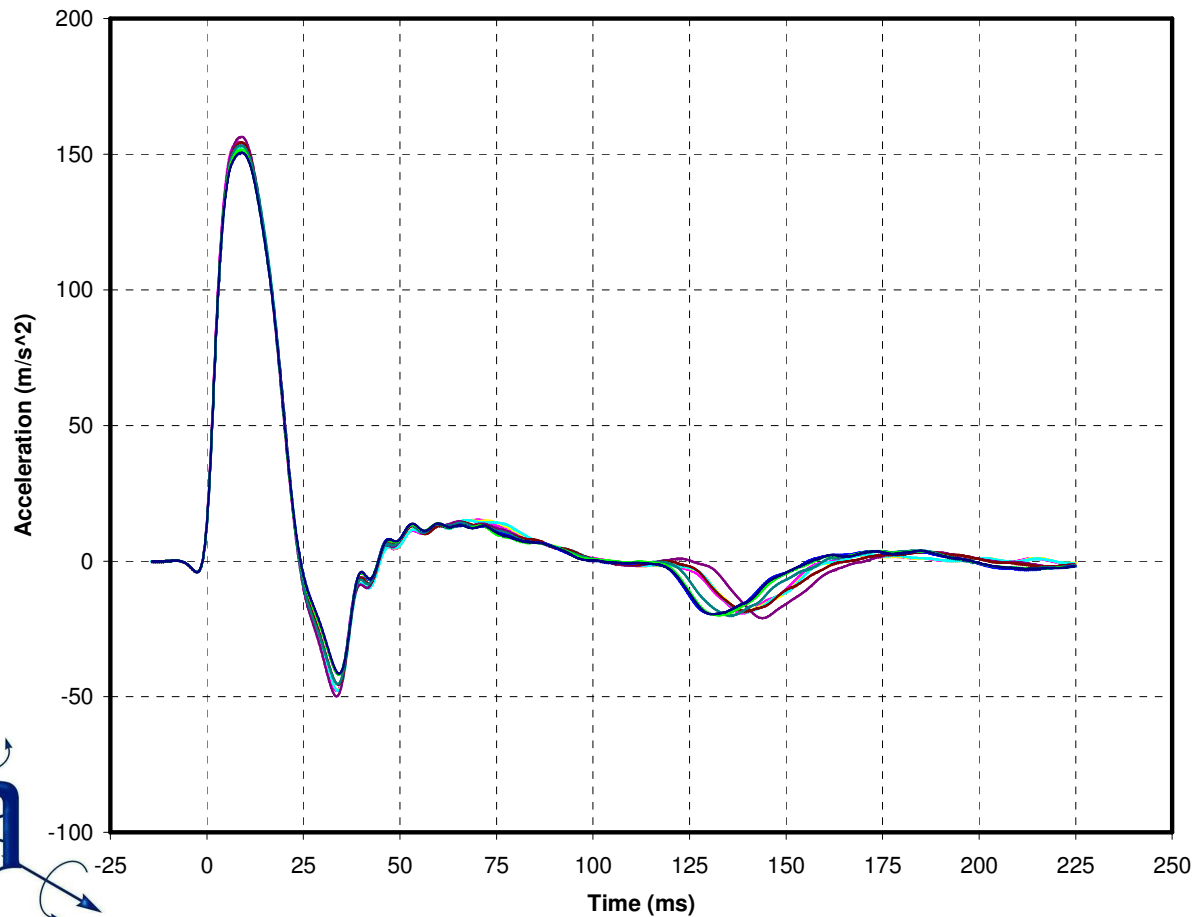
Sled Acceleration

## mini-sled w/o headrest test

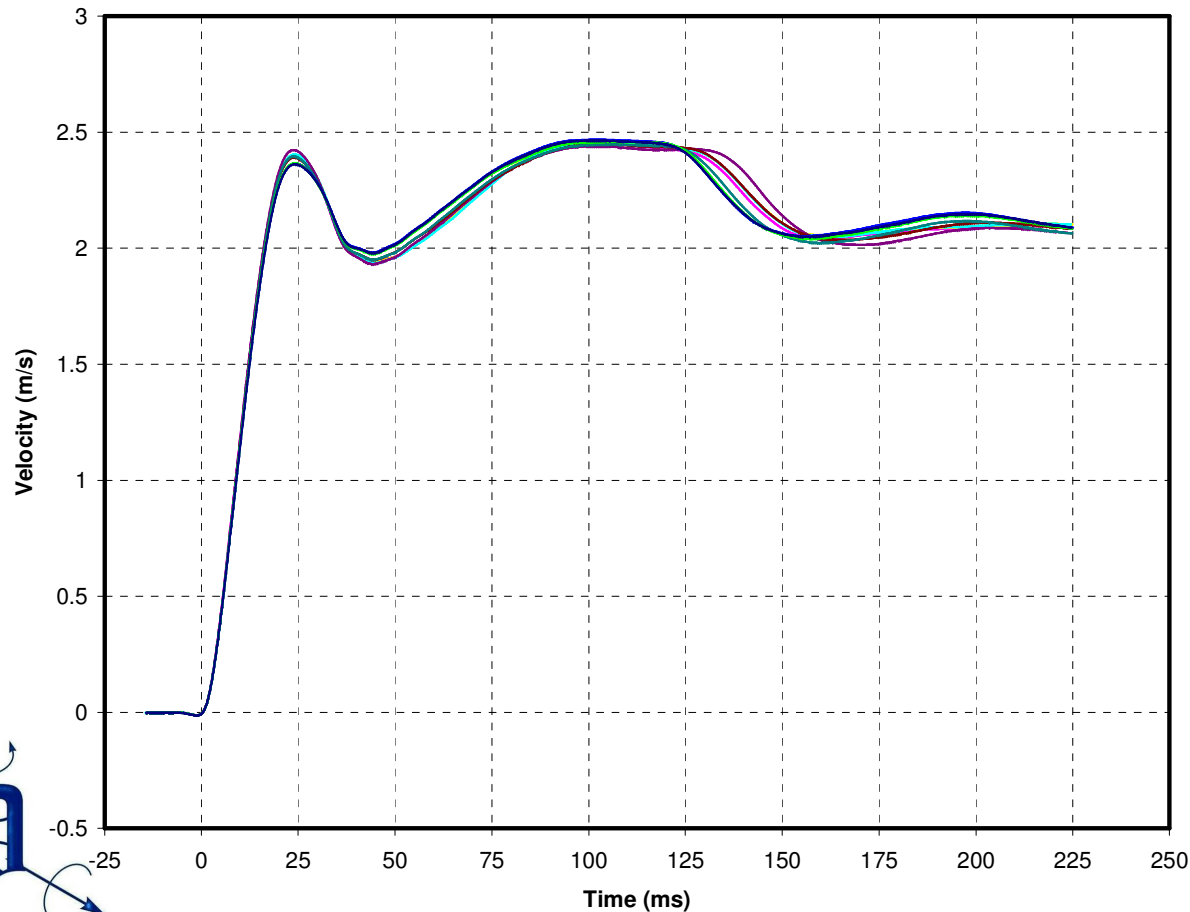
Sled Velocity

## mini-sled w/o headrest test

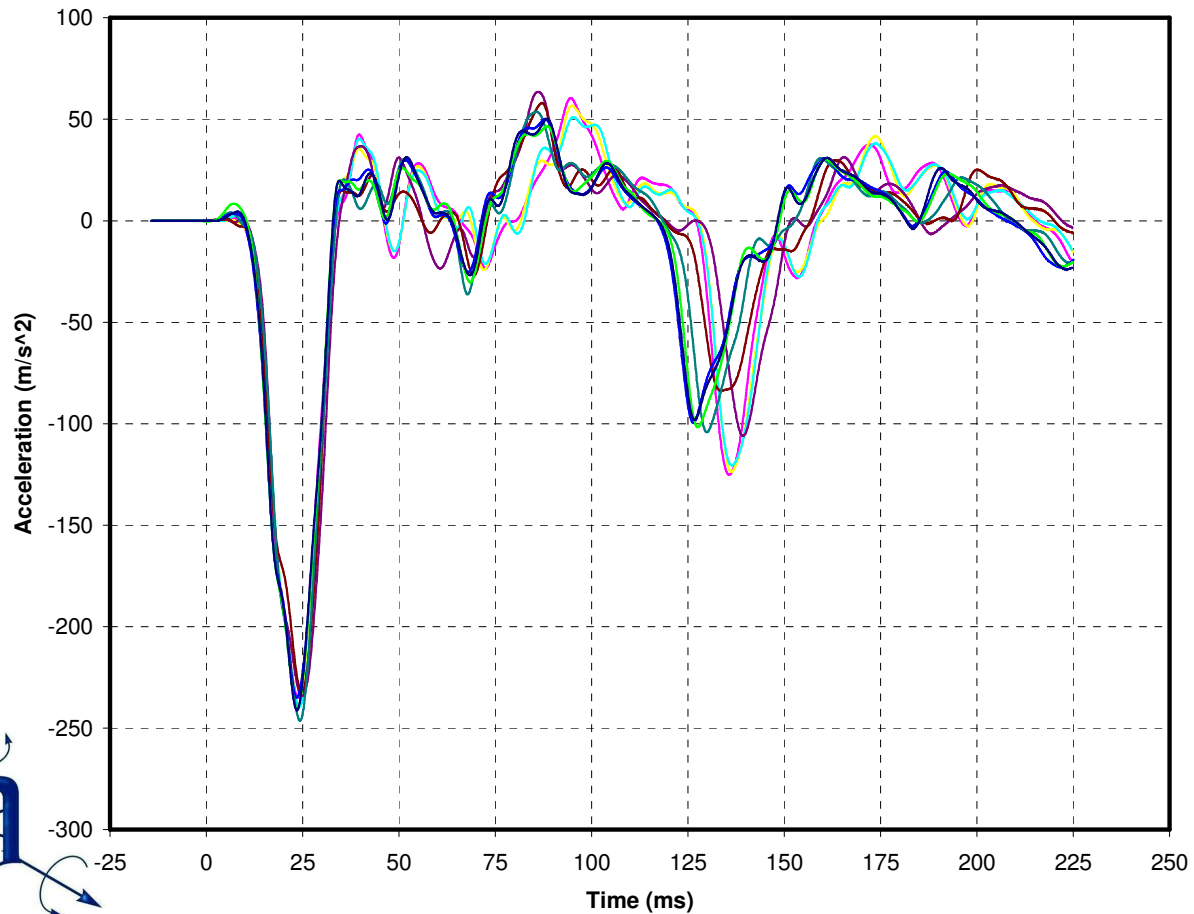
T1 X Acceleration

## mini-sled w/o headrest test

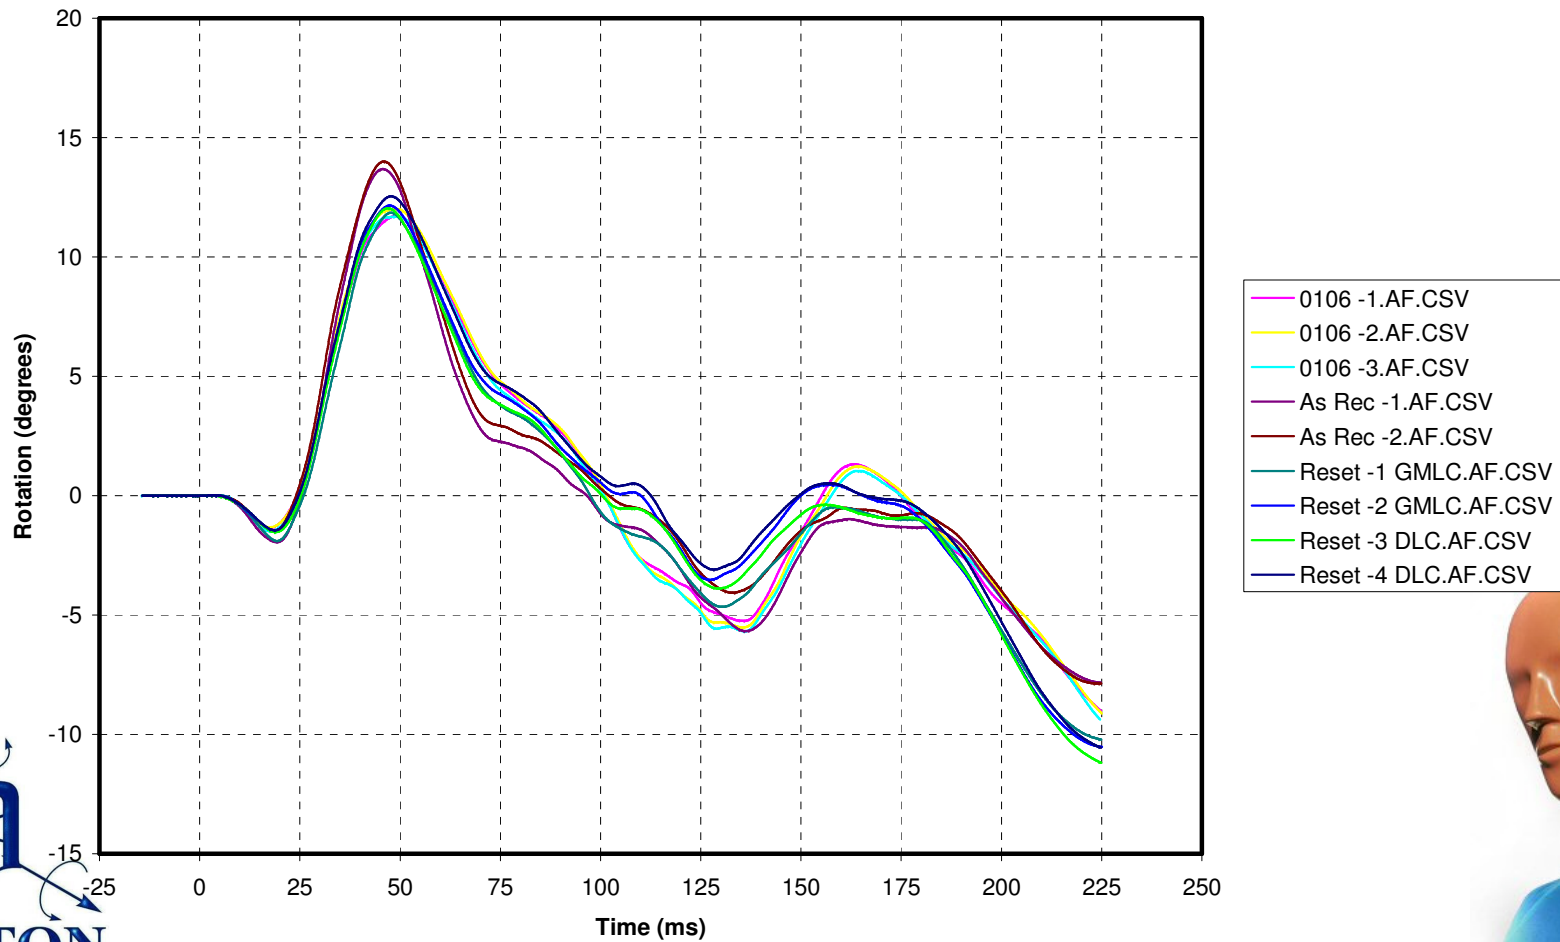
Pot A - Head Rotation

## mini-sled w/o headrest test

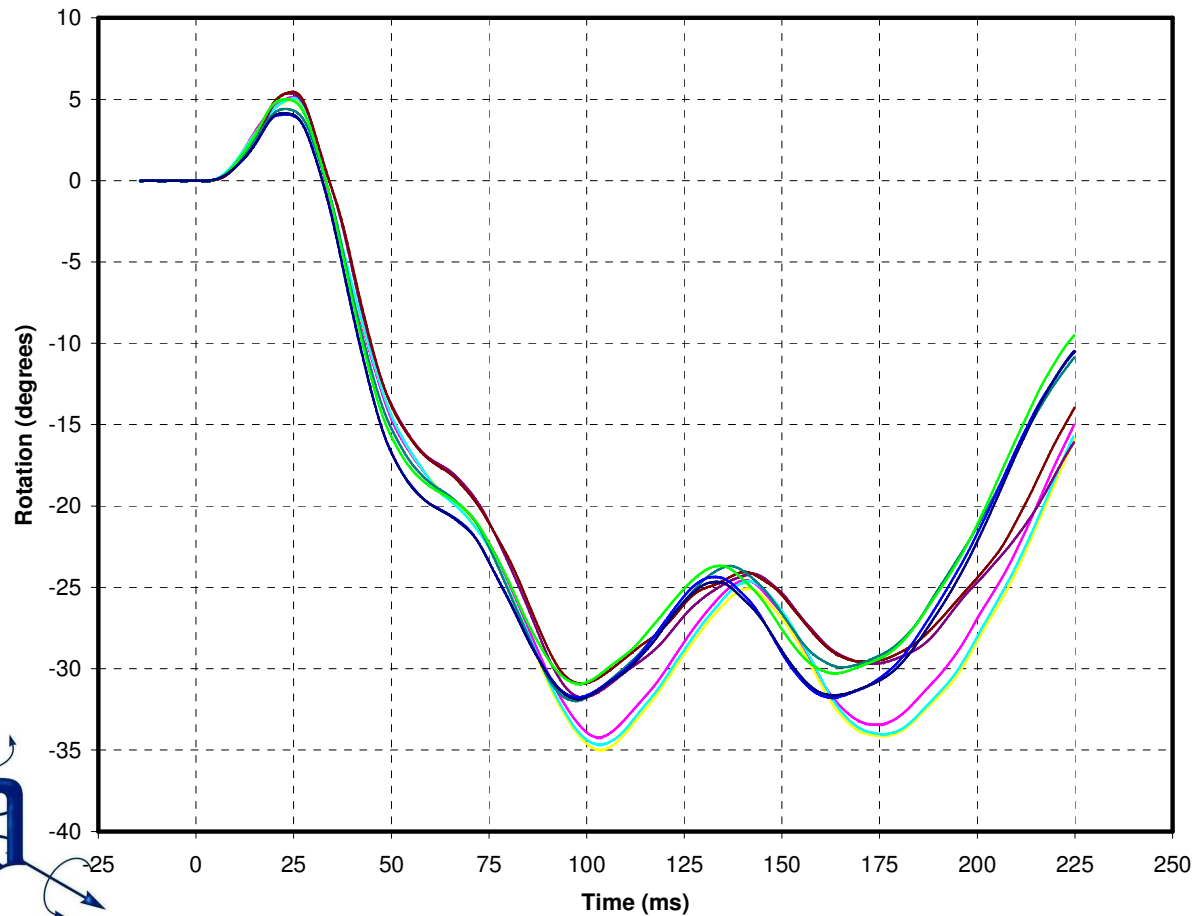
Pot B - Neck Link Rotation

## mini-sled w/o headrest test

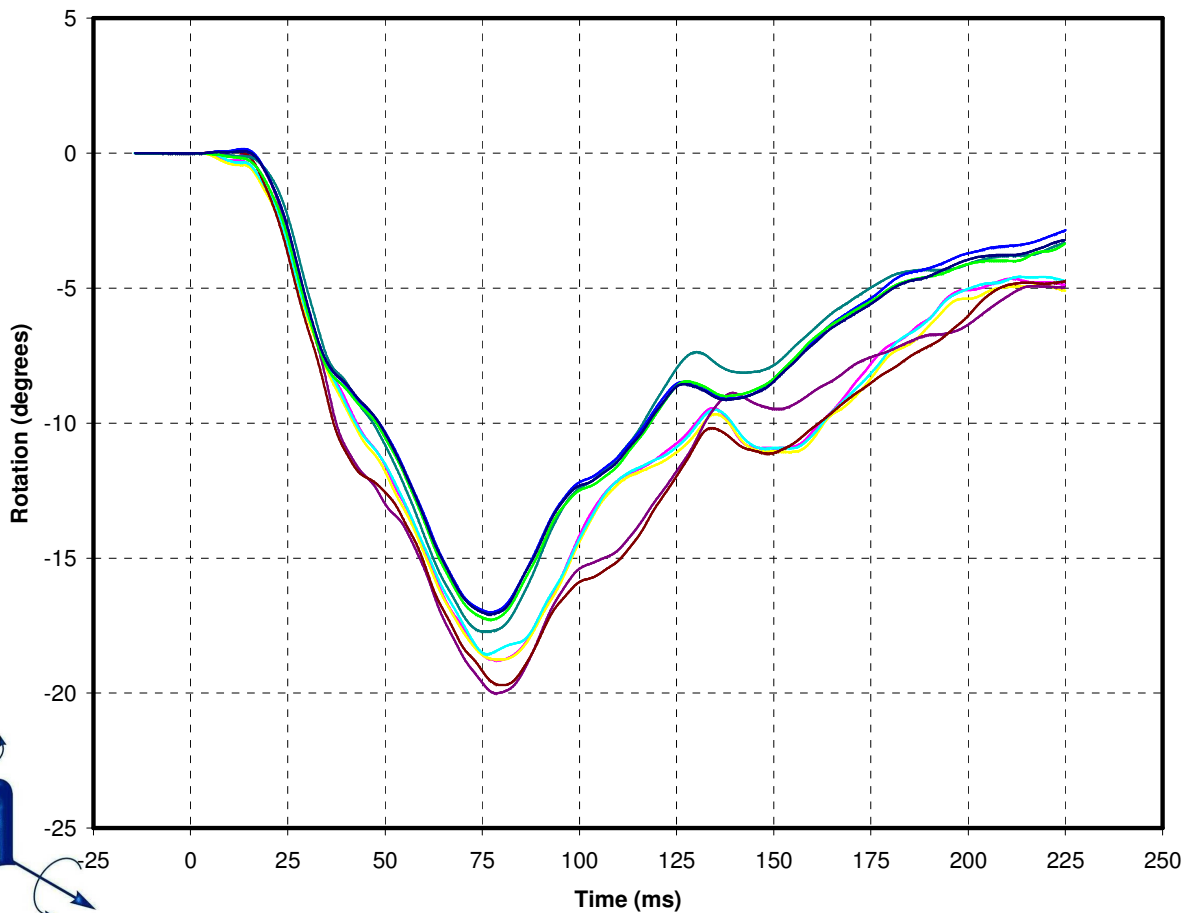
Pot C - Lower Thorax

## mini-sled w/o headrest test

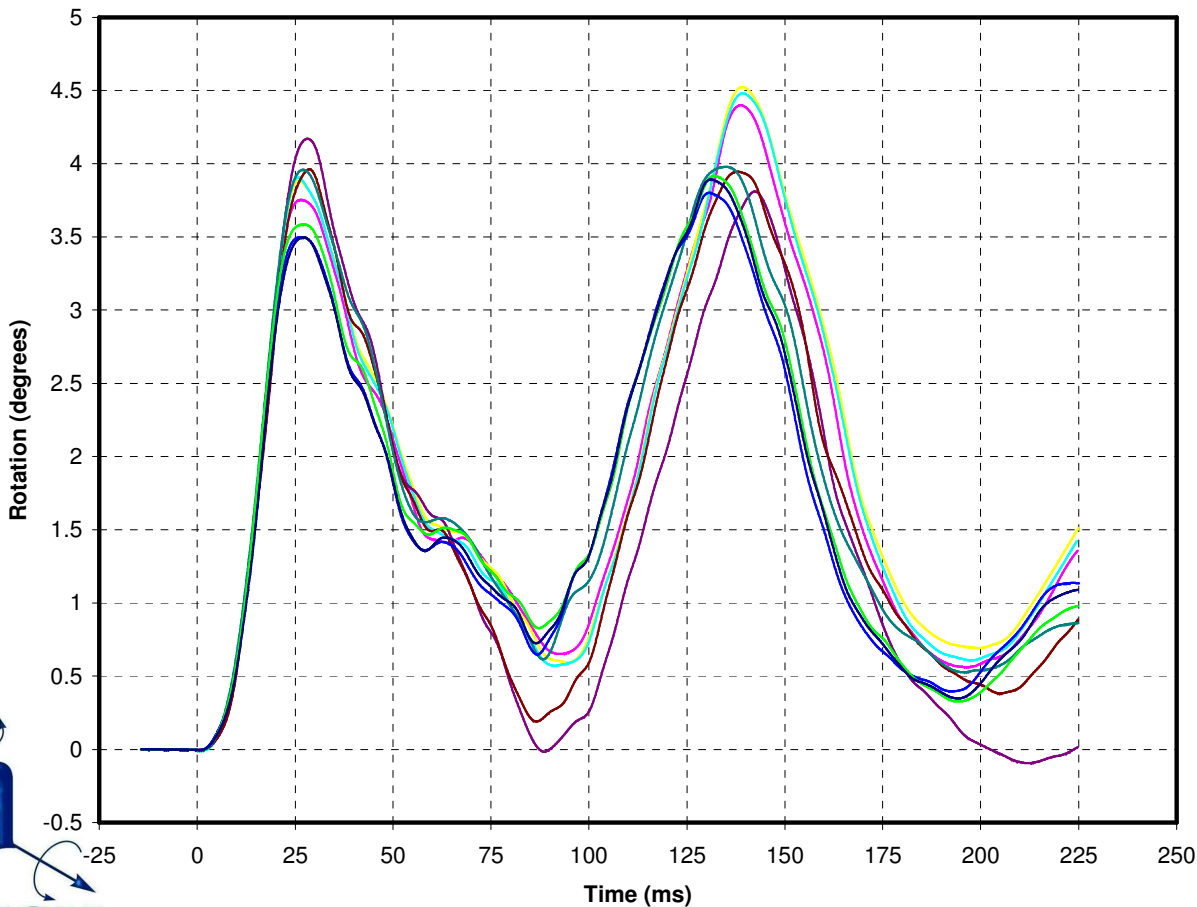
Pot D - Lower Thorax

## mini-sled w/o headrest test

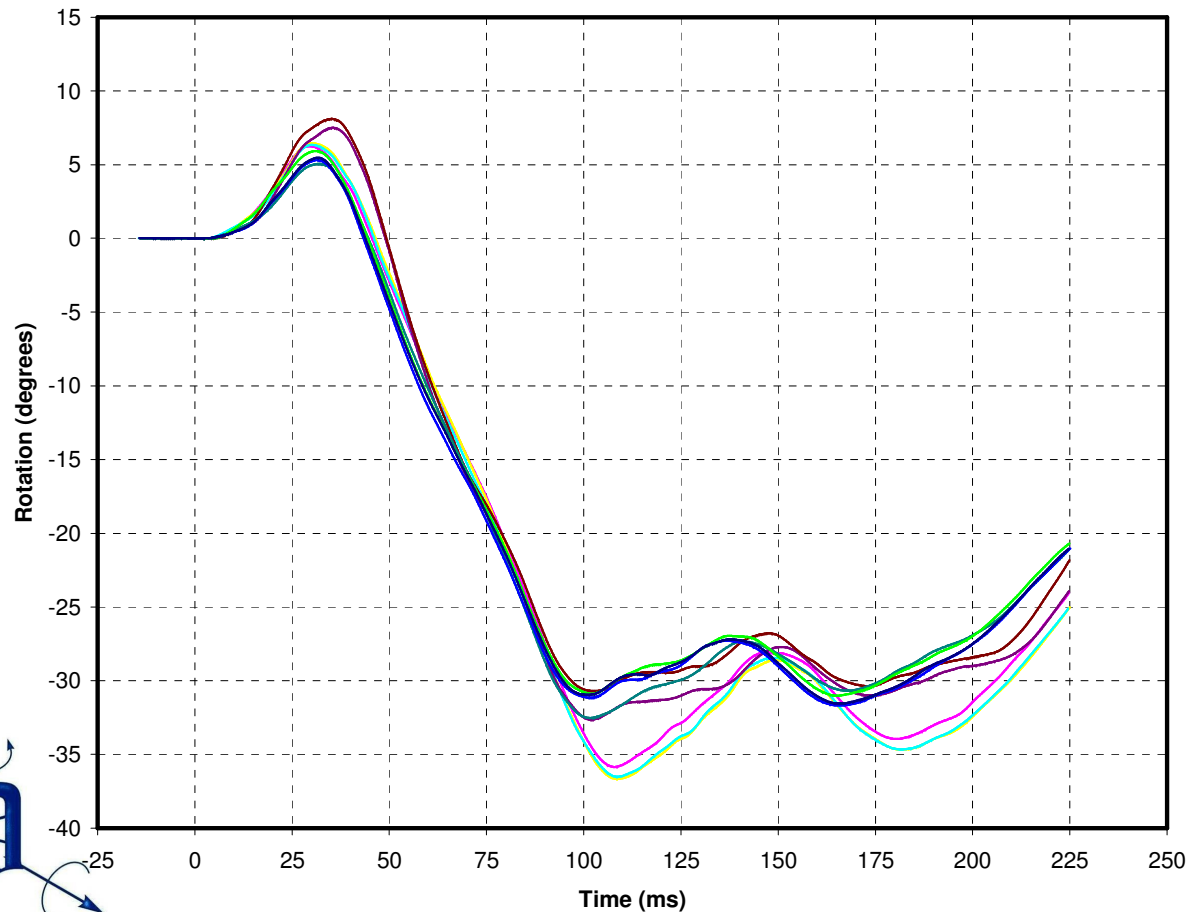
Total Head Rotation

## mini-sled w/o headrest test

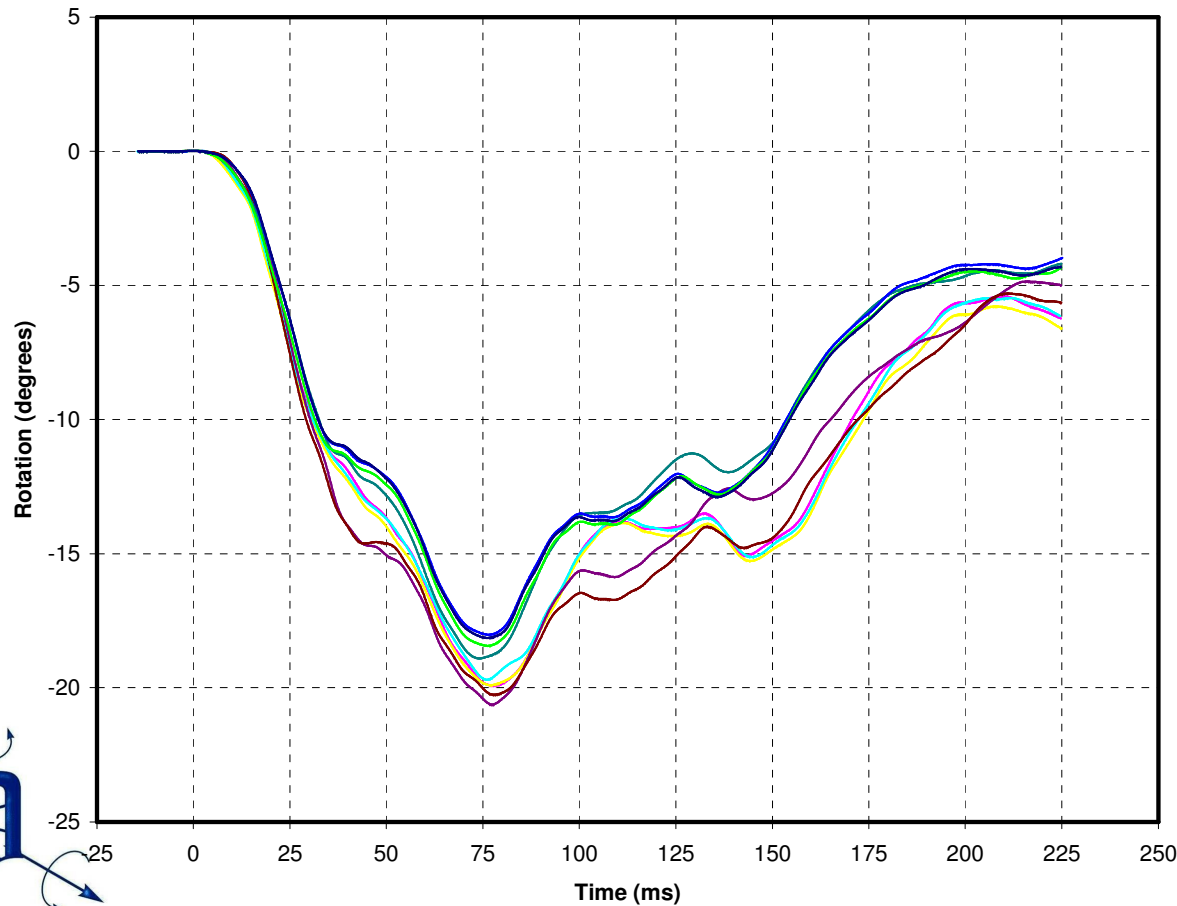
Total Thoracic Rotation

## mini-sled w/o headrest test

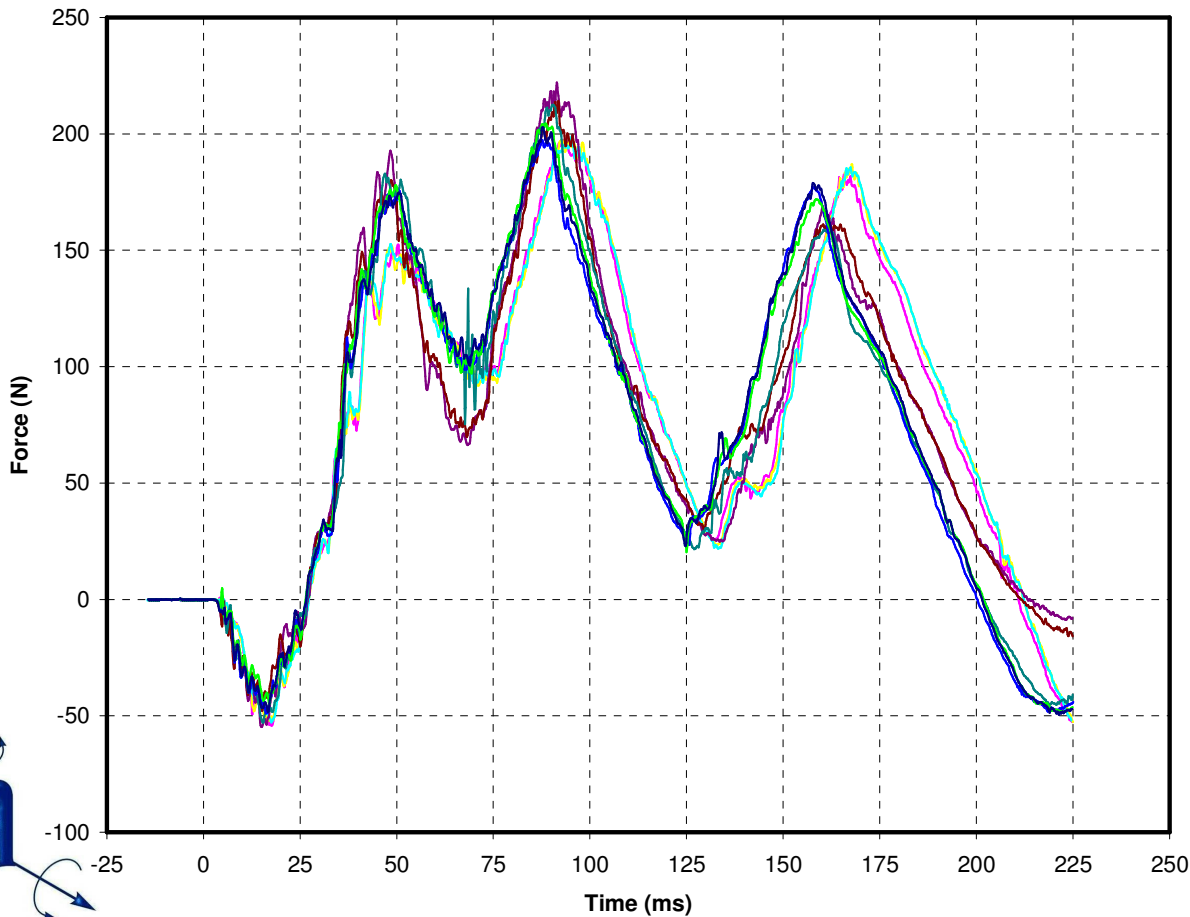
Upper Neck Force FX

## mini-sled w/o headrest test

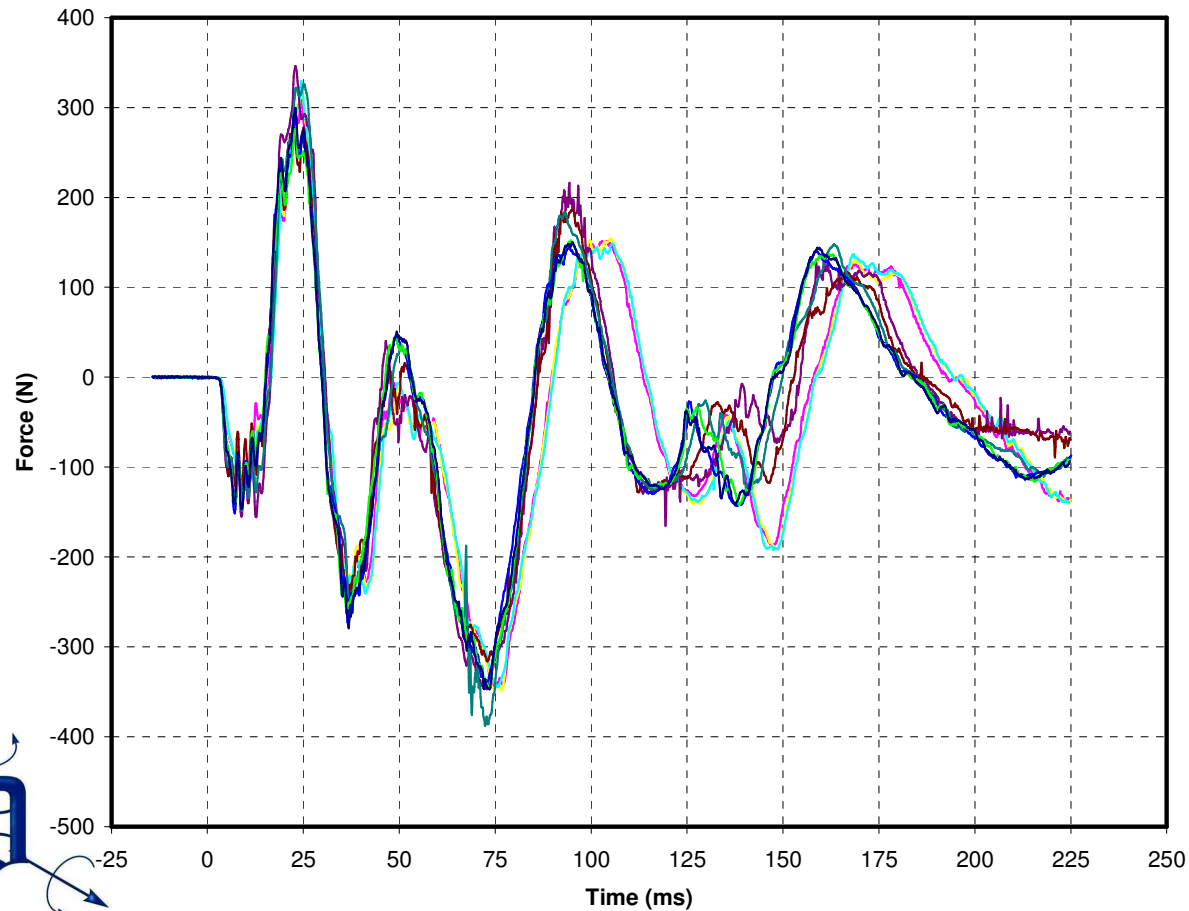
Upper Neck Force FZ

## mini-sled w/o headrest test

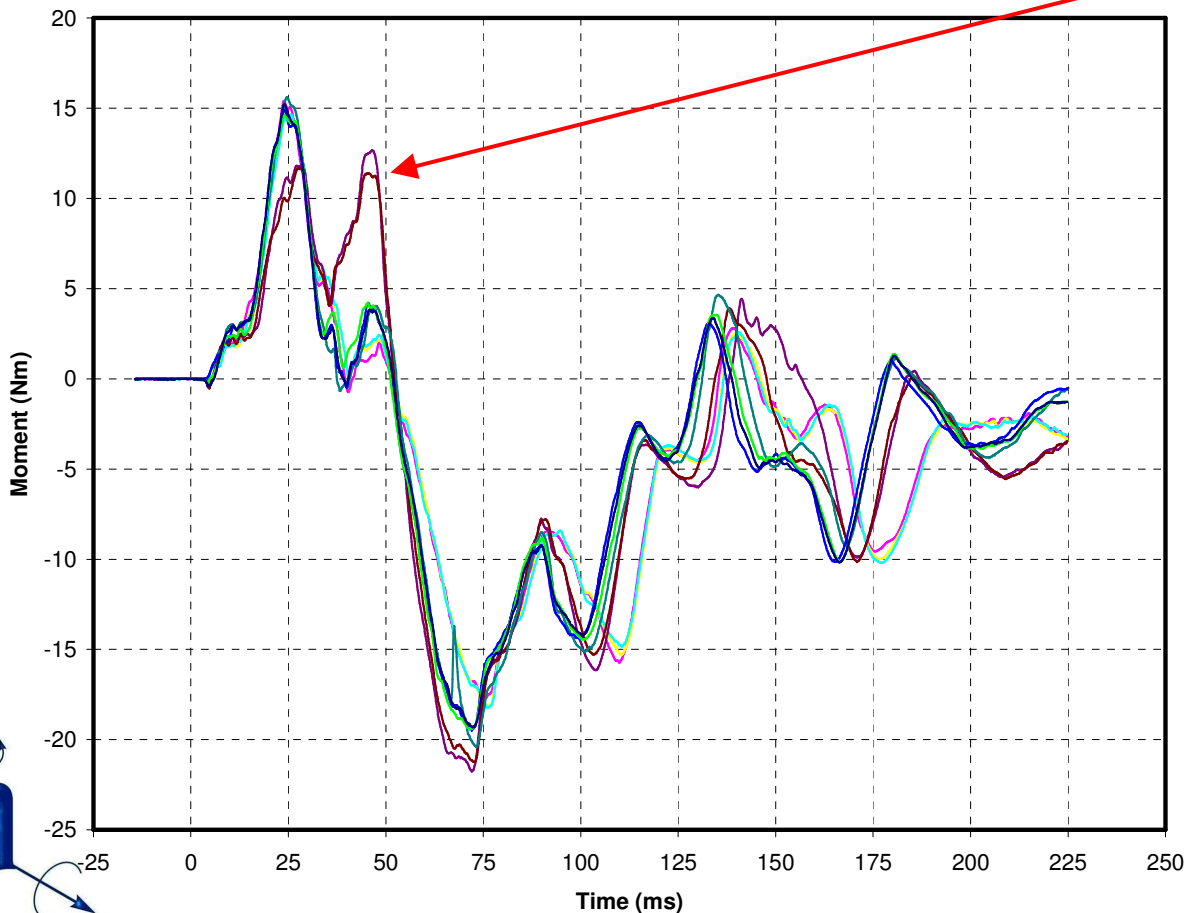
Upper Neck Moment MY

Something repaired changed performance. We will be investigating this further.
