Transport Canada
Transports Canada

Transport Canada testing
in support of the
global technical regulation on
Door Locks and Door Retention Components

Presentation to NHTSA Team Members

January 27, 2004

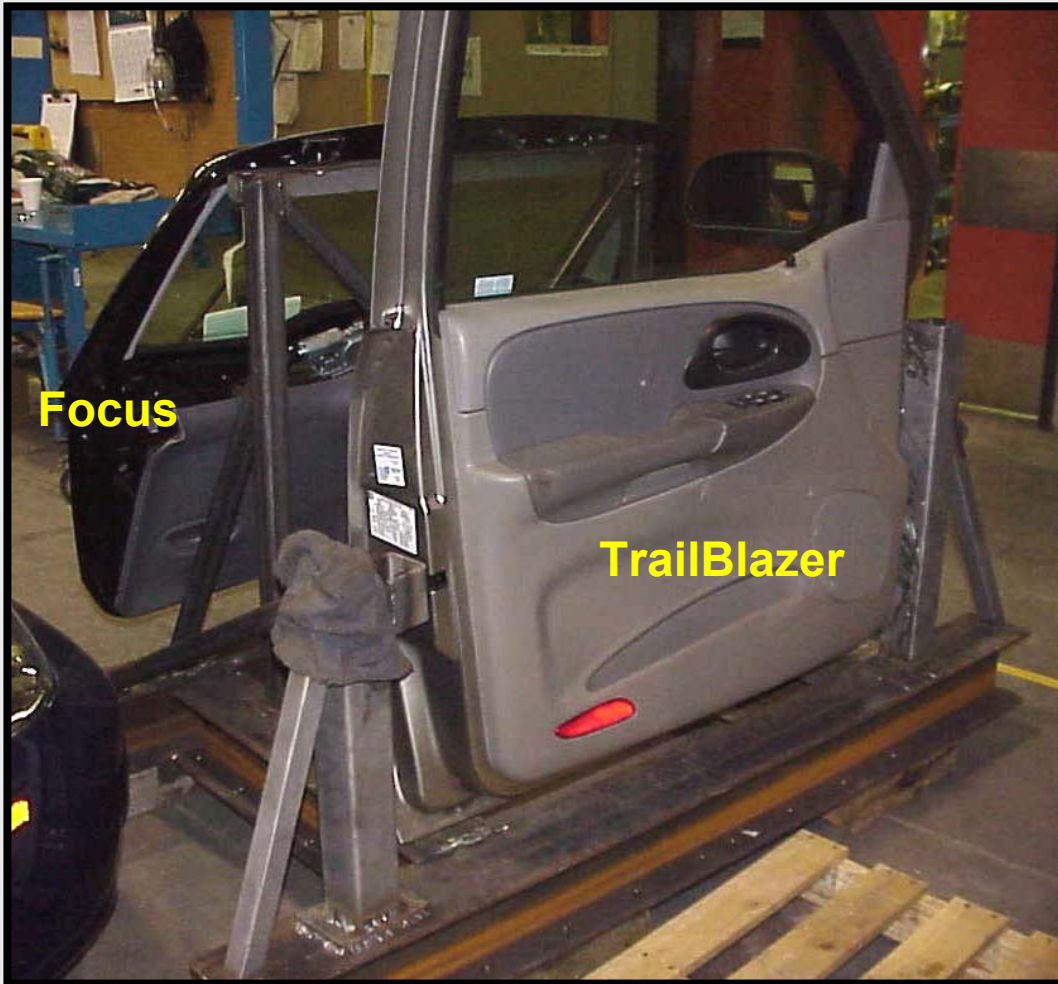
Orthogonal View

Preparation of Doors-on-Sled

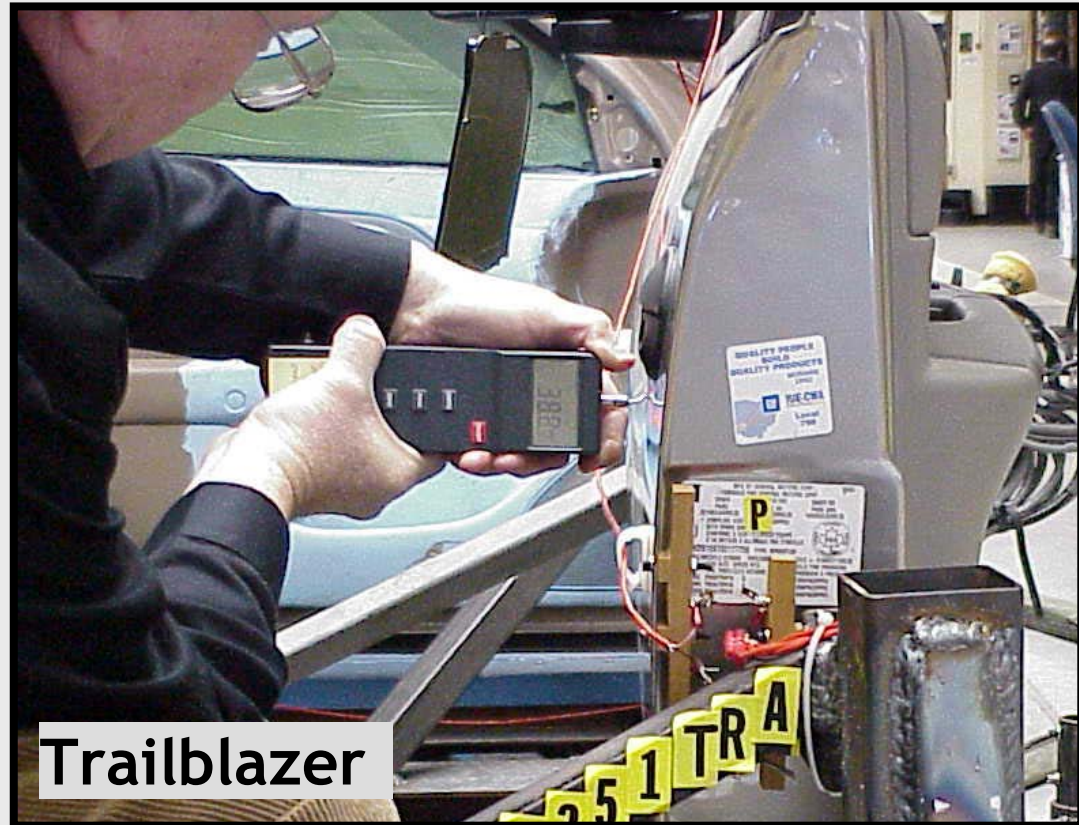
Trailblazer

- Side hinged doors:

- must drill hole without damaging internal linkages

- handle “center” needs better definition

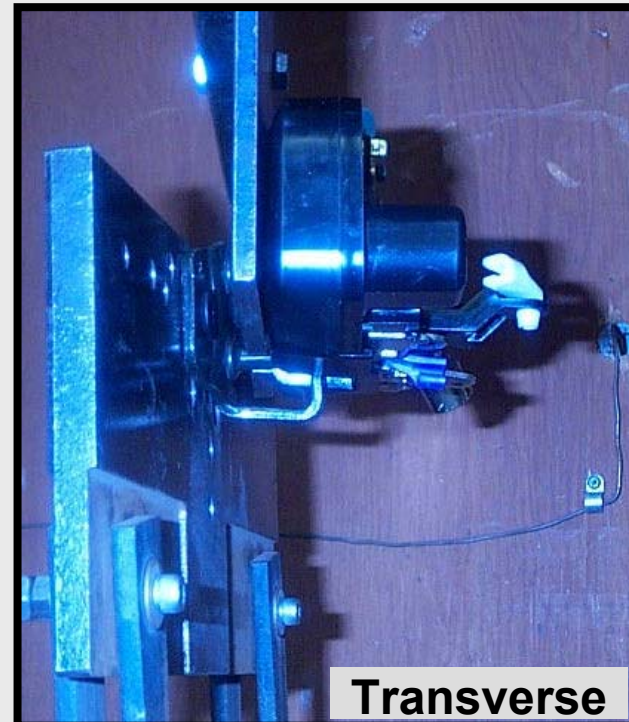
Procedure

As per CMVSS / FMVSS 206 procedure
(SAE J839):

- Longitudinal, transverse directions
- Primary latch only (not secondary)

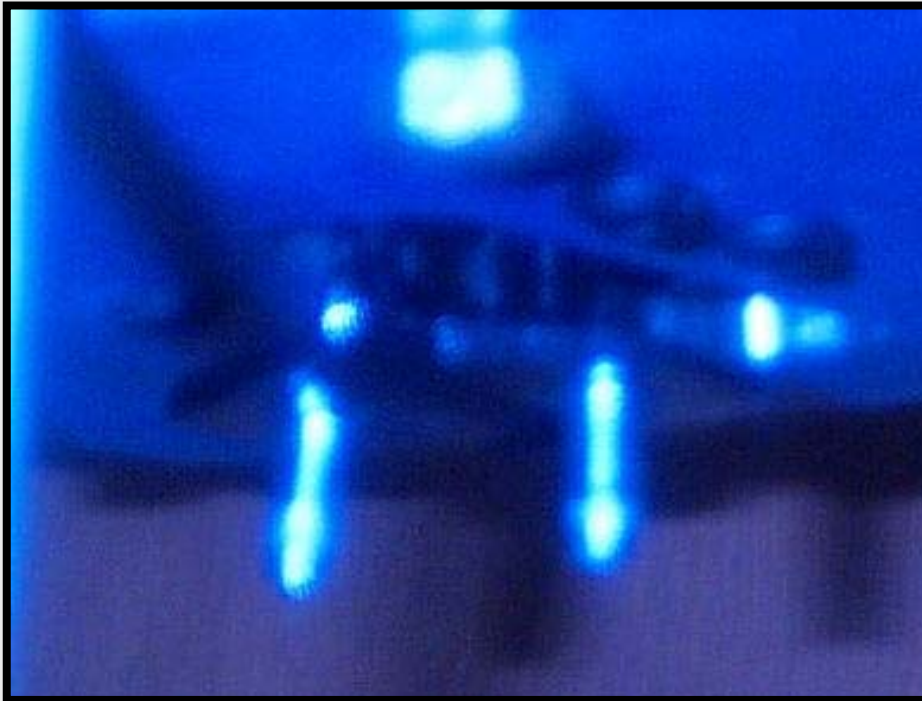
Longitudinal

Failure = 21,128 N (4750 lb.)

Mode = striker bolts stripped

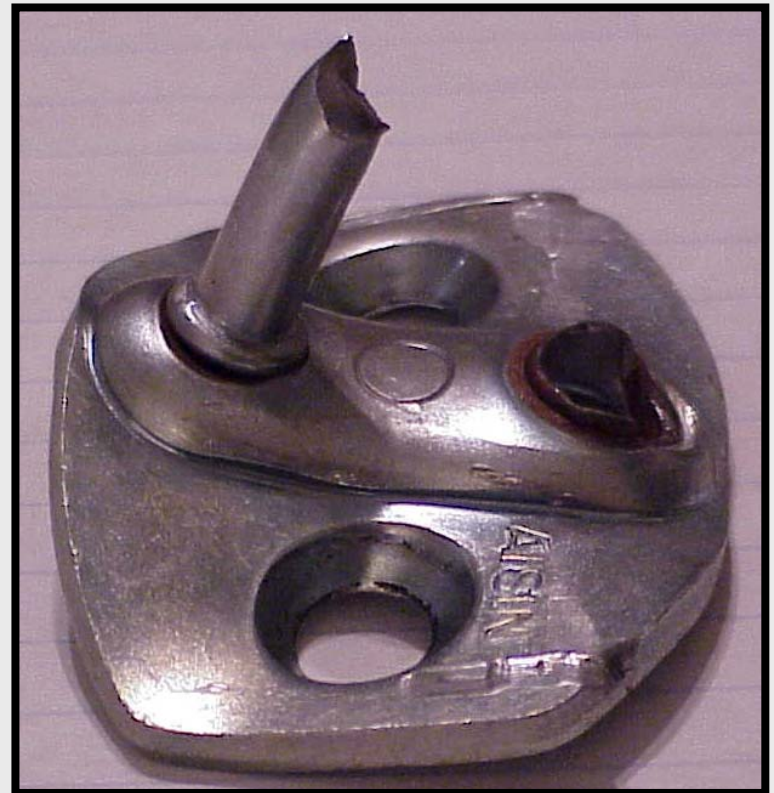
Transverse

Failure = 24,899 N (5598 lb.)
Mode = striker failed at base

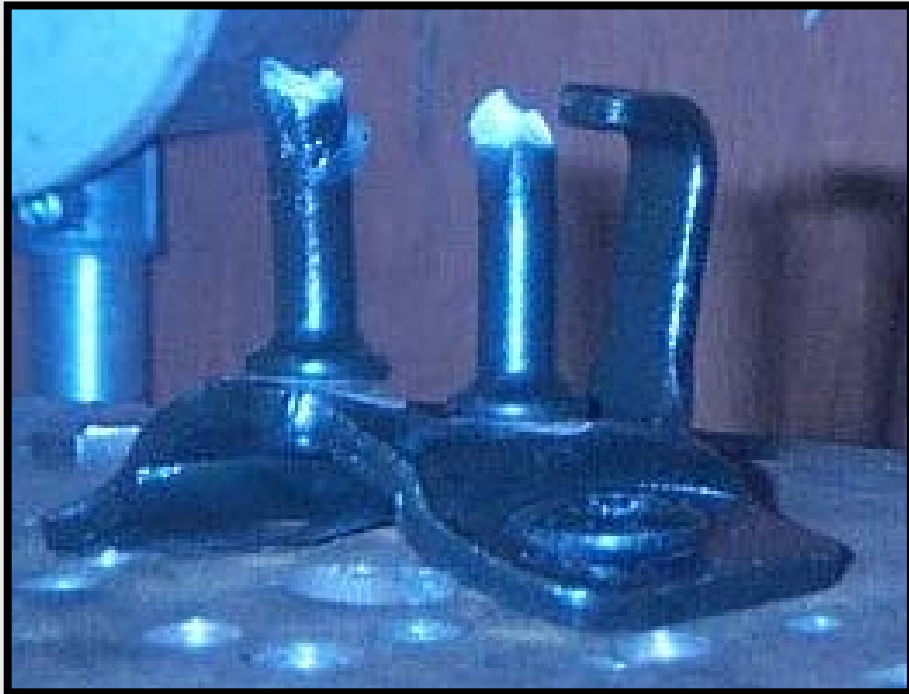
Longitudinal

Failure = 29,948 N (6733 lb.)

Mode = striker failed at top

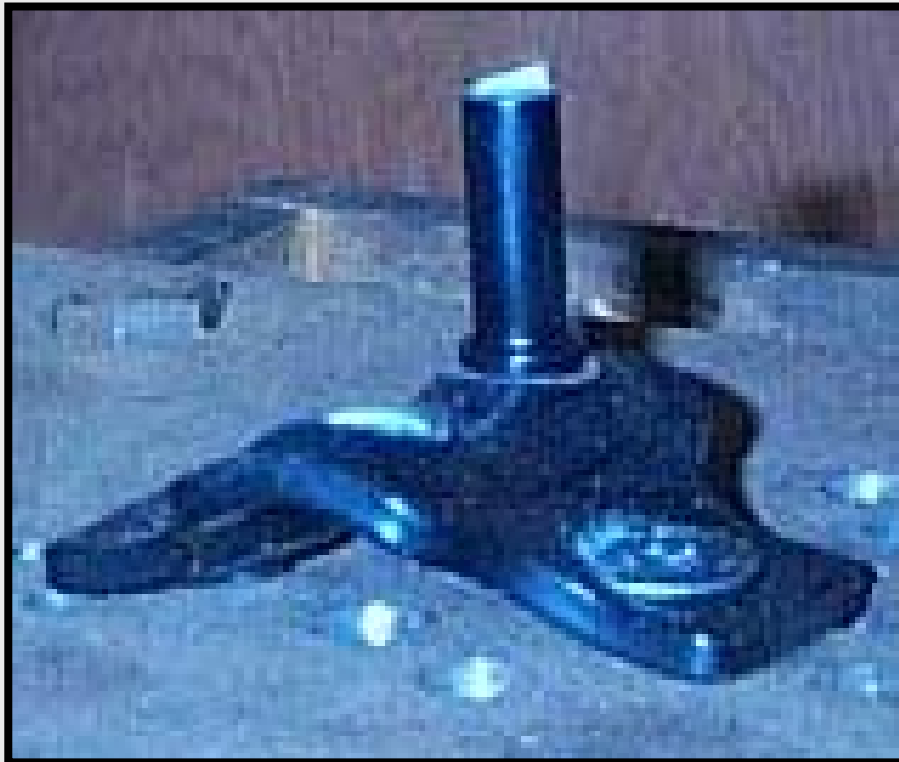
Longitudinal

Failure = 42,981 N (9663 lb.)

Mode = striker failed in 2 places

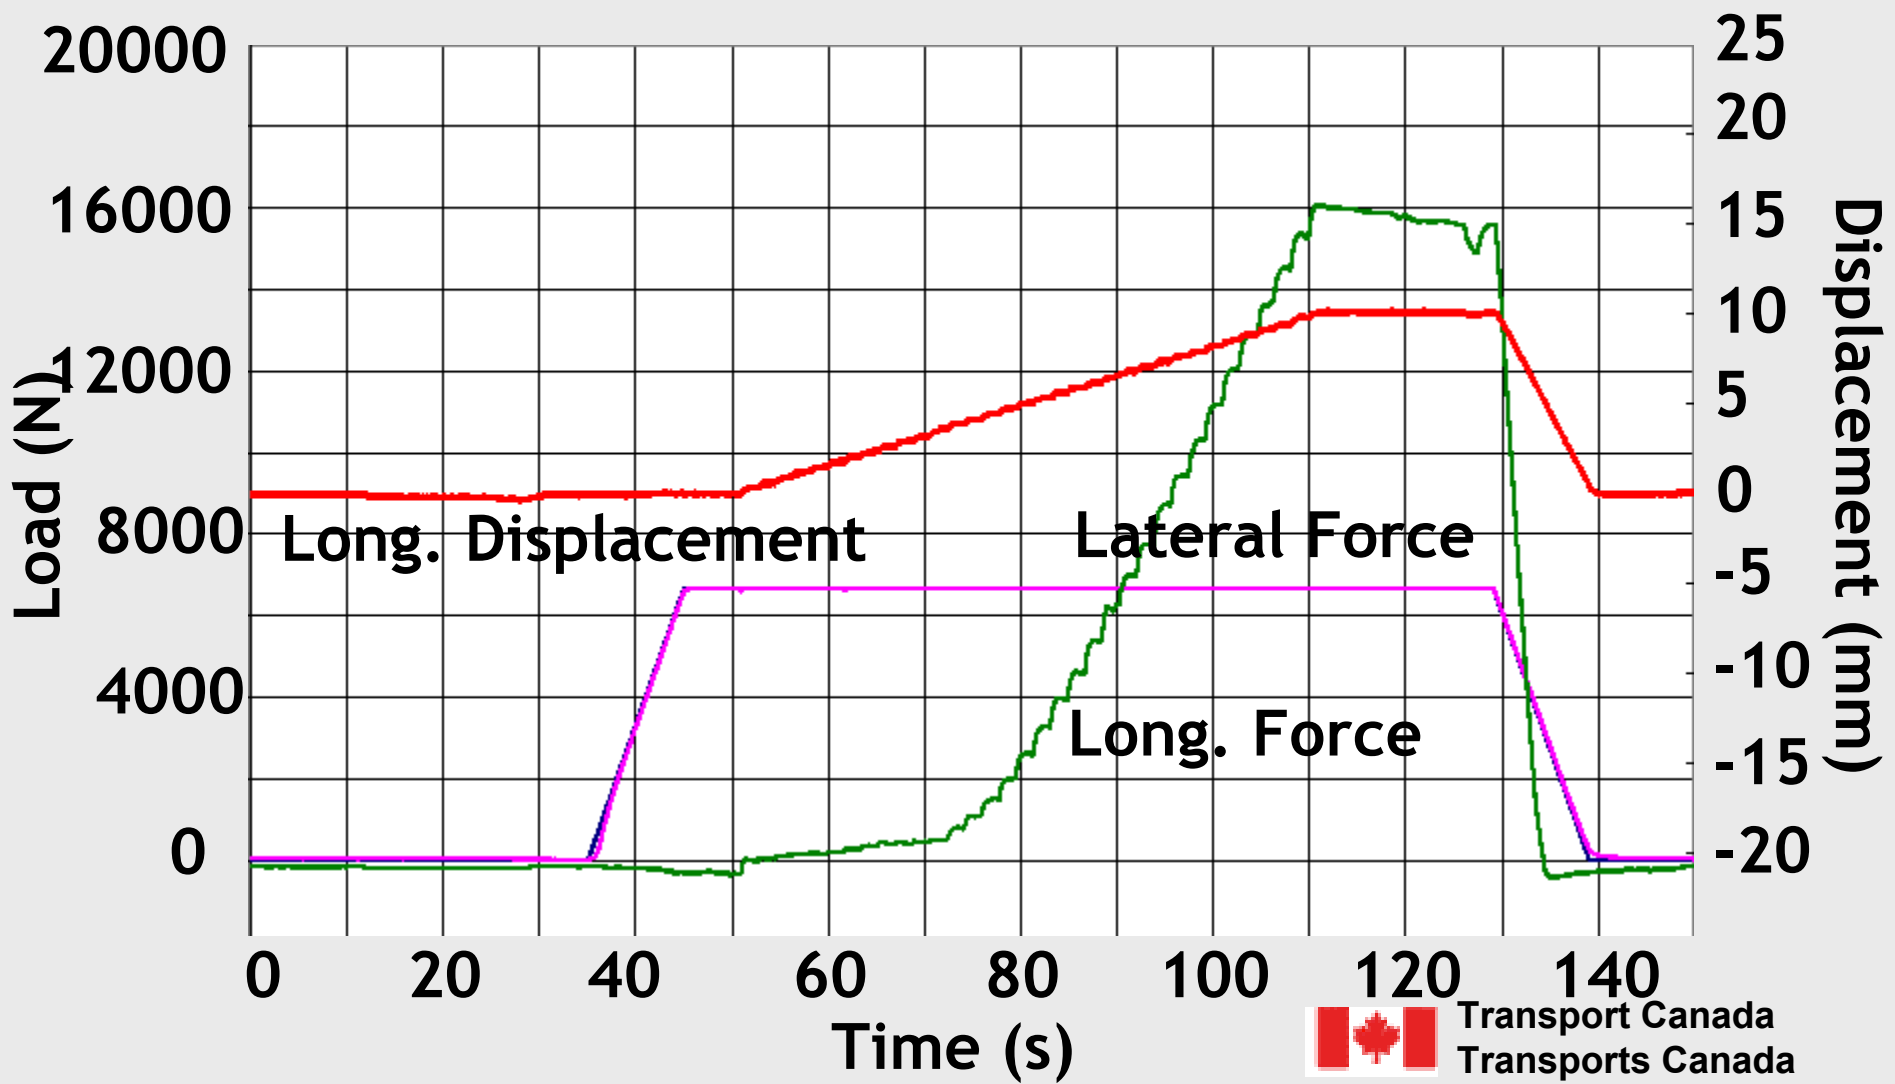
CARAVAN

- Interference between striker plate and latch-supporting plate
- Tests results insignificant

- TC does not recommend the longitudinal compression test using the current test procedure:
not testing latch performance, testing fixture
- Difficult to simulate offset frontal crash forces using only latch
- Longitudinal tension test has potential, BUT:
 - research needed into lateral + longitudinal forces during **actual** offset collisions
 - is this realistic of UNSTRUCK side?
