TRUCK CAB CRASHWORTHINESS IN REAL WORD ACCIDENTS

CEESAR

Presented by RENAULT TRUCKS

11 April 2007

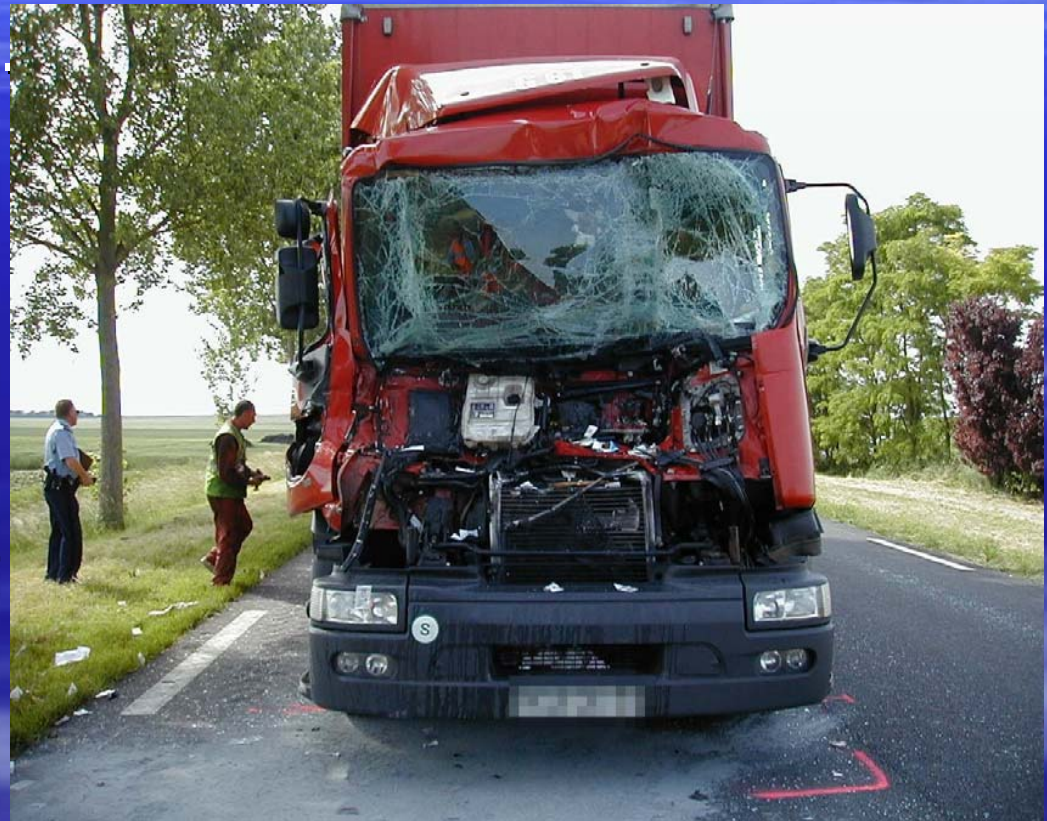
FRONTAL IMPACT

- ACCIDENT N° 02 785.
- Tuesday 19 June 2001.
- Frontal impact against agricultural trailer.
- One cab occupant.

- Front to rear collision.
- Between a truck and an agricultural trailer.
- Overlap of 1700 mm on the truck right front.
- With a high level of intrusion on the right front part.
- But small deformation on the left seat.
- The driver is slightly injured.

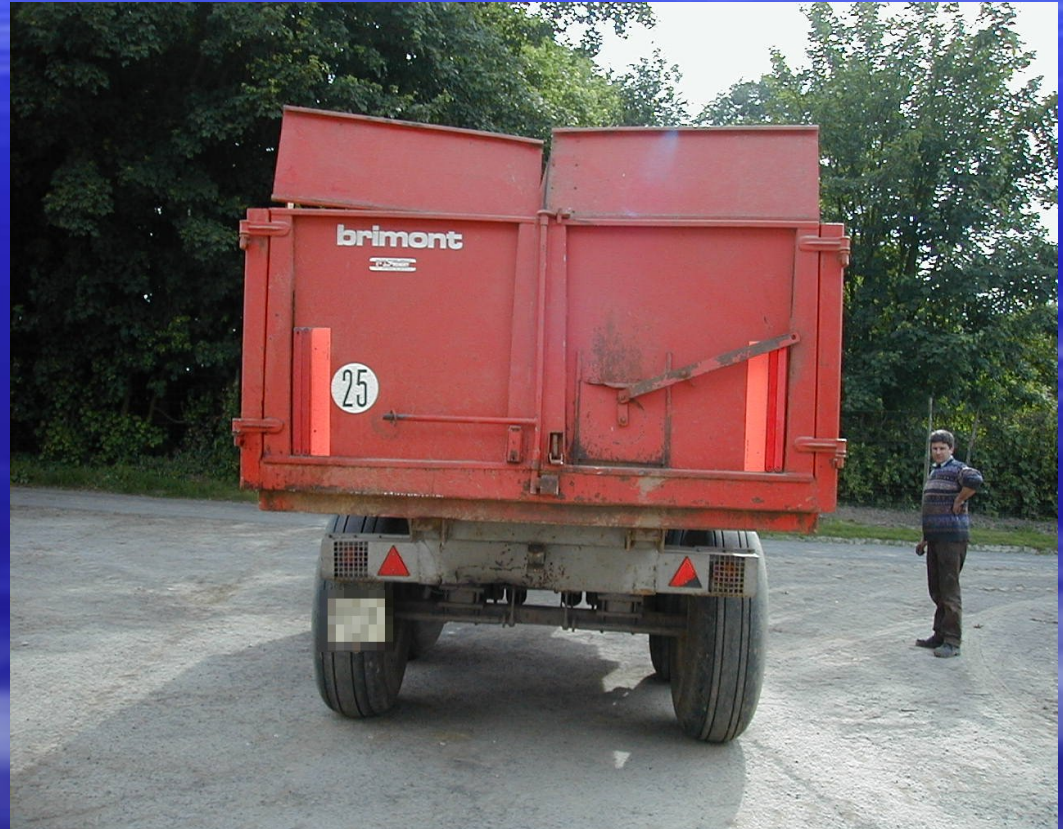
THE OPPOSITE VEHICLE

- The back face of an agricultural trailer.
- Very rigid structure without deformation.
- Main impact height : 1 m 20.

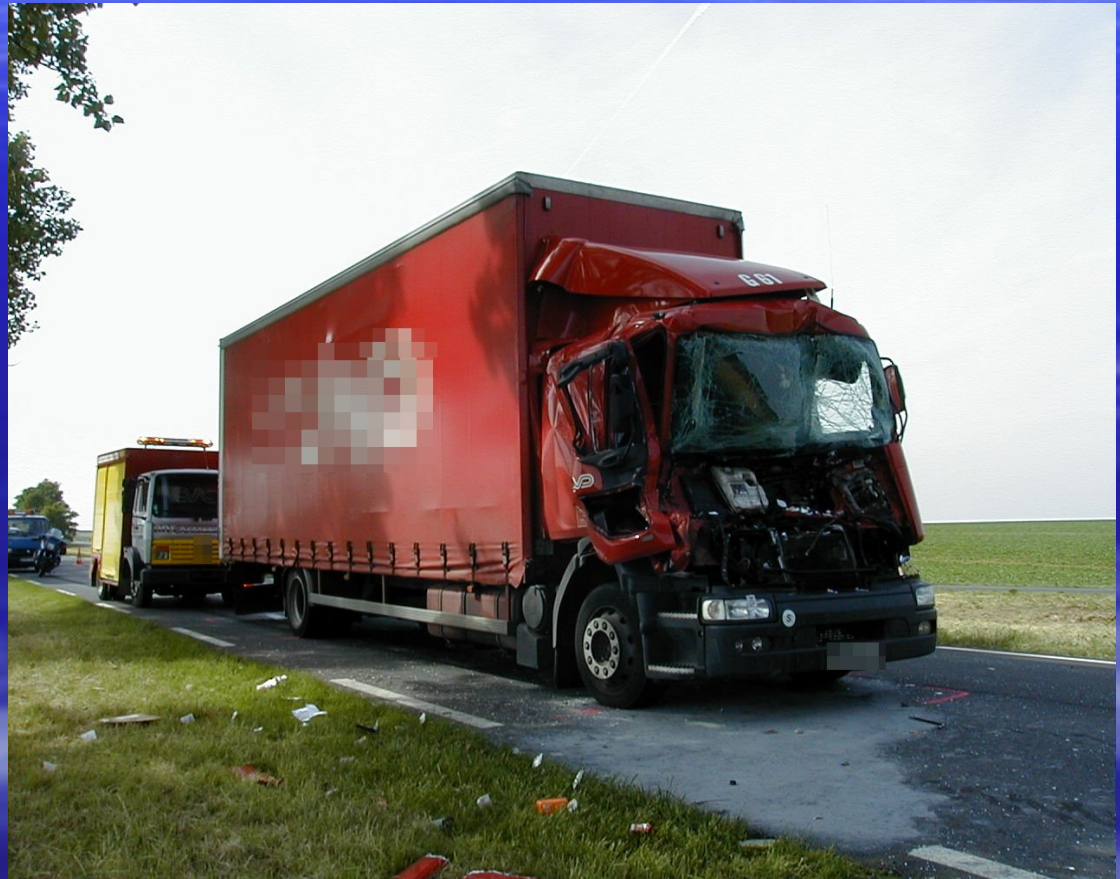
CAB DEFORMATIONS

- Overlap 2/3 right front.
- Intrusion on right seat : 590 mm.
- Intrusion on left seat : 80 mm.
- Intrusion on center : 680 mm.

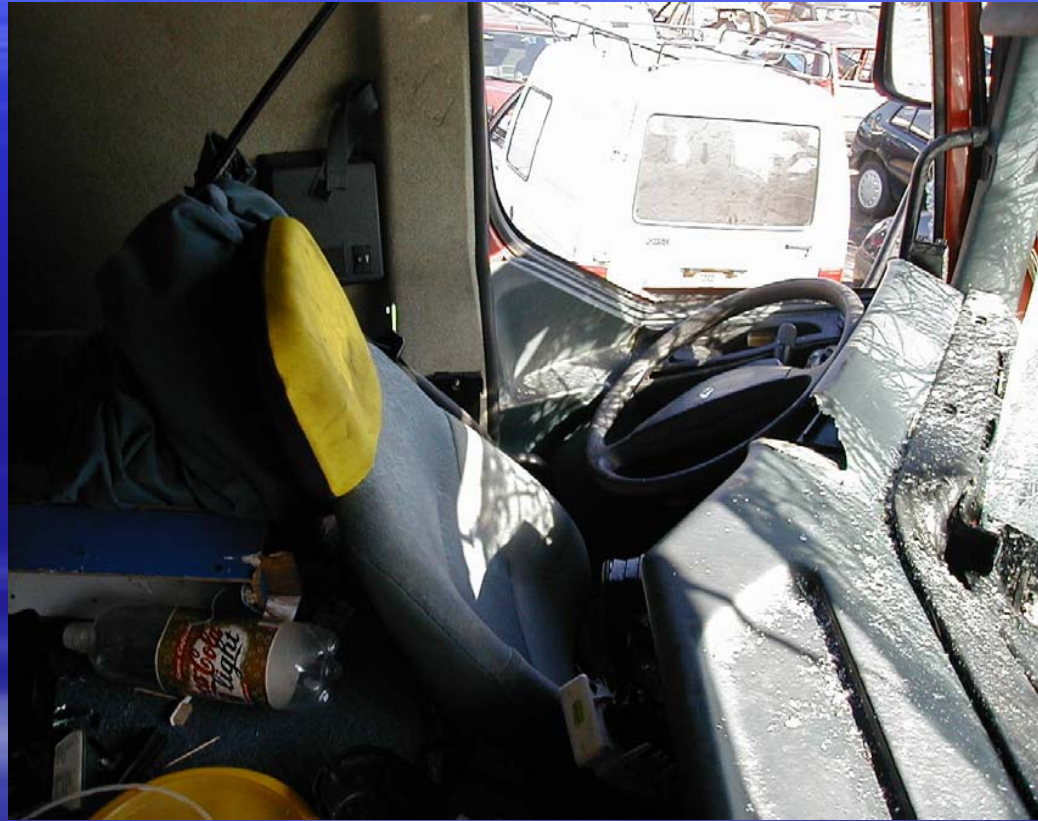
MEDICAL RESULT

- The truck driver is a 42 year old man.
- Very slightly injured
MAIS 1.
- Contusion on right
knee.

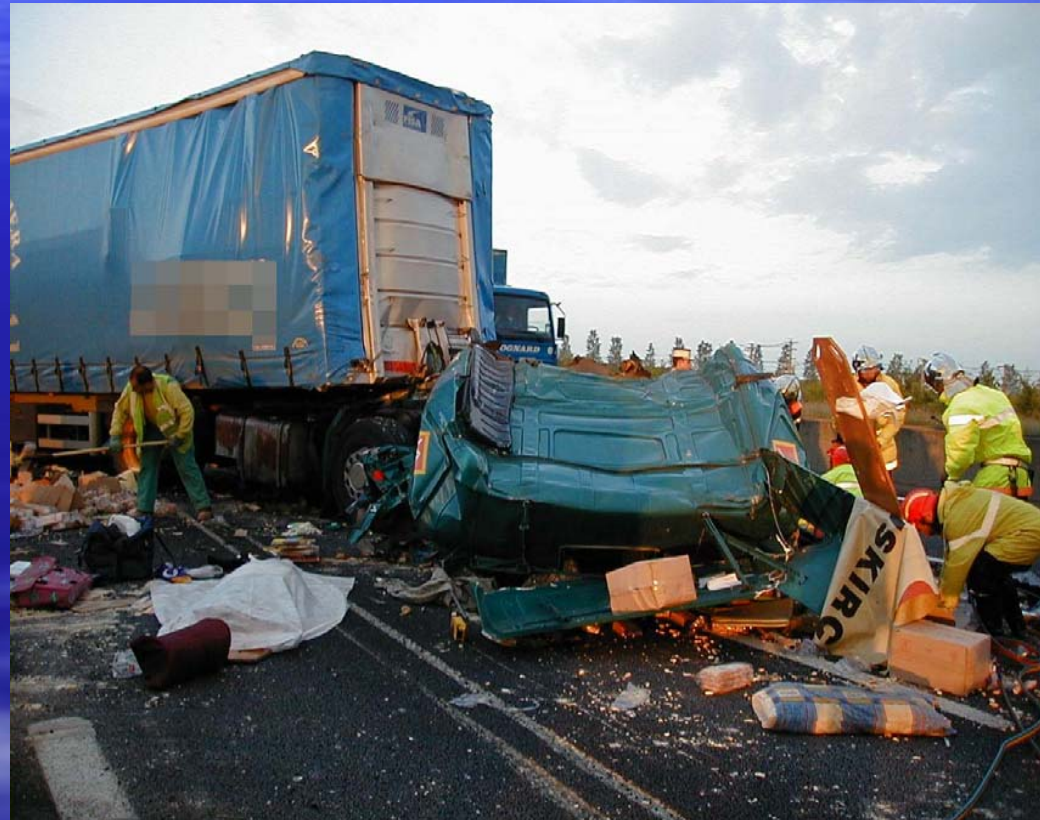
FRONTAL IMPACT SECOND EXAMPLE

- ACCIDENT N° 02 782.
- Friday 15 June 2001.
- Fatal accident between two trucks.
- On a highway at 04:42 am during the night.
- The truck is a SCANIA 143 HA.

- Front to rear collision.
- Between two trucks with trailers.
- 100% front overlap of 2300 mm.
- With a high level of intrusion into the cab.
- With an important deformation of the cab.
- Two occupants fatally injured.

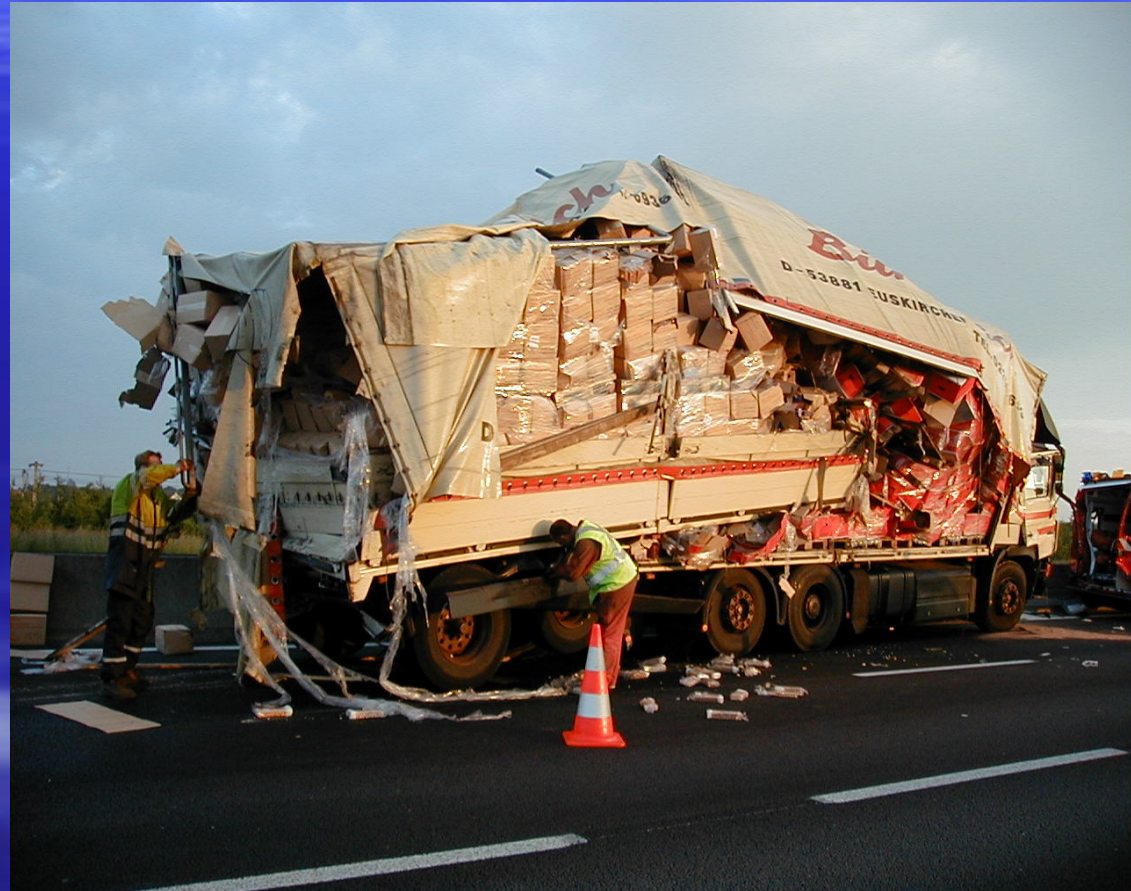
THE OPPOSITE VEHICLE

- Another truck with its trailer.
- Main impact on the rear face.
- Nobody in the cab when the collision happened.

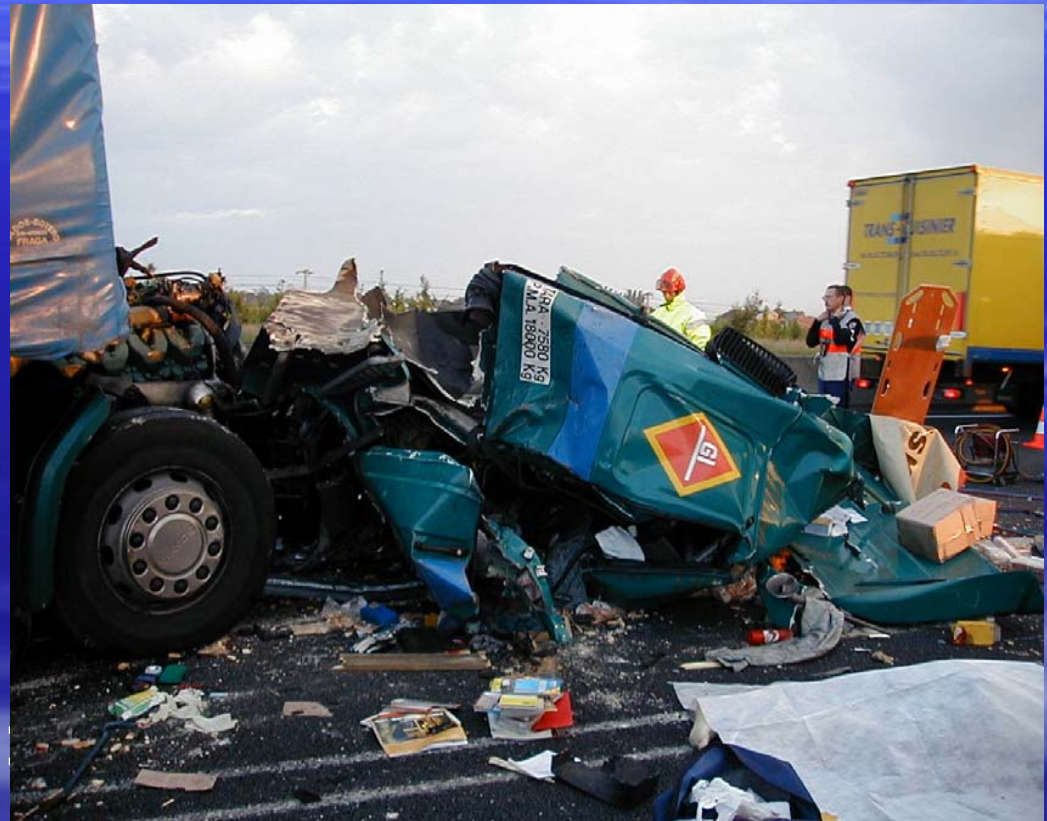
CAB DEFORMATIONS

- Front to rear collision between two trucks.
- 100% overlap of front face.
- Intrusion on left seat : 1090 mm.
- Intrusion on center : 1100 mm
- Intrusion on right seat 1070 mm.

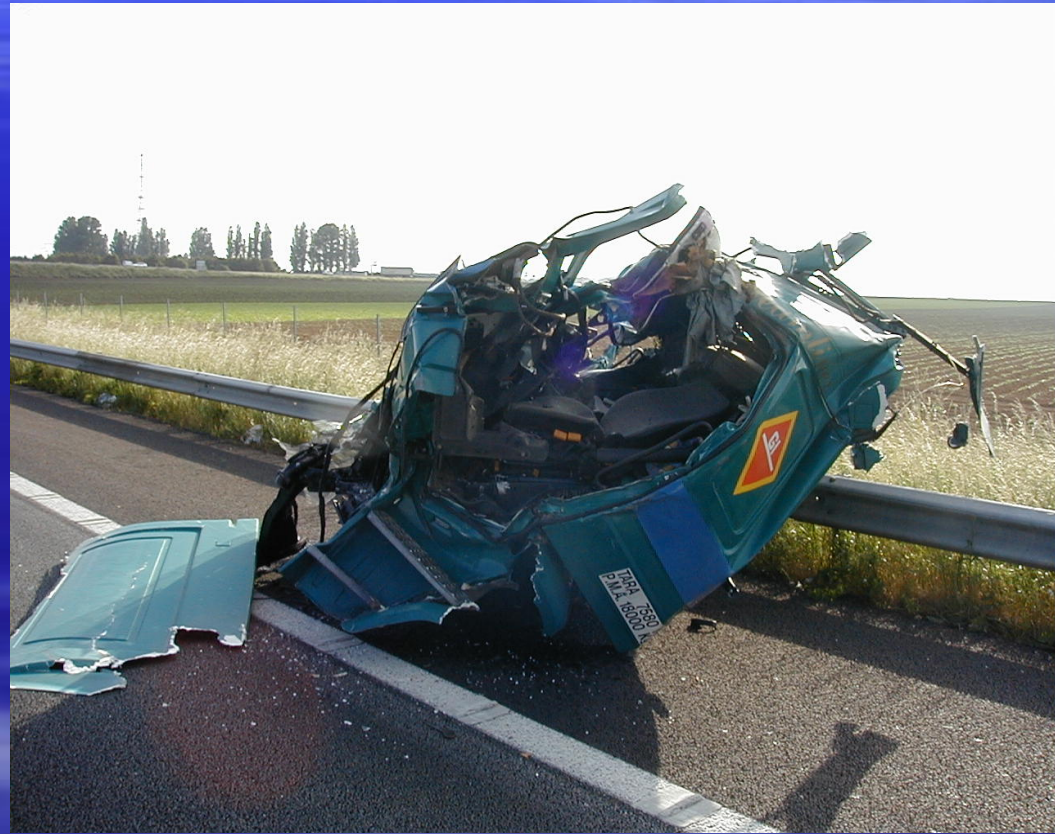
MEDICAL RESULT

- Two occupants inside this cab.
- Two fatalities M.AIS 6.
- Death by intrusion.

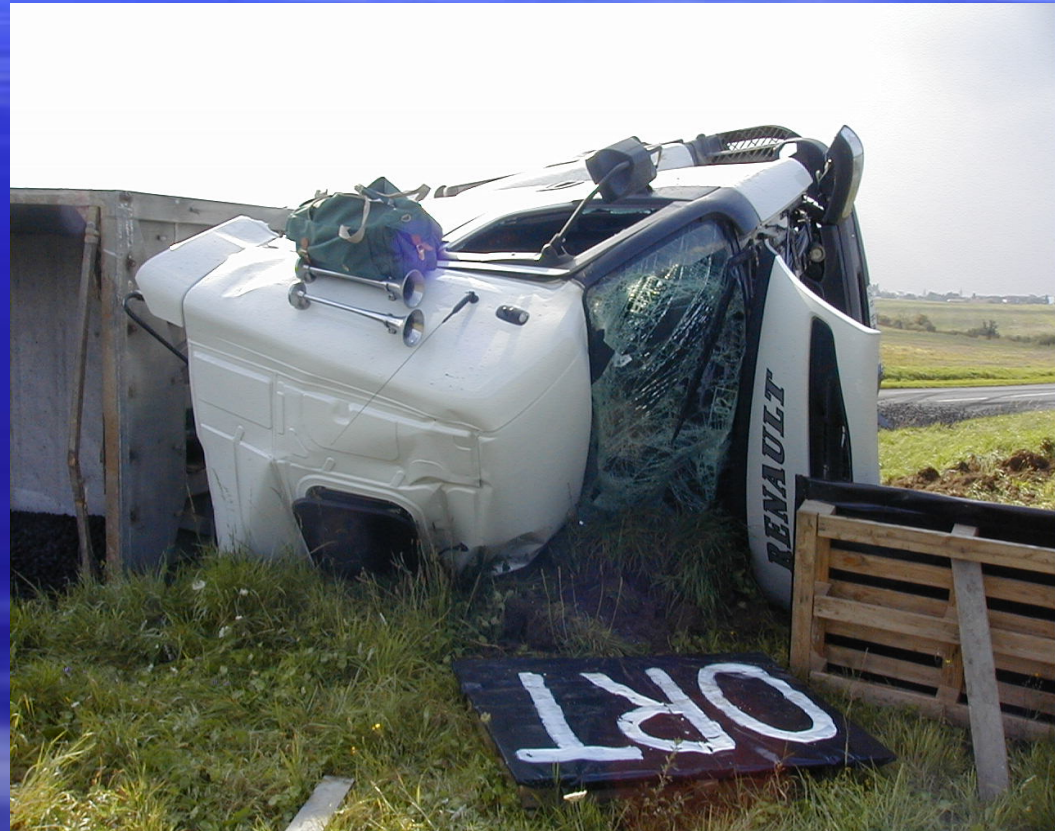
TIPOVER

- ACCIDENT N° 02 792.
- Monday 24 September 2001.
- Loss of control in a right hand curve.
- The truck is a Renault Premium 400.
- One occupant in the cab.

- Tipover on a fixed obstacle.
- Two types of cab deformation.
- Important roof intrusion on right seat.
- Small frontal intrusion on left seat.
- But no cab structure deformation on driver seat.
- One occupant, the driver slightly injured.

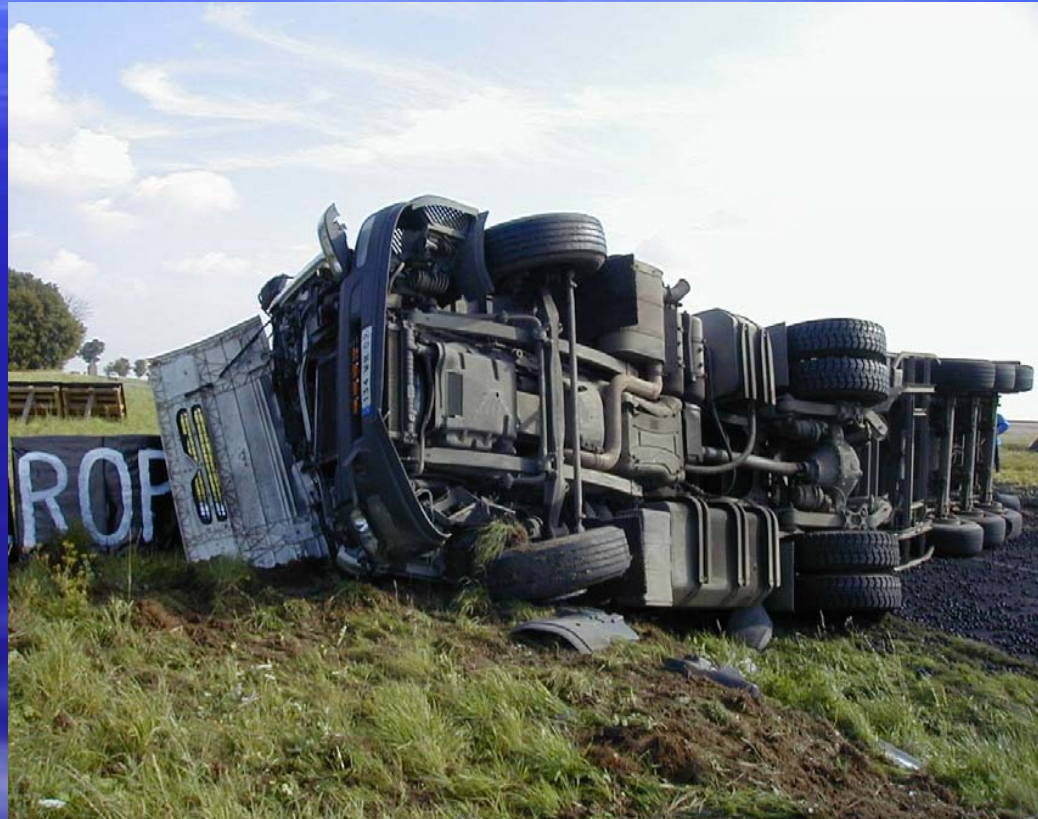
TIPOVER

- Tipover on a fixed obstacle : a bank.
- Main impact on the roof.
- Impact speed : 36 km/h

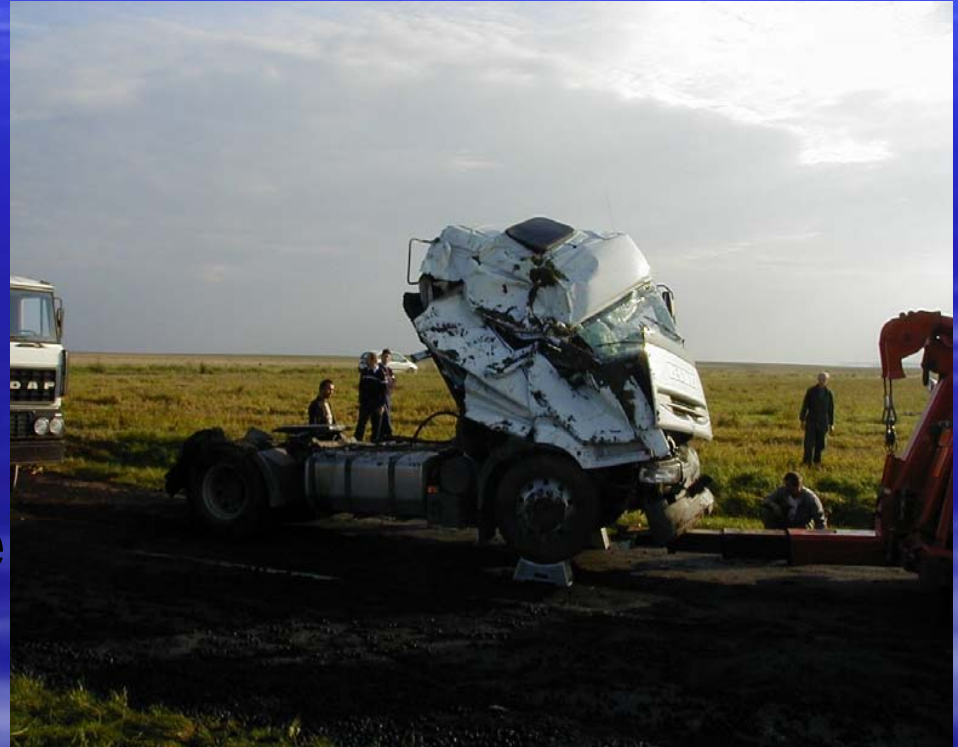
CAB DEFORMATIONS

- First deformation type :
roof intrusion 1200 mm
on right seat
roof intrusion 80 mm on
left seat
- Second deformation type
:
frontal intrusion 300 mm
on left seat without
intrusion on right seat

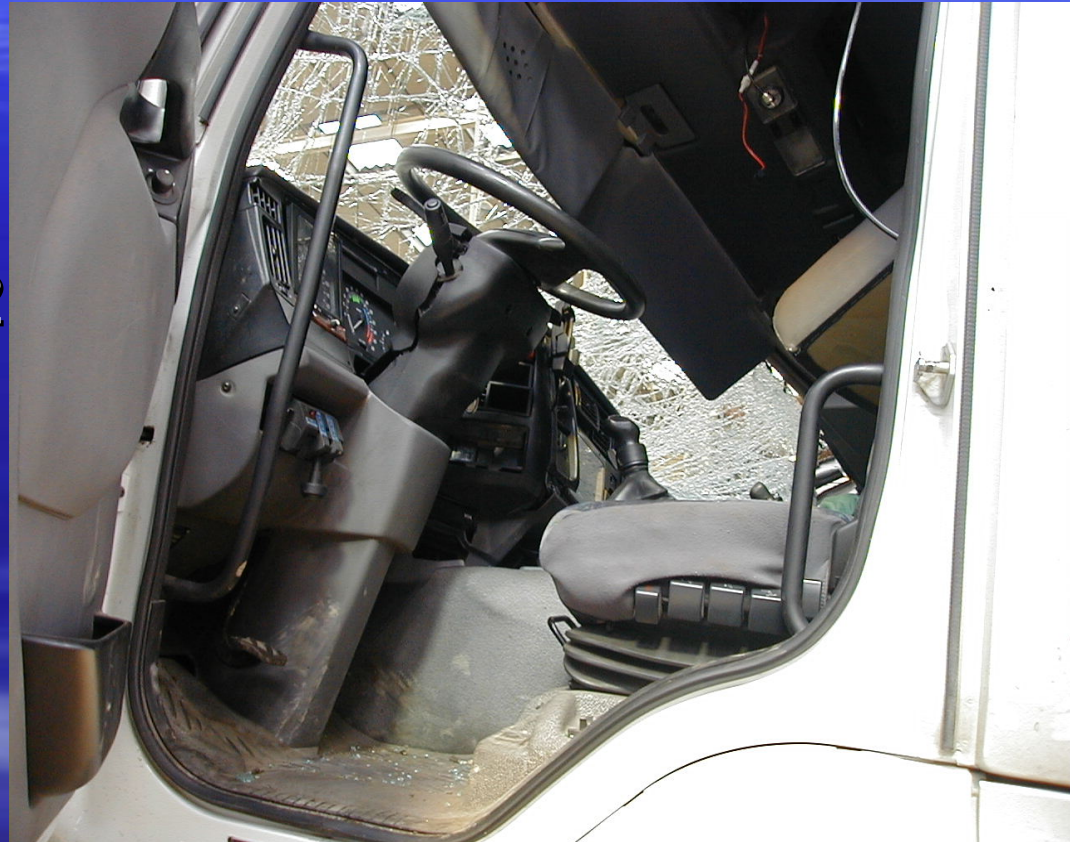
MEDICAL RESULT

- One occupant in the cab.
- The truck driver is a 52 year old man.
- Very slightly injured
M.ASI 1.
- Right ear contusion.

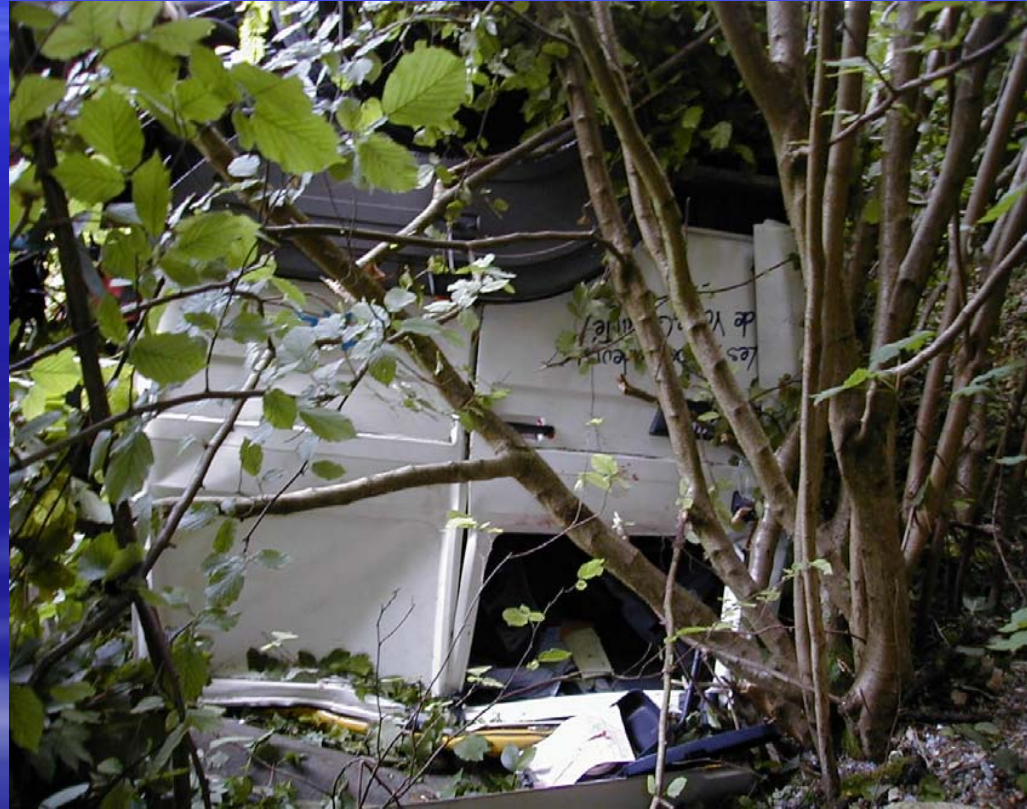
TURNOVER

- ACCIDENT N° 02 783.
- Friday 23 June 2001.
- Loss of control in a left hand curve.
- The truck is a Renault G 340.
- One occupant in the cab.

- Turnover without fixed obstacle.
- Important roof intrusion on right seat.
- Small roof intrusion on left seat.
- Asymmetrical cab structure deformation.
- One occupant, the driver slightly injured.

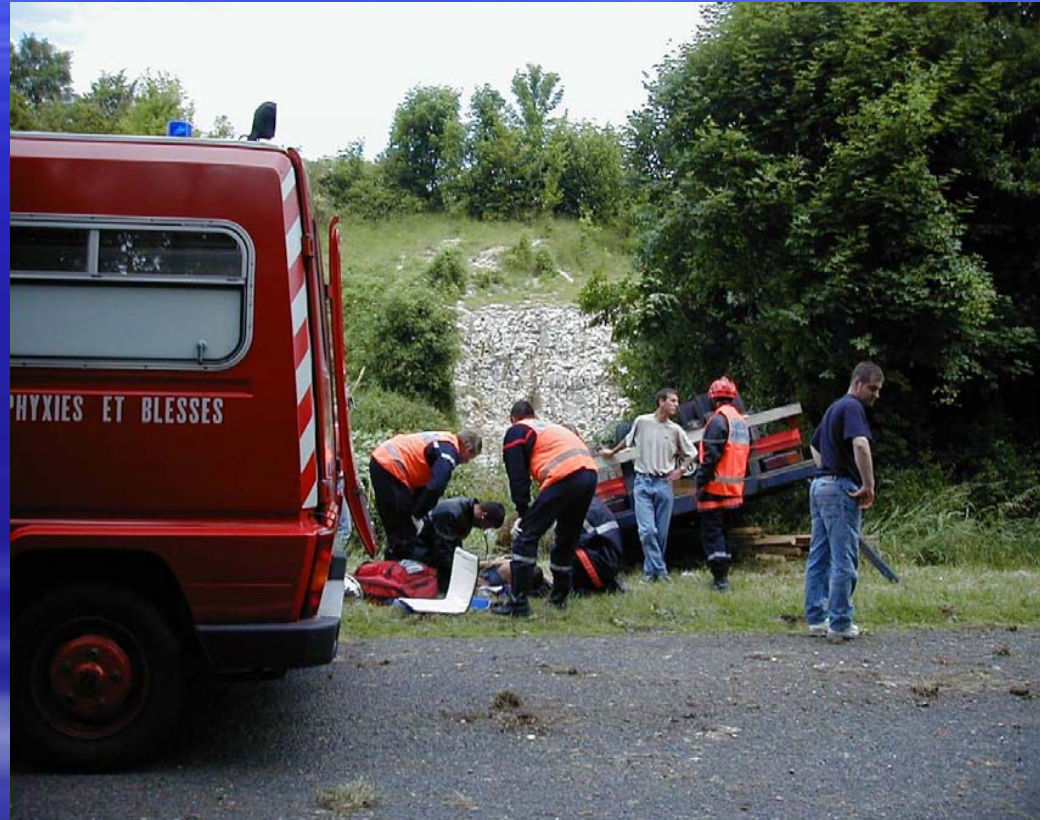
TURNOVER

- Turnover without fixed obstacle.
- Main impact on the cab roof.
- The driver was not trapped inside the cab.

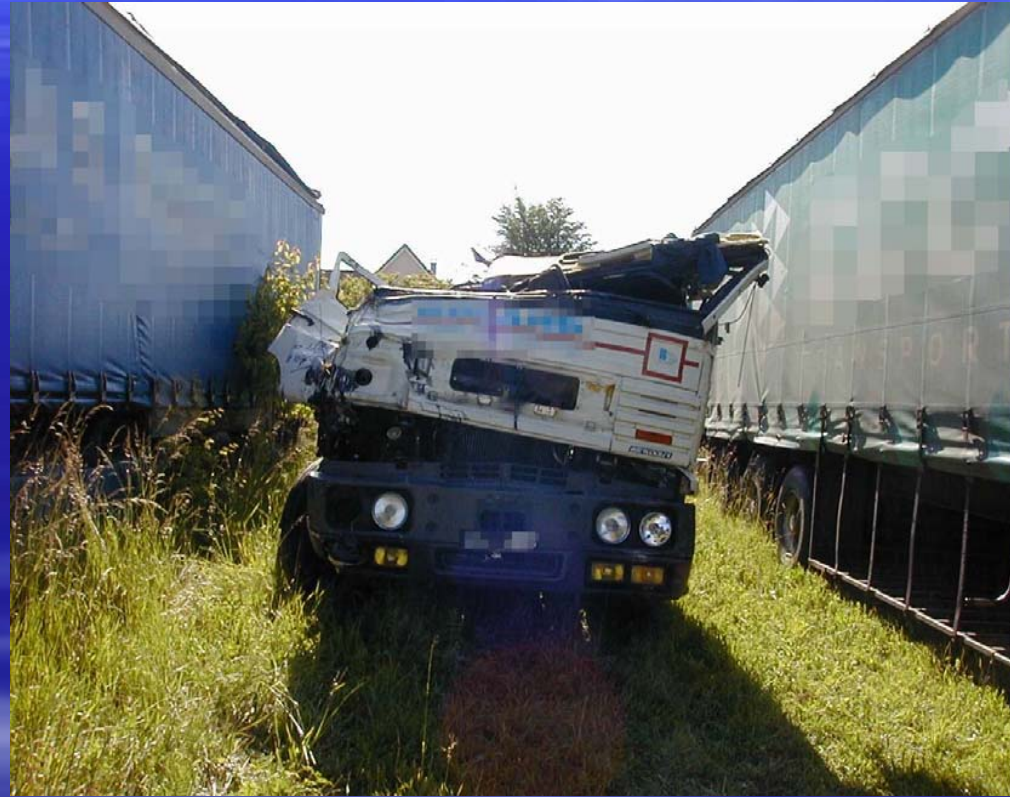
CAB DEFORMATIONS

- Important roof intrusion on right seat : 810 mm.
- Roof intrusion on center : 510 mm.
- Small roof intrusion on left seat : 380 mm.

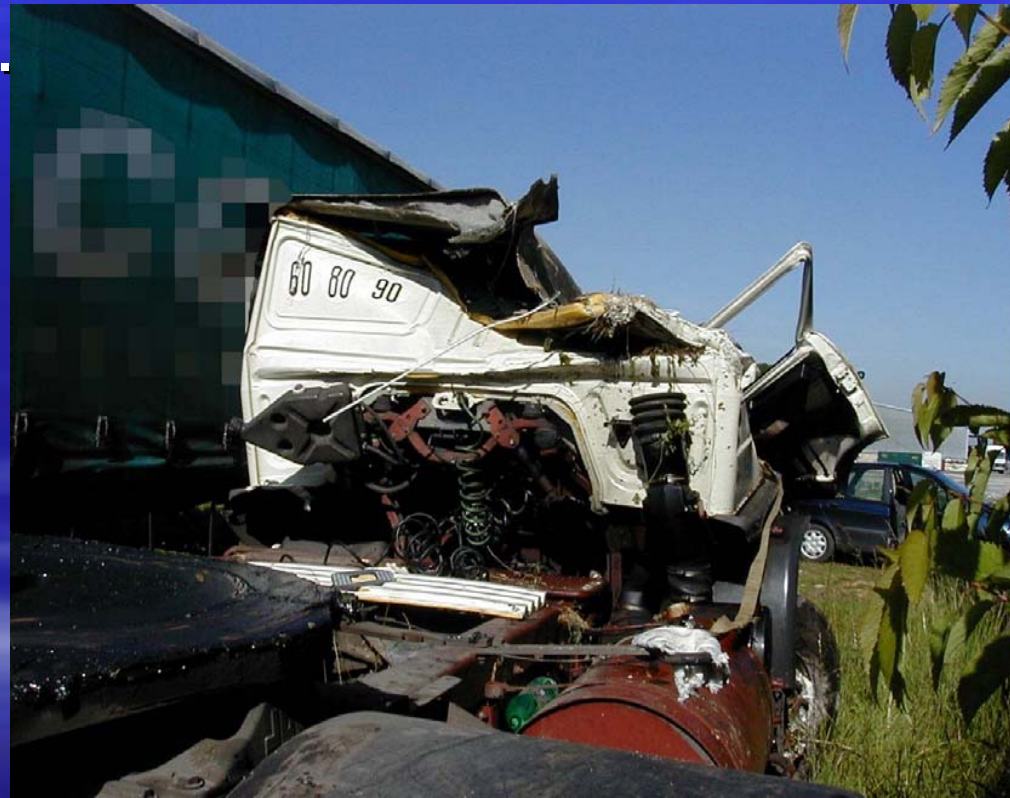
MEDICAL RESULT

- One occupant in the cab.
- The truck driver is a 28 year old man.
- Slightly injured M.AIS 2.
- Head contusion with unconsciousness.

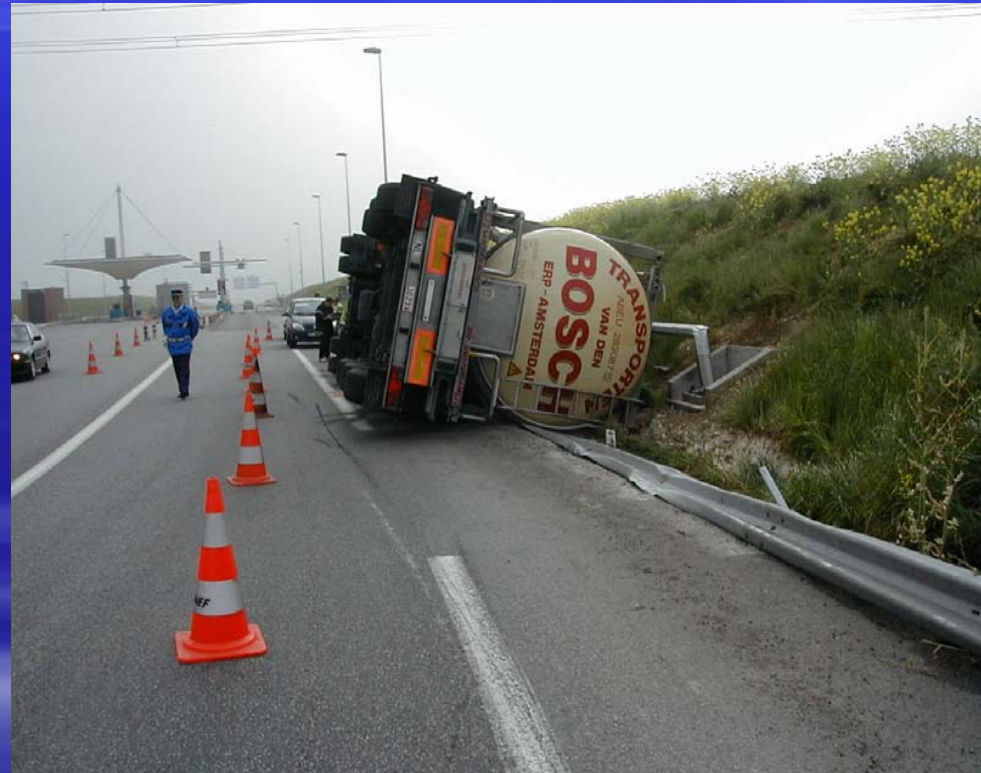
TIPOVER

- Accident n° 02 779.
- Tuesday 15 May 2001.
- Loss of control in a left curve hand due to inappropriate speed.
- The truck is a VOLVO FH 12.
- One occupant in the cab.

- Tipover on a fixed obstacle.
- One type of cab structure deformation.
- Roof intrusion on all seats.
- One occupant, the driver uninjured.

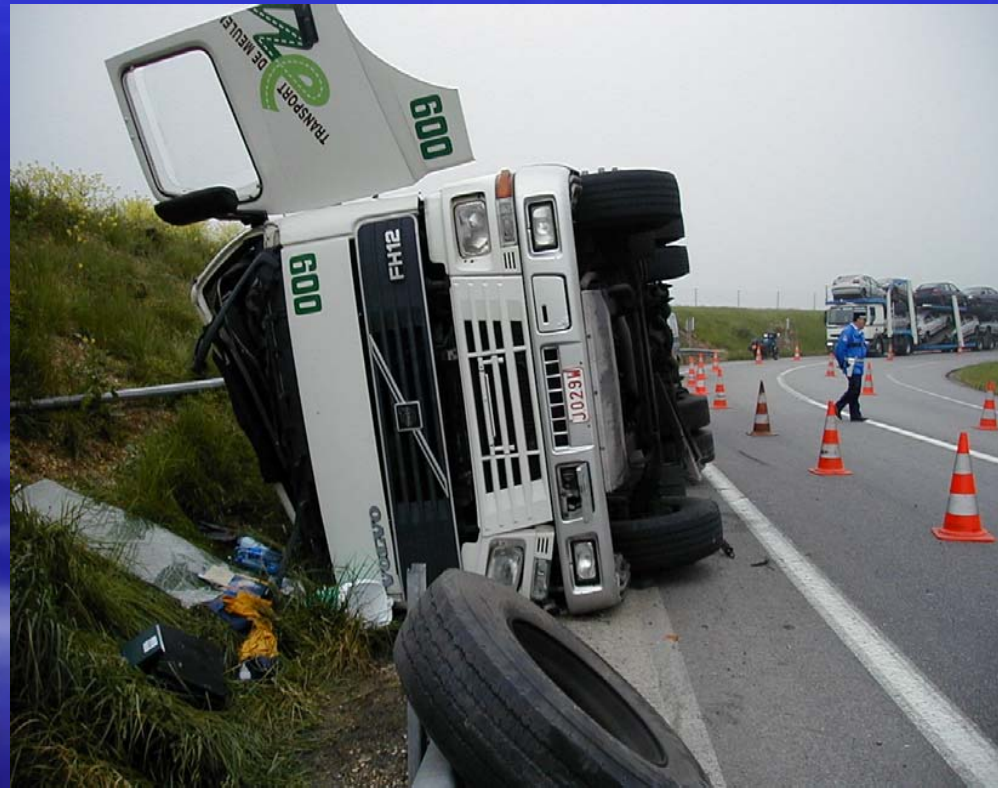
TIPOVER

- Tipover on two fixed obstacles : safety barrier and a bank.
- Main impact on the roof.
- Impact speed : 25 km/h.

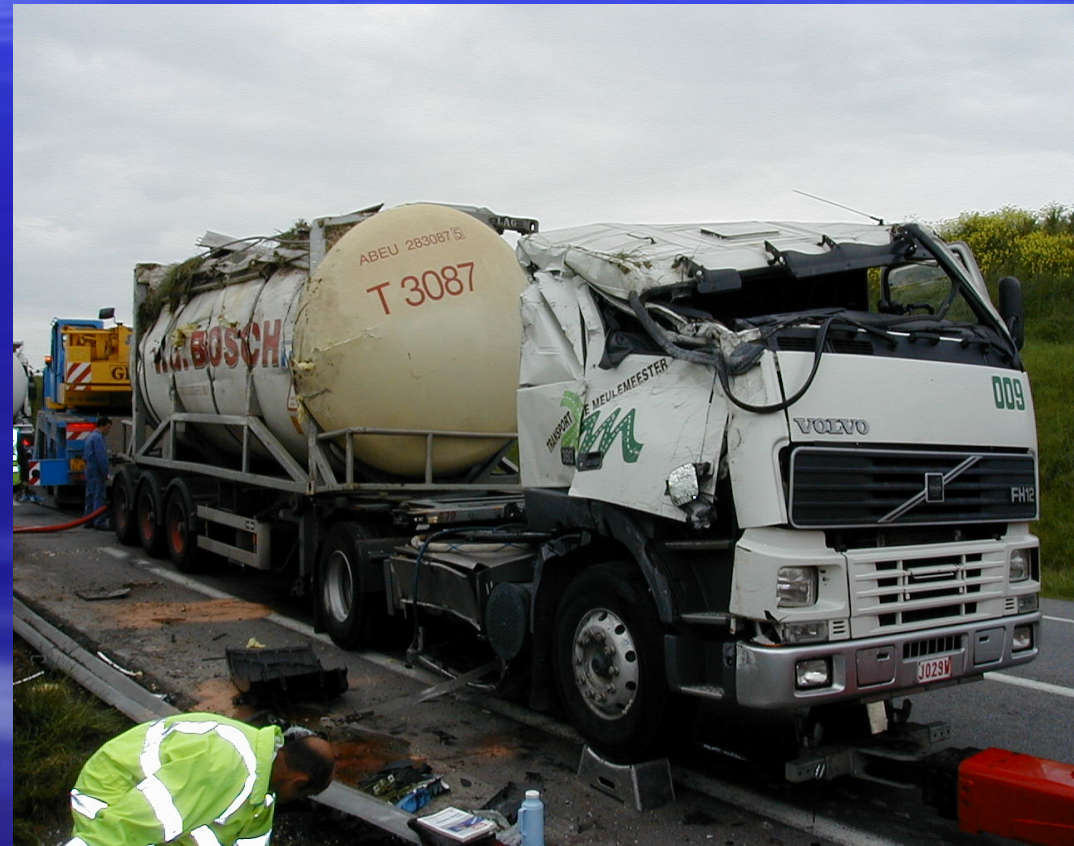
CAB DEFORMATION

- Roof intrusion on right seat : 960 mm .
- Roof intrusion on center : 750 mm .
- Roof intrusion on left seat : 620 mm .

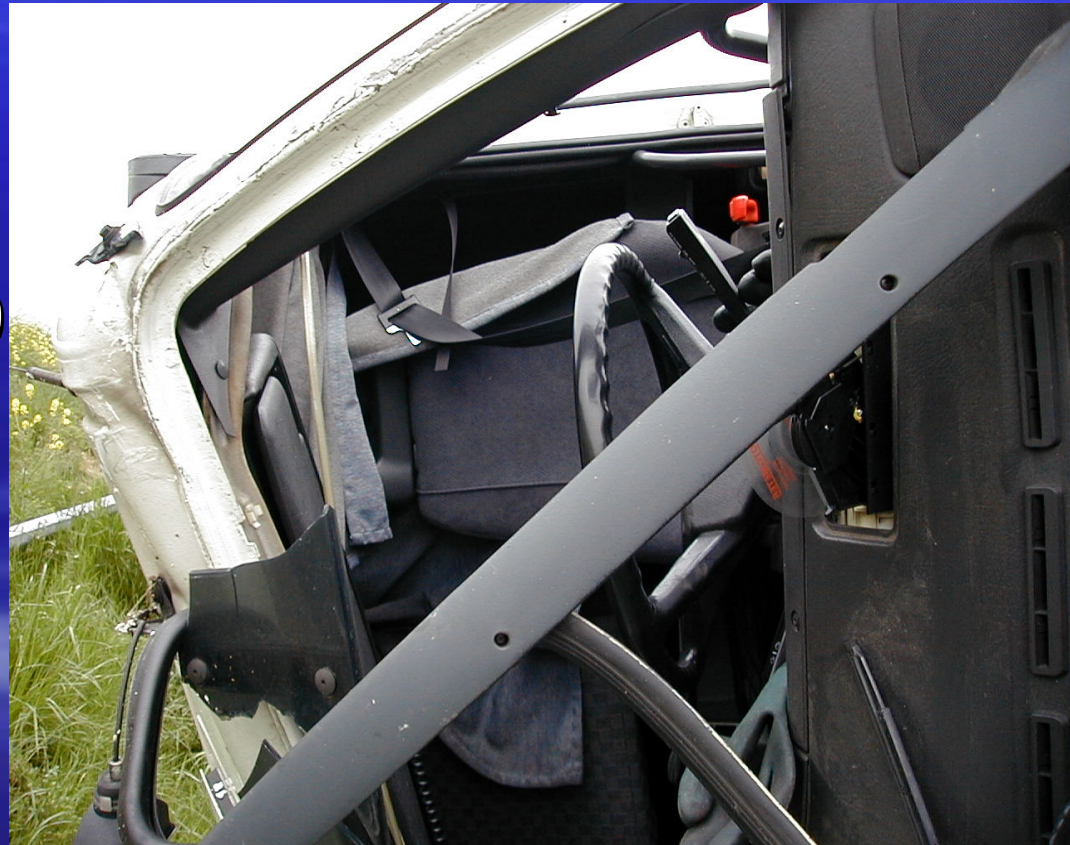
MEDICAL RESULT

- One occupant in the cab.
- The truck driver is a 29 year old man.
- Uninjured M.AIS 0.

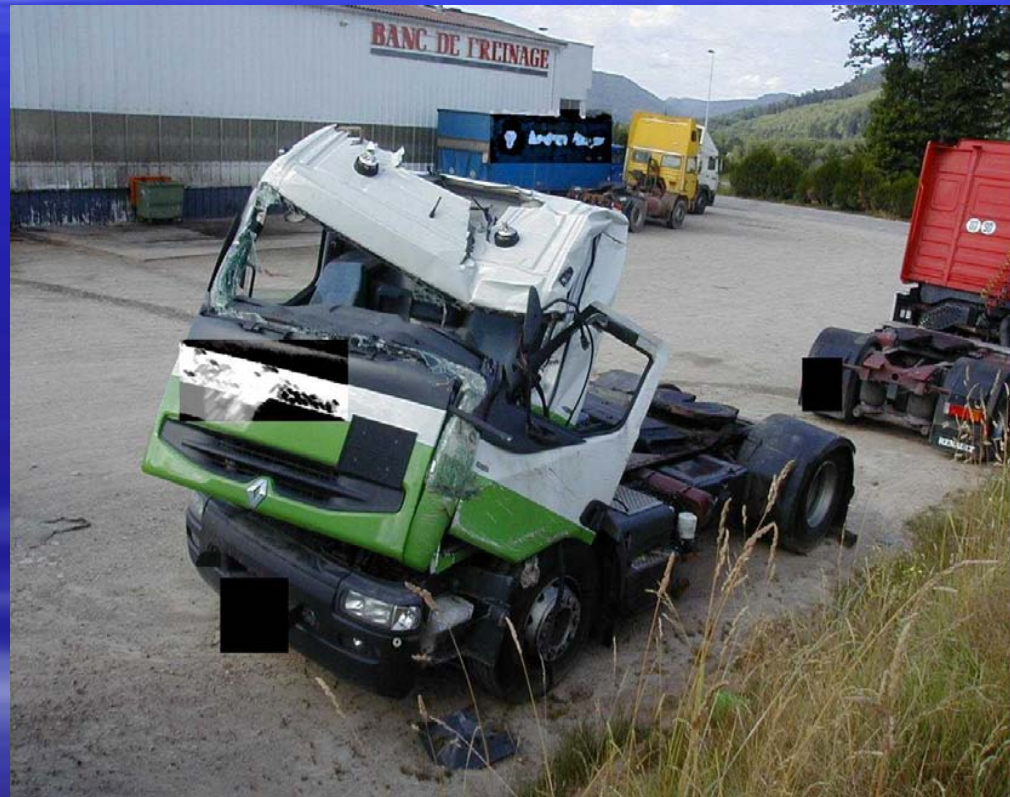
TIPOVER

- Accident n° 02 787.
- Tuesday 29 May 2001.
- Loss of control in a right hand curve.
- Tipover on left side.
- The truck is a Renault Premium 400.
- One occupant in the cab.

- Tipover on a tree.
- First impact tipover.
- Just after second impact is a frontal impact against a tree.
- Major cab structure deformation.
- Roof and frontal intrusion on the driver.
- Driver trapped a very long time inside the cab.
- Driver seriously injured.

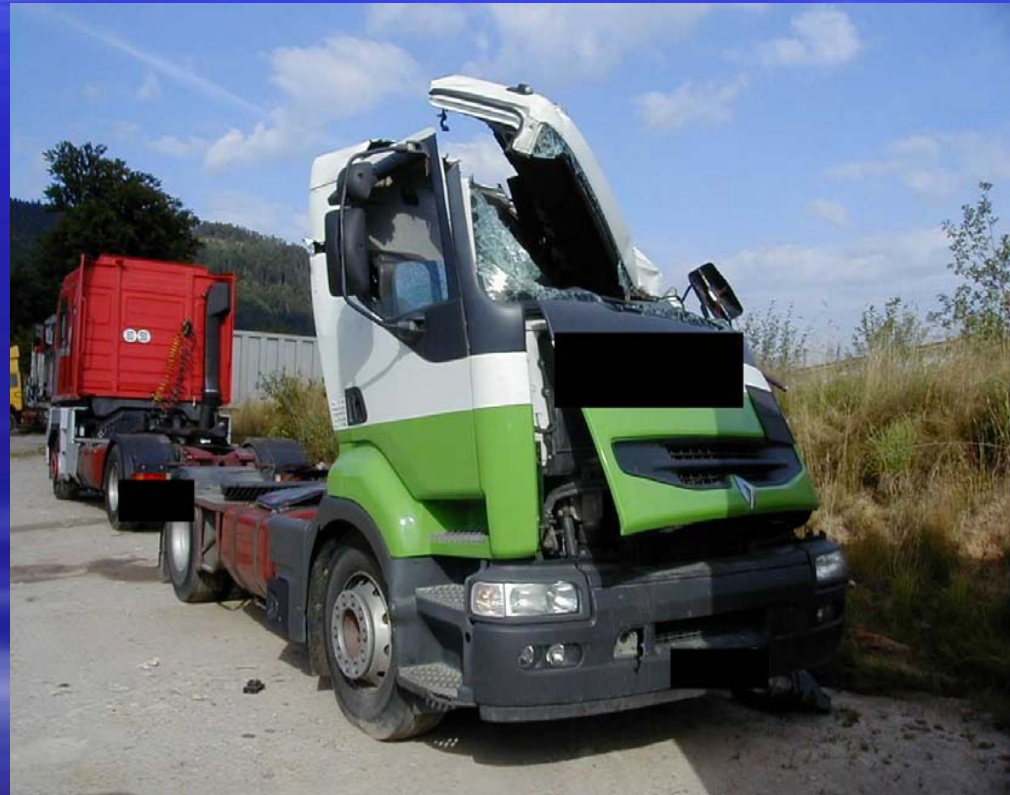
TIPOVER

- Tipover on a fixed obstacle : a tree.
- First impact is tipover.
- Second impact is a frontal impact against a tree.

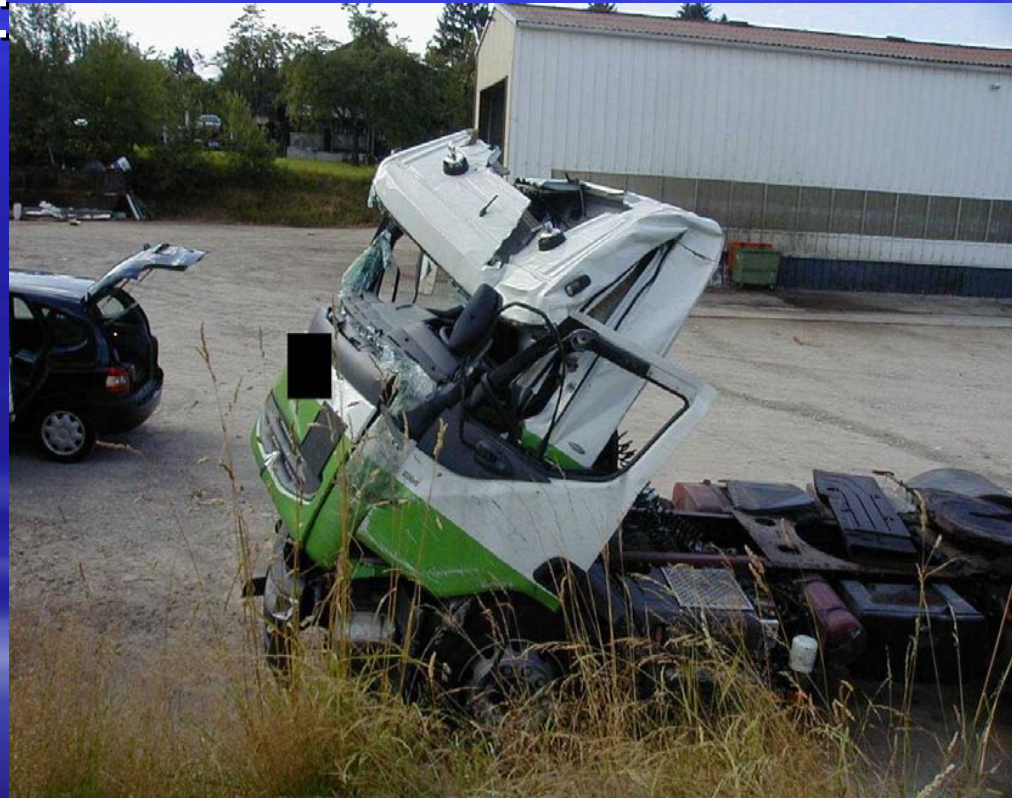
CAB DEFORMATION

- First type of deformation:
roof intrusion 740 mm
on left seat.
- Second type of
deformation :
frontal intrusion 1130
mm on left seat.

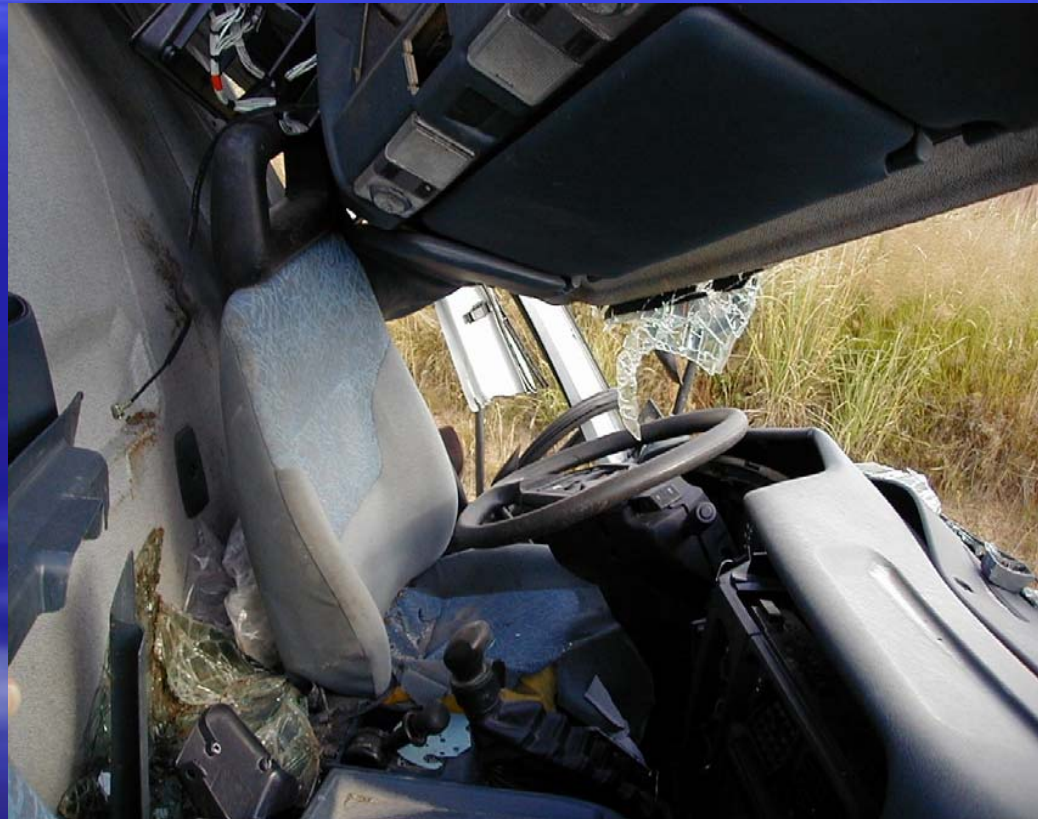
MEDICAL RESULT

- One occupant in the cab.
- The truck driver is a 29 year old man.
- The driver was trapped inside the cab for 4 hours.
- Very seriously injured M.AIS 3.
- Crush syndrome for left leg.

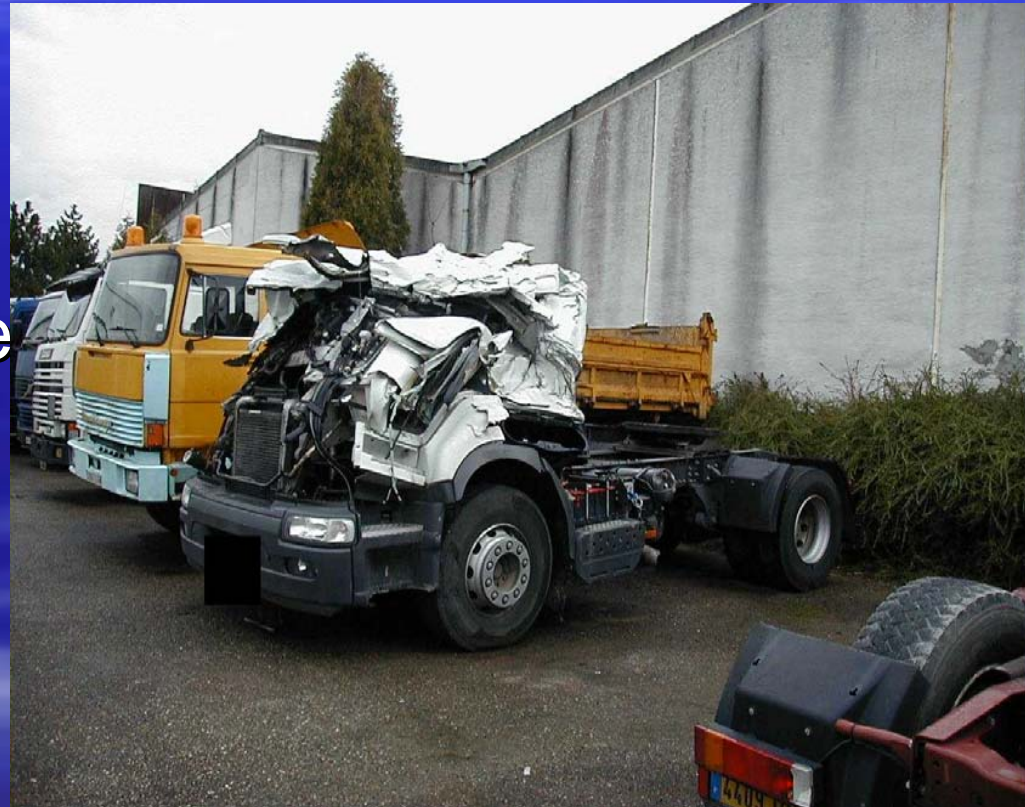
TIP OVER

- Accident n° 02 774.
- Monday 08 January 2001.
- Many impacts during the crash.
- The truck is a Renault Premium 400.
- Two occupants in the cab.

- Tipover on fixed obstacles.
- Many impacts.
- Very important cab structure deformation.
- Two occupants and two fatalities.
