TRUCK CAB CRASHWORTHINESS IN REAL WORD ACCIDENTS

CEESAR

Presented by RENAULT TRUCKS

11 April 2007

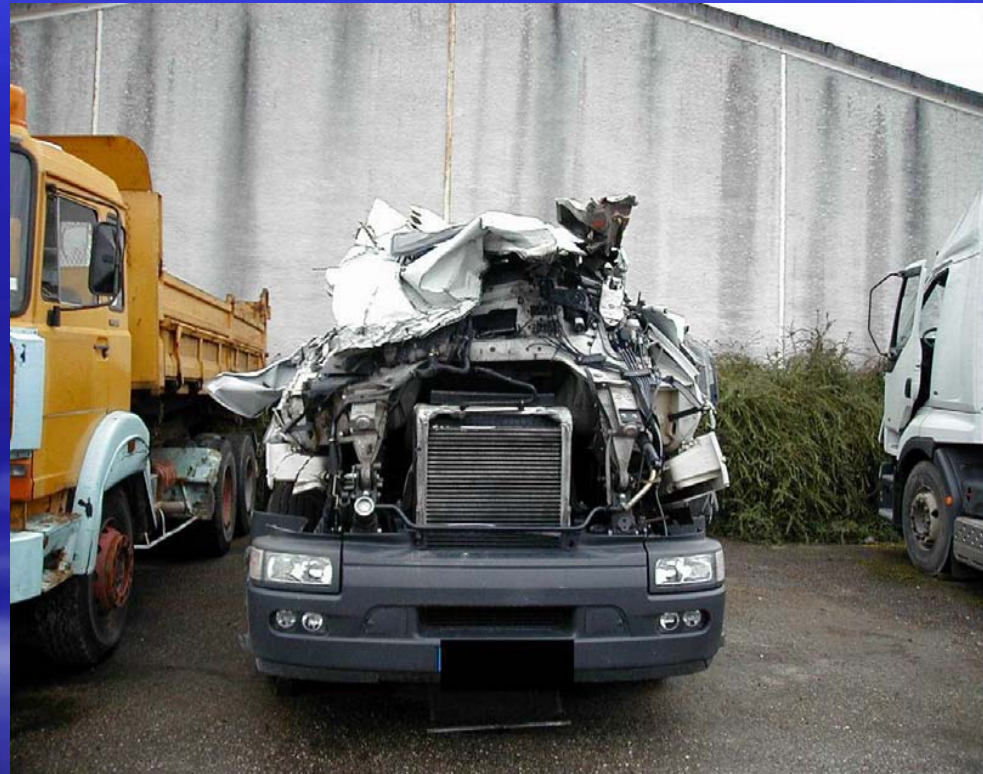
TIPOVER

- Tipover on fixed obstacles : safety barrier
concrete pole
low wall
- Main impact on the roof.
- Major cab structure deformation.

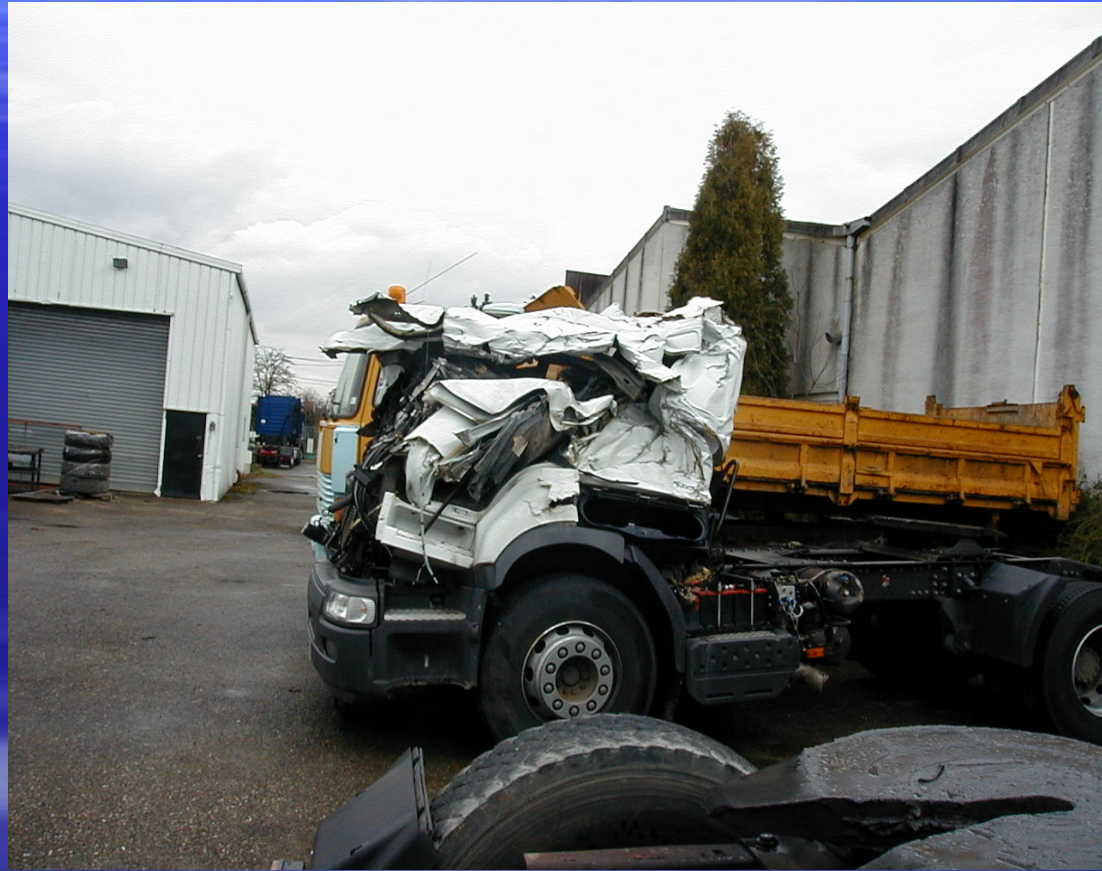
CAB DEFORMATIONS

- Roof intrusion 1310 mm on left seat.
- Roof intrusion 1100 mm on center.
- Roof intrusion 1550 mm on right seat.

- Tipover on fixed obstacles.
- Many impacts.
- Very important cab structure deformation.
- Two occupants and two fatalities.

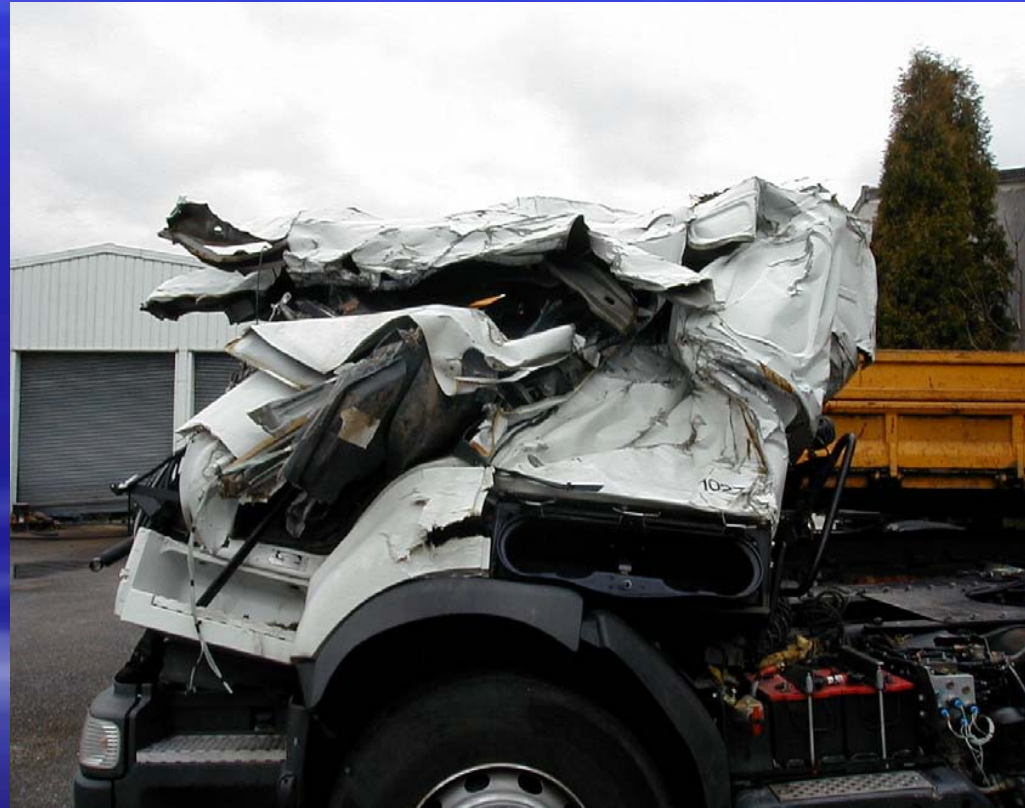
MEDICAL RESULT

- Two occupants in the cab.
- Two fatalities.
