Information concerning an event occurred during carriage of dangerous goods according to 1.8.5

Transmitted by the Government of Romania

Report on occurrences during the carriage of dangerous goods in accordance with RID/ADR section 1.8.5

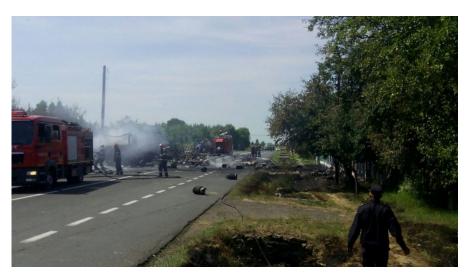
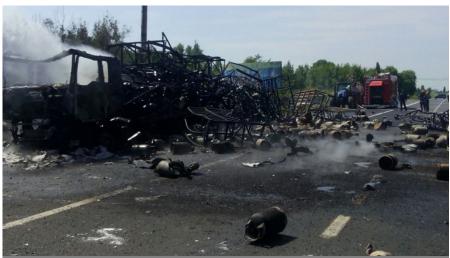
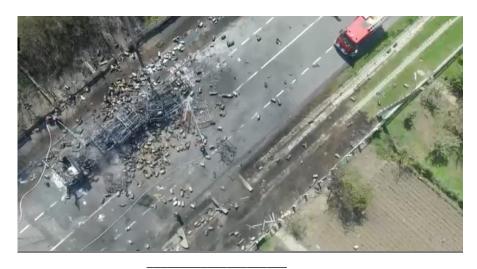
Photos

The overheating was due to the seizure of the bearing of the respective wheel.

- the explosion of the tyre located on the centre of the triple axle of the semitrailer and
- the fire, which extended to the semitrailer floor and then to the LPG cylinders.

The fire engulfed the vehicles and the cylinders quickly, although the driver acted promptly using the fire extinguishers available on the semitrailer.

5. Description of o								
□ Derailment/Leaving the road								
□ Collision								
□ Overturning/Rolling over								
□ Fire								
■ Explosion								
■ Technical fault								
Additional description of occurrence:								
One of the wheels of the triple axle of the semitrailer was seized causing overheat and the explosion of the tyre. The fire that engulfed the vehicle and the cylinders arose shortly.								
The road infrastructure and the electricity network were both affected
