Reference: BLR 75701

REVIEW MEETING AT ENVIROCENTRE WITH PORT OF TYNE REGARDING THE PLACEMENT OF CONTAMINATED DREDGE MATERIAL OFFSHORE.

Yorkhill Basin Site Visit

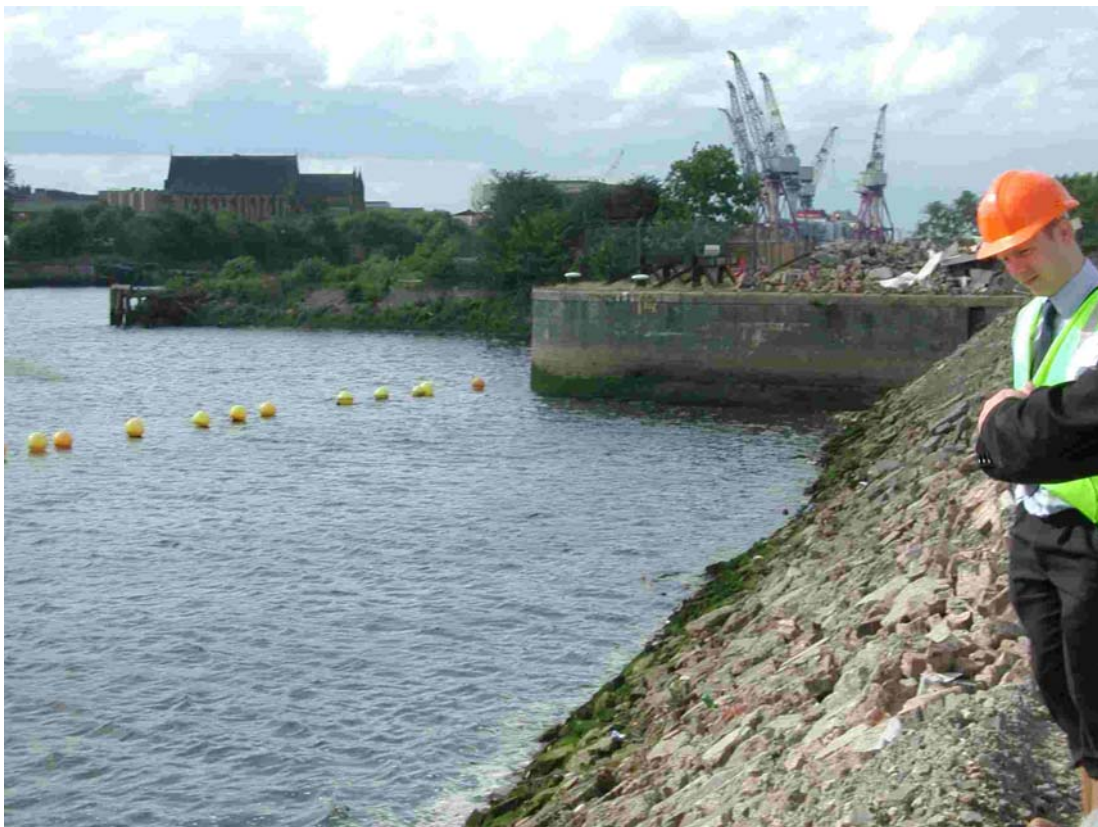
a) **Picture 1** Yellow buoys indicate the edge of a silt curtain, and compacted crushed demolition material has been used as a bund in front of the dock.

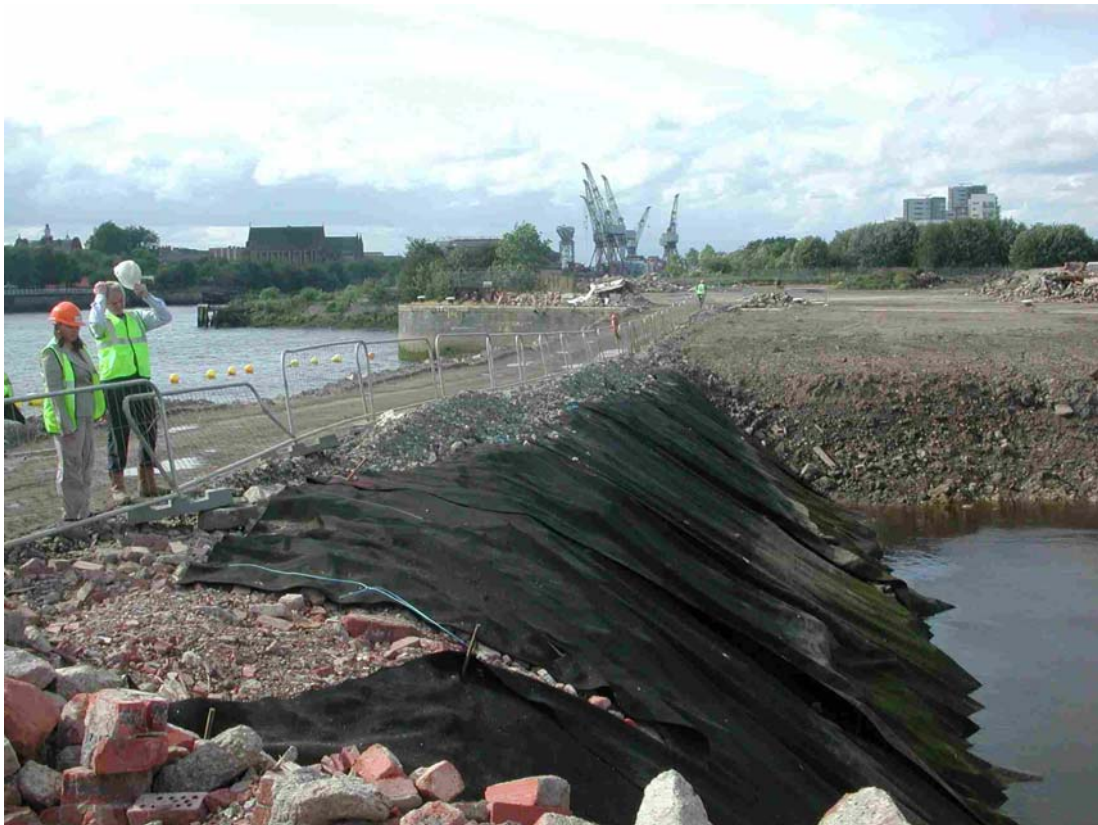
b). **Picture 2** A geotextile membrane was laid across the bund, to prevent fines from the soil being trapped in the bund or being transported into the river.

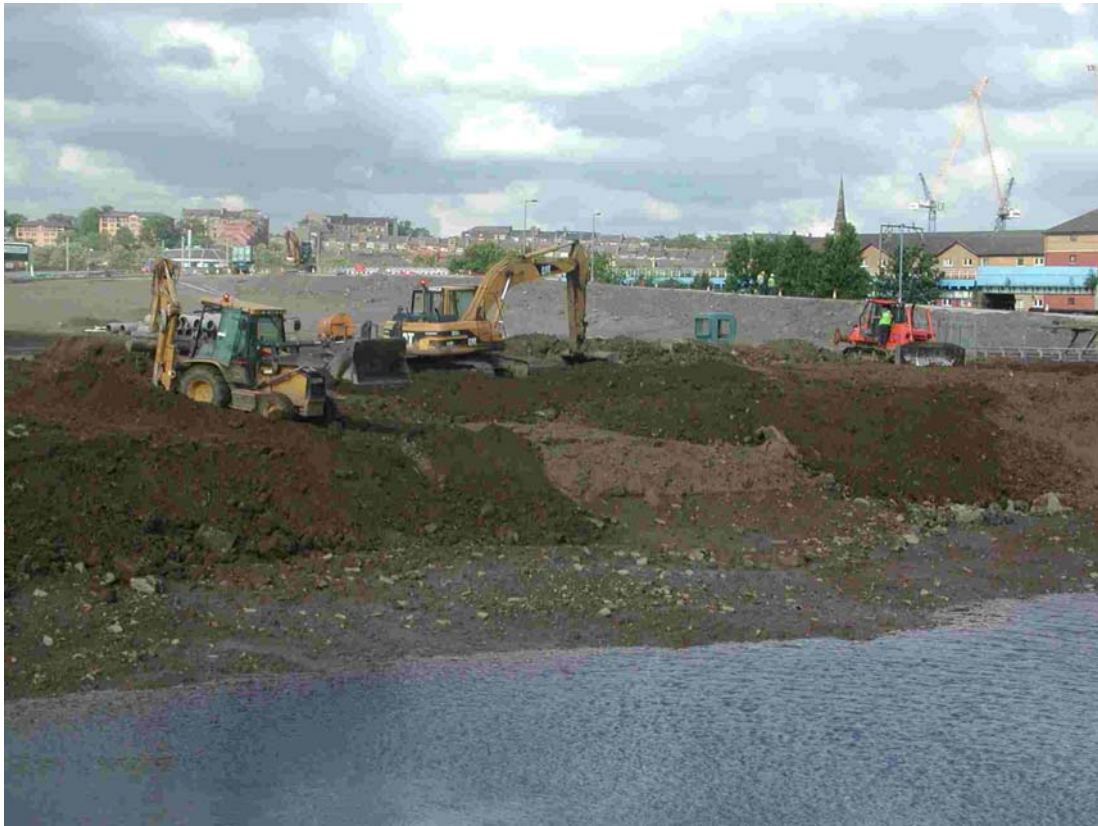
3. **Picture 3.** Tipped poor quality topsoil from within the construction site and within the planning application area (outside the material would be considered as waste, and for sale as top soil would require exemption under SEPA) is pushed by dozers into the dock and levelled.

The tide inundates through the bund and membrane and fills up the dock. On leaving the water helps the soil to naturally compact. Whilst the material itself is not suitable for construction, piles can be driven through it as large pieces of rock are removed. Below the dock is bedrock into which the piles can be driven.

17. The area in front of the bund is to be sheet piled and a large void created, into which contaminated dredge material is to be placed and removed from the marine environment.
