OSPAR CONVENTION FOR THE PROTECTION OF THE MARINE ENVIRONMENT OF THE NORTH EAST ATLANTIC

Capping of Contaminated Dredged Material Case Study Port Of Tyne UK

Presented by the United Kingdom

Capping of Contaminated Dredged Material - Case Study from the Port Of Tyne UK

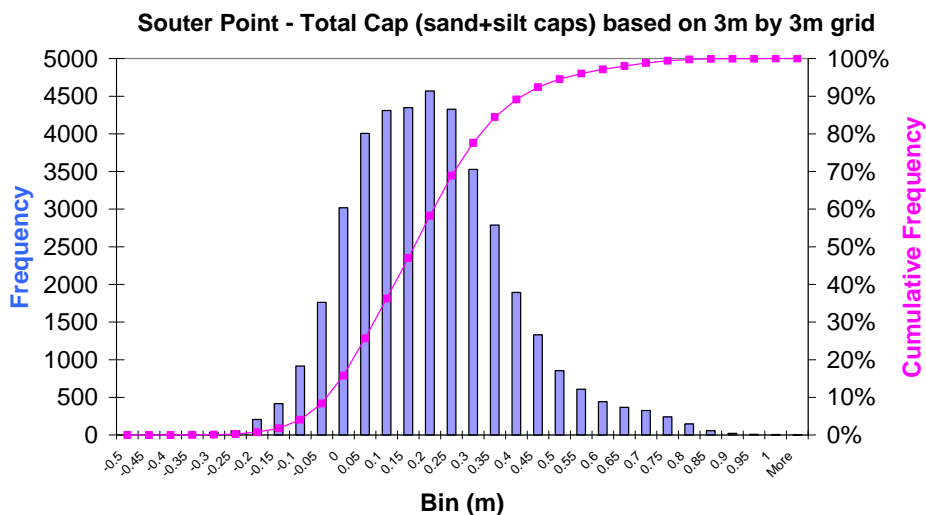
Figure 9. Histogram of total cap thickness based on 3m by 3m grid along with a cumulative representation of the thickness

The histogram (Figure 12) of Total cap thickness shows a median size of between 0.2 m and 0.25 m. Note also the negative estimates of thicknesses, which give an indication of the error bars associated with this method i.e. up to 0.2 m as it is highly unlikely that the seabed surrounding the trial cap site has been eroded by 0.2 m.

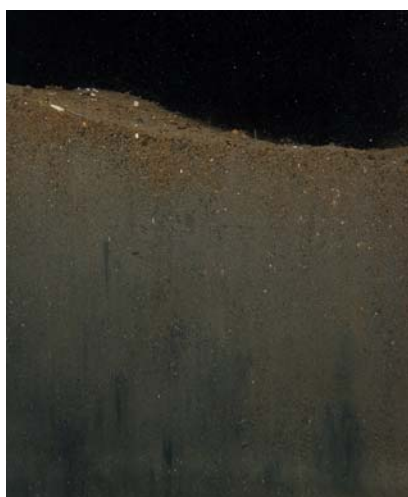
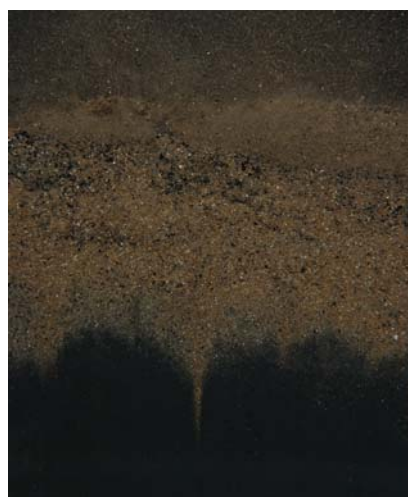
SPI Image from outside the cap site SPI Image from within the capping site

Figure 10. SPI taken over the disposal site during the Endeavour Survey summer 2005

North Tyne and Souter disposal sites have been subject to monitoring in the past and the Cefas undertook a survey of the site again this year. Samples from 2005 and 2006 are currently being processed and the work will be reported in due course. A SPI survey was carried out in 2005 after the capping exercise. Transects covered the trial site, outside the trial site but within the disposal site, and reference sites away from Souter Point. The images below show how there are benthic organisms in the disposal site but not yet established within the trial site.
