NEW REQUIREMENTS TO EMERGENCY EXITS AND THEIR USE ON BUSES

Dr. MATOLCSY, Mátyás

Warsaw meeting: January, 2009

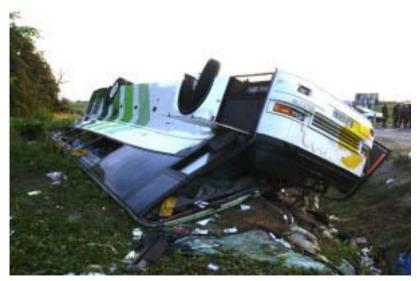
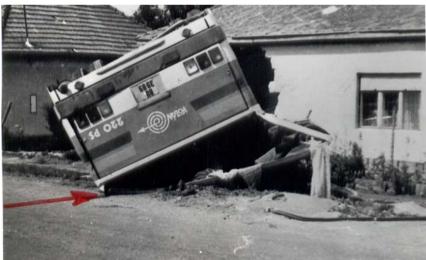
General collapse of the superstructure

In these cases no sense of emergency exits

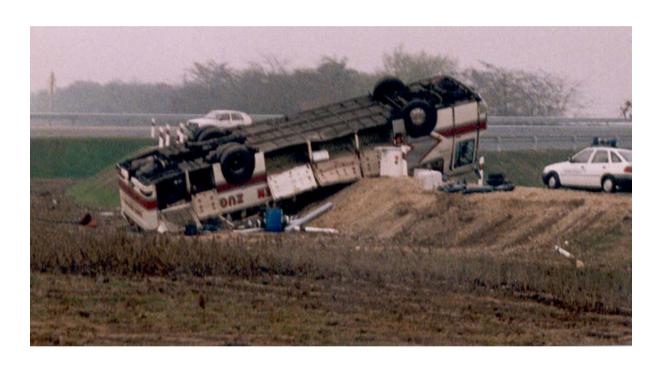
Local large scale deformation of the bodywork

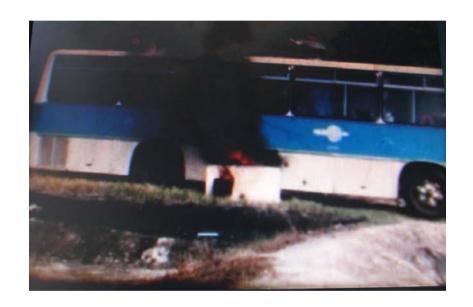
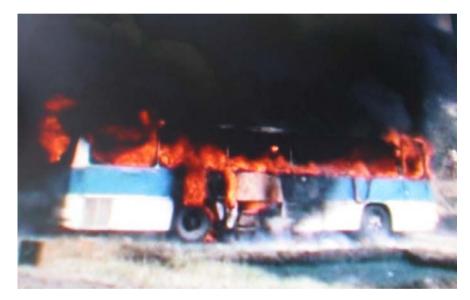
Fire tests with three buses (type: IK255 and IK415) Smoke, poisoning gases and temperature

Fire started in the box of the heating device

Available time for evacuation:

200 - 300 sec

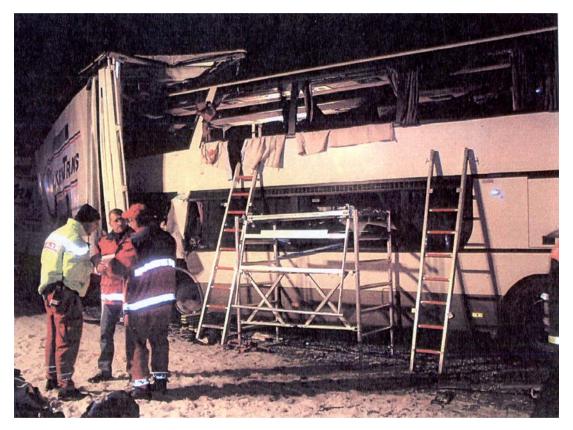
Emergency side windows in DD coaches

Frontal collision

Upper deck, side windows, usability: very weak

Lower deck, side windows, usability: very good

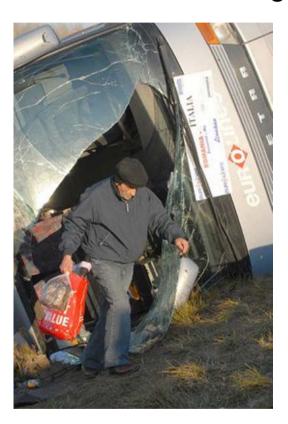
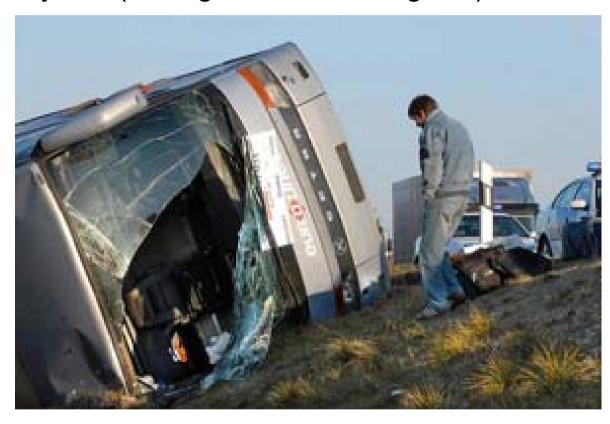
Windscreen as emergency exit (cutting the laminated glass)

The bus is lying on its side (door side)

The usability of the windscreen: good or very good

The service door and the emergency windows on the right side are unusable

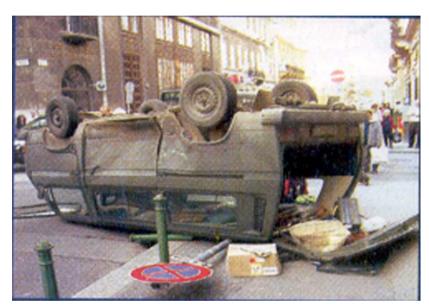
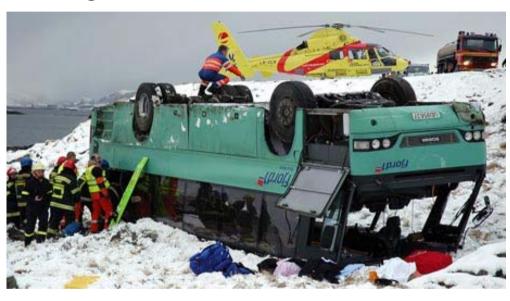
Standing on the roof

small bus

large bus

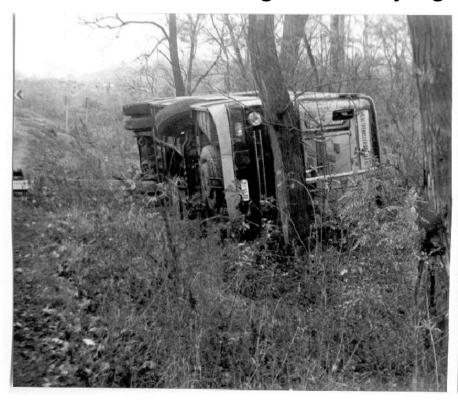
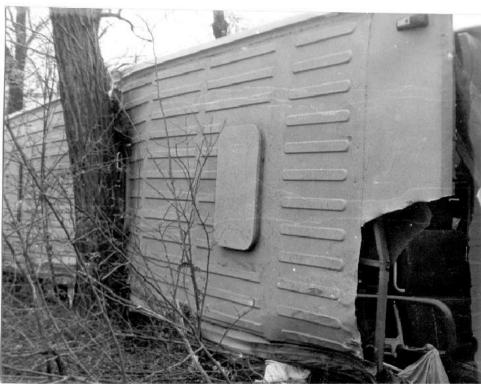
Standard 12 m long coach laying on its left side

Rear window (broken) usability is good or very good Escape hatches usability is good (or unusable, see the tree)

Side emergency windows on the left: unusable

Side emergency windows on the right: usability is very weak

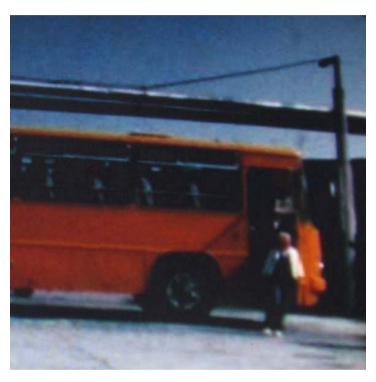
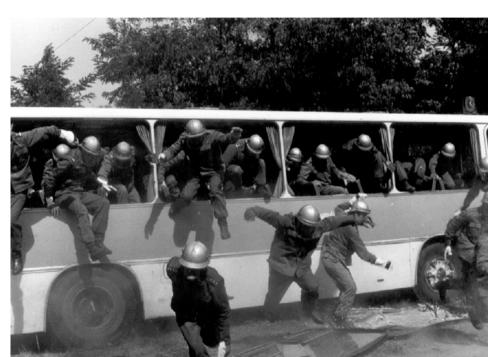
Hungarian tests (AUTOKUT)

- Class III coach with 45 passengers
- Two groups of passengers: firemen (20-40 y); adults (25-45 y)
- Service door, emergency door, side window was tested
- Complete evacuation times were measured (empty bus)

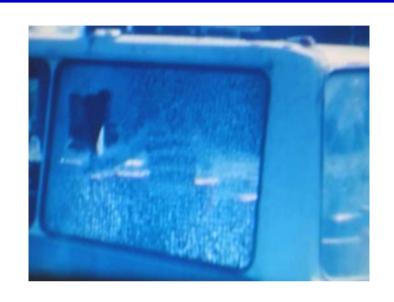
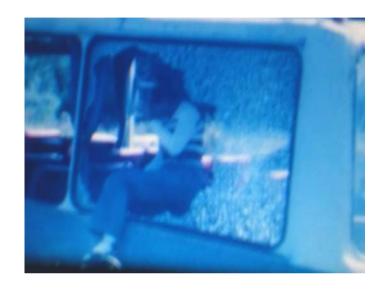
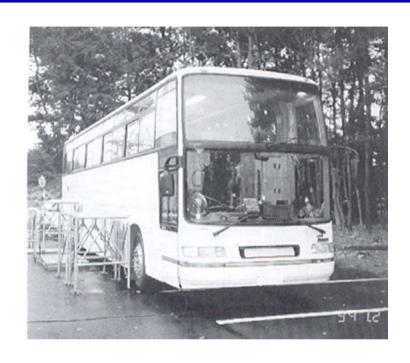
Breaking the side window (30 years woman)

finding and getting the hammer, cracking the glass 	15 sec
 creating a "free exit" with appropriate size, additional 	25 sec
 leaving the bus with strong outside help, additional 	50 sec
	\sum 90 sec

The woman was afraid of climbing up and jumping through the window (sharp, pointed glass fragments on the waistrail)
