NEW REQUIREMENTS TO THE EMERGENCY EXITS OF BUSES

Dr. MATOLCSY, Mátyás

Paper Number: 09-0181

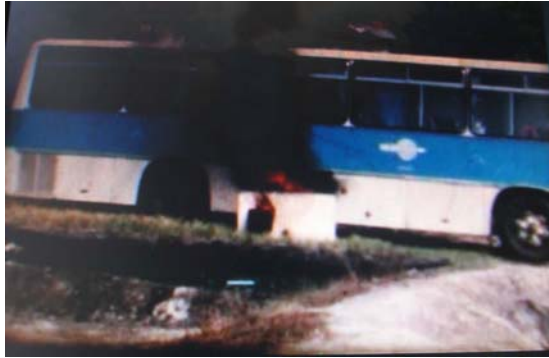
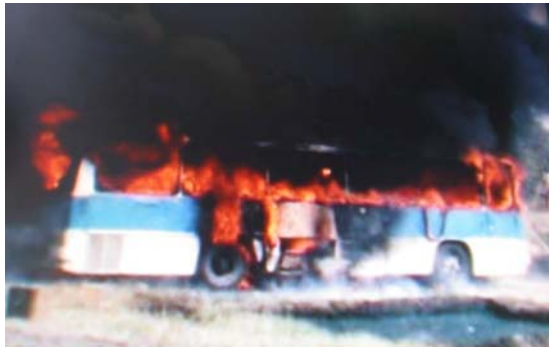
Figure 3. Fire tests with complete bus type IK255

Fire tests were carried out in Hungary with three complete buses (type IK 255 and IK 415) simulating five fire sources. Figure 3. shows one test when the whole fire propagation process was observed and studied with the measurement of temperature and some poisoning gas concentration increasing. [1] The source of fire was in the closed box of the heating device, under the floor. The measured values (CO, HCl, HCN gas concentrations; temperatures T_{far} far from the fire source and T_c close to that) are presented on Figure 4. Without detailed discussion of the test results it may be said that from the first possible observation of the fire, the available time for evacuation was in the range of 200-300 sec. The smoke density was not measured, but visually detected by filming it was developed very rapidly. The critical values of gas concentrations are marked by a horizontal line on the left side of the diagram. The life danger is mainly due to the gas and smoke concentration and less to the high temperature.

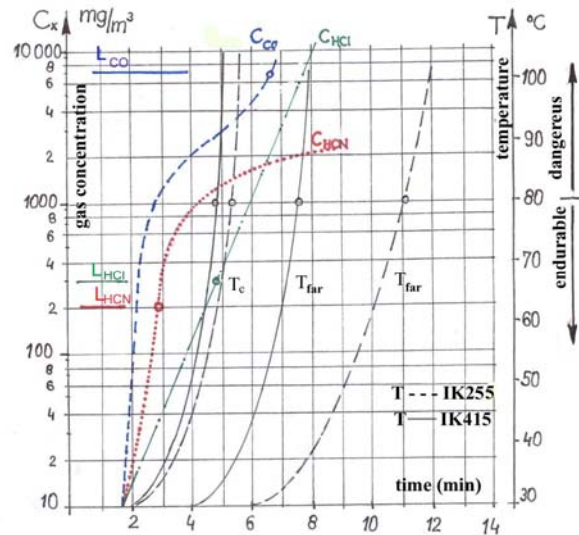
Figure 4. Increasing of temperature and poisoning gas concentrations in the bus fire.

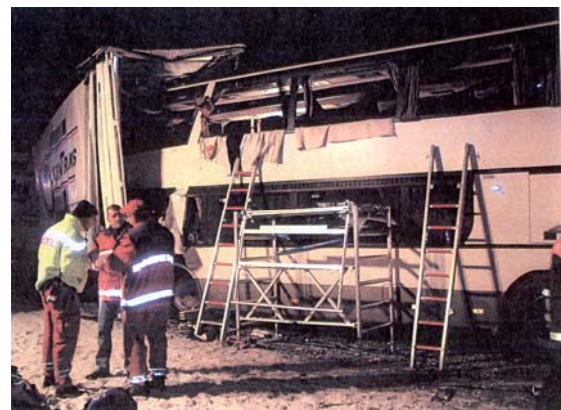
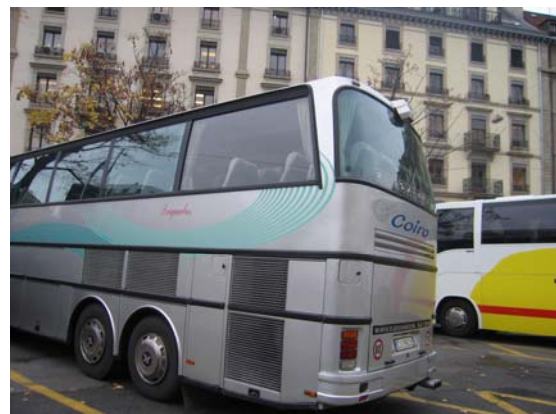
Figure 5. Usability of side emergency window

The assumption that the usability of a certain type of EE is the same in every bus categories is not true. Figure 5. shows the usability of the side emergency windows in case of double deck (DD) bus comparing the upper and lower level passenger

compartment (after a frontal collision) and also the situation on a high (but single) deck (HD) tourist coach. The side emergency window is a very useful exit in the case of the lower level of a DD bus or on low floor buses, but they cannot be used in the case of the upper level of a DD bus or on a HD coach.

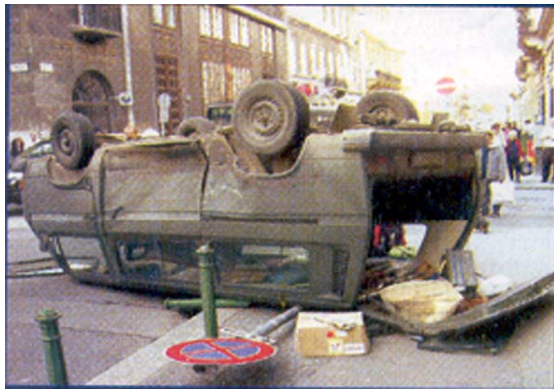
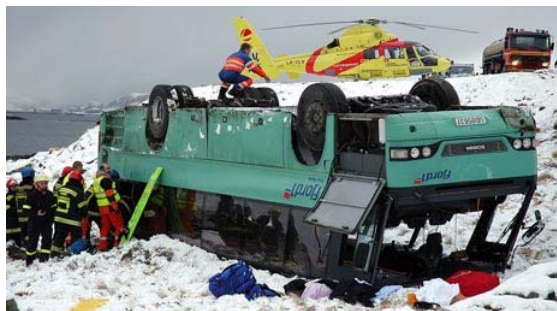
Figure 6. Usability of escape hatches (?)

The assumption that the usability of a certain type of EE is the same in different accident situation is also not true. Figure 6. shows some examples. The escape hatches are absolutely not usable when the bus is laying on its roof. The side emergency windows are well usable (on both side) in this situation in large buses, but they are almost useless in small buses. For small buses the rear wall door is very useful in this case.

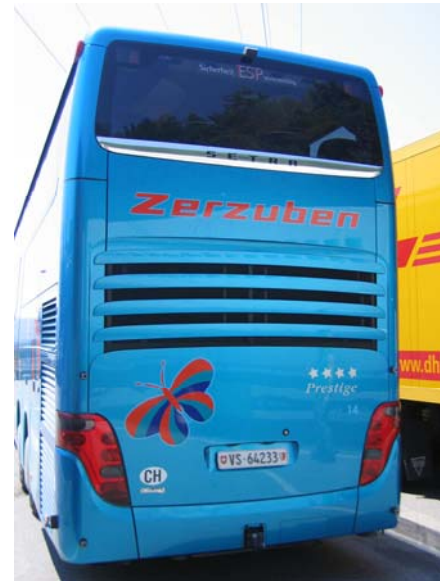
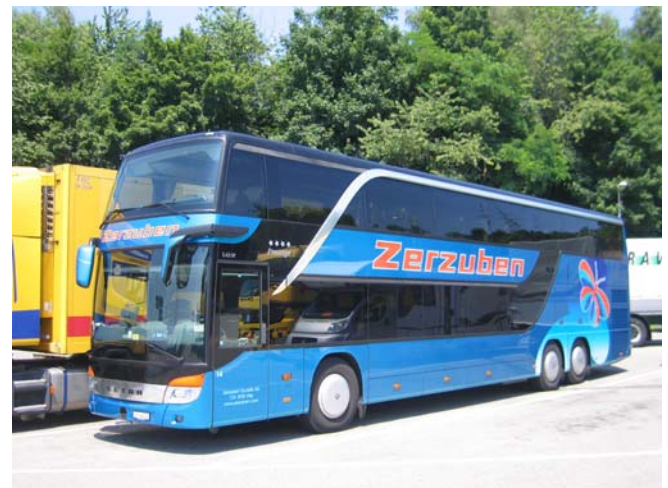
Figure 7. Different emergency exits do not have the same usability

The assumption that all kind of EE-s have the same usability (they are equivalent and replaceable) is also not valid. Figure 7. gives a very clear argument considering and comparing all the possible (and required) EE-s on DD coaches, e.g. side windows, escape hatches, rear wall window, service door and the door of the driver compartment.

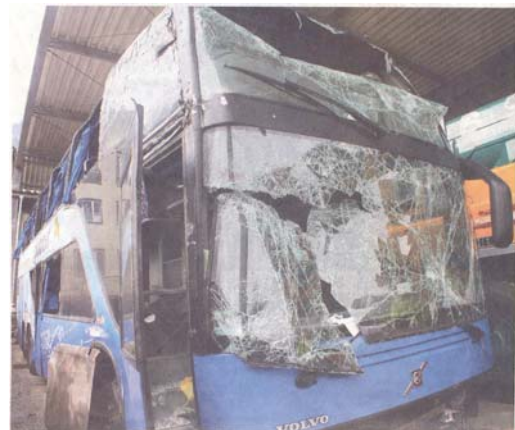
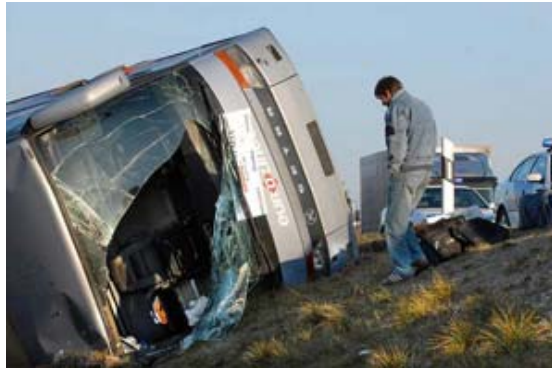
Figure 8. Using the windscreen as emergency exit by cutting it.

There is one important question to be raised. In the existing regulation the windscreen is not considered as possible EE. The reason of that is that the windcreens are made from laminated glass and therefore it is not breakable. But in the last few years a very effective new technology has been developed and already used by the firemen: to cut the laminated glass with a small (4 kg of mass) electric rescue saw. It could be placed in the driver's compartment. (similarly to the fire extinguisher) and if necessary, used by the driver. Figure 8. shows examples, when this device was used after an accident

by the fire brigade. It can be seen easily that the windscreen is one of the best, most usable EE in many accident situation, so in the future it should be considered.

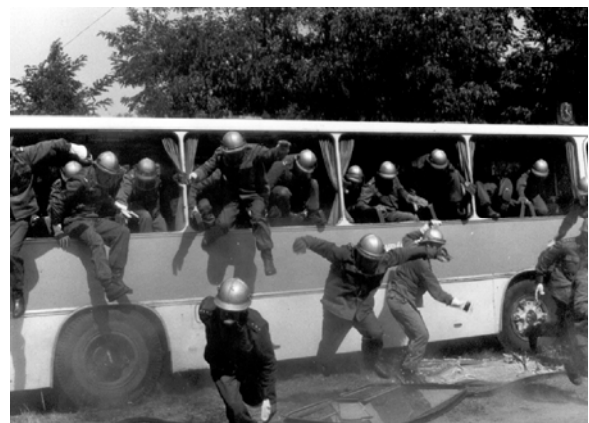
Figure 13. Evacuation tests in Hungary: service door and side window

In this last case the firemen kicked out – in the same moment – all the side windows together with the rubber mounting on both sides of the bus and jumped out through the empty window frames, see Figure 13.
