Hungary

CONCLUSIONS OF A SEVERE ACCIDENT

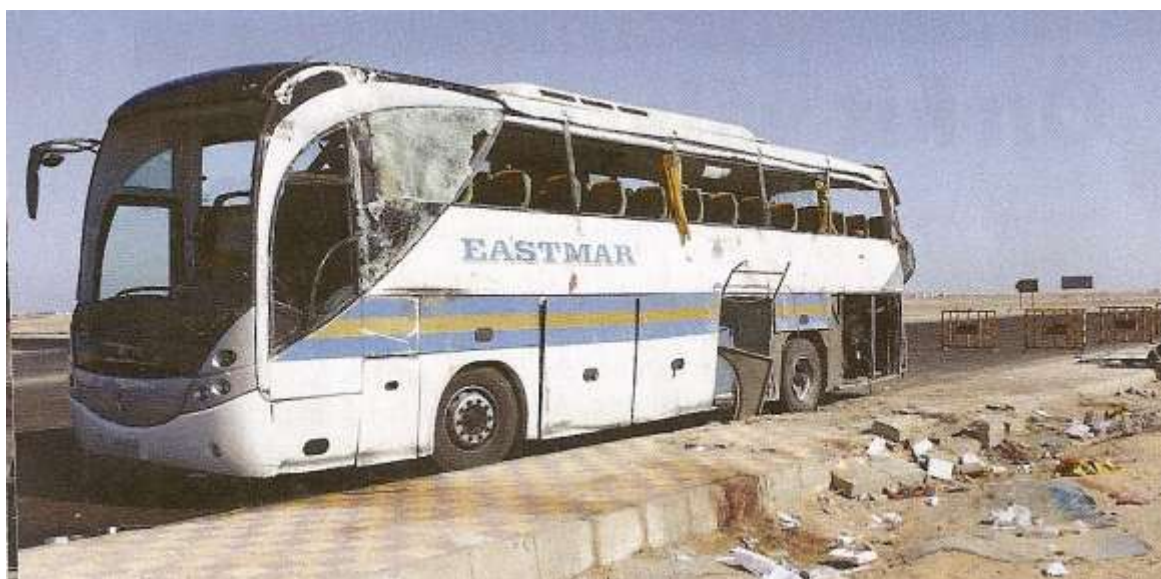
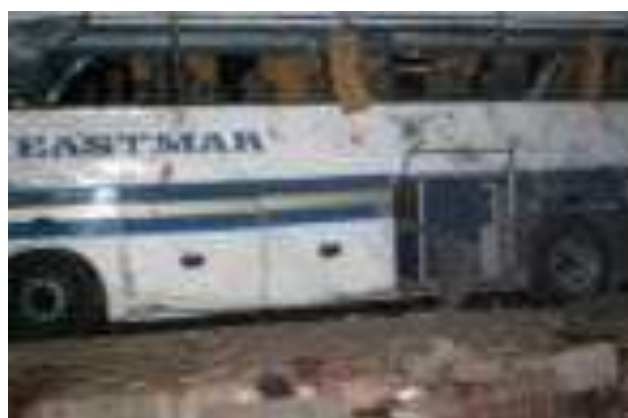
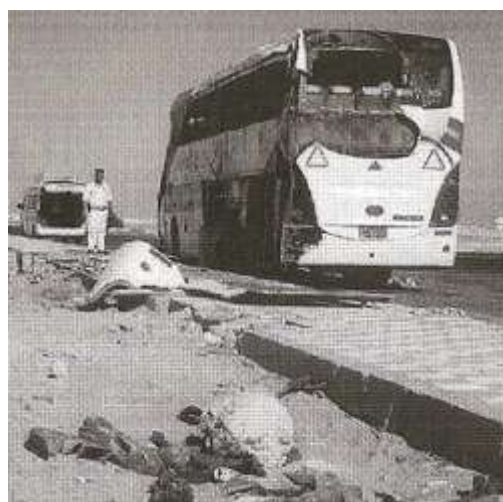
2. The superstructure was strong enough, no significant structural deformation. The casualties were caused by ejection of the passengers, mainly by partial ejection. This was said by the doctors and by the surviving passengers. All the side windows were broken, the outside panelling of the side wall and the ground was covered with blood. The surviving passengers said that all passengers fell onto the left side of the bus, compressing the people sitting next to the window to the window and to the road surface and they were ground by the broken glass fragments and by the ground.

3. The fire brigade and the ambulance people were on the scene in 20 minutes. The firemen rescue the passengers through the windscreen and the rear wall window. Escape hatches were not mentioned and from the pictures it is difficult to estimate the number and the position of this kind of emergency exits (see the long AC device on the roof). But it is clear that these injured passengers could not evacuate the bus even with the powerful help of the firemen, through the escape hatches

- 5.1. The ejection (total and partial) of the passengers in rollover accident shall be avoided, steps are needed in the regulatory work to solve this problem.

- 5.2. One good possibility is the use of the laminated safety glass as side window. It should be allowed (or required it) in buses.
 - 5.3. In the case of severe rollover accident, (many seriously injured passengers) when the bus is lying on its side, the rear wall window and the windscreen are the good emergency exits (EE) to rescue the seriously injured people.
