## **CASE STUDY 1: Gas drainage gallery (subsurface pre-drainage)**

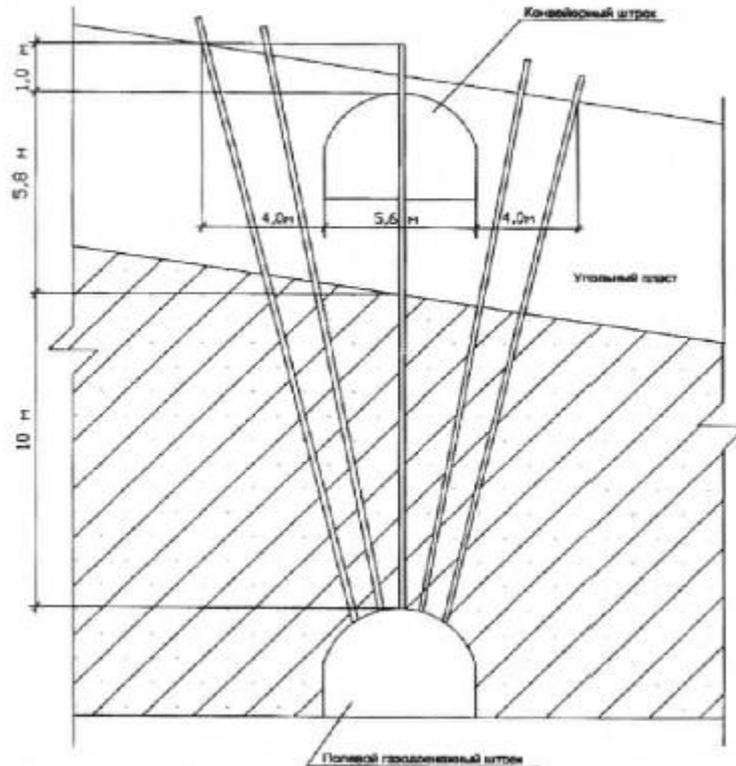
**Figure 1. Drainage gallery (pre-drainage) - Courtesy of Coal Division of AMT**

Borehole length is 17 – 19m, borehole diameter 93mm, standpipe diameter 80mm, standpipe length 12m. Standpipe is said to be sealed by synthetic resin. The final section of the borehole is cased with perforated pipe (dia. 80mm). The span of borehole fan is 4m. The boreholes are connected via 2“ rubber hose to pipe manifold that is linked with a rubber hose to the reticulation system. There is no regulation valve at the borehole valve, at some boreholes simple „valve“ is stabbed in the hose for gas sampling. Flow rate is measured in the orifice meter installed in the pipeline for the whole gallery. Methane concentration is less than 20%. Boreholes must be ready for gas drainage more than 3 months before the start of the longwall face. The boreholes are disconnected just after the passage of the longwall face. The gallery is supported with steel arches and steel bolts.

There was a decision made to implement a new drainage method: another roadway was built under the gassy seam and boreholes drilled from there towards D6 with a purpose to drain gas downwards from the coal face just before the front abutment, where the strata becomes de-stressed. Thus a certain efficiency of pre-drainage was reached. A headway (gallery, width of 5,7m) driven in the floor rocks 10 meters below the mined coal seam along the future longwall gate. The gallery is set up only for drilling of the fans of five up-holes (see the Figure 1 below). After the passage of the longwall face the roof is deformed, the support is left in place, the access is prohibited.
