A Discussion on Rear Underride Protection in Canada

Denis Boucher and Daniel B.T. Davis
Road Safety and Motor Vehicle Regulation Directorate, Transport Canada

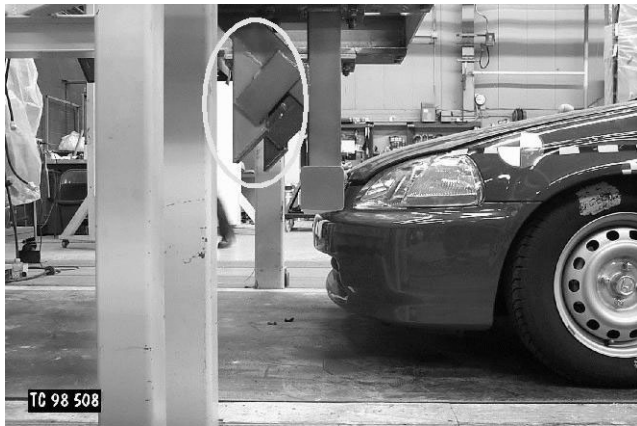
Figure 1. Detail of displacement limiting device on DLG

480 mm DLG, 65 km/h - For this test only, a 25 mm solid square rod was welded behind each of the stoppers, between the stopper itself and the concrete barrier at the rear. This was done to prevent any movement of the stopper during the crash. The 480 mm DLG provided much better protection to the passenger compartment of the Chevrolet Cavalier than the 480 mm guard did; there was no contact between the structure and the vehicle or windshield. Some damage was evident inside the passenger compartment on the driver side, but none on the passenger side.

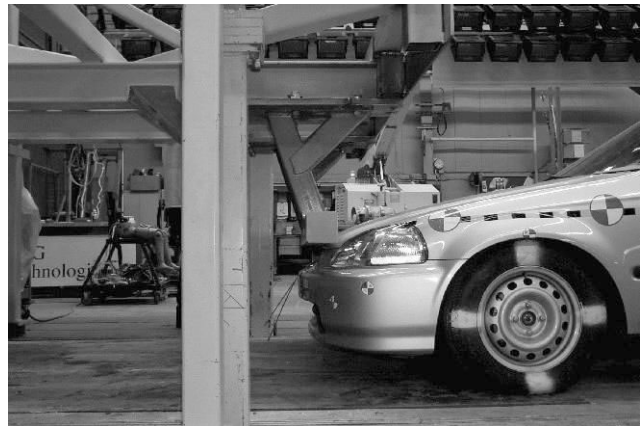
Figure 2. Close-up of SSG

560 mm SSG, 48 km/h - The test with the 560 mm SSG was performed at 48 km/h since no previous quasi-static or dynamic testing had been performed with this guard; the guard designer originally believed that the guard could withstand 320 kN but, when tested in the full-width test, it could only withstand 287 kN. The 560 mm SSG provided good protection to the passenger compartment; there were no contact between the structure and the vehicle or windshield (see Figure 11). There was no visible damage to the passenger compartment. The post-test ground clearance of the guard was 600 mm. Close examination of the guard after the test revealed that it had moved more than the expected 125 mm in the longitudinal direction. Also, the guard had rotated such that it was now resting on the vehicle structure; it is doubtful that this guard could have provided acceptable passenger compartment protection at a speed of 56 km/h (36% more kinetic energy at the beginning of the crash).

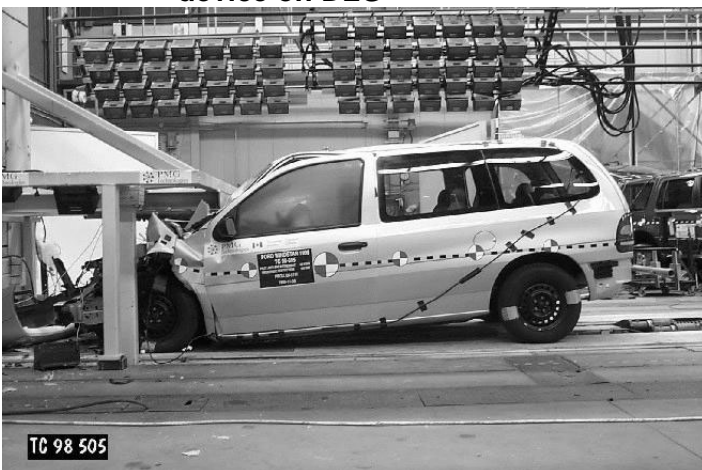
Figure 3. Ford Windstar, 560 mm MCG, 48 km/h

Ford Windstar - The 560 mm MCG provided good protection to the passenger compartment of the Windstar and there was very little damage inside the passenger compartment. This test demonstrated that a minimally complying guard could offer good protection to occupants of a minivan in a collision at 48 km/h. Figure 3 shows the Windstar in the post-test condition.

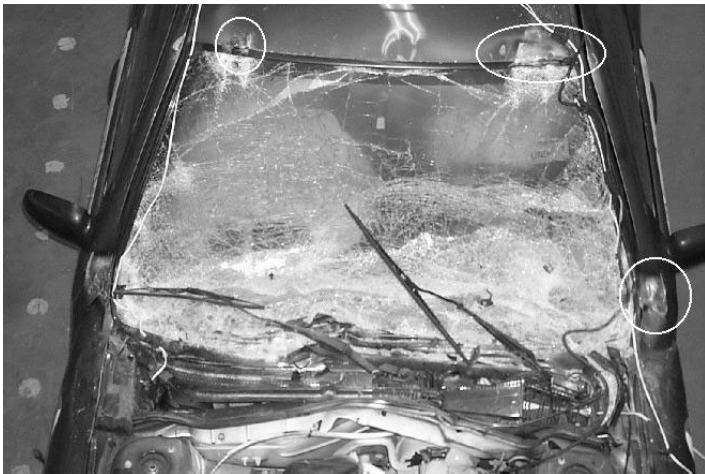
Figure 4. Exterior damage to Chevrolet Cavalier, 560 mm MCG, 48 km/h

560 mm MCG, 48 km/h - The 560 mm MCG did not provide good protection to the passenger compartment; the guard contacted and deformed the A-pillar on the drivers-side. The test structure came in contact with the top of the windshield (see Figures 4 and 5). Also, the steering wheel was displaced downward, pinching the lead bags used as weight between its rim and the seat.

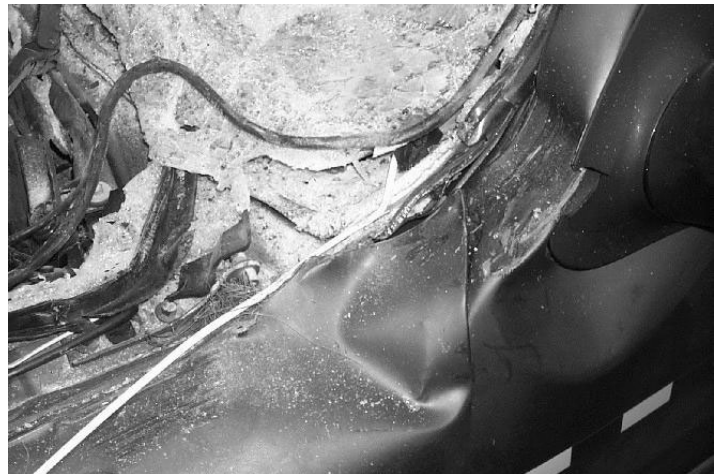
Figure 5. Detail of damage to A-pillar, Chevrolet Cavalier, 560 mm MCG, 48 km/h

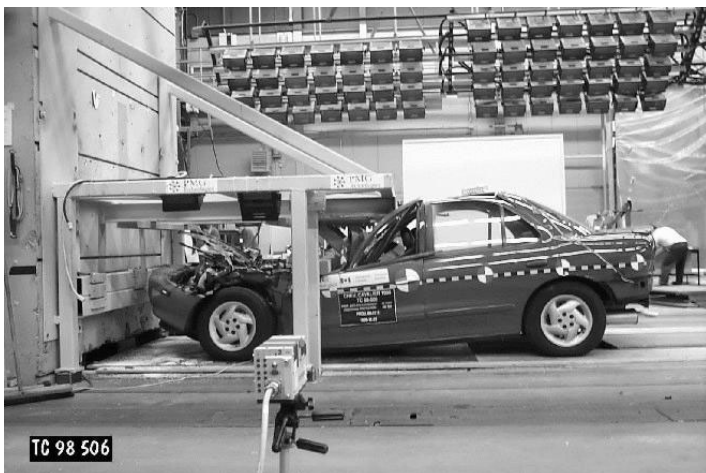
Figure 6. Chevrolet Cavalier, 480 mm MCG, 65 km/h

480 mm MCG, 65 km/h - The 480 mm MCG did not provide good protection to the passenger compartment of the Cavalier in the test at 65 km/h. The vehicle came to rest only after undergoing severe intrusion and extensive deformation of the A pillars (see Figures 6 and 7).

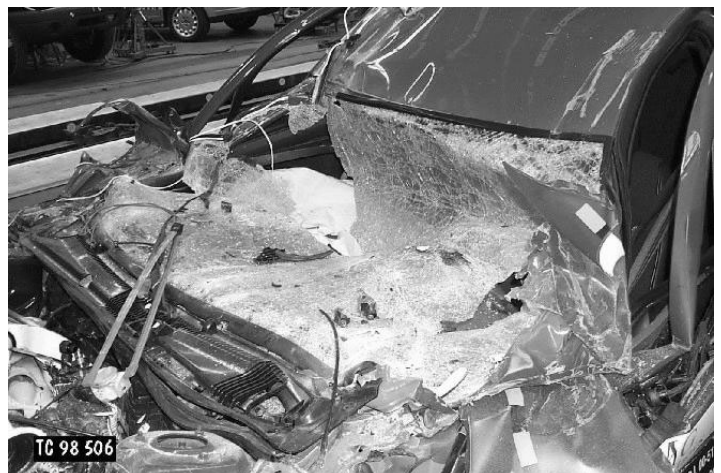
Figure 7. Details of damage to A-Pillar, Chevrolet Cavalier, 480 mm MCG, 65 km/h

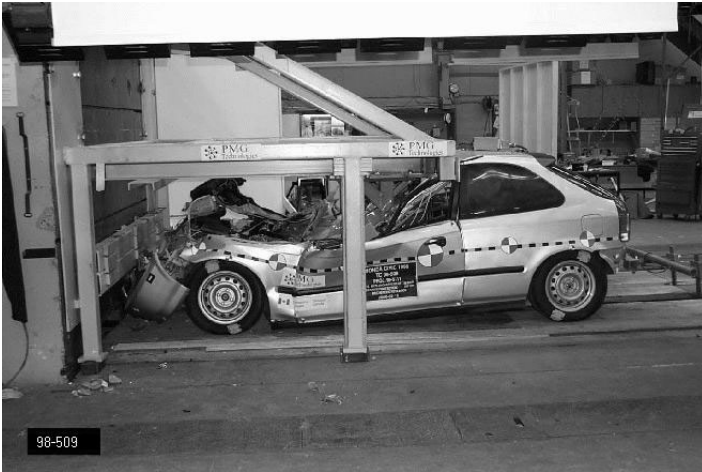
Figure 8. Honda Civic, 560 MCG, 56 km/h

560 mm MCG, 56 km/h - The 560 mm MCG failed to stop the Honda Civic before it collided with the concrete wall supporting the structure. The Civic was travelling at approximately 22 km/h when it struck the concrete barrier. This barrier is located approximately 2.4 m from the rearmost surface of the structure. The post-test ground clearance of the guard was 660 mm. The necks of both ATDs were damaged beyond repairs. Damage to the passenger compartment was severe; the roof was pushed down by the underside of the structure (see Figures 8 and 9).

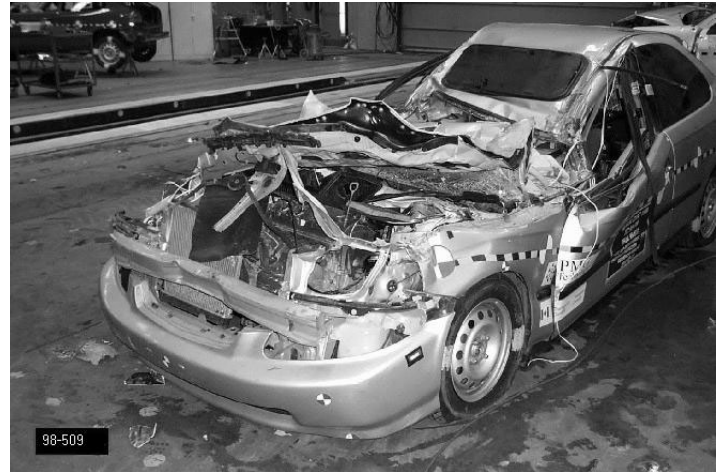
Figure 9. Front View, Honda Civic, 560 MCG, 56 km/h

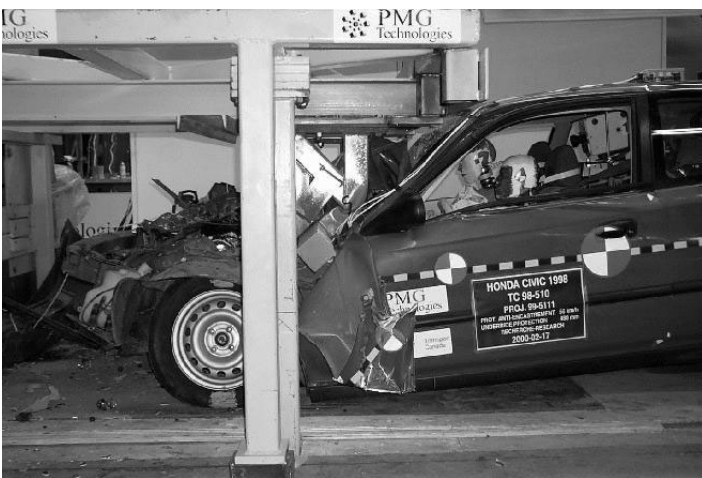
Figure 10. Honda Civic, 480 mm DLG, 56 km/h

480 mm DLG, 56 km/h - The 480 mm DLG provided good protection to the passenger compartment. There was little or no contact between the structure and the vehicle or windshield (see Figure 10). There was no visible damage to the passenger compartment. The post-test ground clearance of the guard was 555 mm.

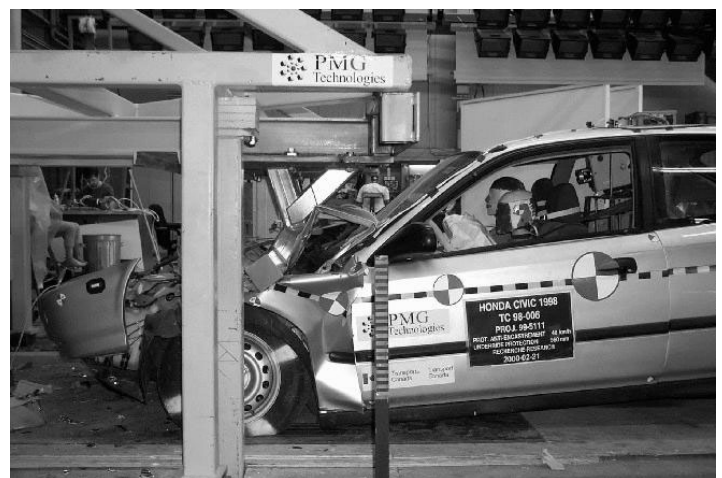
Figure 11. Honda Civic, 560 mm SSG, 48 km/h

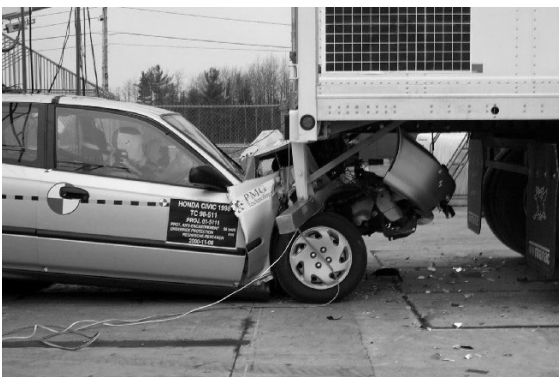
Figure 14. Honda Civic, Manac Guard, 56 km/h

The crash speed was 56.5 km/h; under the impact the tractor-trailer combination vehicle moved forward a distance of 185 mm, despite the fact that the tractor and trailer parking brake had been set. There was no contact between the trailer frame and the Honda Civic and the damage inside the passenger compartment was minimal (see figures 14 and 15). The maximum vehicle deceleration was 24.3 G.

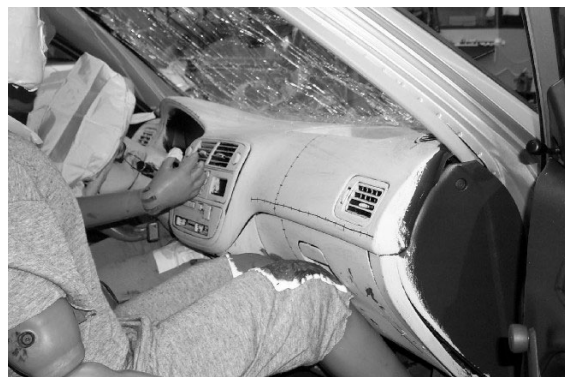
Figure 15. Passenger compartment damage, Honda Civic, Manac Guard, 56 km/h
