## Analysis of accident statistics:

**Accidents with injured truck driver  
all Volvo cabs- all pendulum tested  
455**

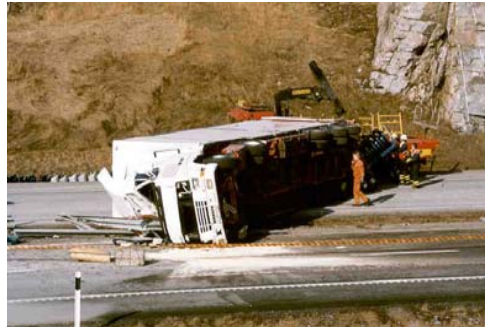
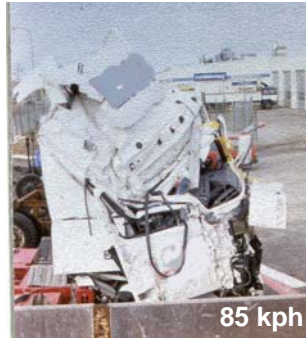
# Deformation of cab in single vehicle accidents- some severe examples:

Rollover+ collision with guard rail

Mainly as a result of impact against ground, earthen bank, guard rail, rock, tree, etc. after the rollover there is a deformation of upper a-pillar in 39% of the single vehicle accidents, i.e. 21% of all accidents in sample.

> Longitudinal strength in roof structure and upper a-pillar is needed to protect driver in a single vehicle accident.

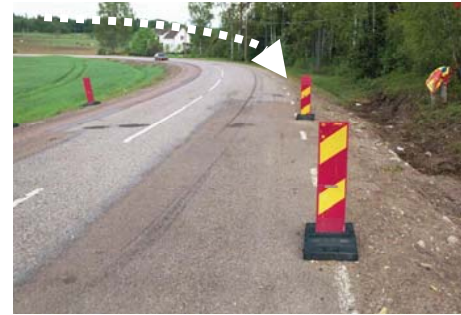
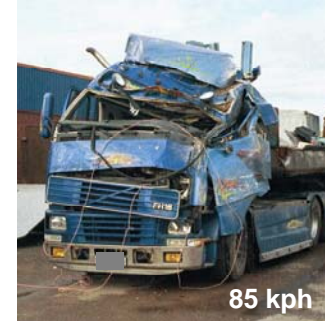
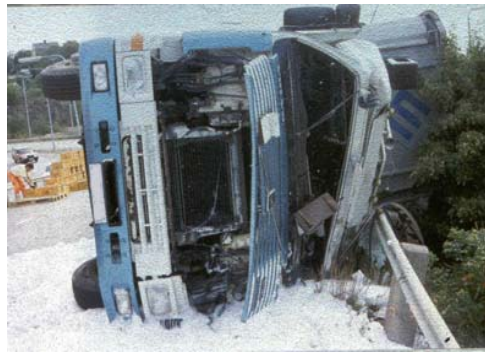
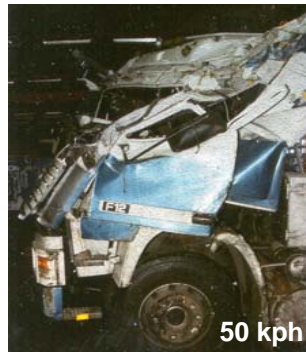
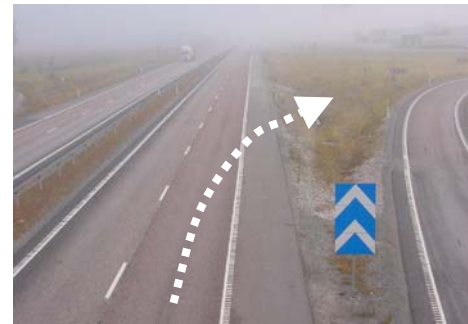
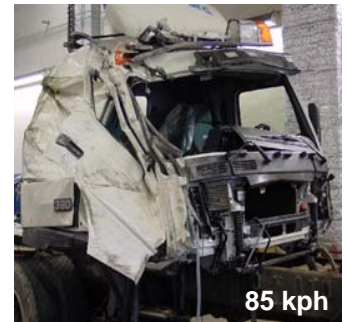
Rollover+ collision with earthen bank

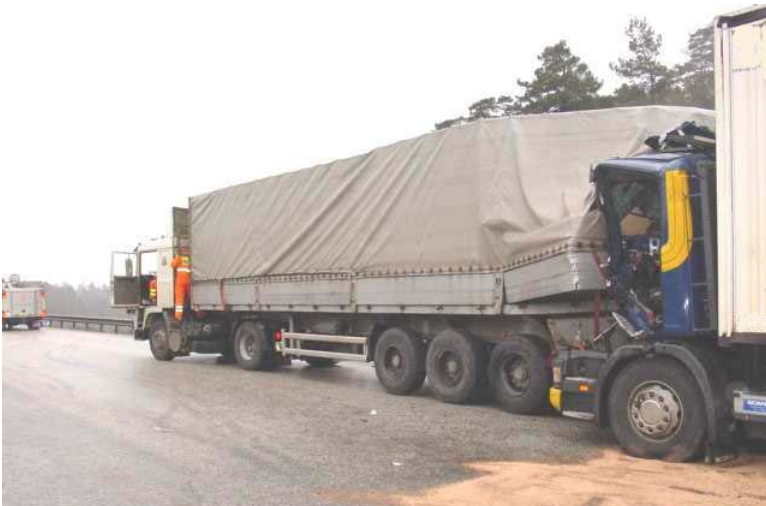
## Deformation of cab in truck to truck collisions- severe example:

Collision truck front vs truck rear

42% of the accidents resulting in truck driver injuries are collisions. There is a deformation of upper a-pillar in 39% of all collisions, i.e. 16% of all accidents in database.

This deformation is in most cases a result of the 1st collision to other vehicle. In only 6 of the car truck collisions with deformed a-pillar, the deformation is a result of impact against ground after a rollover, i.e. ~1% of all accidents in sample.

> Longitudinal strength in roof structure and upper a-pillar is needed to protect driver in a collision.
