How should signs warn of ruts?

Information for
UNECE Expert Group
on Road Signs and Signals
M. Pronin, 31 May-1 June '18, Geneva

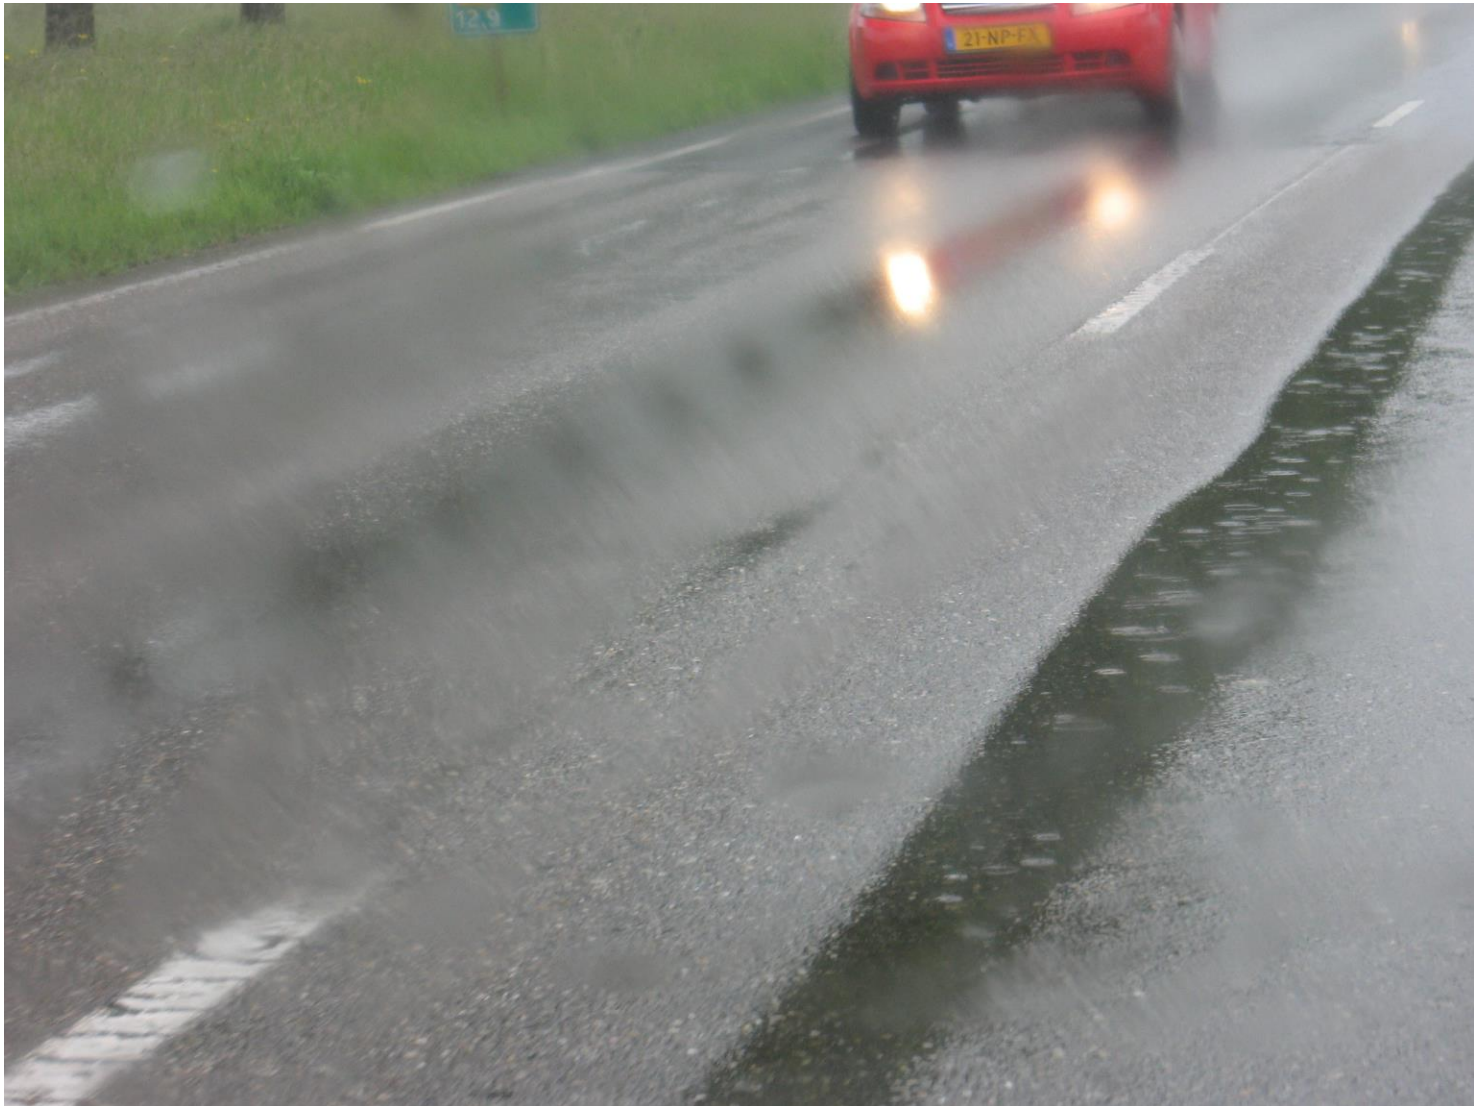
Water-filled Ruts – Danger of Hydroplaning

Courtesy of © M.M. Minderhoud. N57 Motorway, Netherlands. "Spoorvorming." 2007.

- ✧ When it rains, one wet rut and one dry rut may propel a vehicle out of its lane.
- ✧ When both ruts fill with water, vehicles may hydroplane (total loss of traction leading to loss of vehicle control).
- ✧ On wet rutted roads, turning and changing lanes are especially unsafe.
- ✧ Rut length varies from a few hundred meters to hundreds of kilometers.

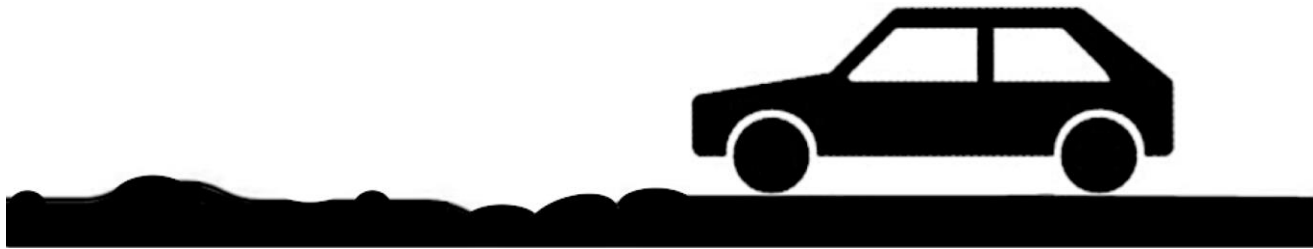
Bumpy road

These road surfaces are uneven, but each in different ways.

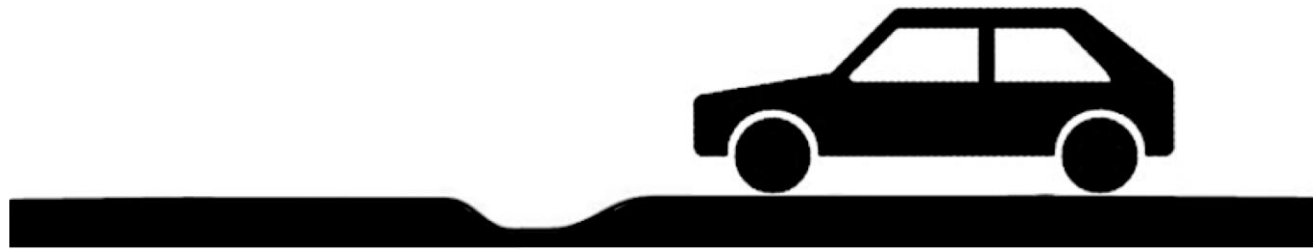
Lateral depression

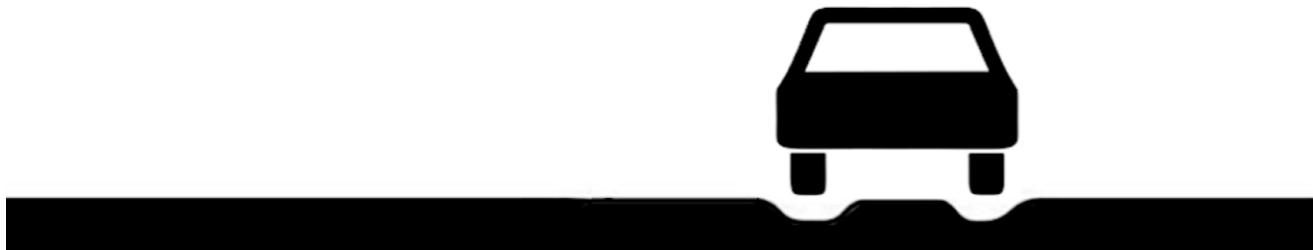
Longitudinal rut or ruts

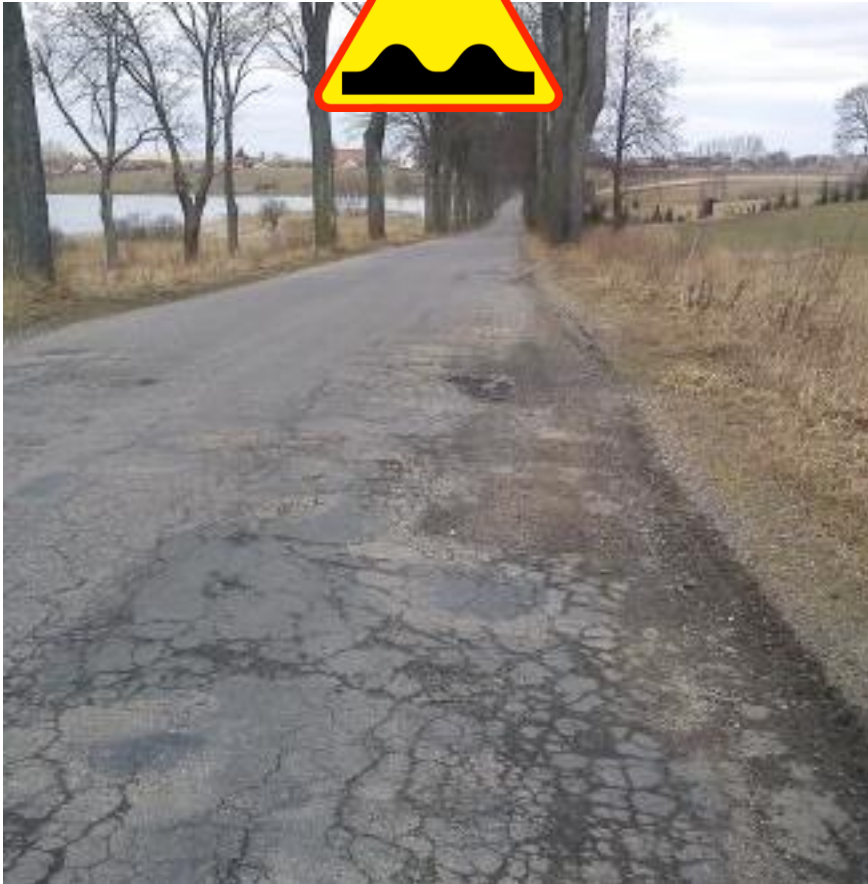
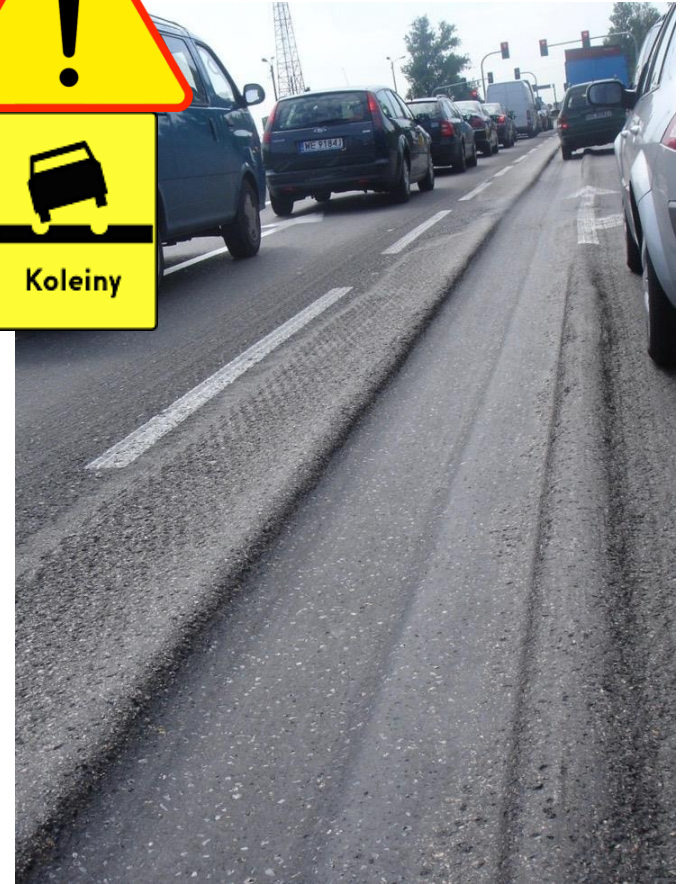
How Poland interprets uneven road vs. ruts.

On left: rough road surface, potholes, and/or natural humps. On right: lengthy longitudinal depressions.

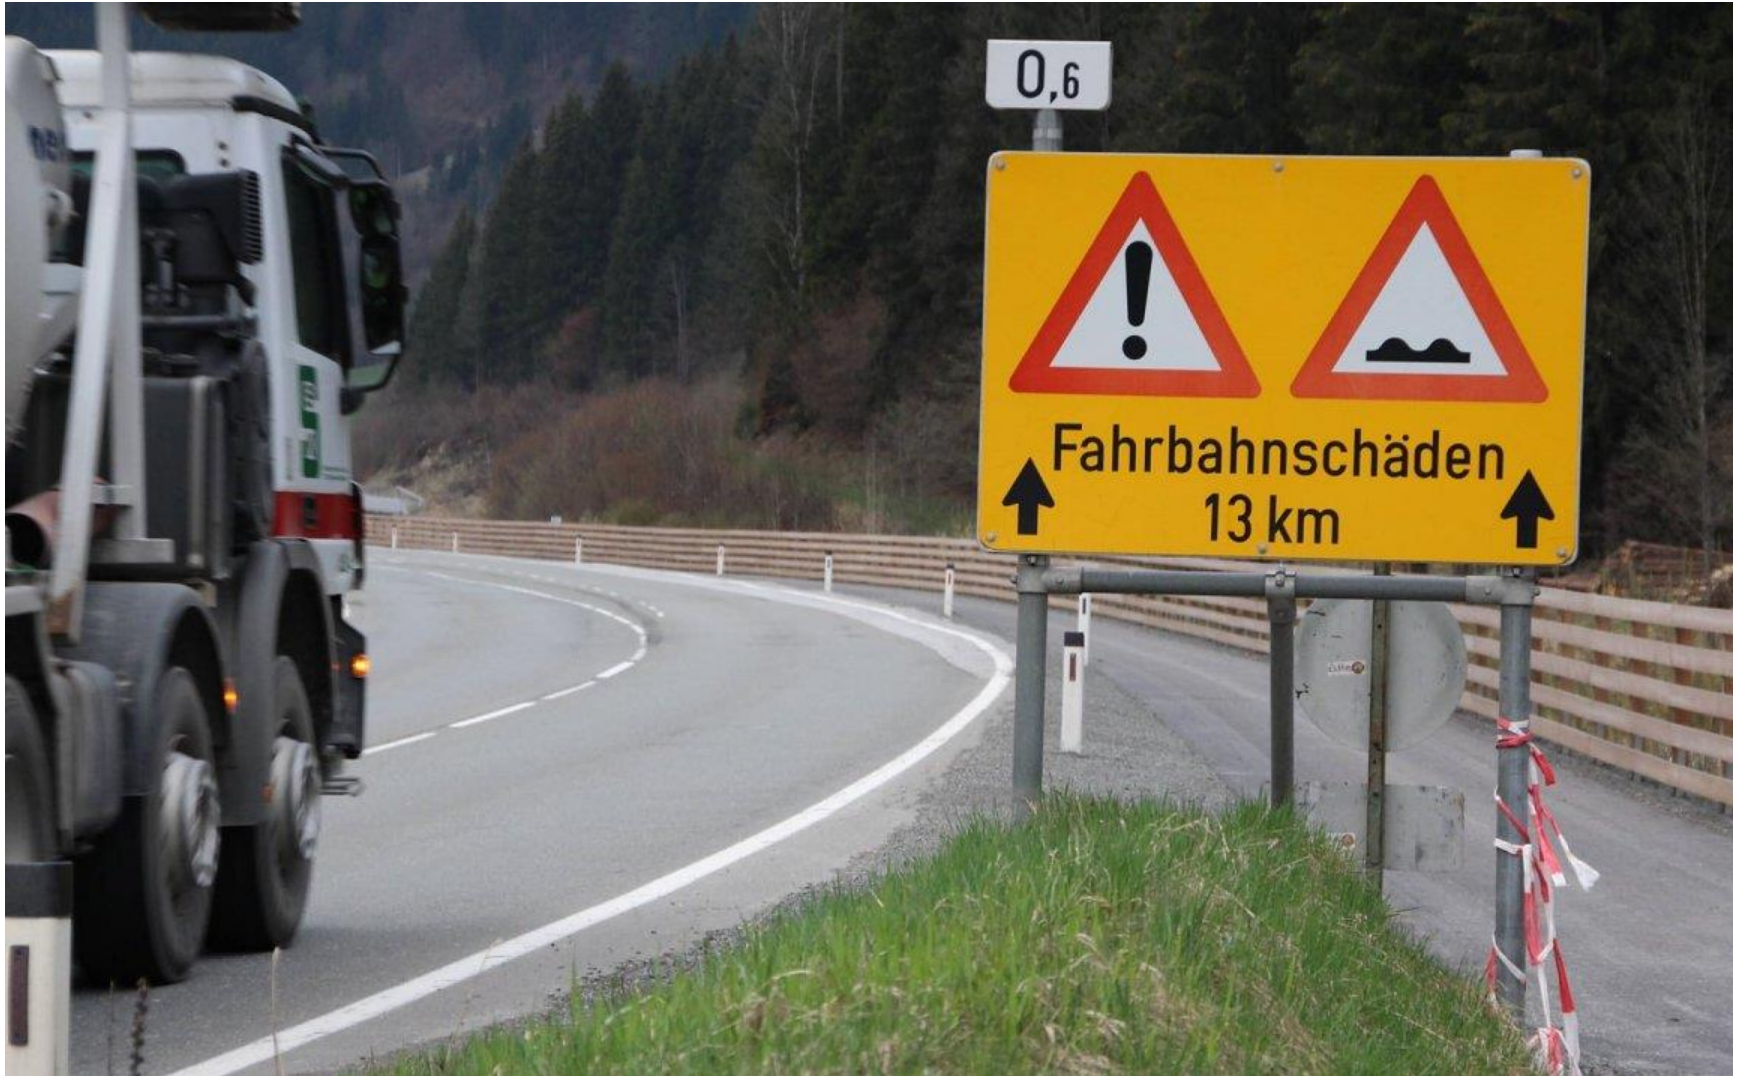
© Salzburger Nachrichten, Damaged road. [Warning sign points to kilometers of ruts.] Salzburg, Austria, 2016.

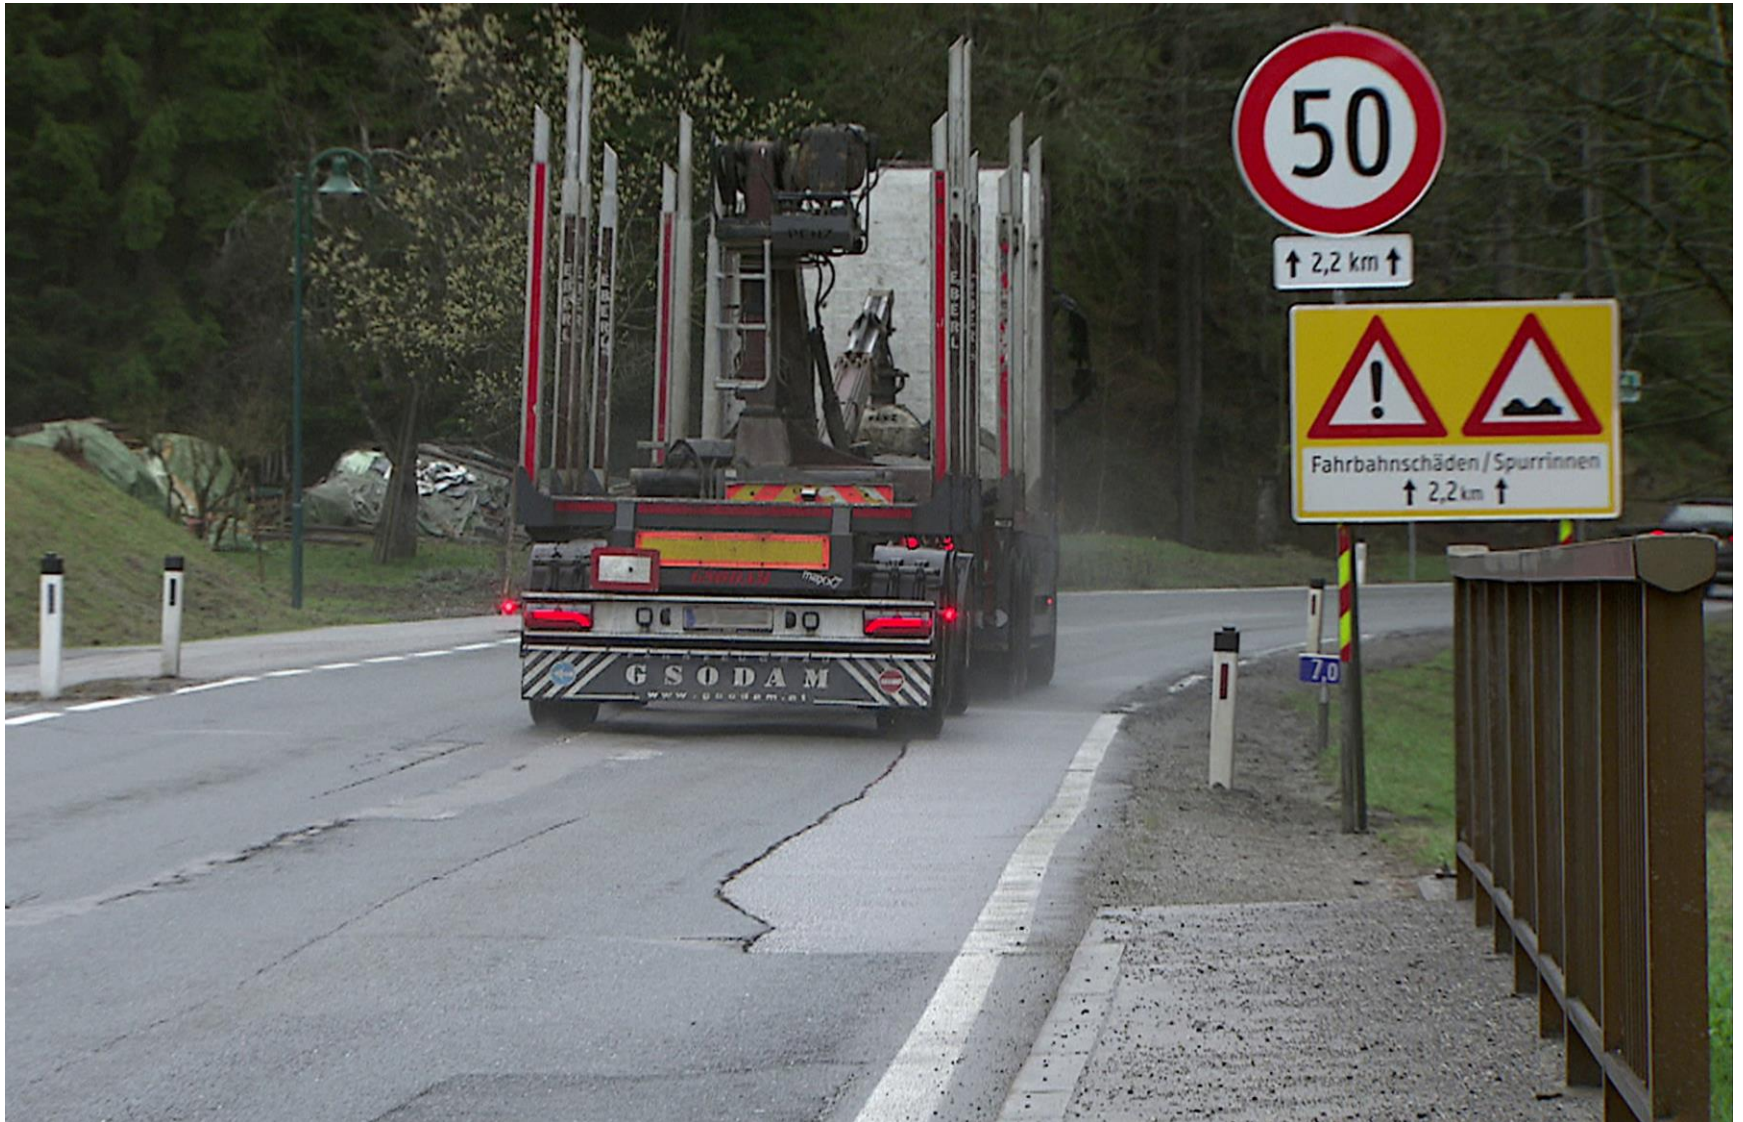
Courtesy of © ORF, Ruts: 50 km / h instead of repair. Annaberg-Lungötz, Austria, 2017. Photo cropped.

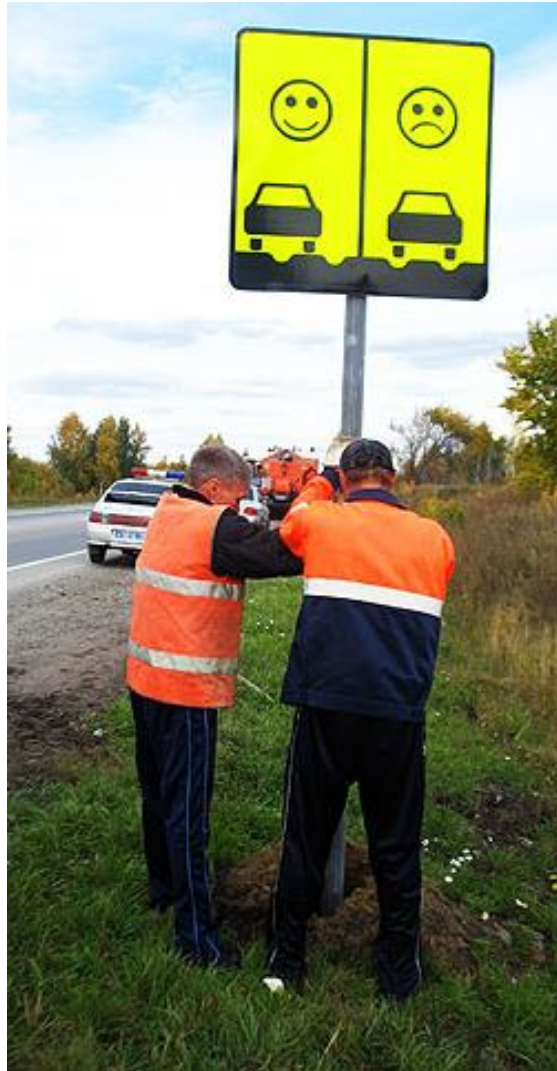
✧ To prolong the life of the road, an experiment in 2010 advises drivers not to drive in the ruts.

✧ New signs, shown on the next slide, with an altered symbol, appear in 2015.

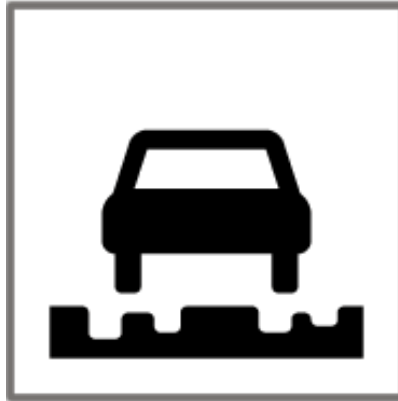
Mr. Egger's Symbol

✧ Because rutted roads differ in number of ruts (one or more), width and depth of ruts, and presence or absence of longitudinal humps, one symbol cannot accurately depict the rut pattern for all roads.
