Road Infrastructure in Bosnia and Herzegovina in the Aftermath of the May 2014 Floods

June 2014

Global Aftermath of the May 2014 Floods

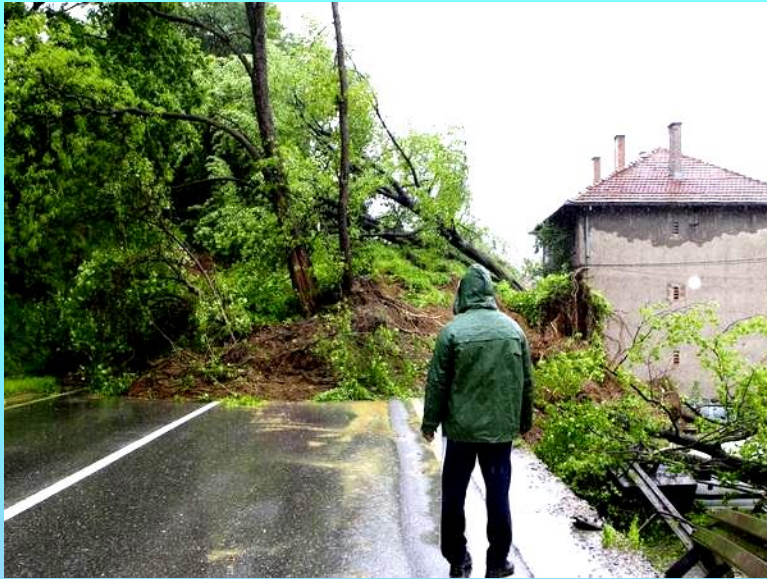
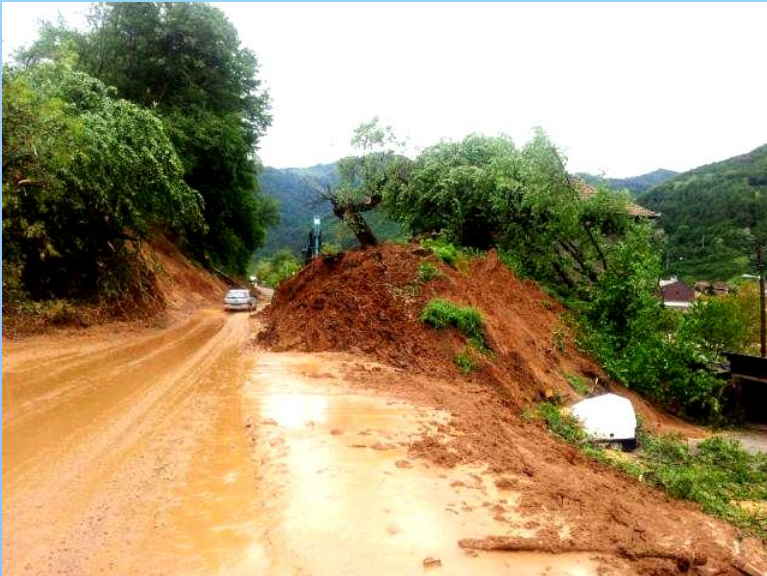
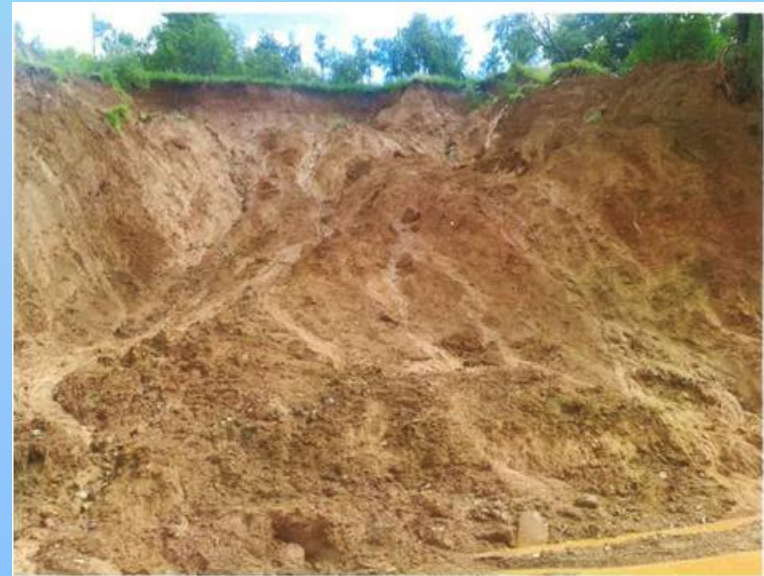
Nemila, M17, Topčič Polje, Lašva km 3+880

- Landslide from slope 20 meters above the finished road level,
- Earth material constantly falling on the carriageway.

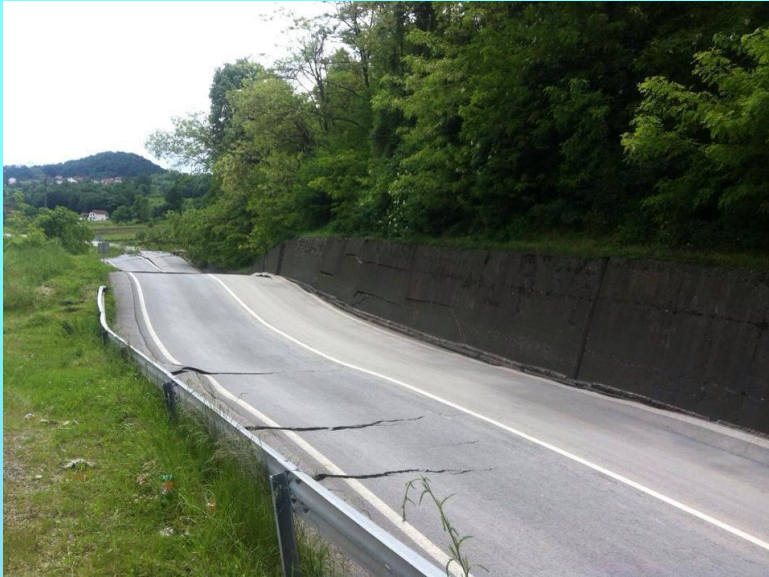
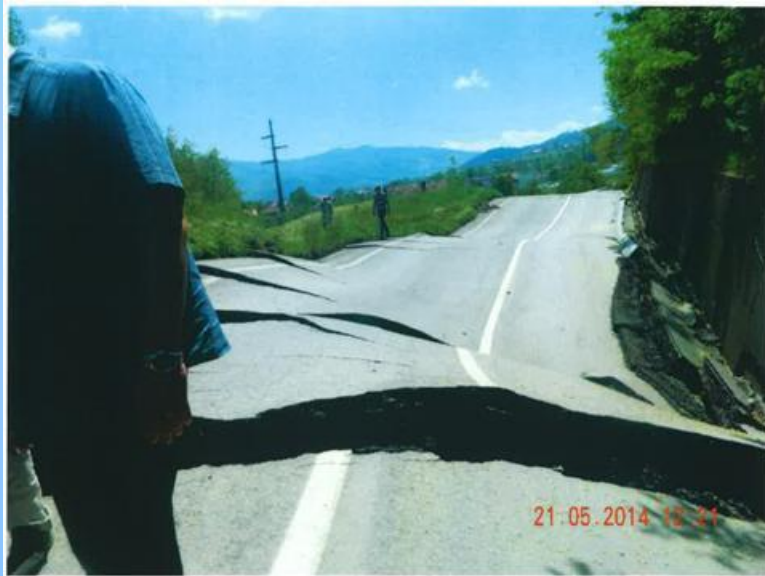
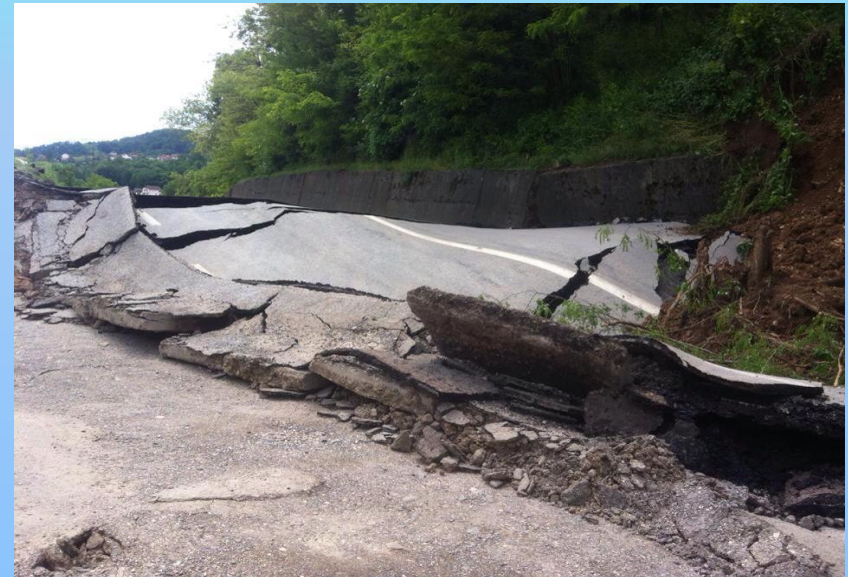
Kosova, M17, Karuše – Ozimica km 9+050-9+270

- Landslide approx. 300 meters above the finished road level,
- Movement of the entire hill,
- 200 meters of road totally destroyed.

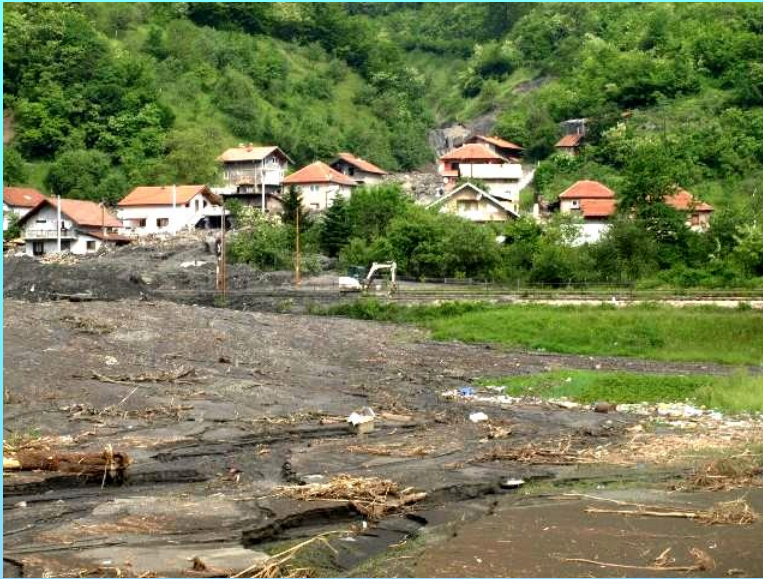
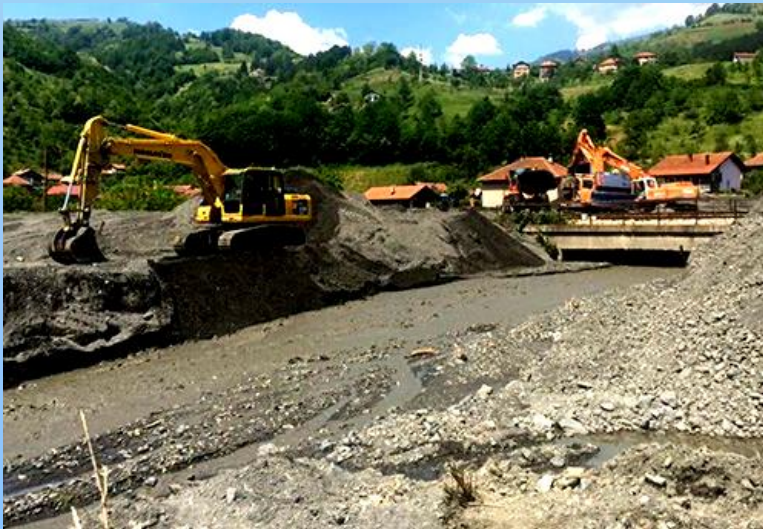
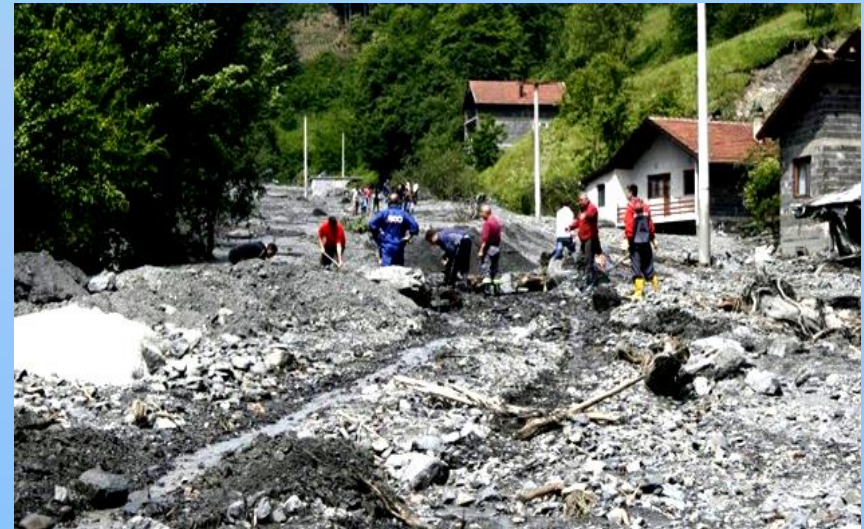
Topčič Polje, M17, Topčič Polje – Lašva km 1+600,

- Runoff of large quantities of water,
- Runoff of large quantities of silt,
- Water constantly covering the carriageway,
- Regional road R465 also covered.

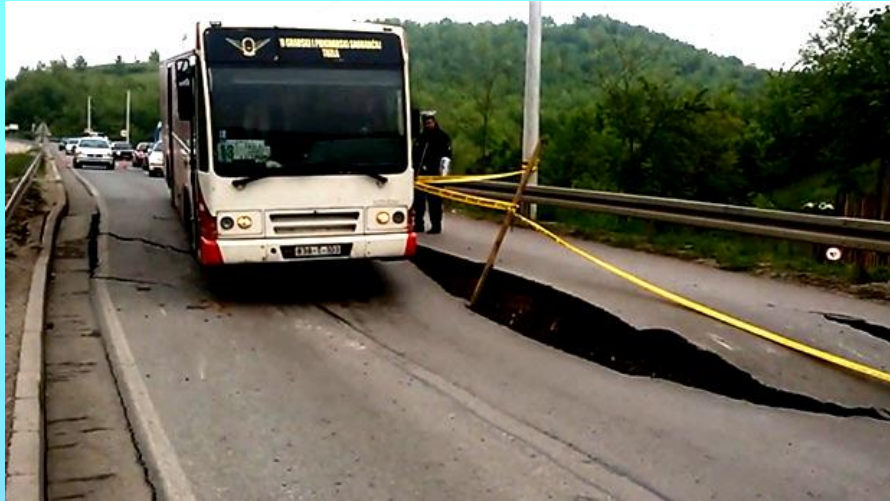
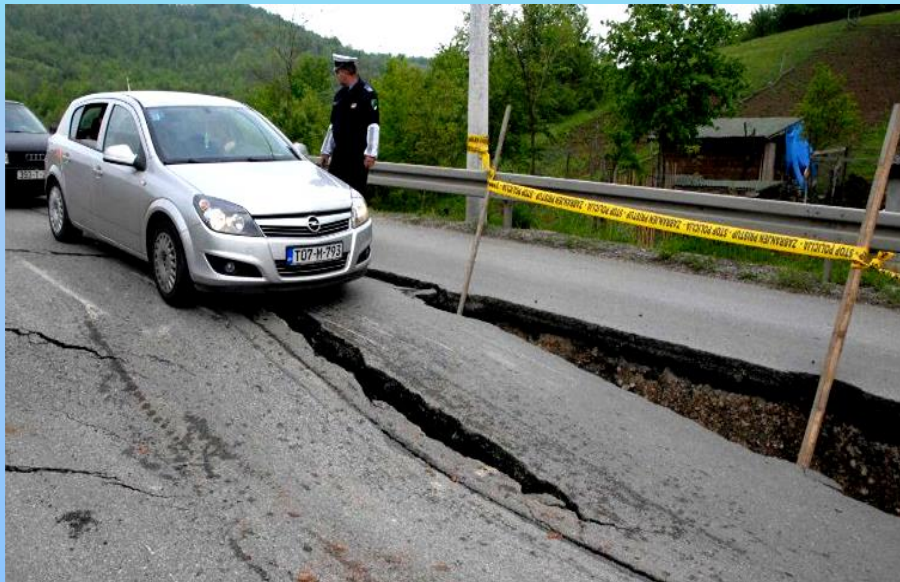
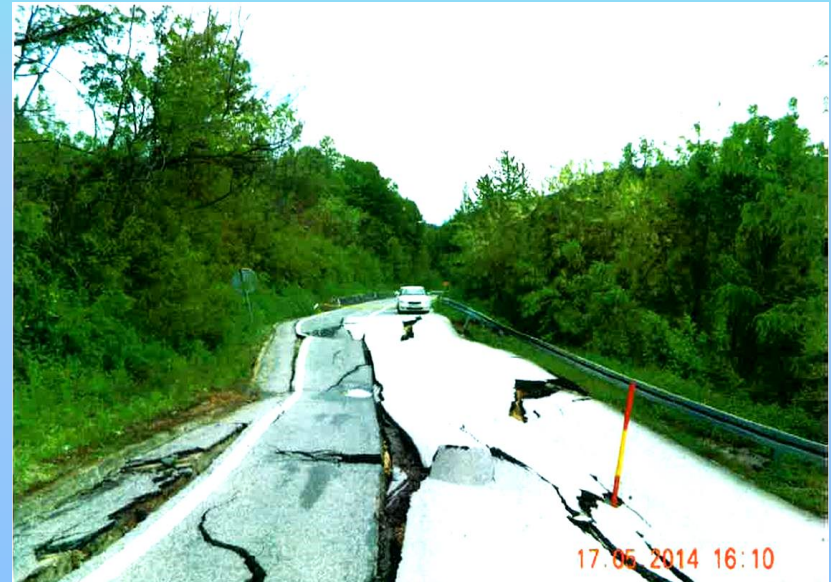
Priboj – Simin Han km 14+420 – 14+650

- Landslide below and above the finished road level,
- Total destruction of the road base,
- Mined area.

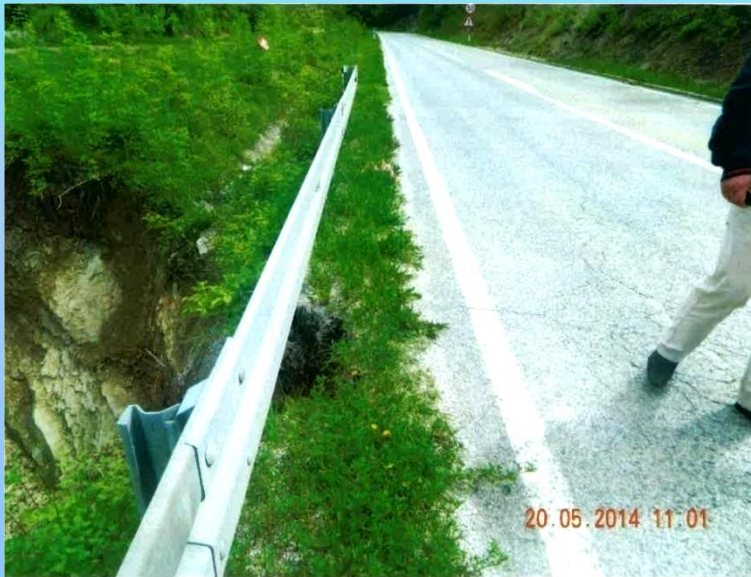
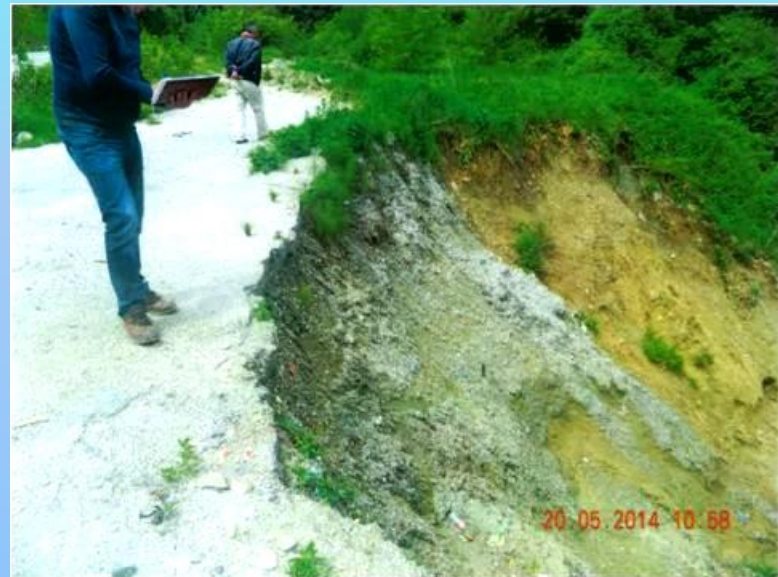
M18, Priboj – Simin Han km 11+900 – 12+100

- Landslide below the finished road level,
- Carriageway collapsed,
- Mined area.

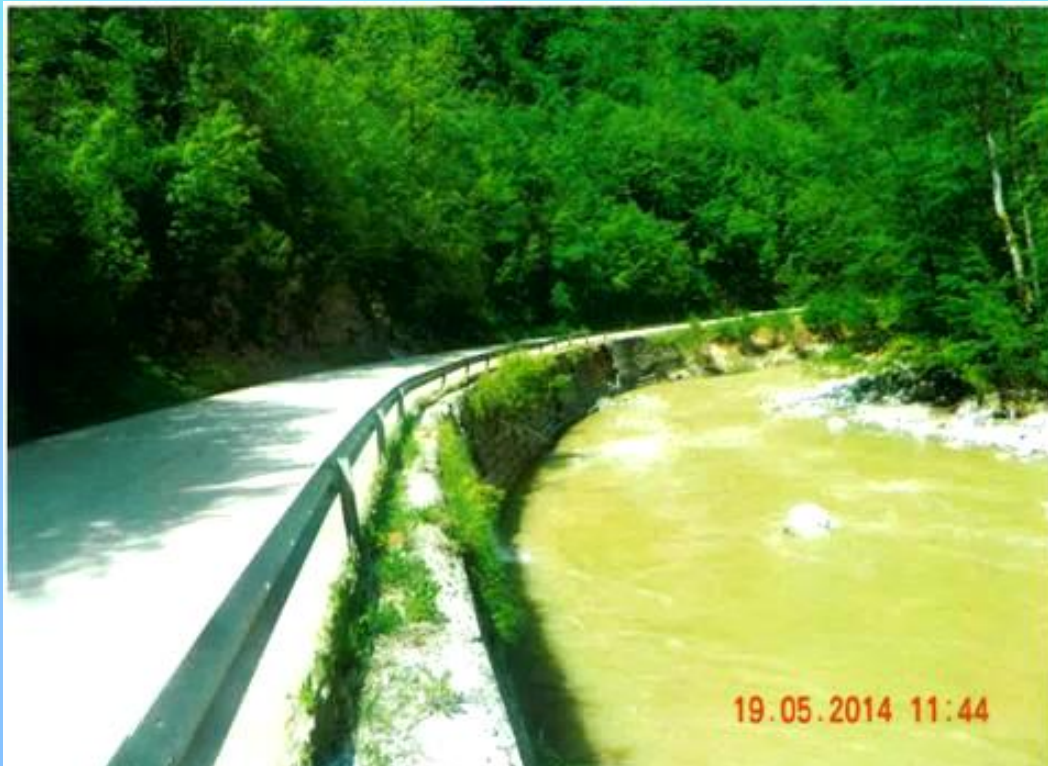
M18, channel of the Drinjača River, Kladanj – Vlasenica, km 6+500 – 11+500

- Water caused damage to walls and embankment slopes below the finished road level,
- Individual areas,
- Approx. 500 meters in length.

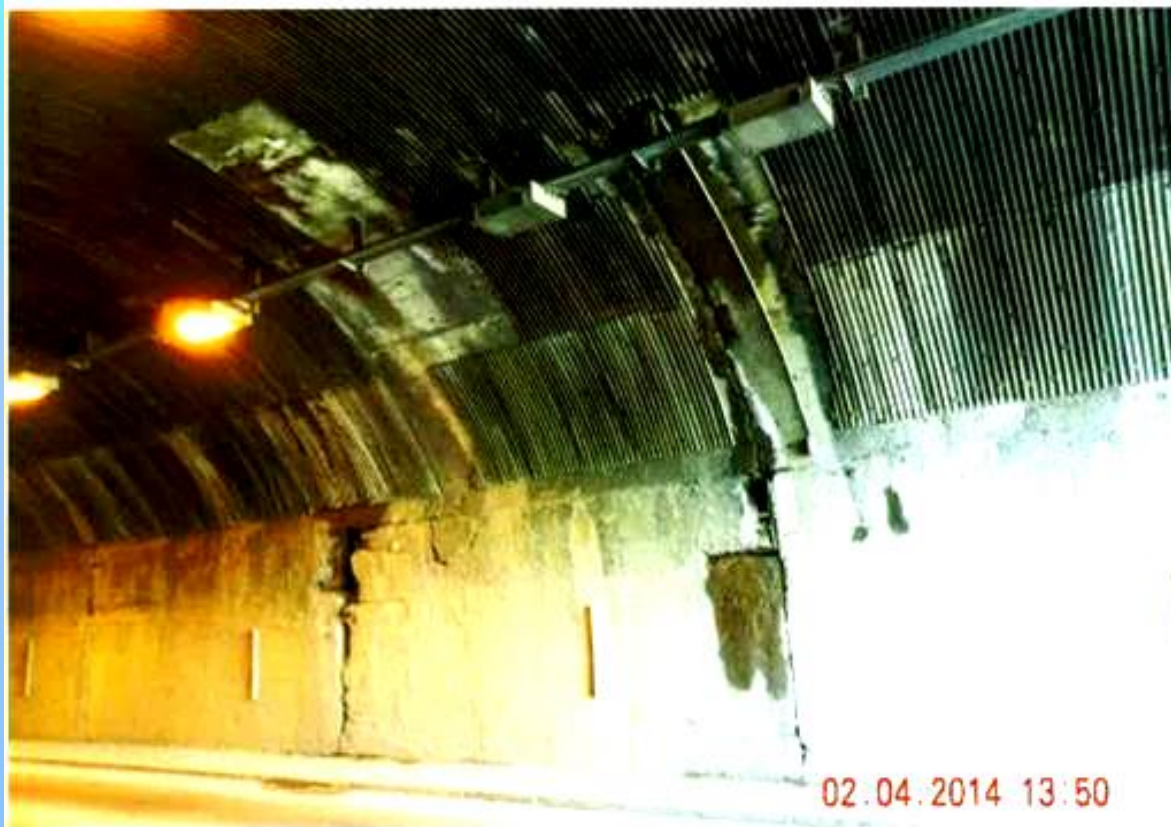
Site: M1.8, channel of the Drinjača River, Pelagićevo – Srebrenik km 16+210

- Leakage through tunnel lining,
- Tunnel tube deformation,
- Risk of the entire tunnel profile collapsing.

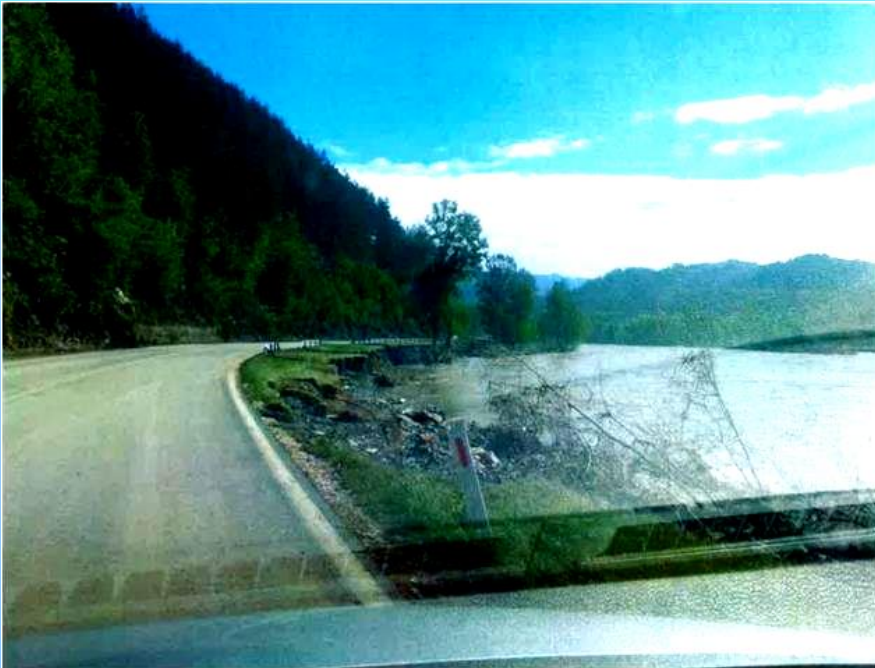
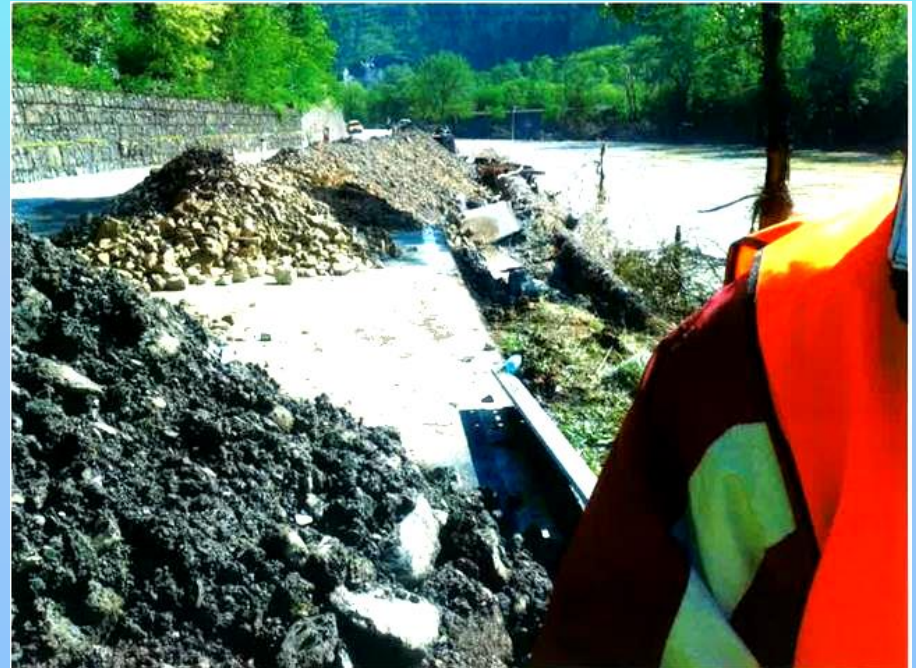
Site: M17, channel of the Bosna River, Karuše – Ozimica, km 16+600 and 15+750

- **Damage to the road embankment,**
- **Erosion of the embankment and narrowing of the bank revetment,**
- **Risk of the entire road base collapsing.**

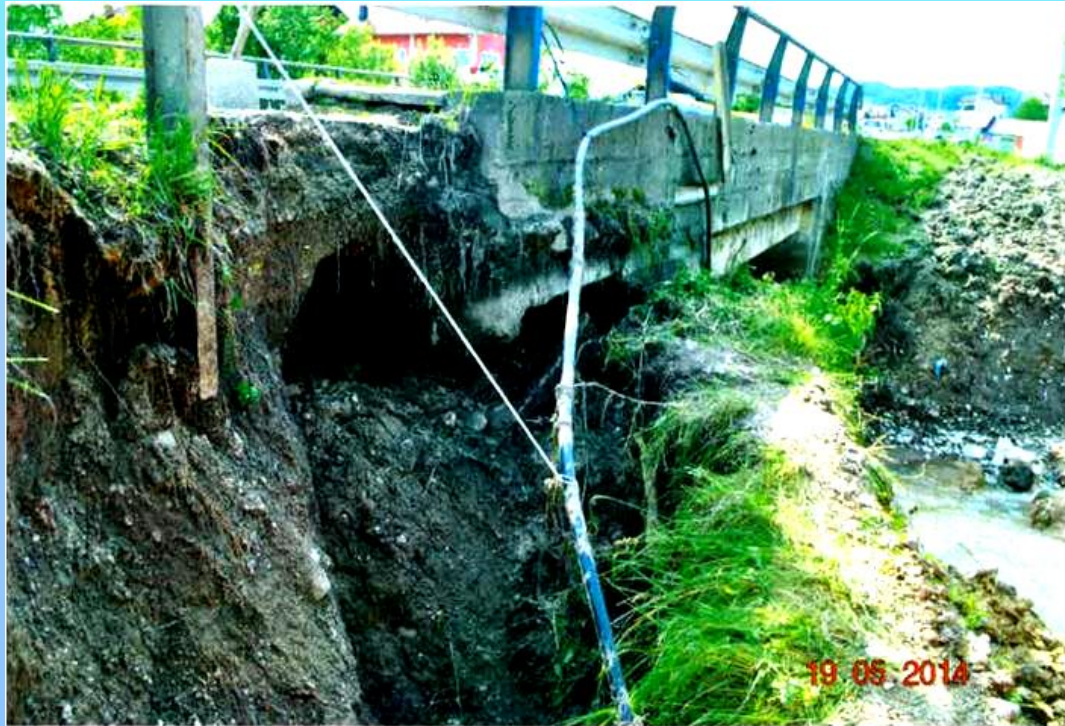
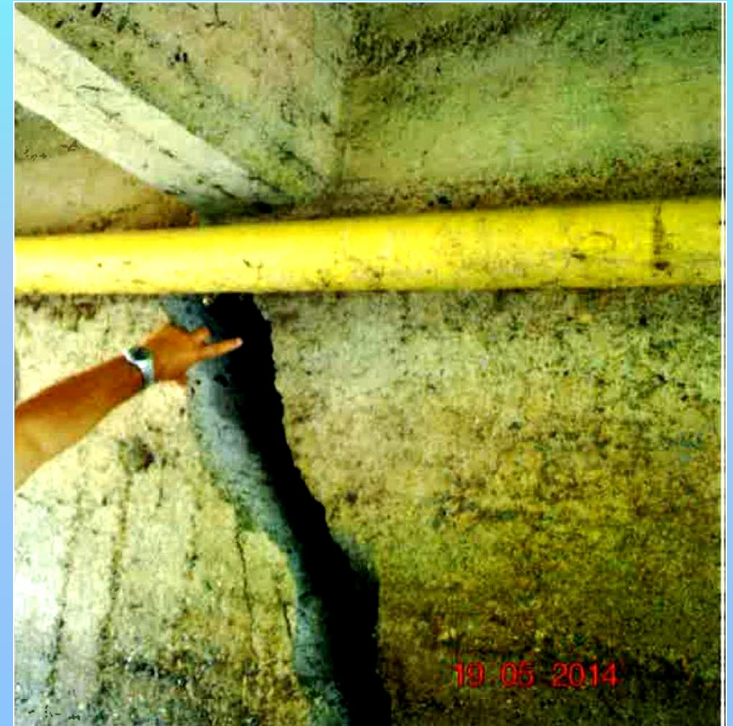
Site: M4, Dobož – Oraštica km 11+312

- Damage to the bridge structure,
- Breaking of the abutment,
- Loss of a part of the linear bearing.
