## **Aberdeen Western Peripheral Route**

### **Pre-Ground Investigation Walkover Report - Kingcausie Estate**

**Final Report**

**April 2008**

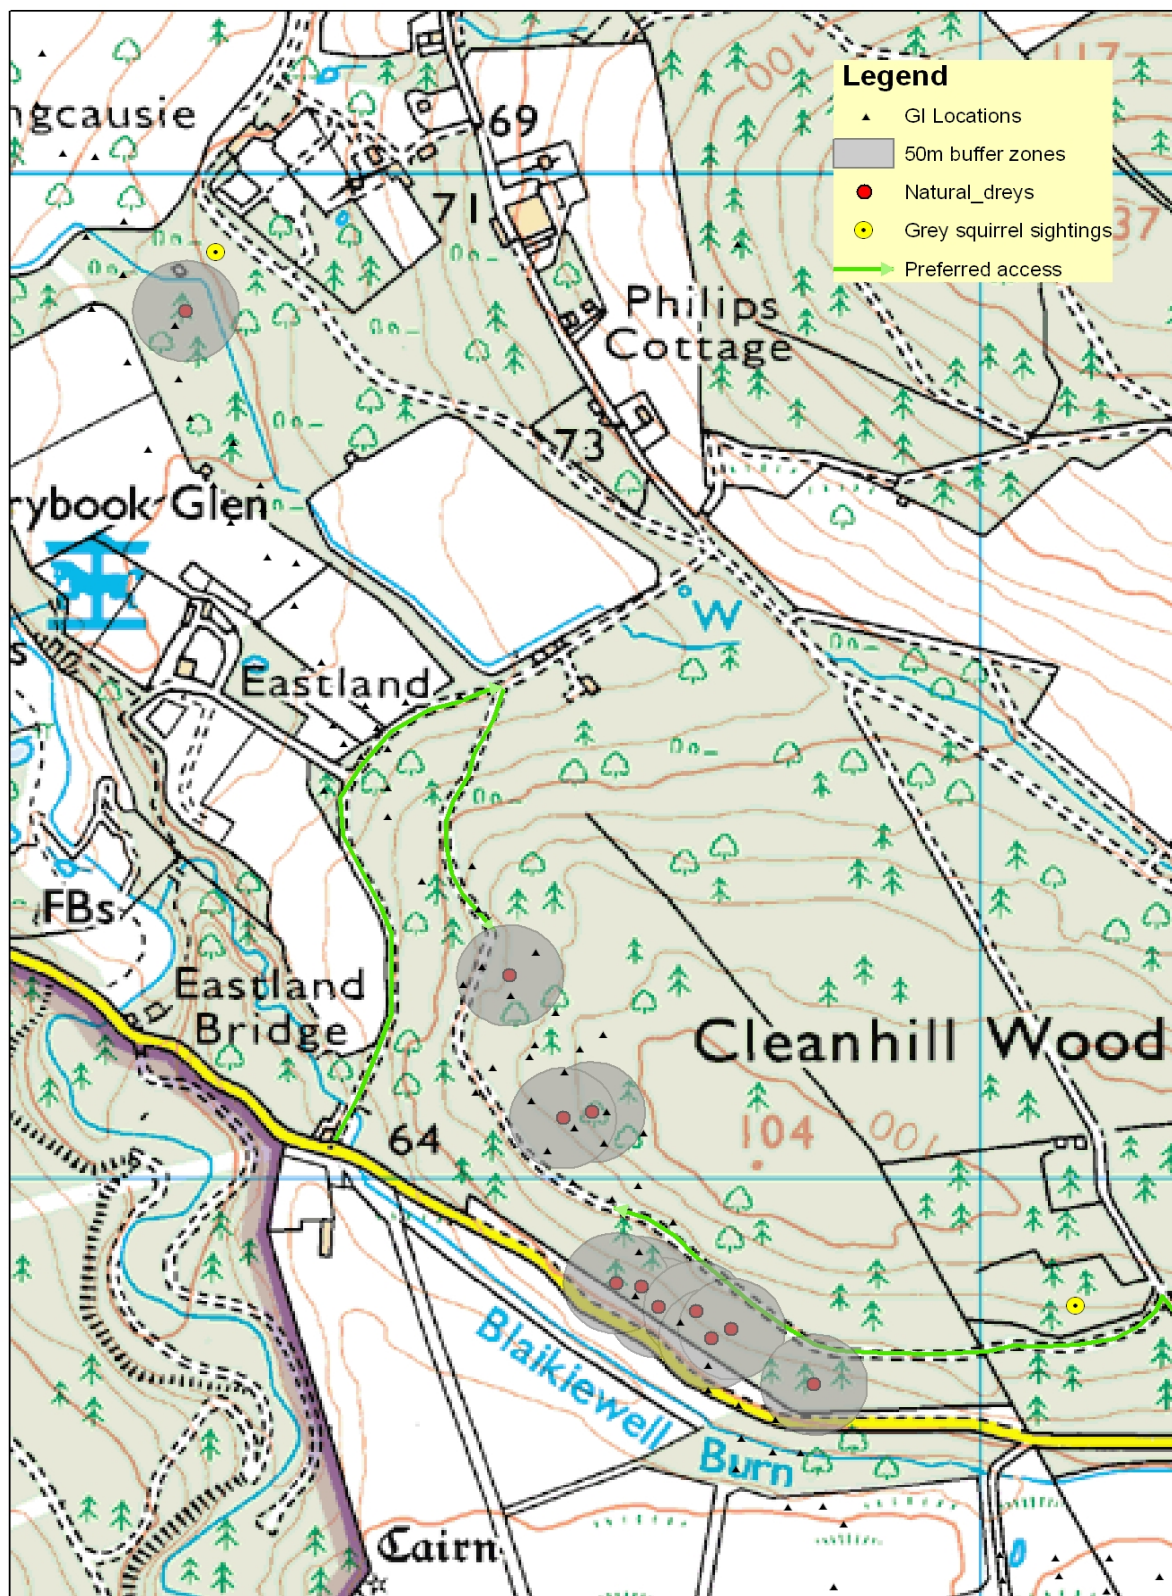
Eleven dreys or potential dreys were recorded and are shown in Figure 1 with the 50m buffer as indicated in the Method Statement for Red Squirrel Dreys. With the exception of one, they were all located in the south west of Cleanhill Wood. The majority were contained within the crown of mature Scots pine. Although many stripped pine cones were found in the vicinity of the dreys, no evidence to indicate the squirrel species was observed. No particular “feeding stations” were recorded.

Figure 1: Map to show GI locations and known potential dreys

The contractor's preferred access is shown in Figure 1. Access from both the north *and* south may be required to avoid felling trees and/or rhododendron in the more densely vegetated areas.

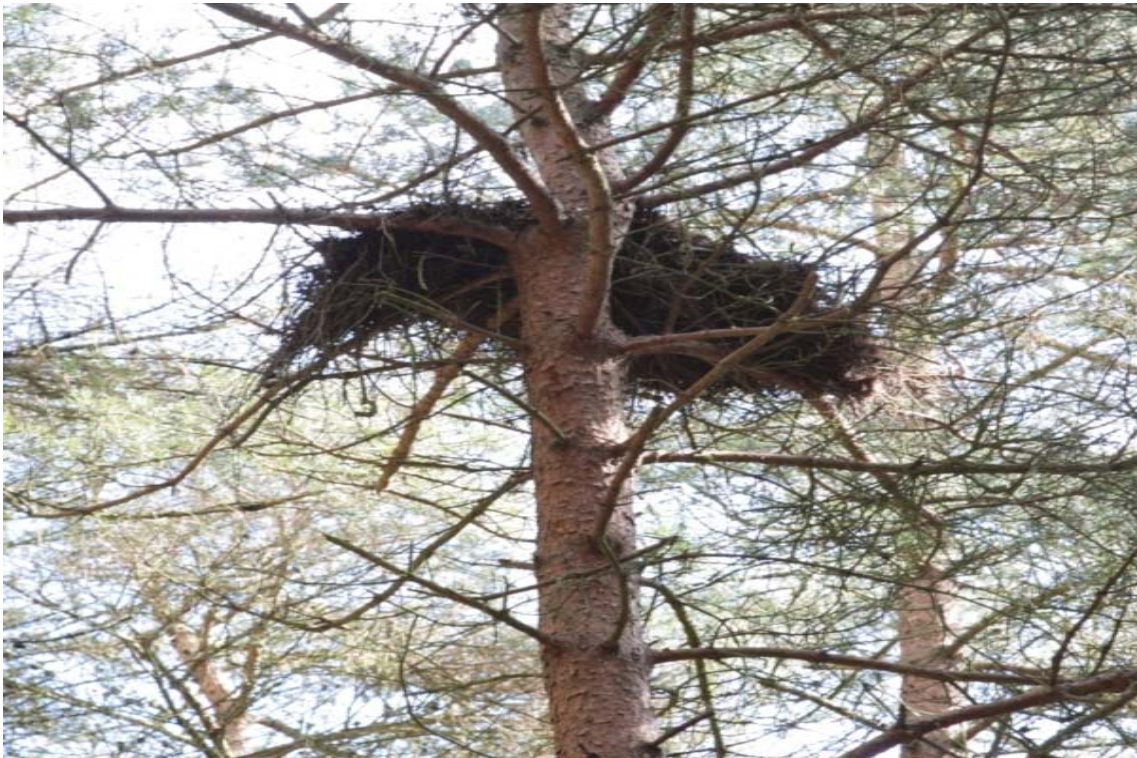
The “state of repair” of each drey was recorded. Six were assessed to be in a poor state of repair (thin, small or partial destroyed) and therefore unlikely to be in use by squirrels. However, they may also have been under construction. A typical drey is shown in Figure 2.

Figure 2: Typical drey

A hair tube survey to establish whether the natural dreys and the new nest boxes are currently being used as places of shelter by red squirrels should be undertaken as per the Method Statement for Red Squirrel Dreys. In order to allow time for this to be carried out, surveys should begin within the next two weeks.

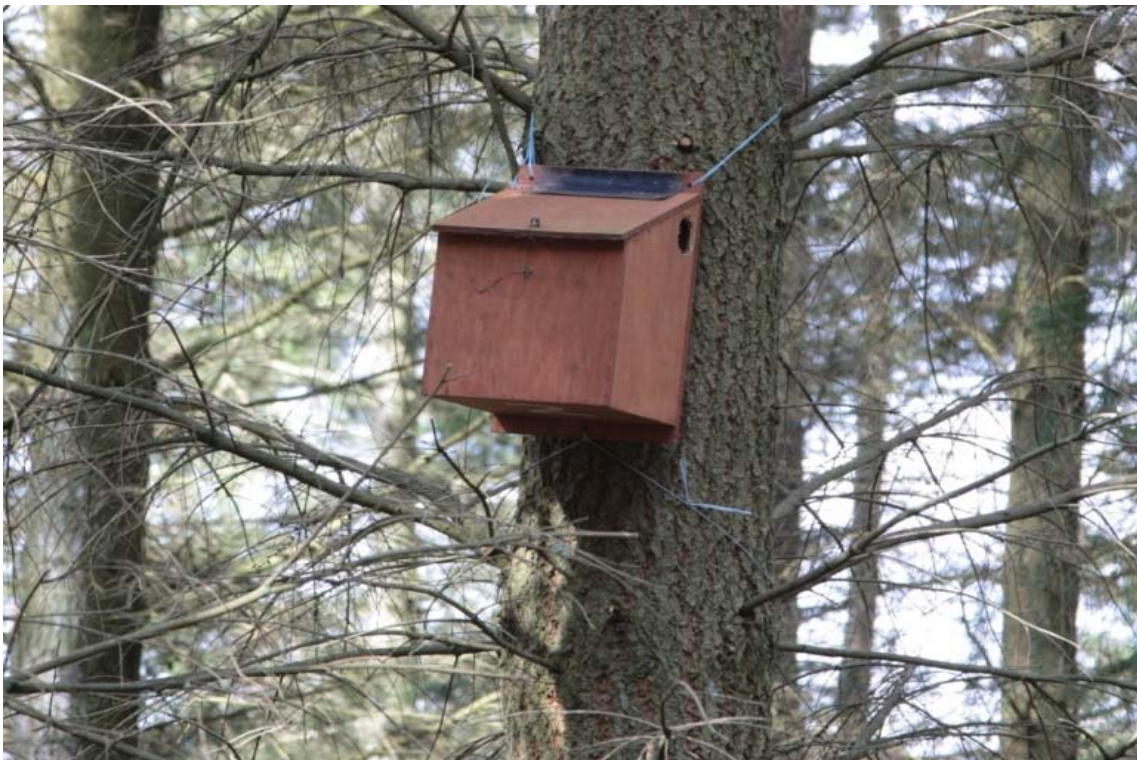
A number of squirrel nesting boxes (Figure 3) have been erected on or in the vicinity of the proposed alignment, spaced at approximately 50-60m. The boxes are numbered and a Number 30 was observed. It is not known how many boxes there are in total or their geographical extent as this walkover did not cover the entire wooded area. The majority of the boxes are attached with string to mature Scots pine, typically 4-5m from the ground.

Figure 3: Squirrel nesting box

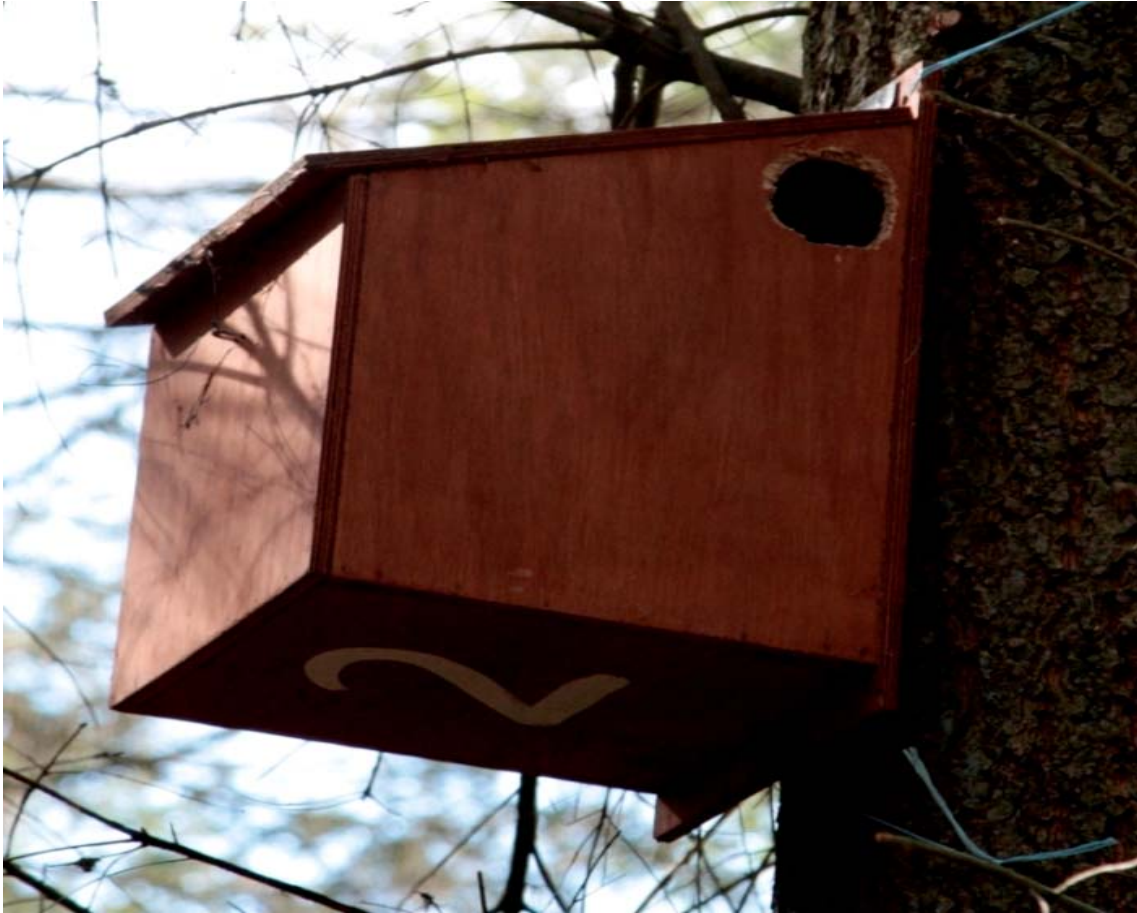
The boxes all seem to be new (*estimated* at less than one month old) and the majority show no signs of habitation such as claw marks, hair or discolouration around the entrances or any bedding material on the floor beneath them. The only exception is box No.2 where the entrance hole has been chewed / enlarged (Figure 4).

Figure 4: Squirrel nesting box No.2 showing enlarged entrance hole
