Earthquake Engineering in Armenia

SPITAK DEVASTATING EARTHQUAKE M7.1

Armenia 07.12.1988.

Brief Information on Spitak M7.1 Earthquake

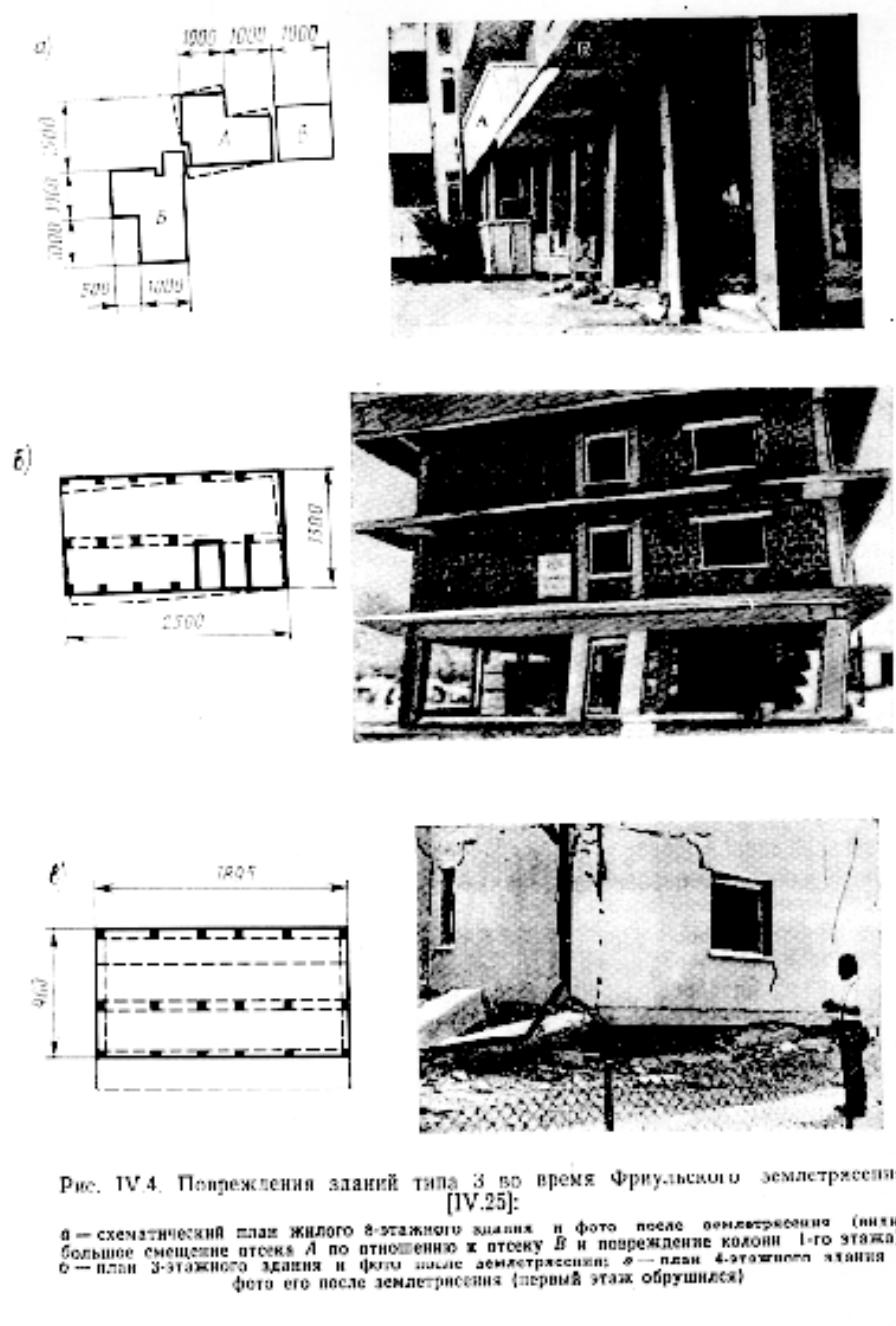
Friuli, Italy, 06.05.1976, M6.5

Рис. IV.4. Повреждения зданий типа 3 во время Фриулийского землетрясения [IV.25]:
а — схематический план жилого 8-этажного здания и фото после землетрясения (линия большое смещение отсека А по отношению к отсеку В и повреждение колонн 1-го этажа); б — план 3-этажного здания и фото после землетрясения; в — план 4-этажного здания и фото его после землетрясения (первый этаж обрушился)

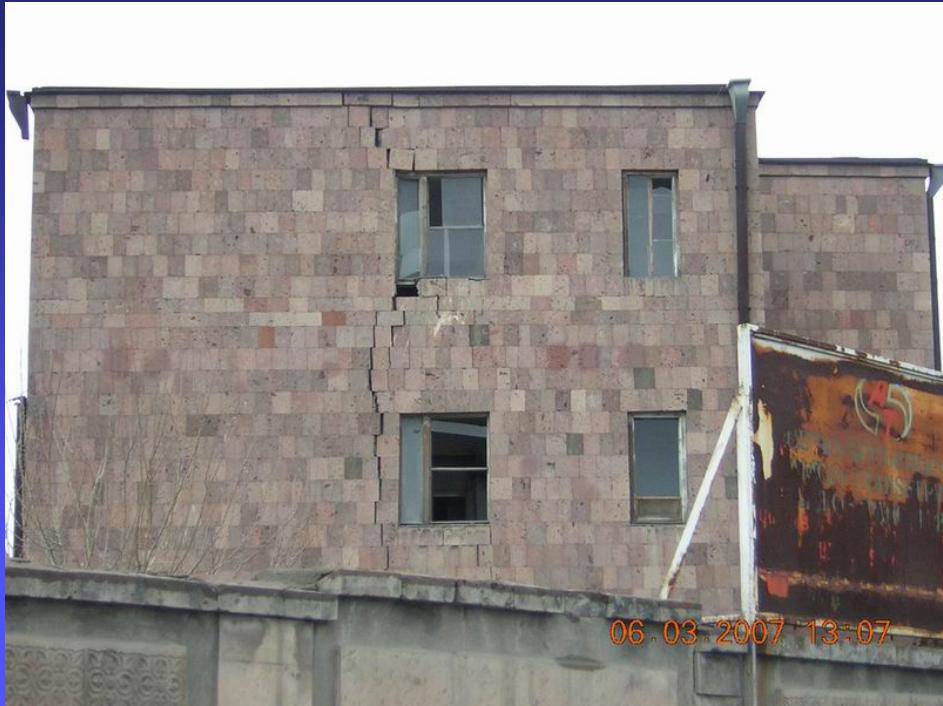
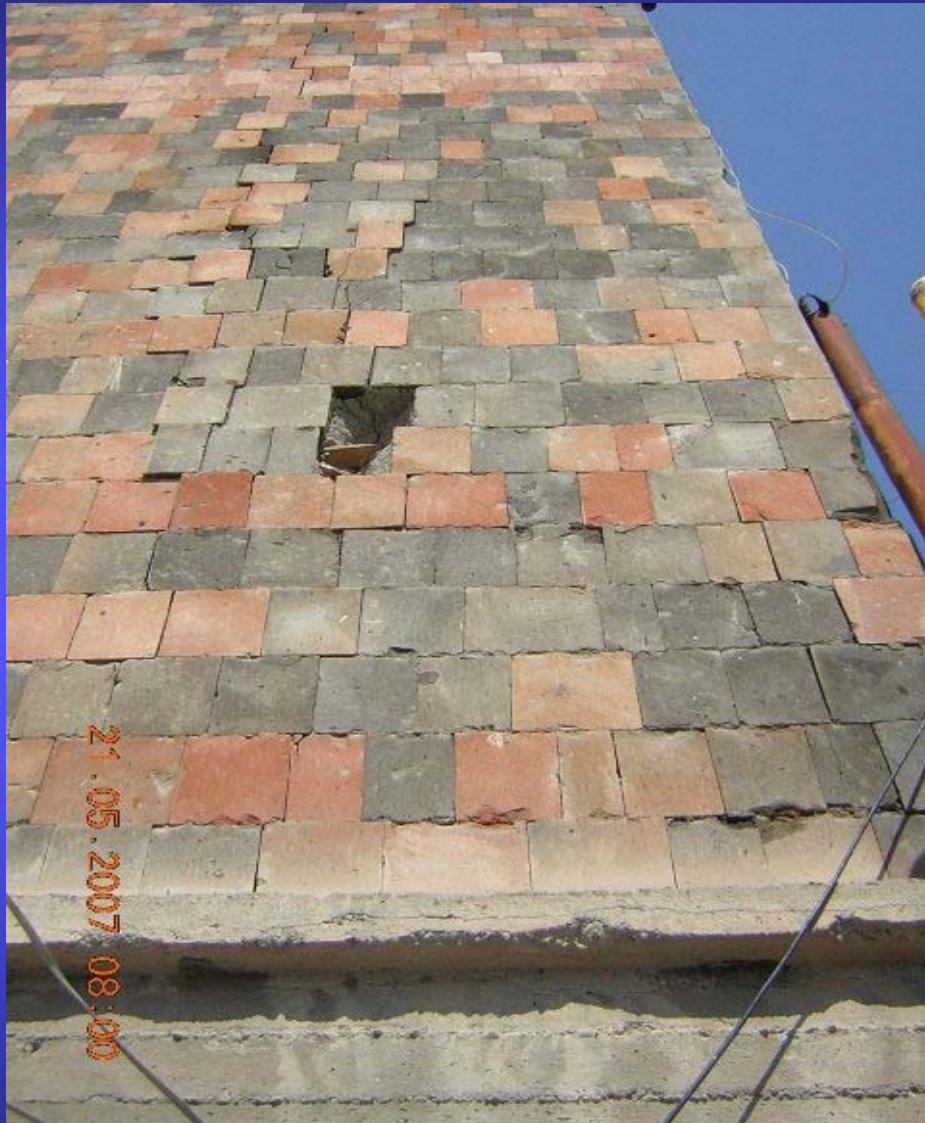
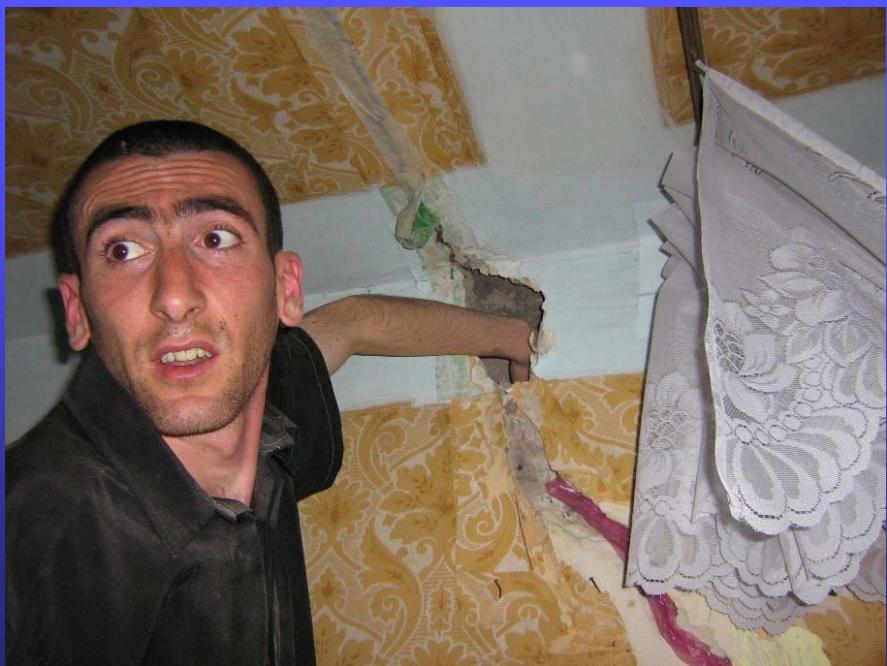
Low quality of construction works

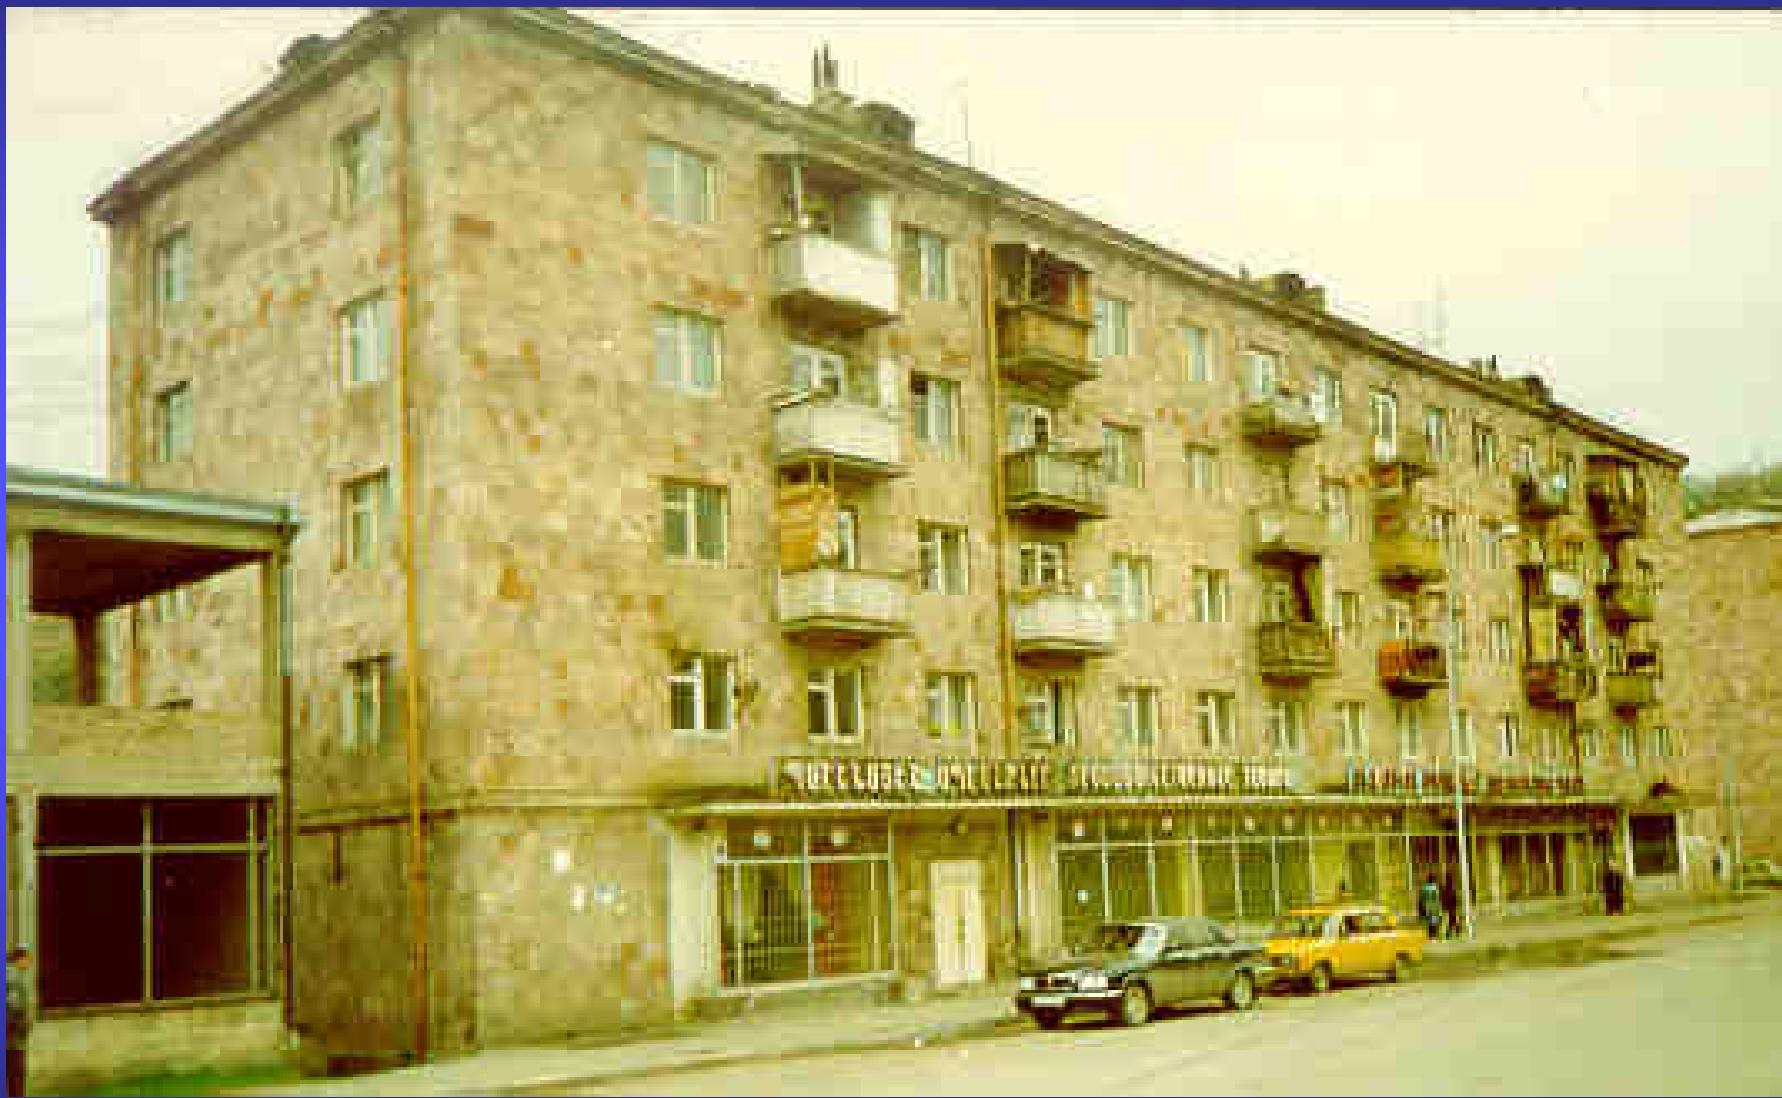
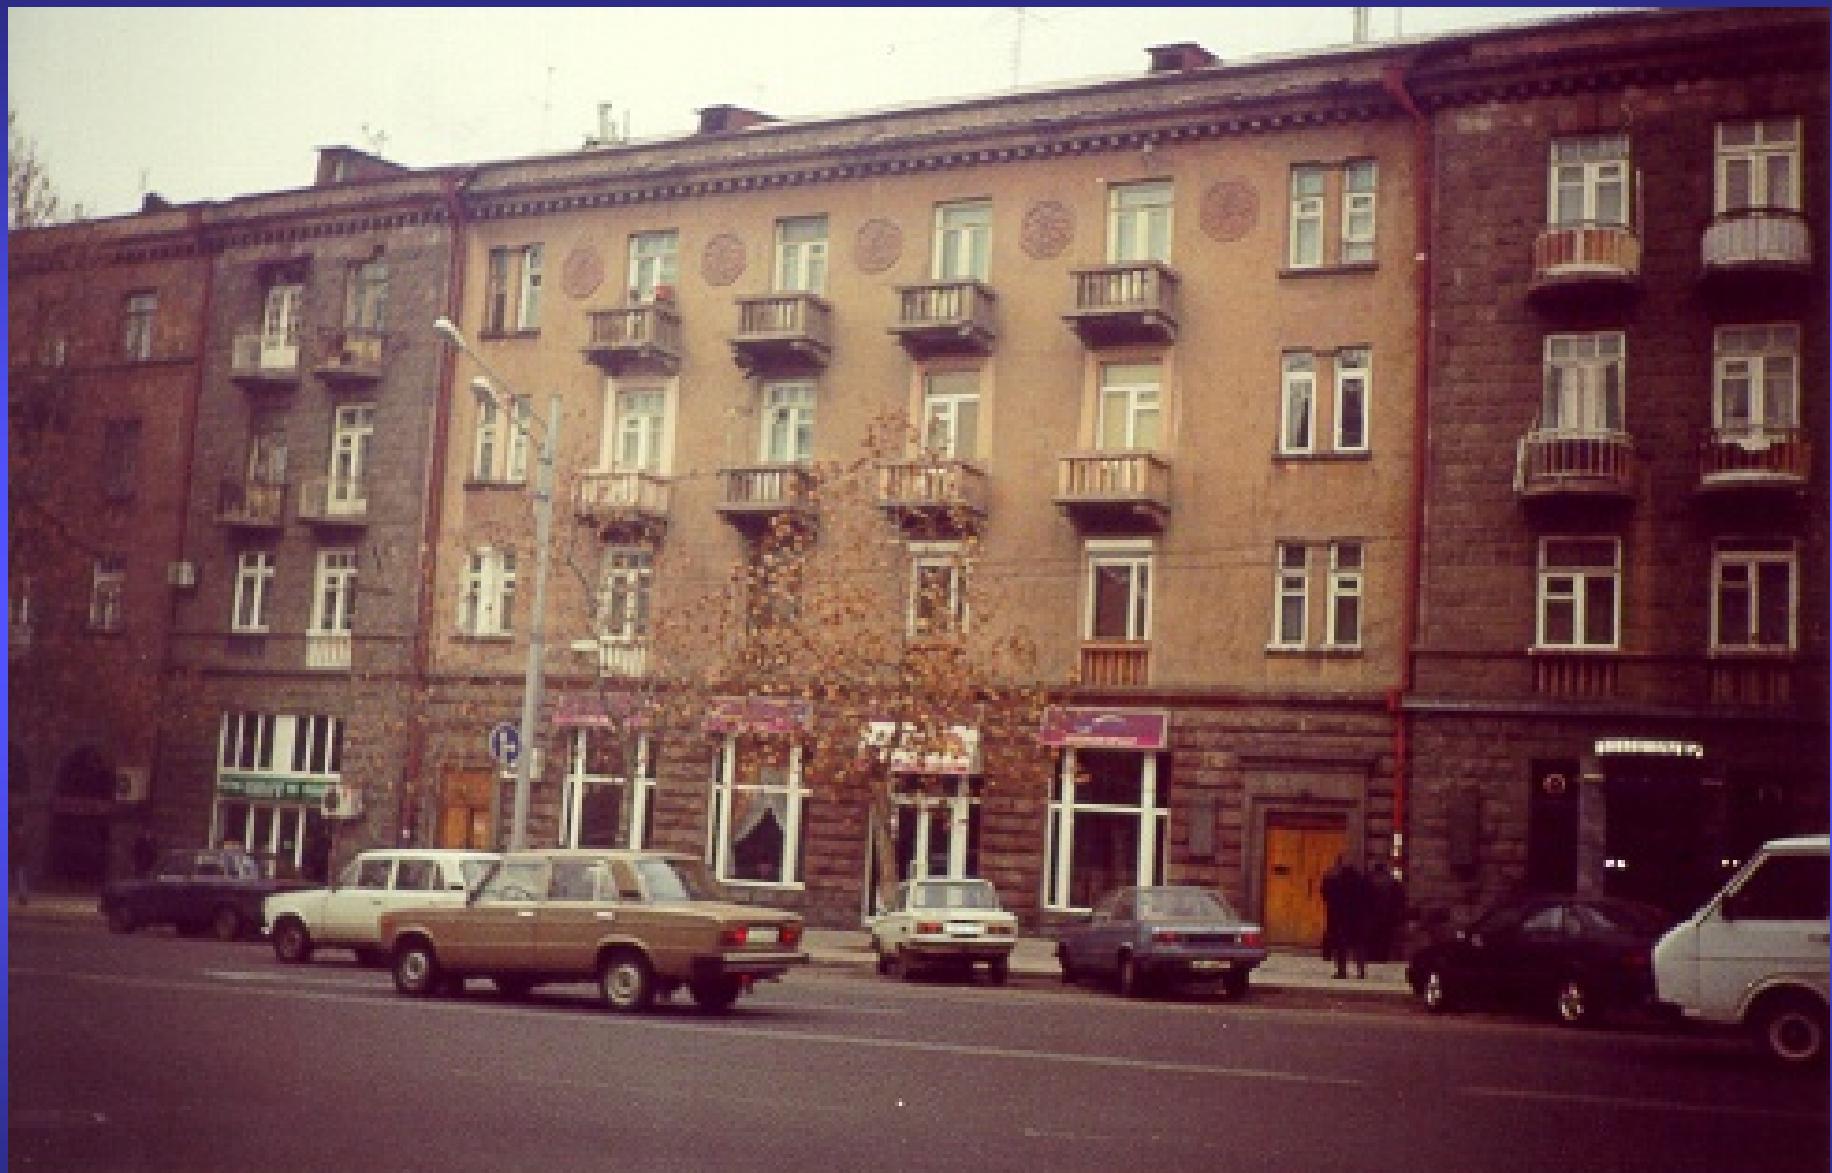
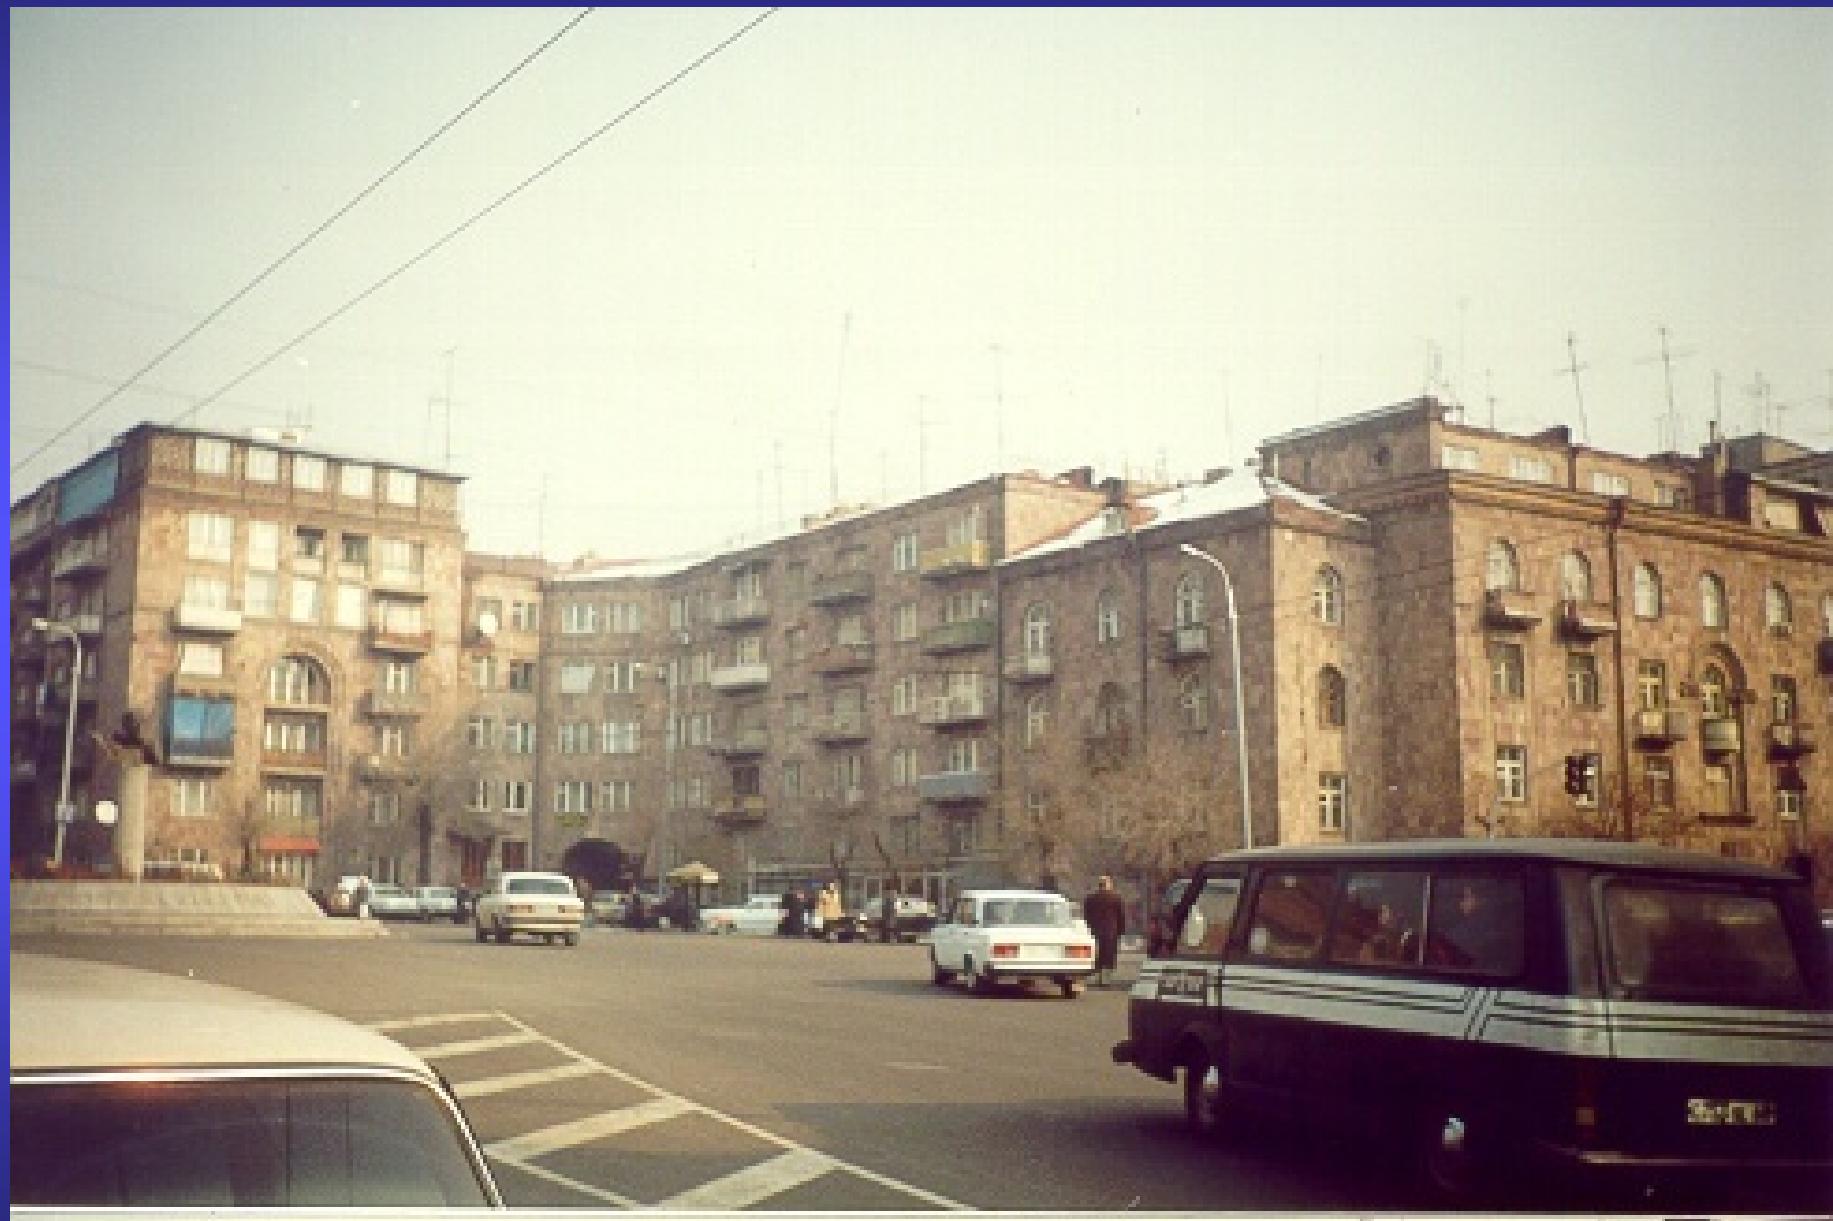
Stone-wall (masonry) buildings (up to 5 story)

30 percent of building stock

High vulnerability

Retrofitting required

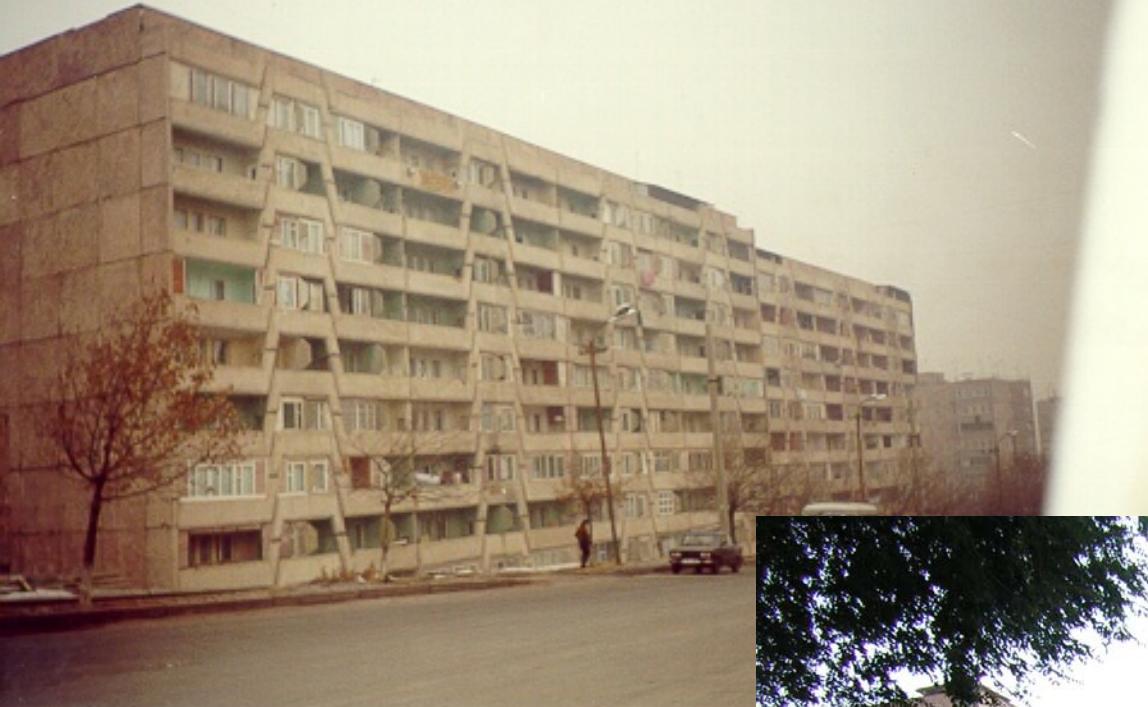
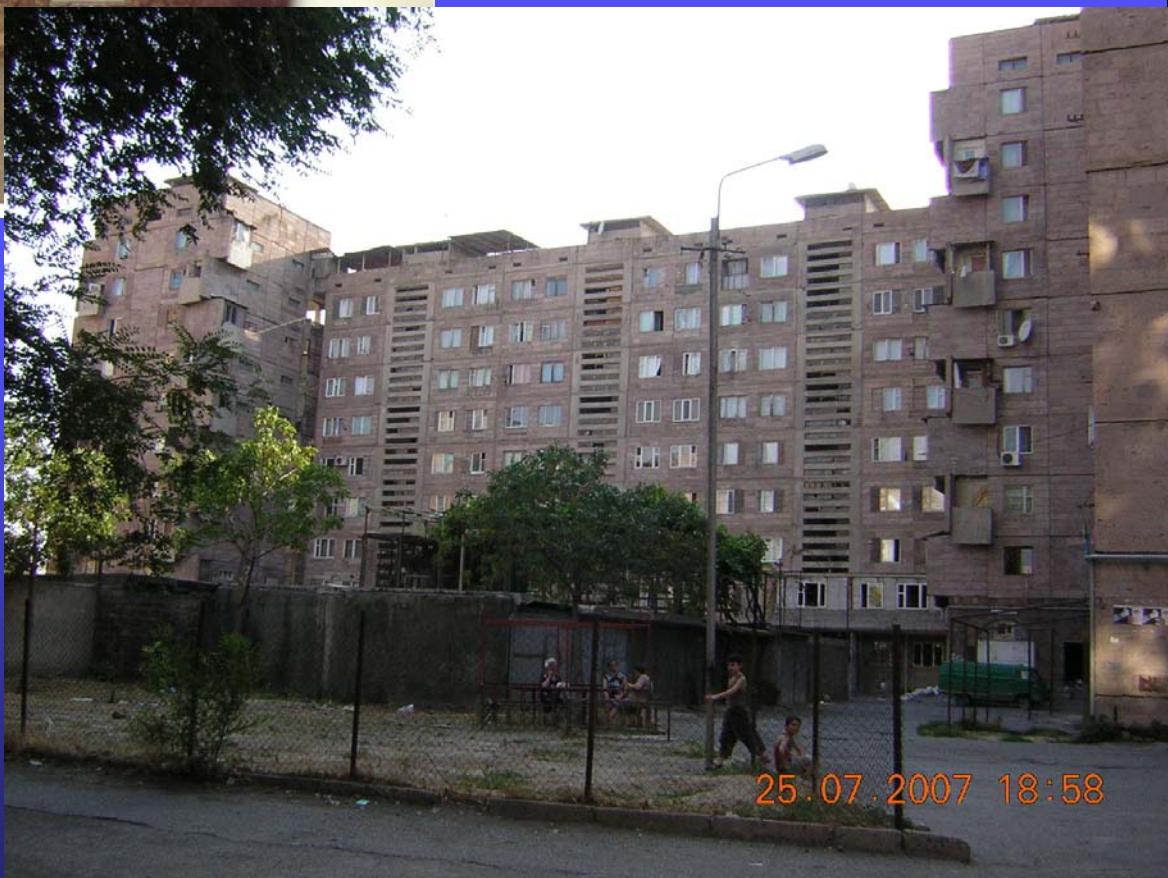
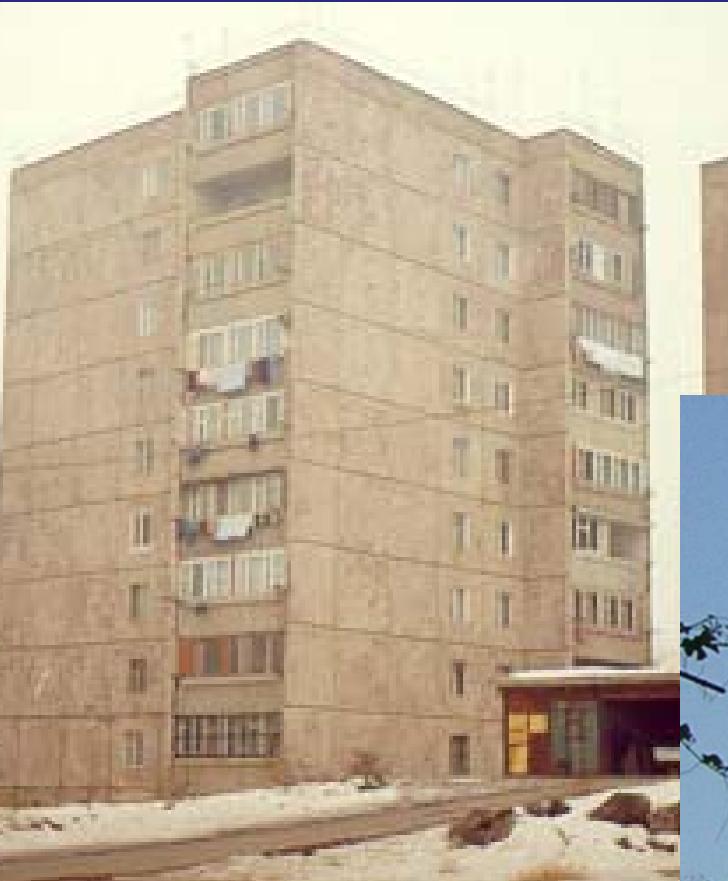
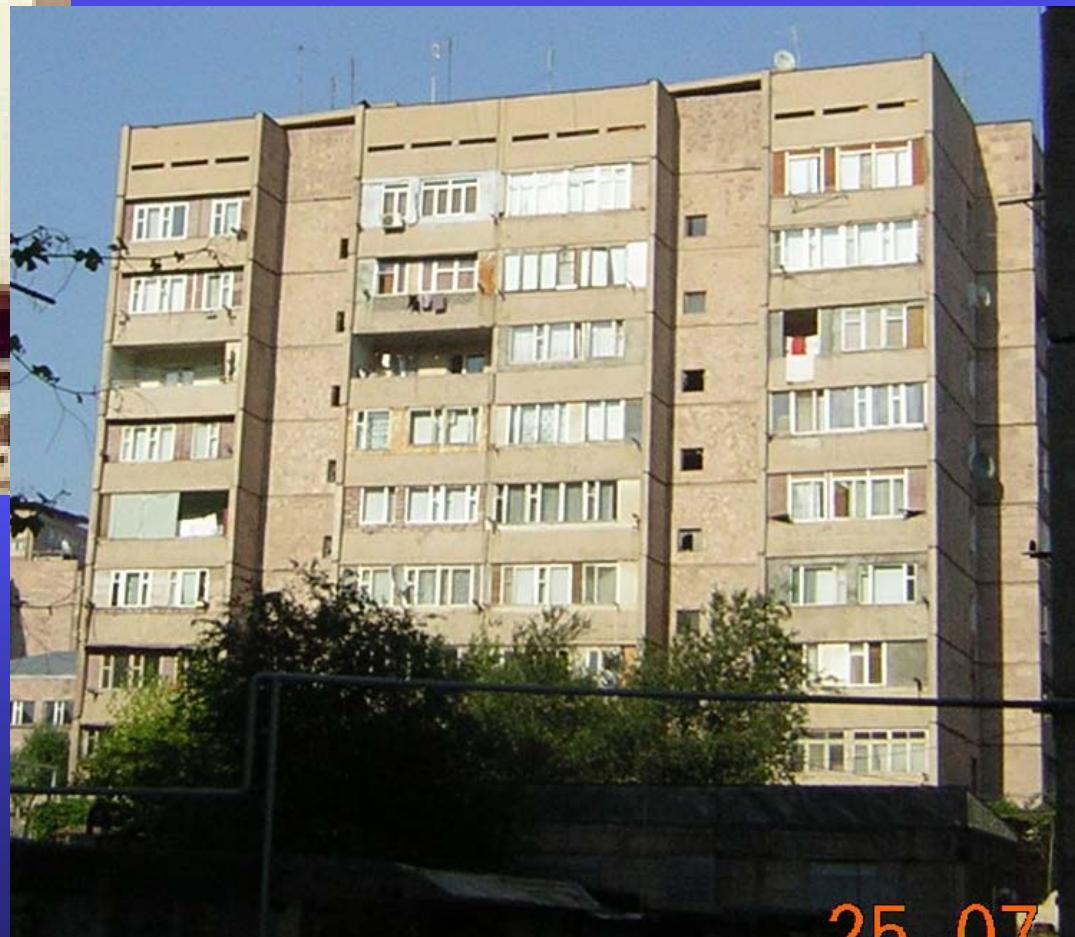
Large Panel Buildings (9 story)

10 percent of building
stock

Low vulnerability

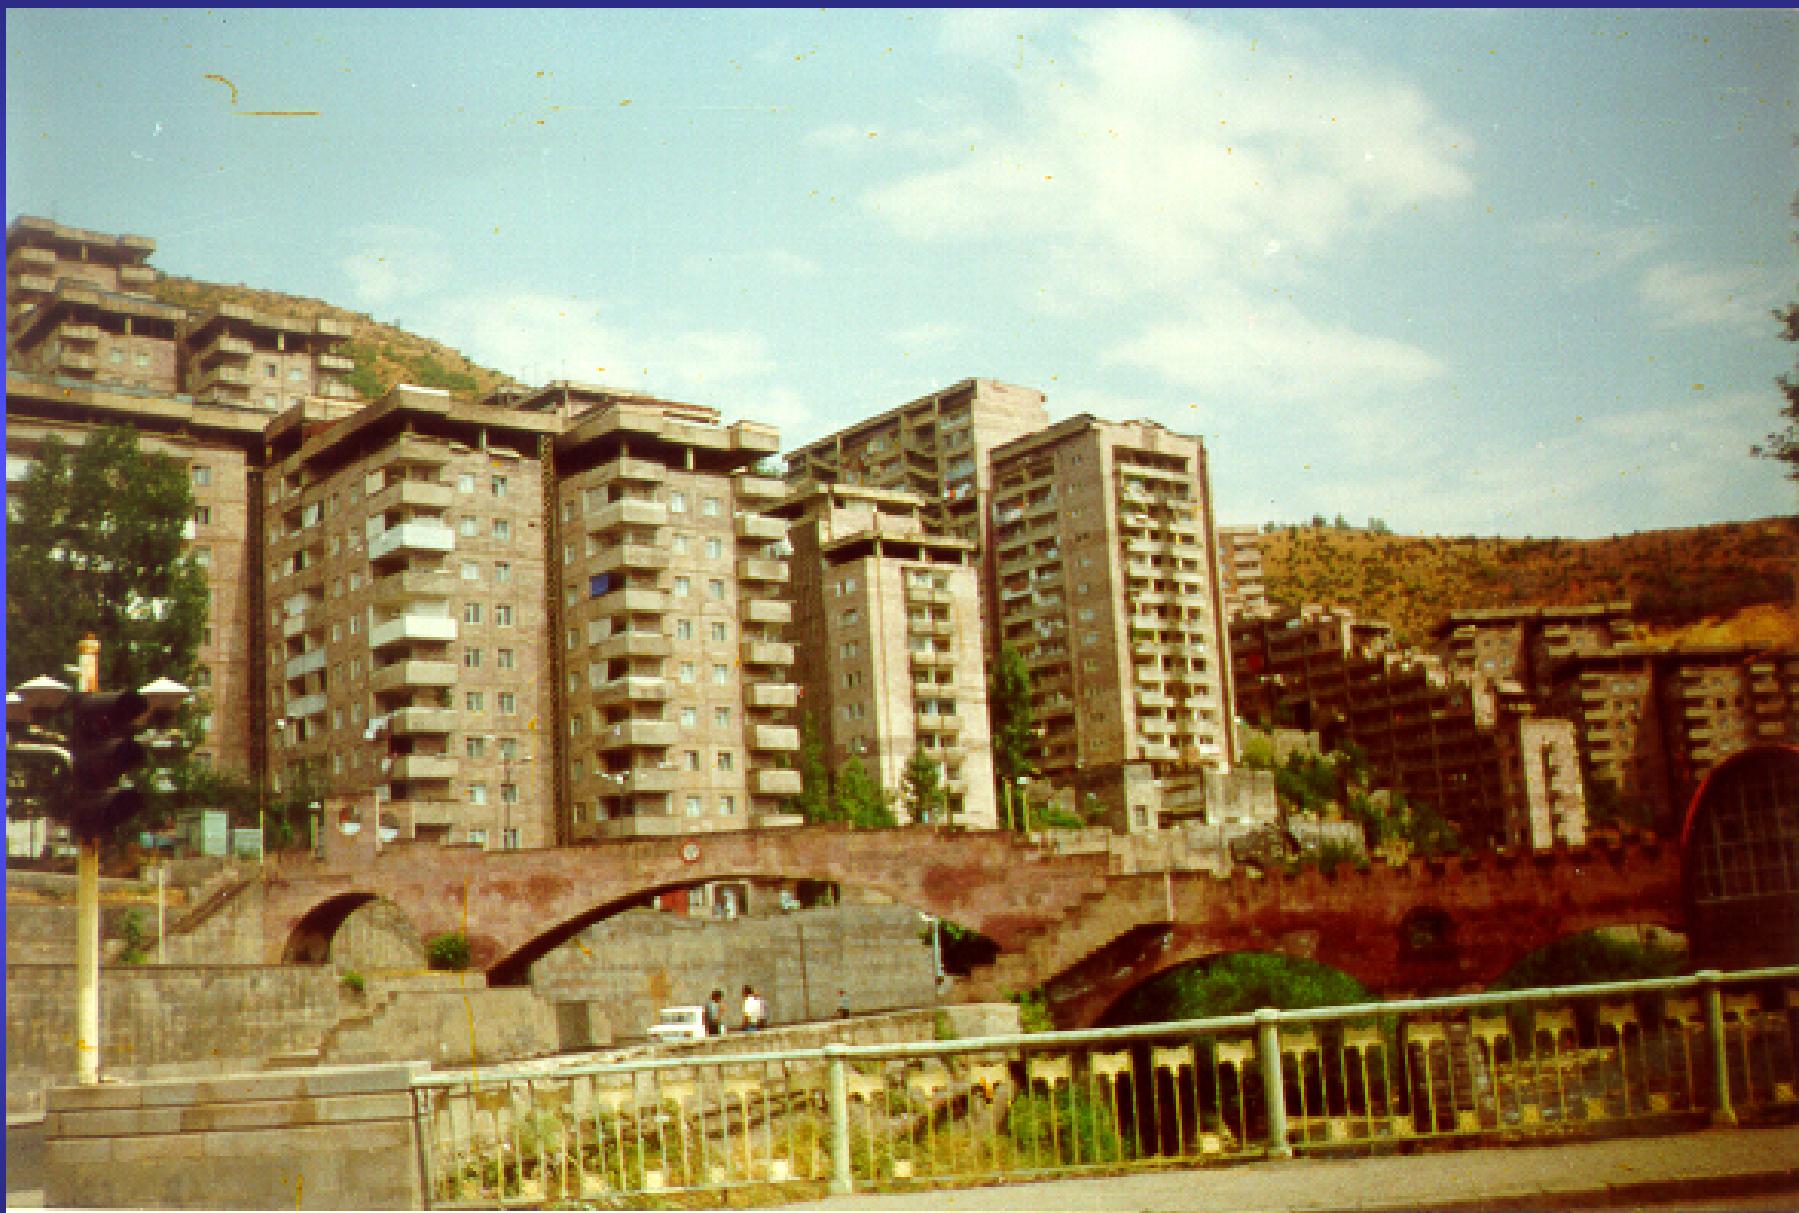
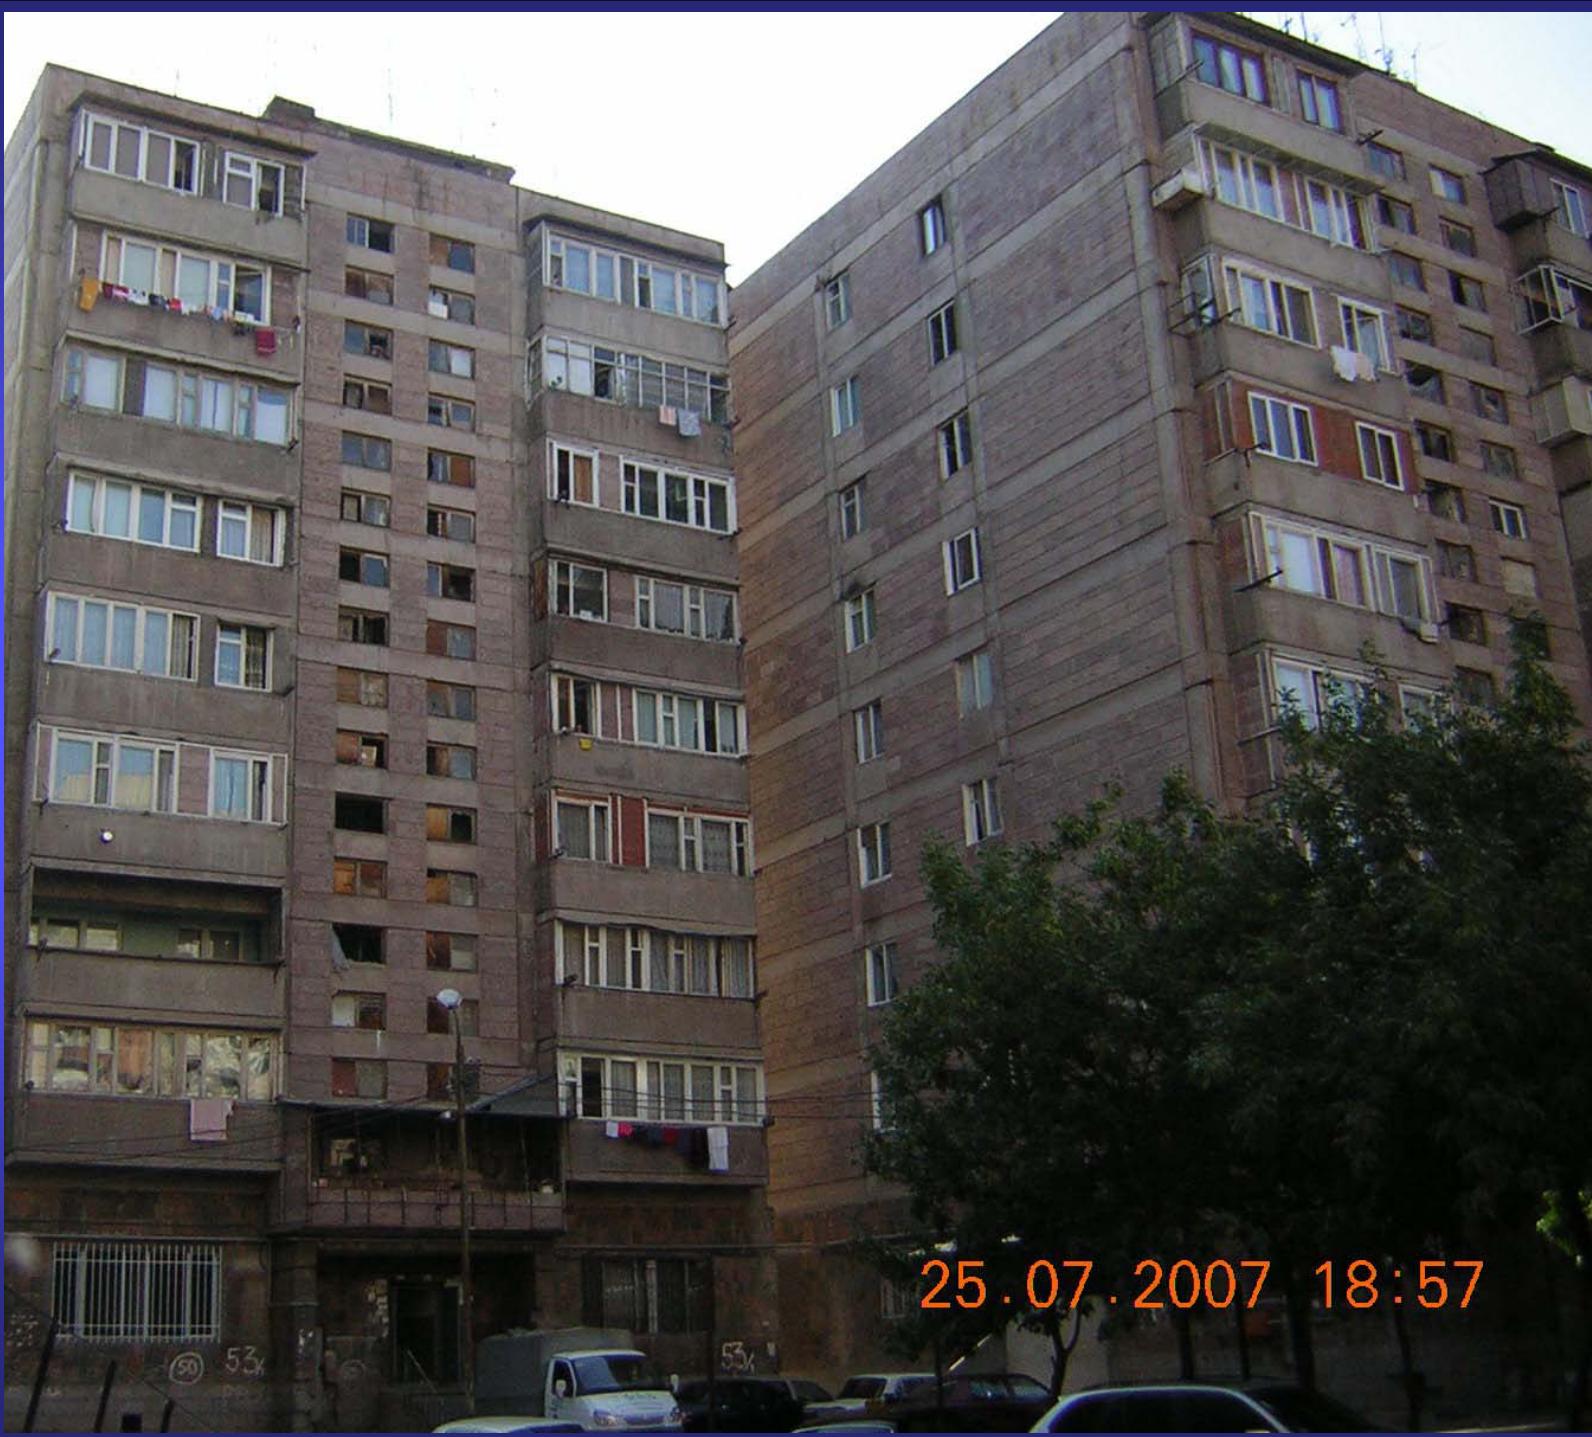
Frame Panel Buildings (9 story)

15 percent of building
stock

High vulnerability

After Spitak 1988 Earthquake were not constructed

Retrofitting required

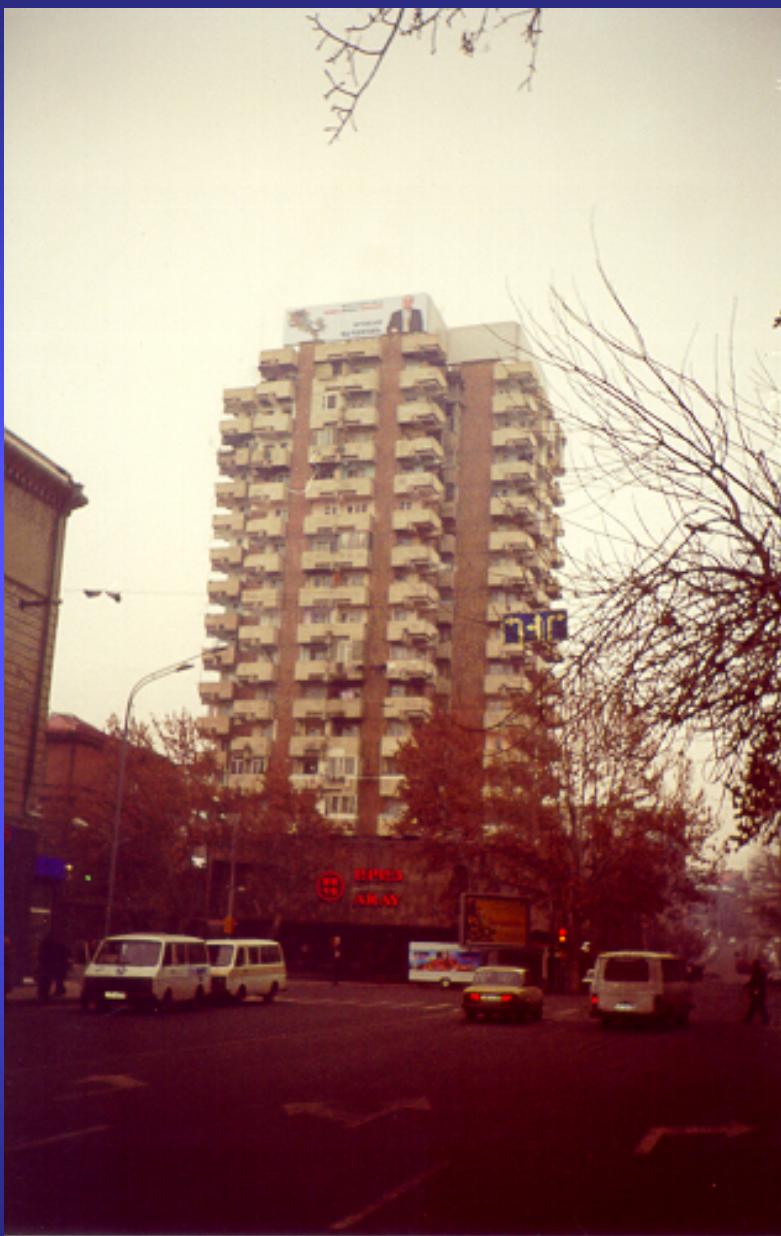
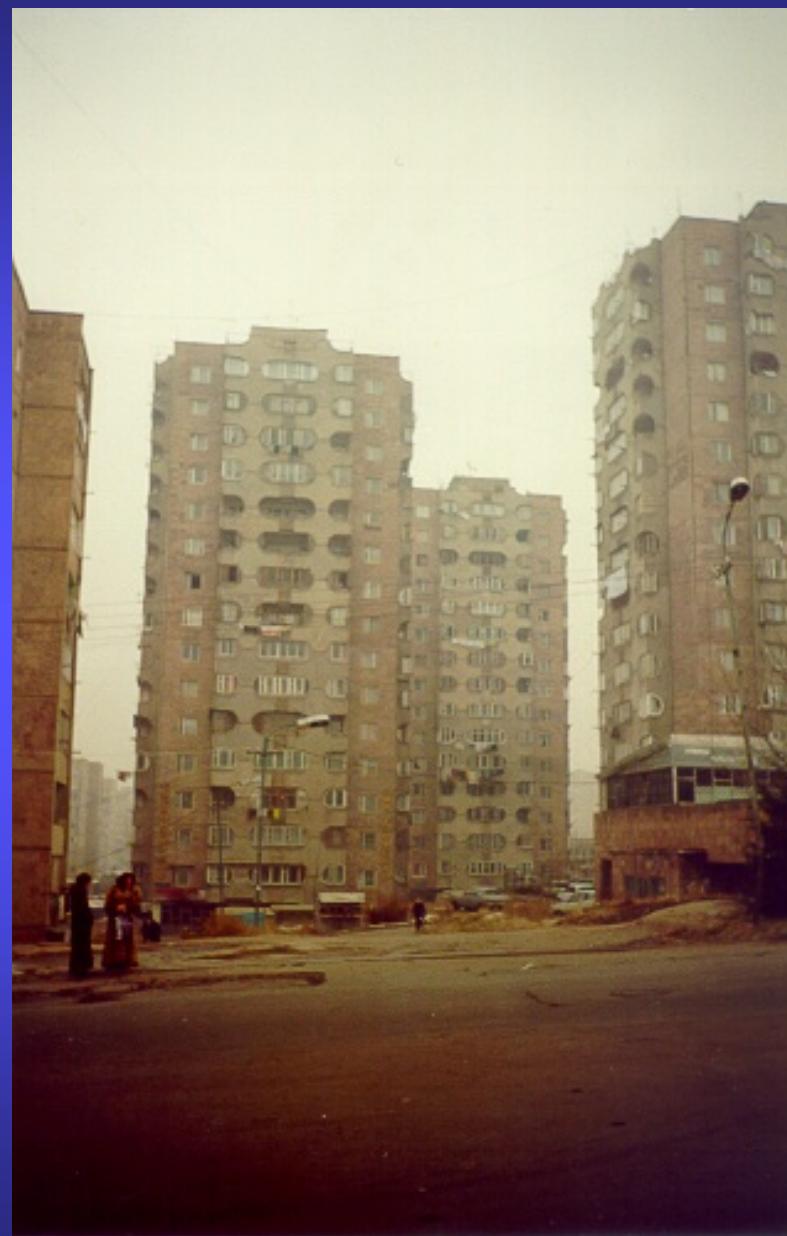
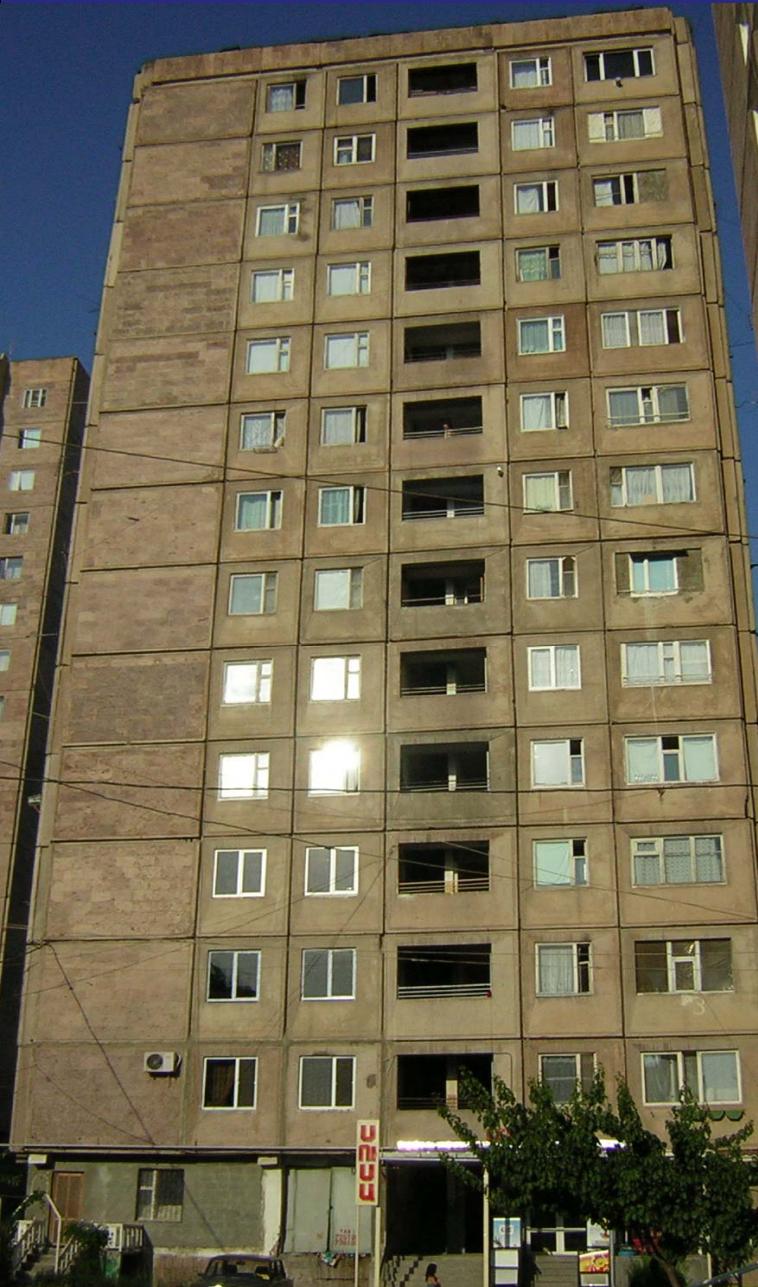
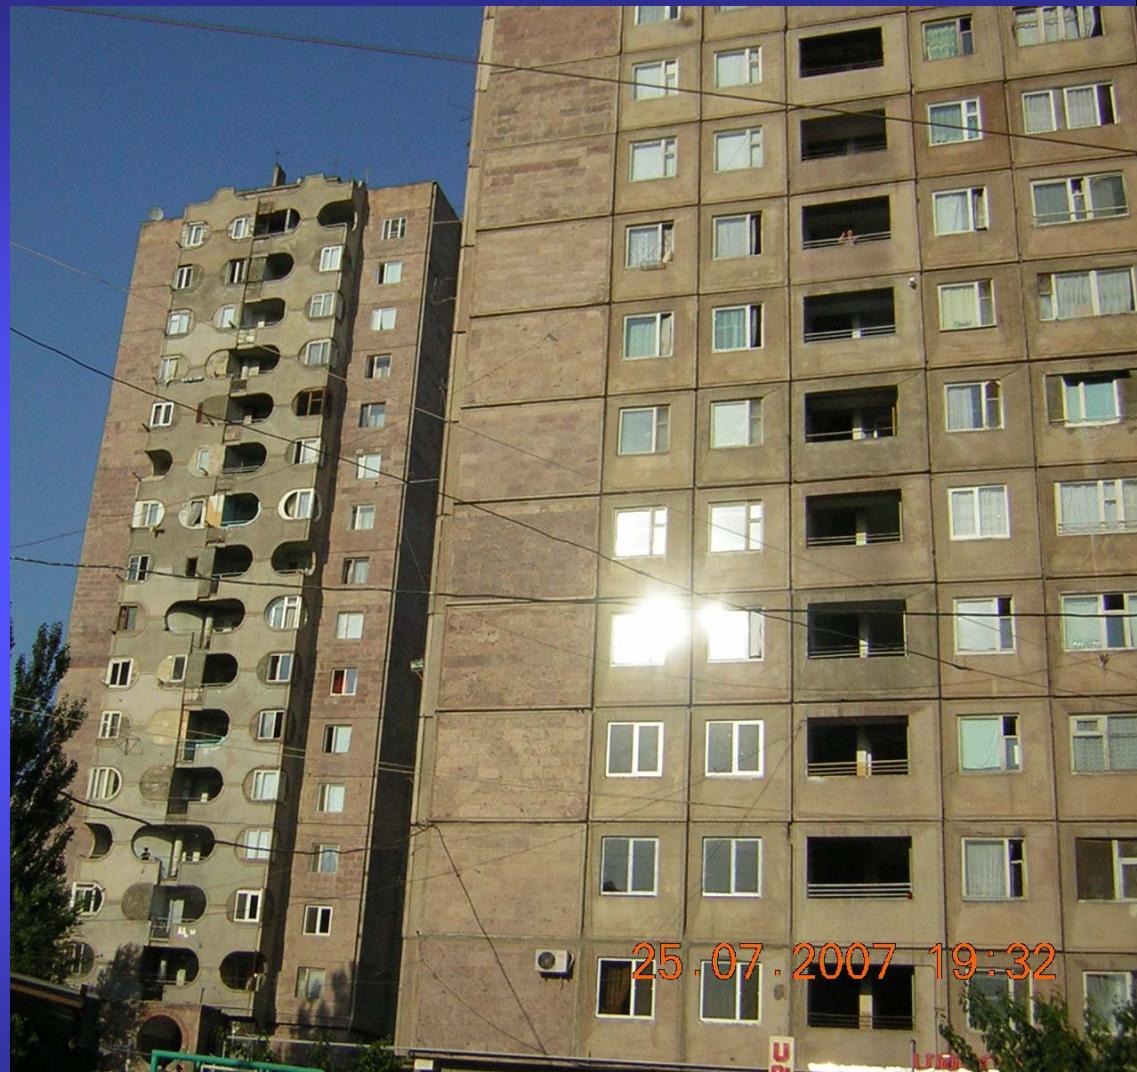
Buildings with Frame-Tied System (12-16 story)

15 percent of building stock

Low vulnerability
