Earthquake Engineering in Armenia

SPITAK DEVASTATING EARTHQUAKE M7.1

Armenia 07.12.1988.

Brief Information on Spitak M7.1 Earthquake

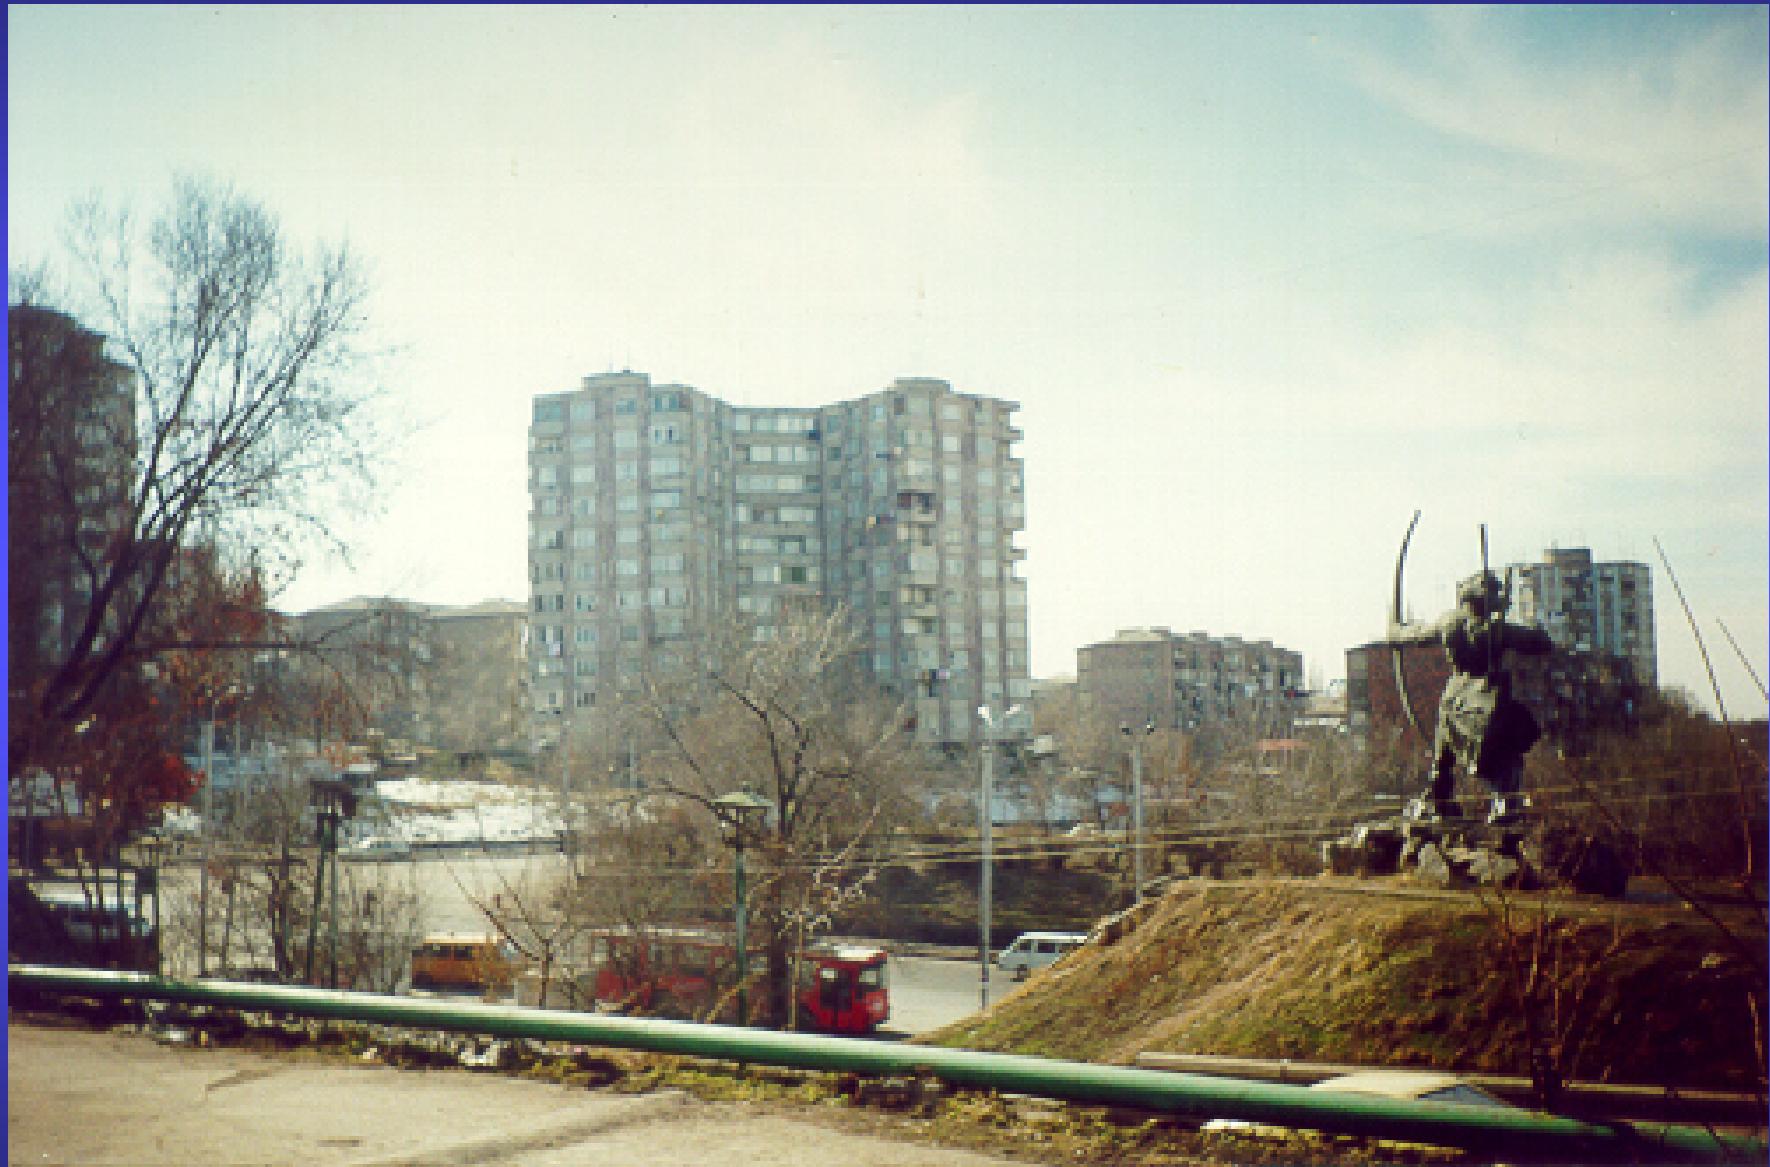
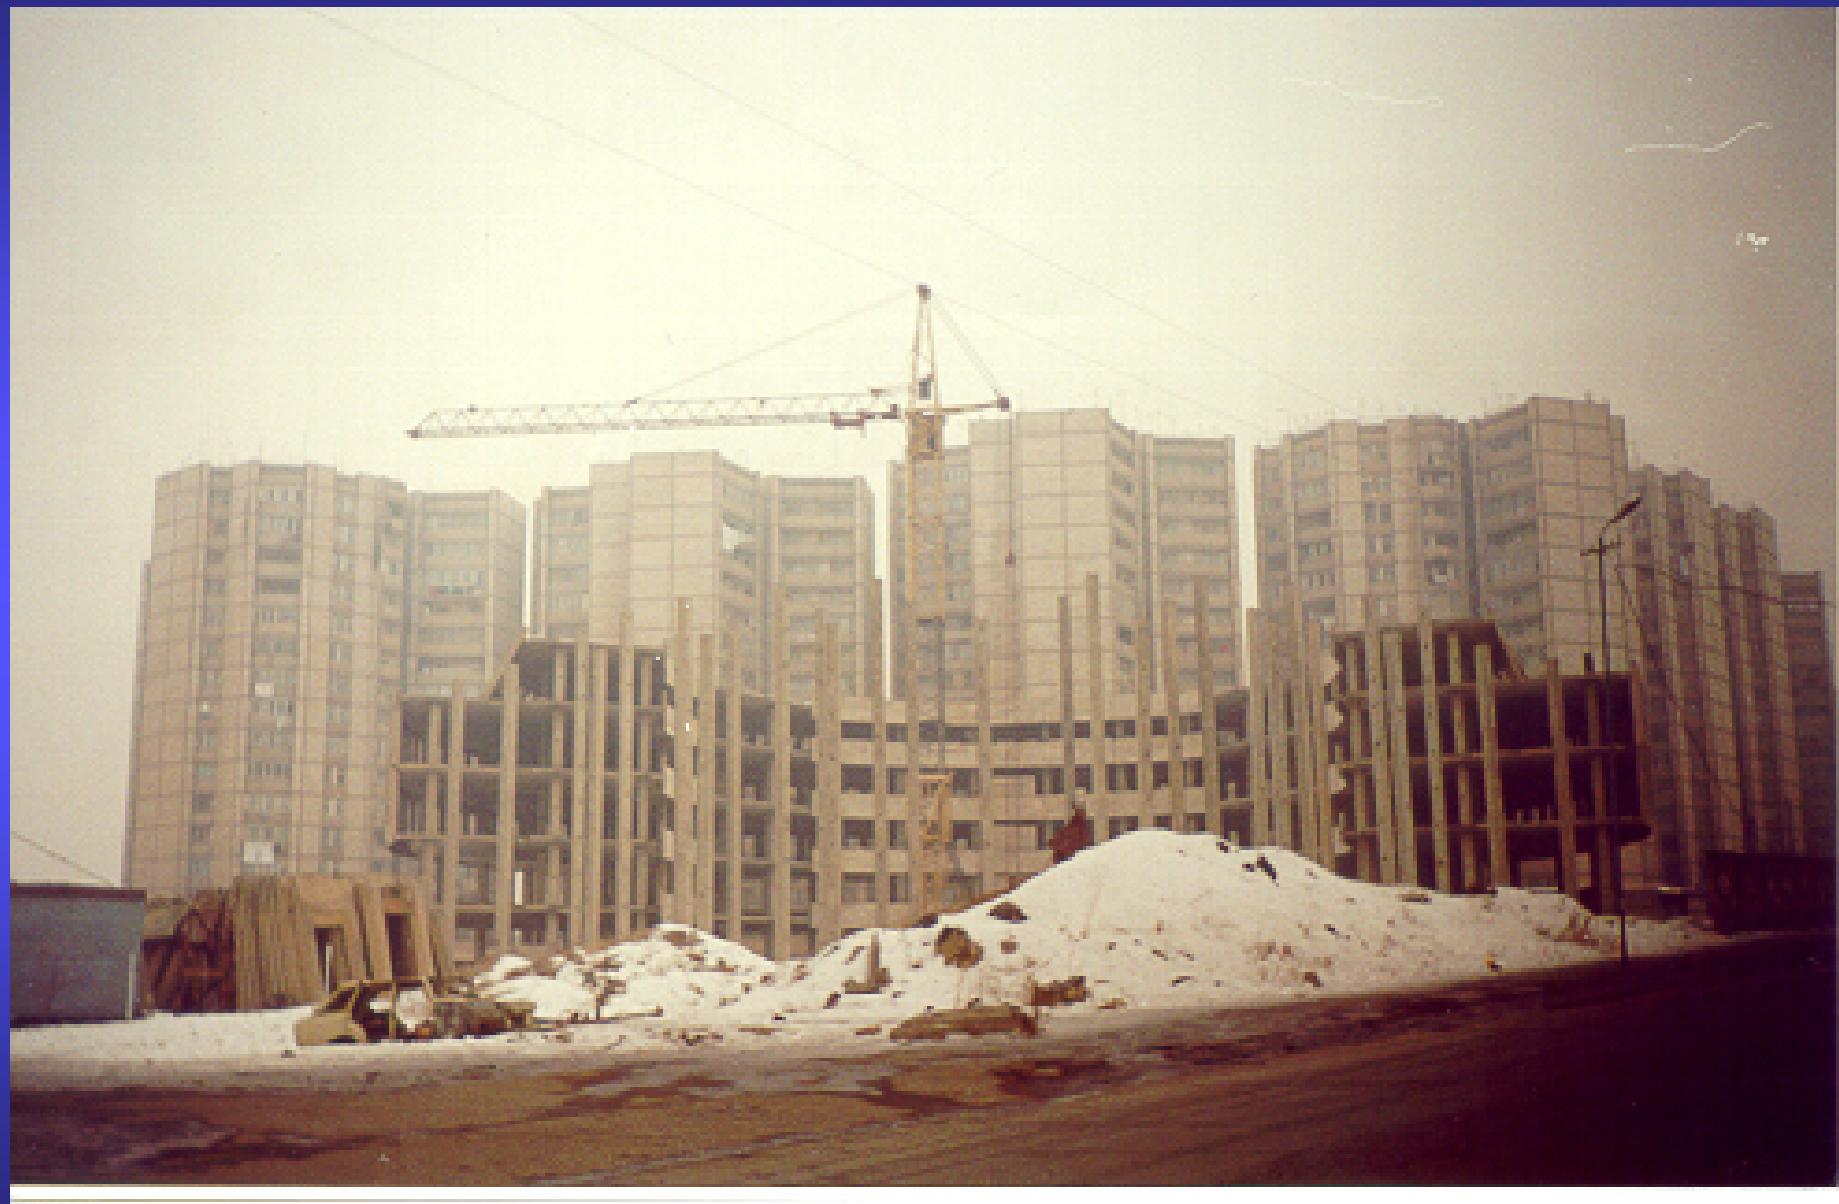
Buildings Constructed with Slab Lift Technology (12-16 story)

7 percent of building stock, mainly in Yerevan-city

After Spitak 1988 Earthquake were not constructed

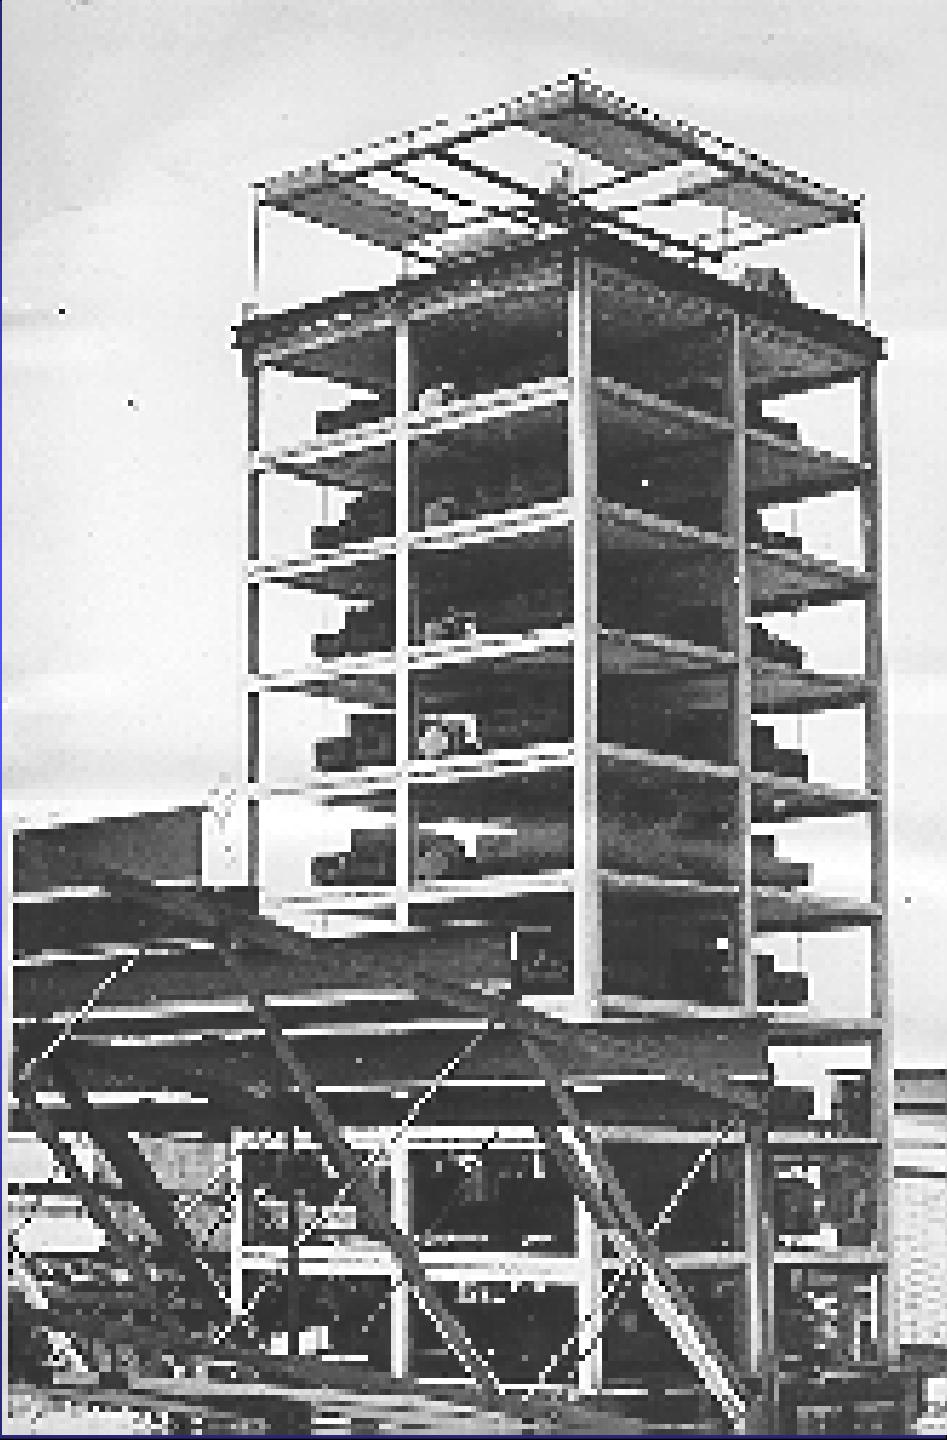
Model of 9 story frame
building with dynamic
damper

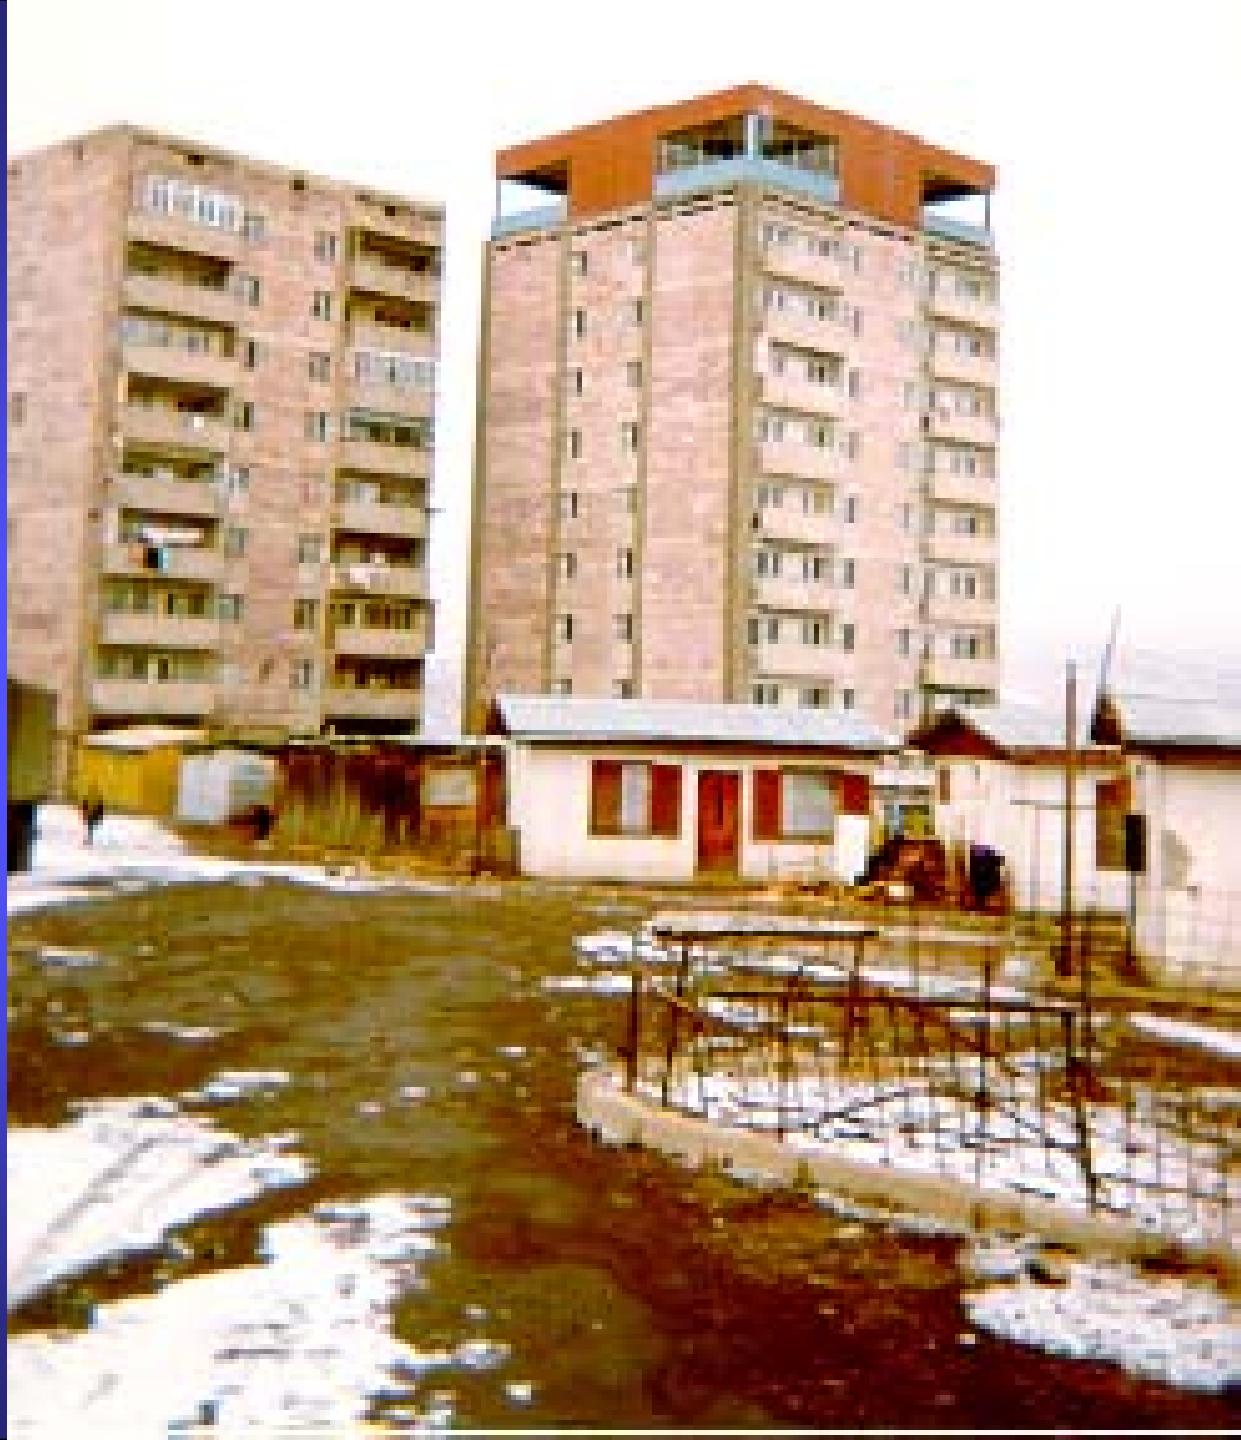
Building in Vanadzor
town strengthened
with dynamic damper

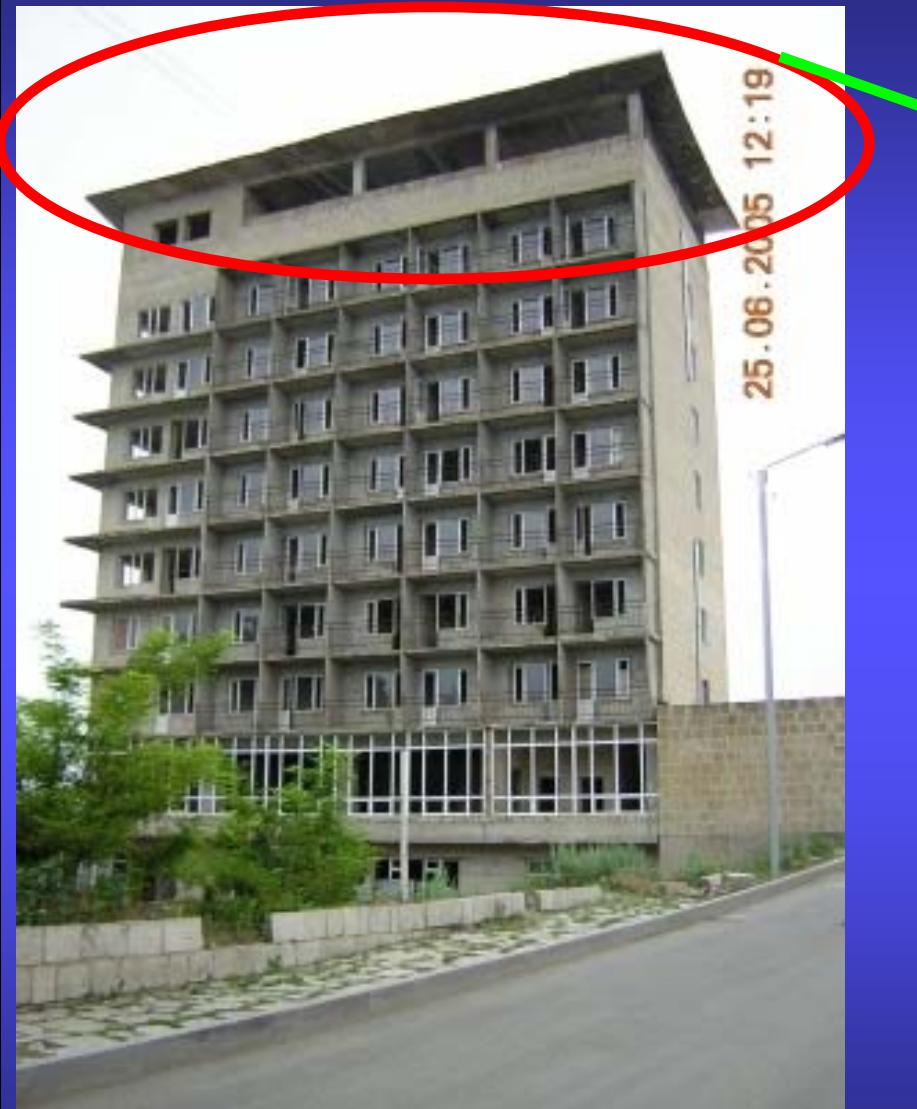
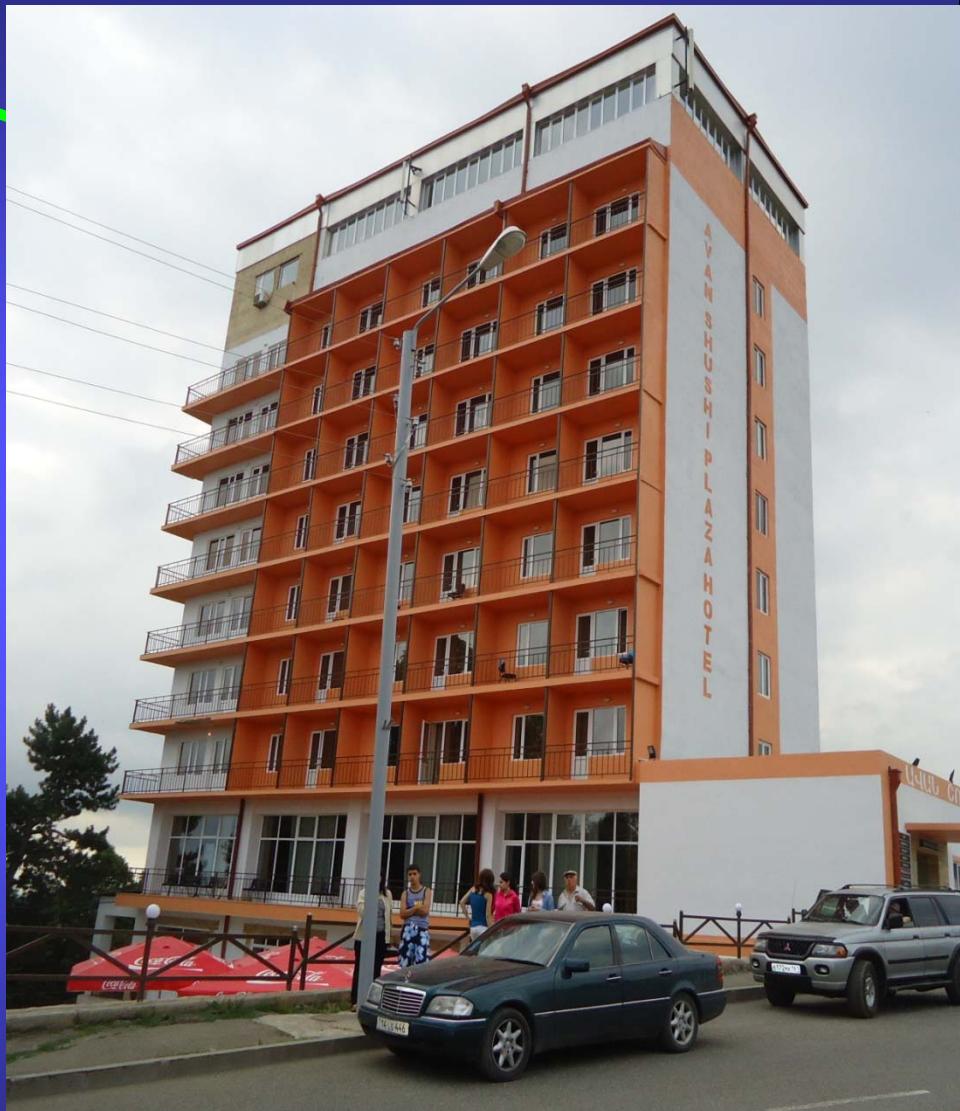
Upper flexible story on rubber metallic bearings

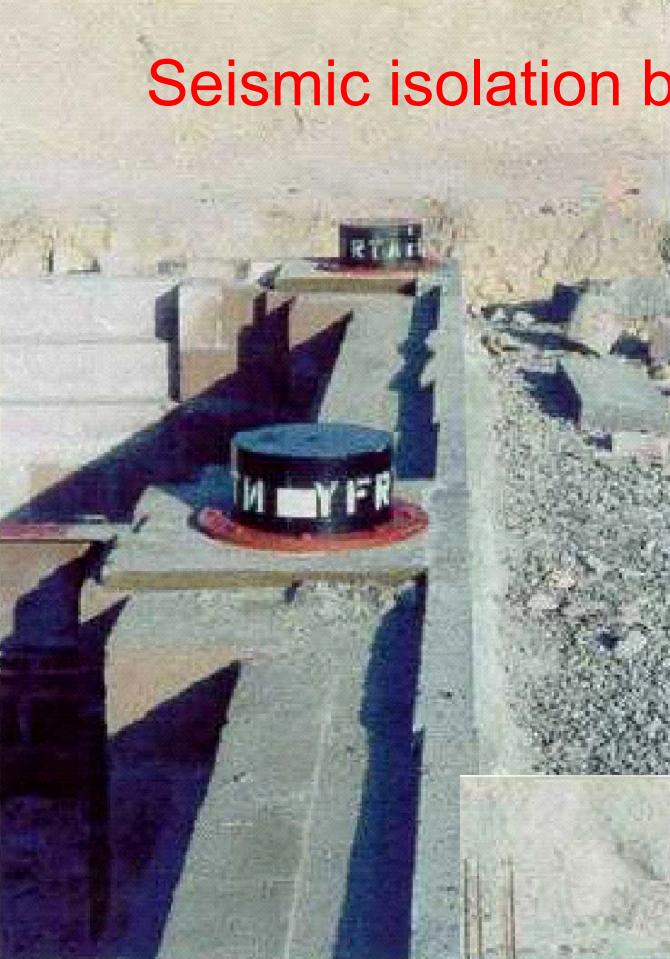
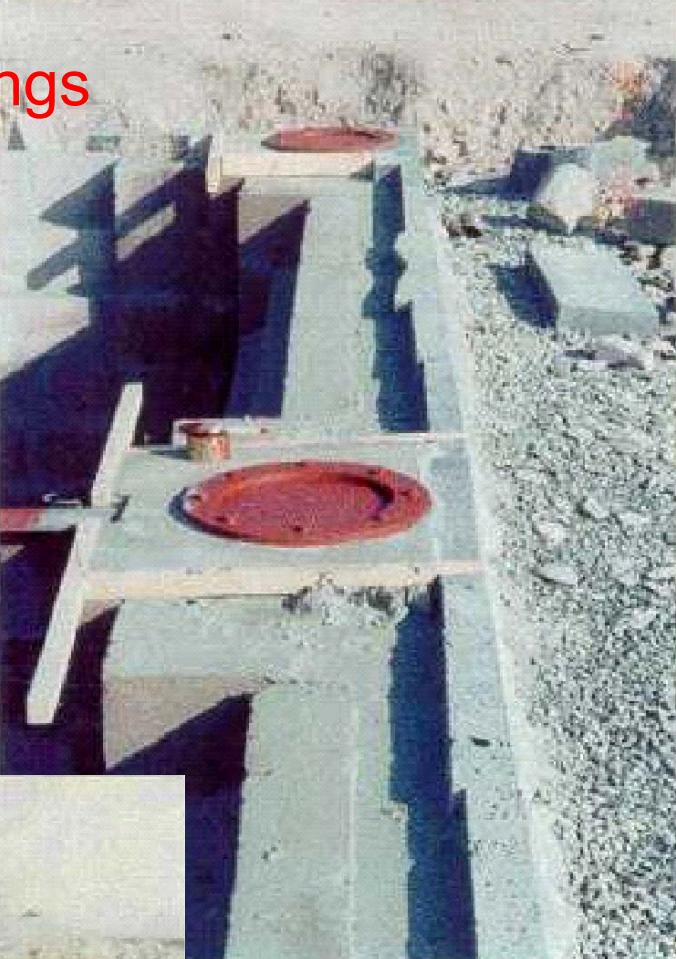
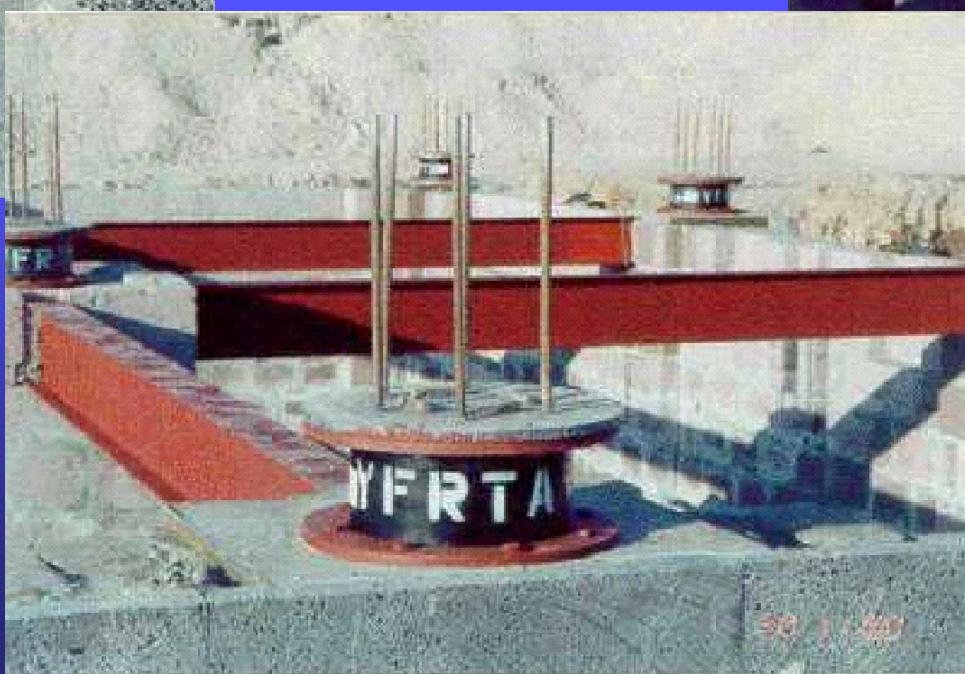
Seismic isolation bearings at the buildings

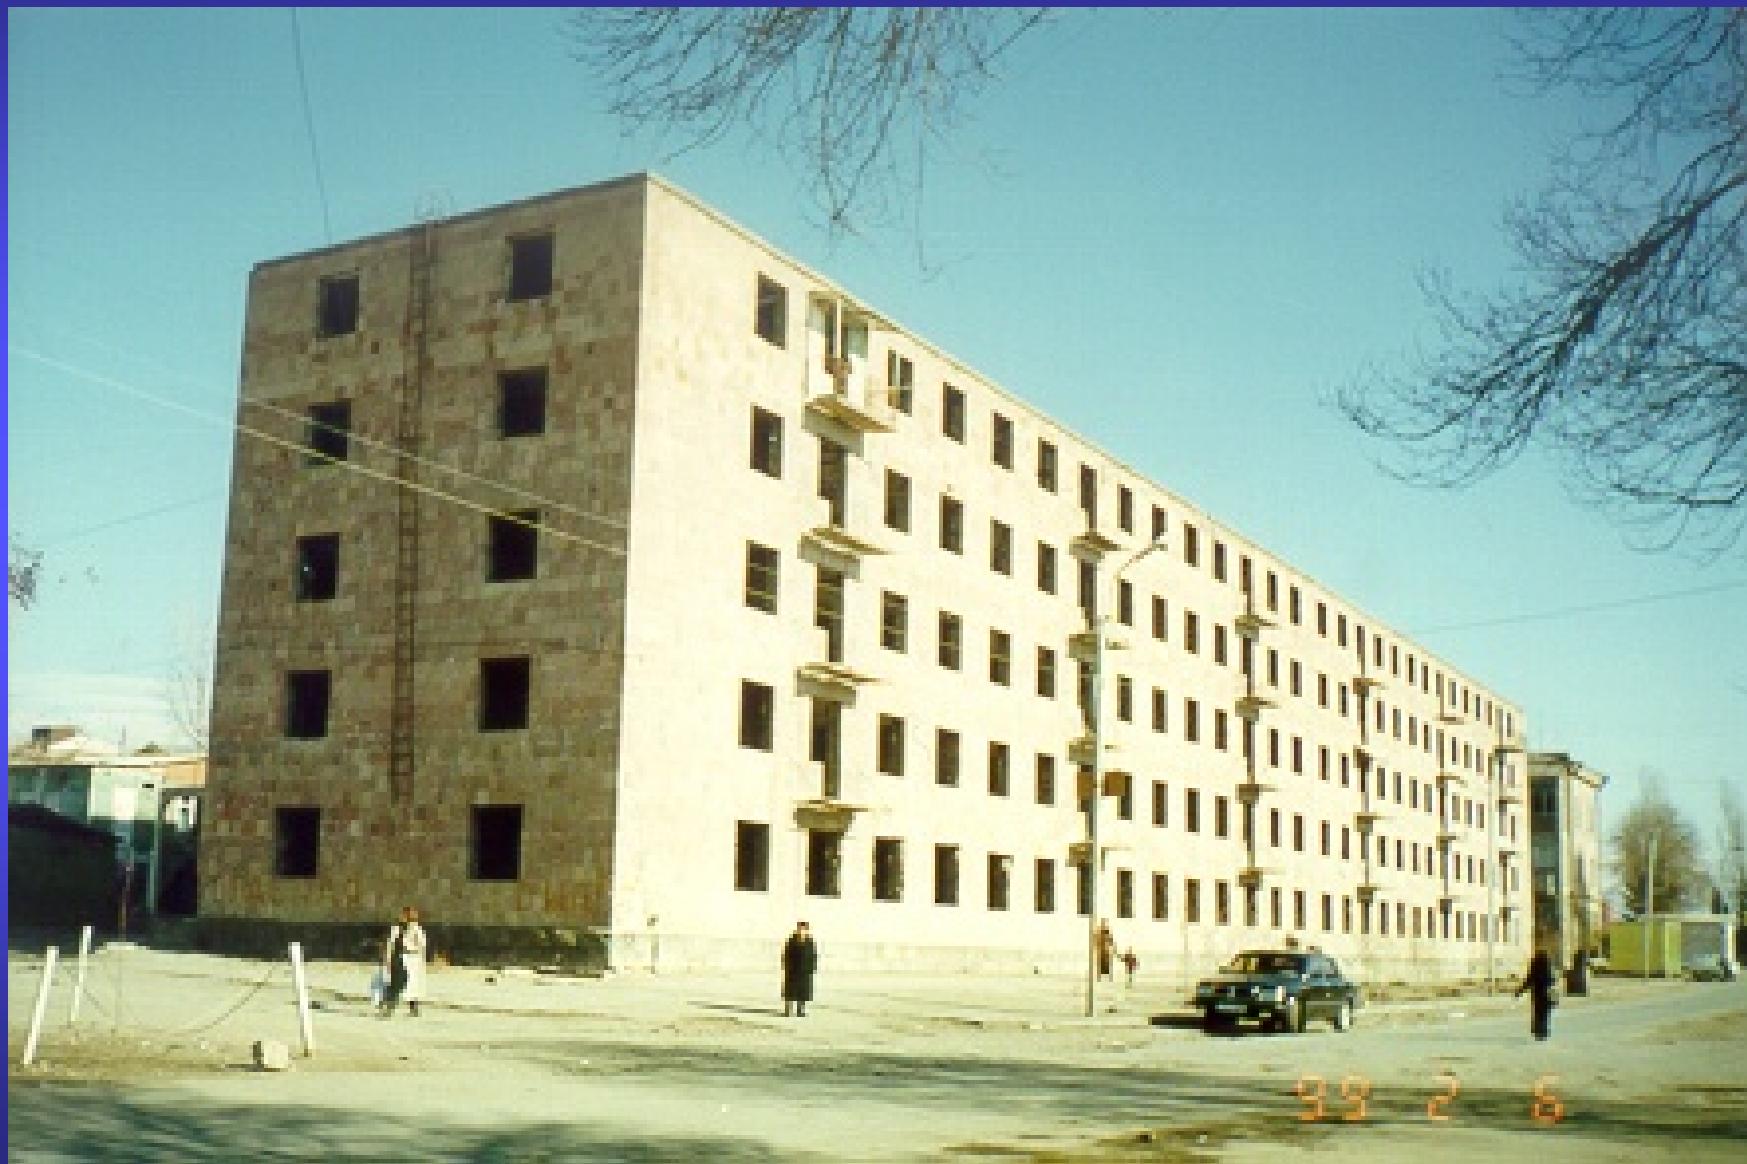
Building before reconstruction

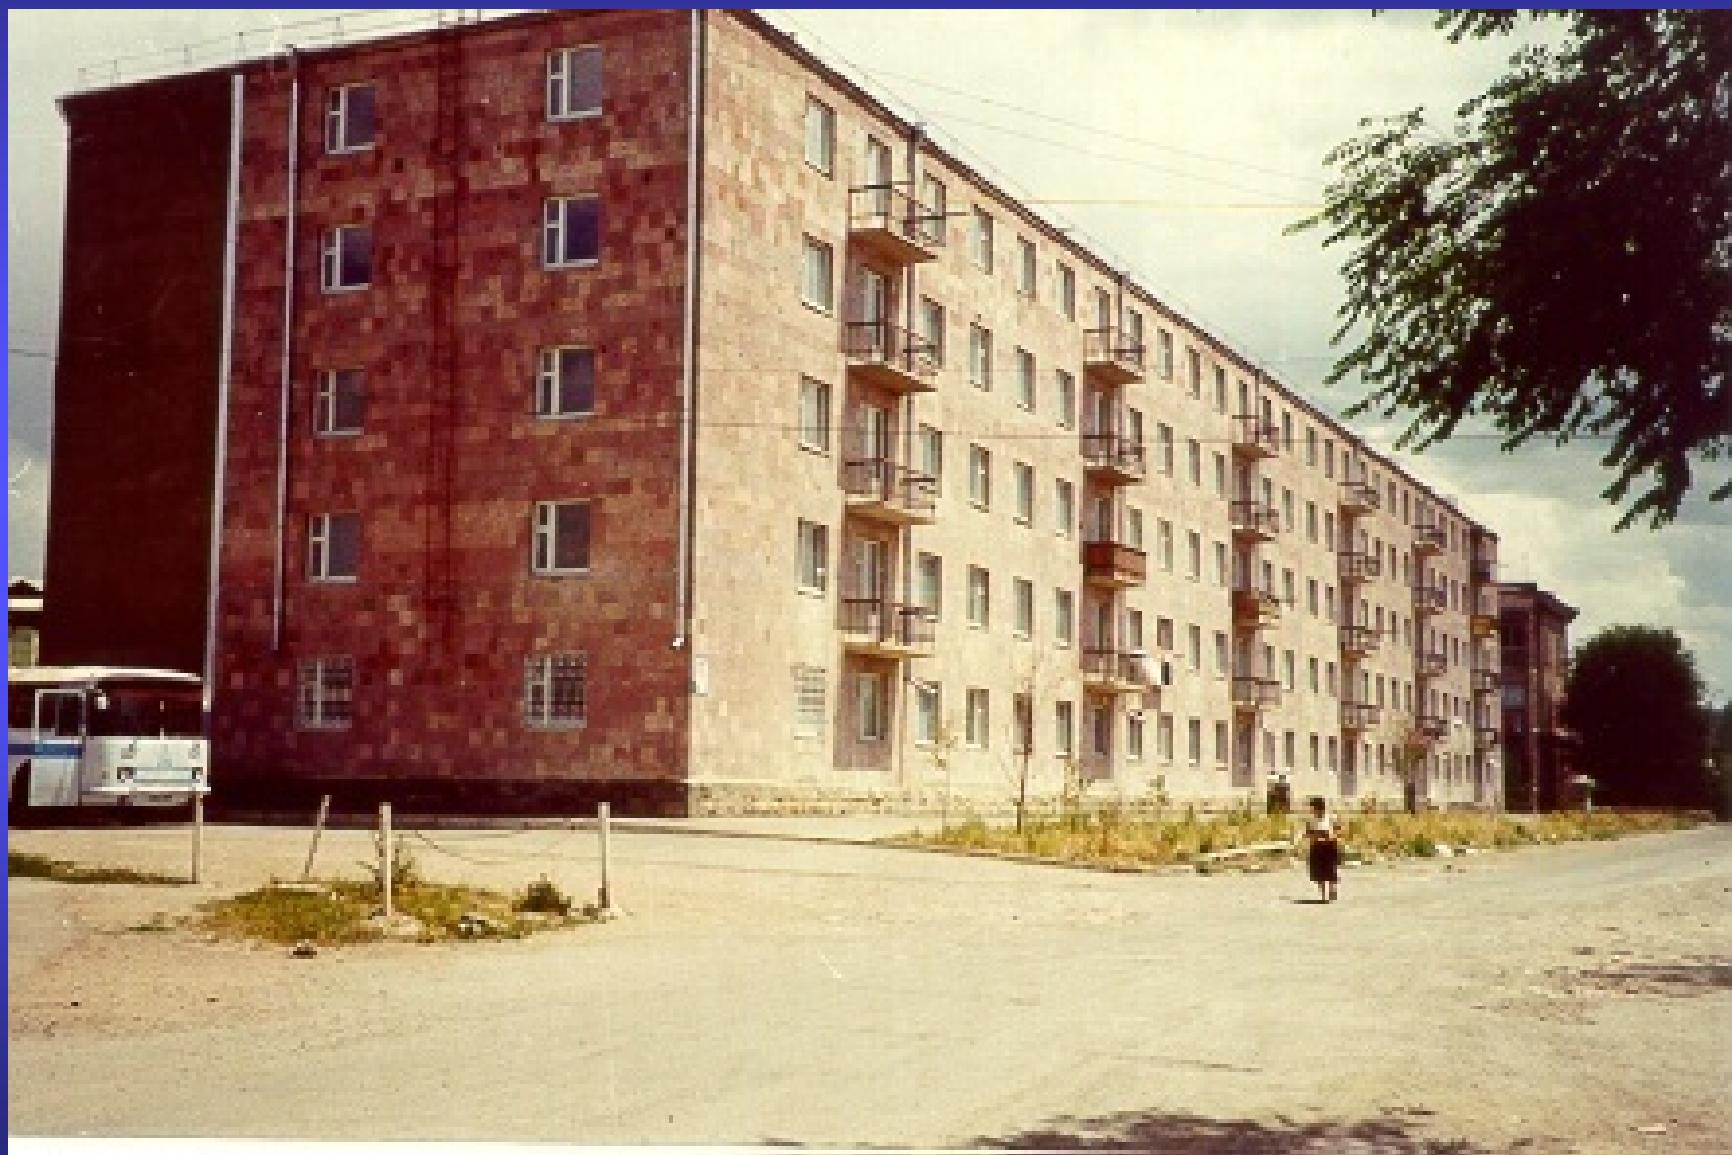
Building after reconstruction
