# TMF safety and management following the Baia Mare accident (2000) Lessons learned and Good Practices

# Baia Mare disaster – 30 January 2000

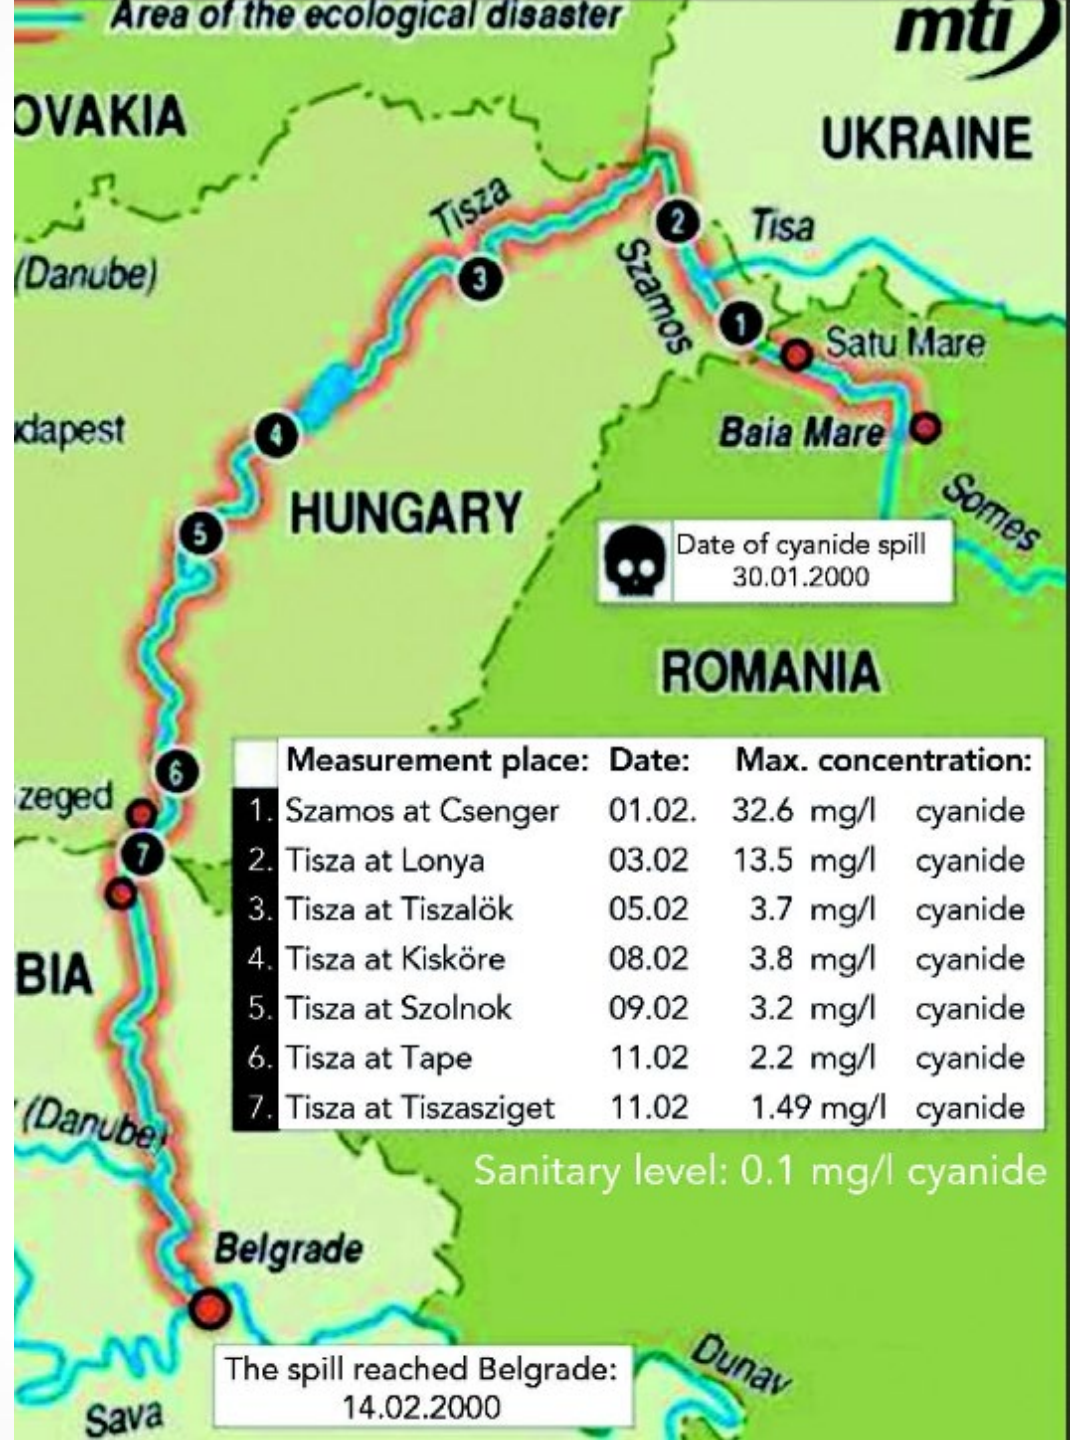
Cyanide concentration measurements in Hungary:
