UNECE WP 6 MARS meeting

Hidden costs of counterfeited products

23 - 25 April 2014 - Belgrade

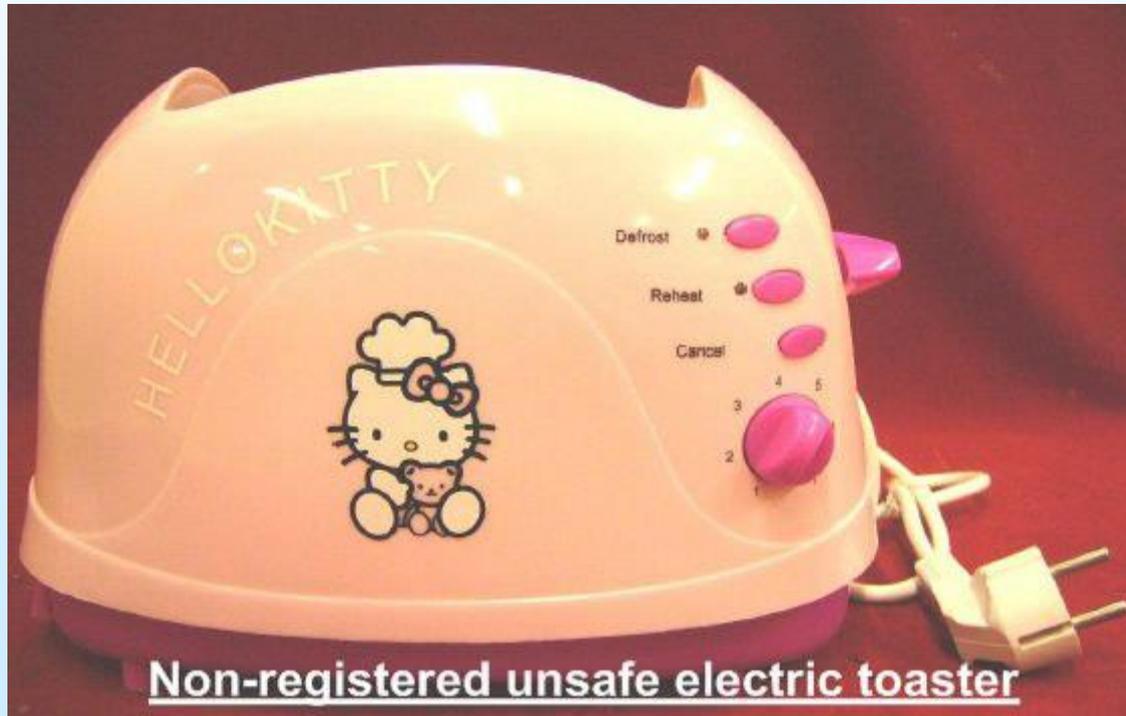
A defective toaster may cause fire in the house

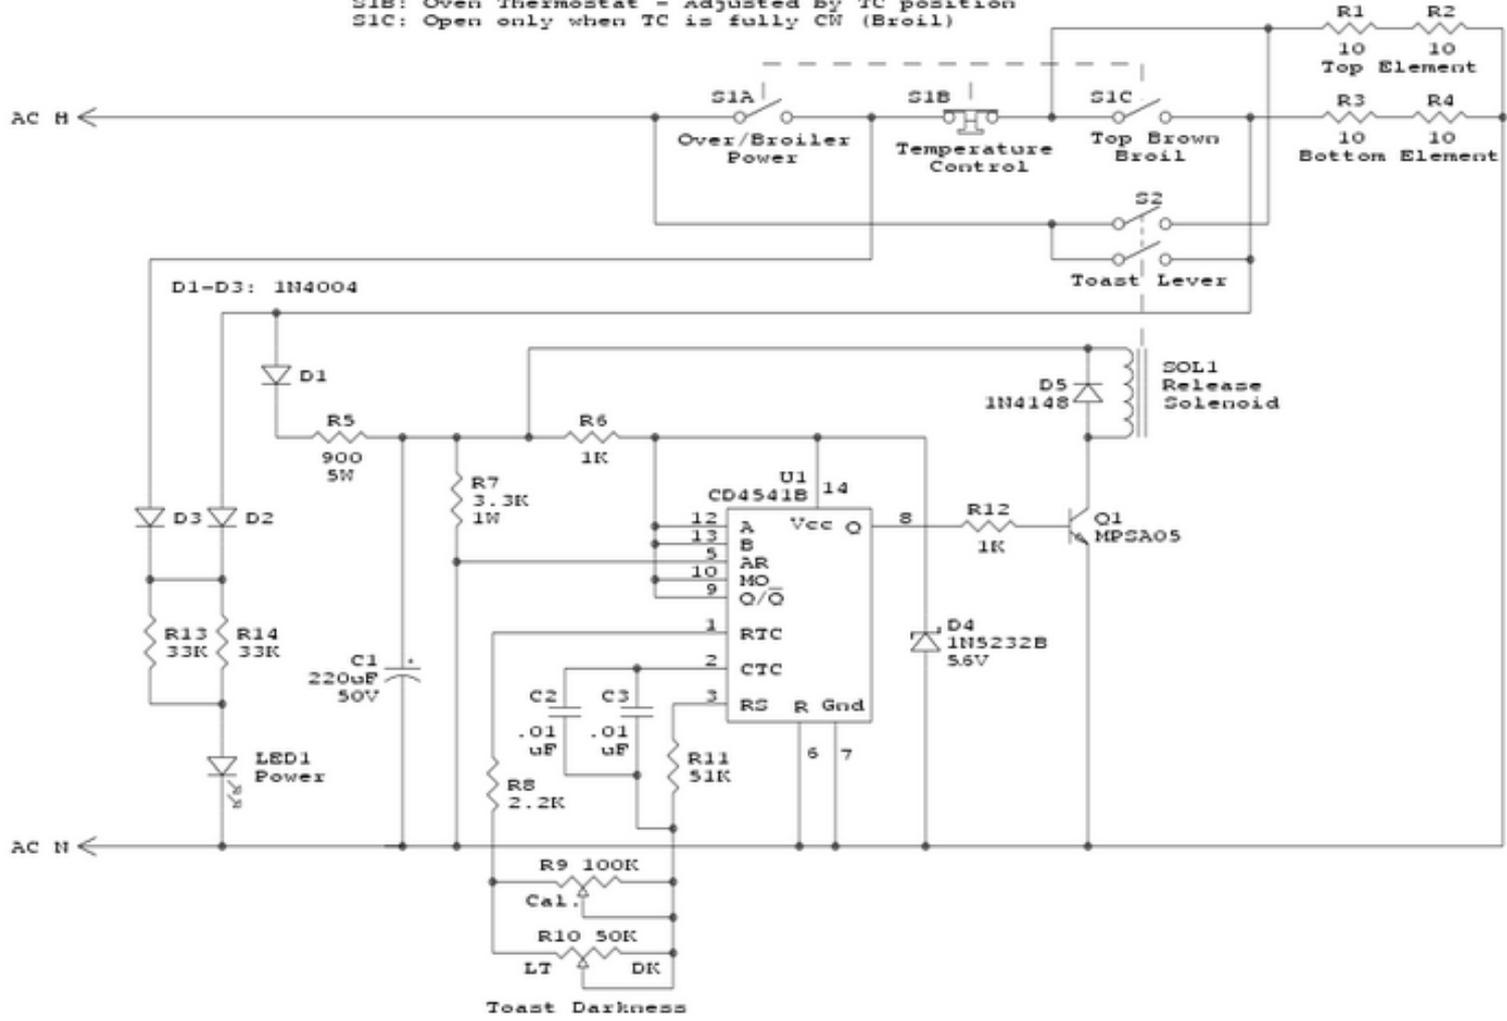
Toaster schematic

S1A,B,C are all part of Temperature Control (TC)

- S1A: Closed except when TC is fully CCW (OFF)
- S1B: Oven Thermostat - Adjusted by TC position
- S1C: Open only when TC is fully CW (Broil)

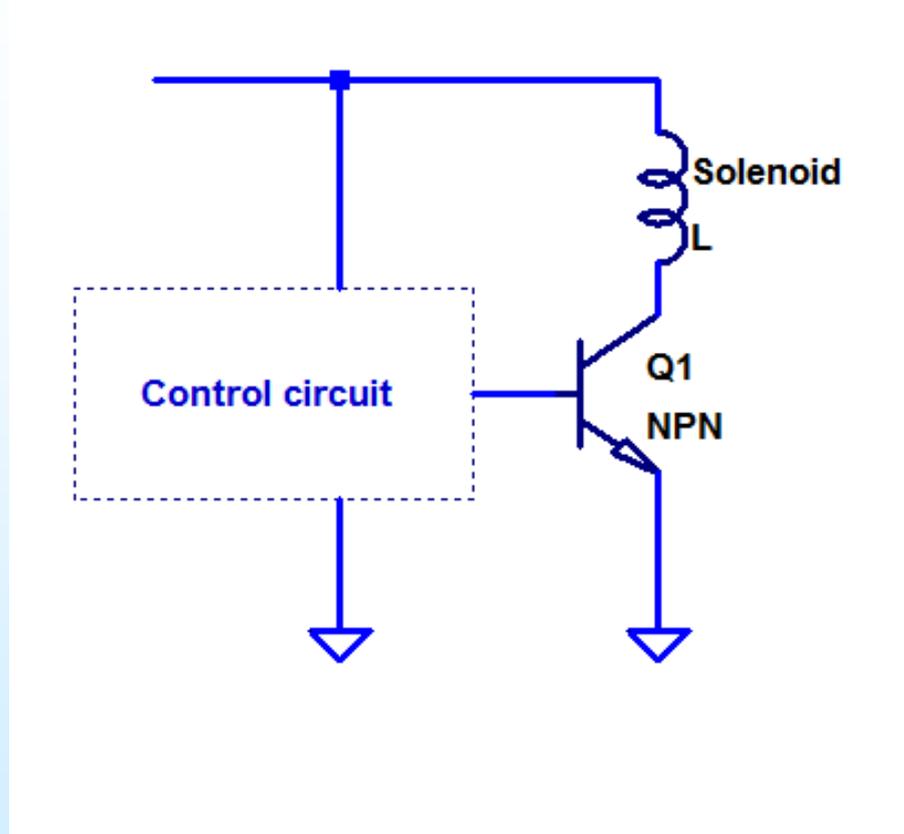
Toaster schematics simplified

The temperature control in the schematic is bypassed when the relay is engaged: the heating elements remain heating because Q1 is short-circuited (= simulated fault: defect through surge).

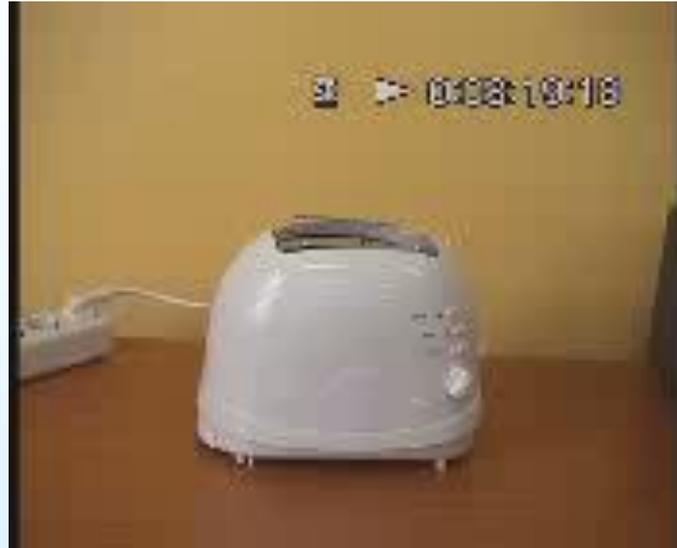
Toaster testing

Clause 19.102 Toasters, loaded with the bread specified for normal operation, are operated at rated power input. The ejector mechanism is prevented from releasing and the supply is maintained to the heating elements after the timer has completed its cycle. The test is terminated after any fire has extinguished, after which any residual bread is removed from the toaster.

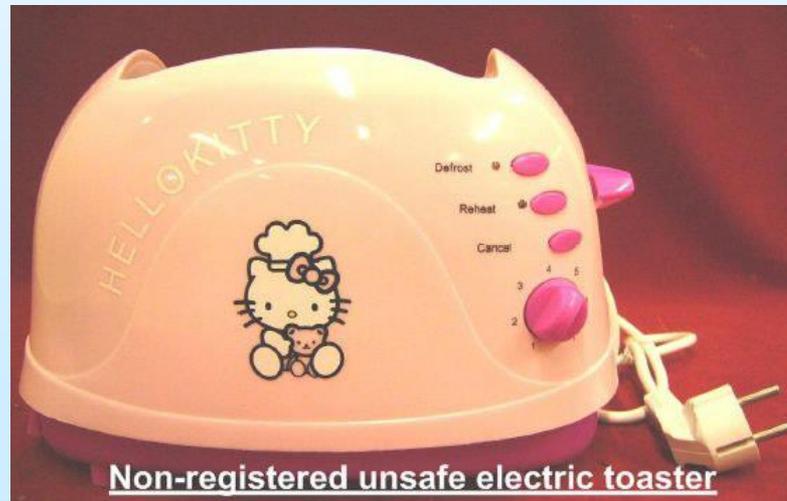
Apparently, the design of the counterfeited product was removed from protective devices like transzorbs or other safety devices, making it cheaper and... dangerous in use.

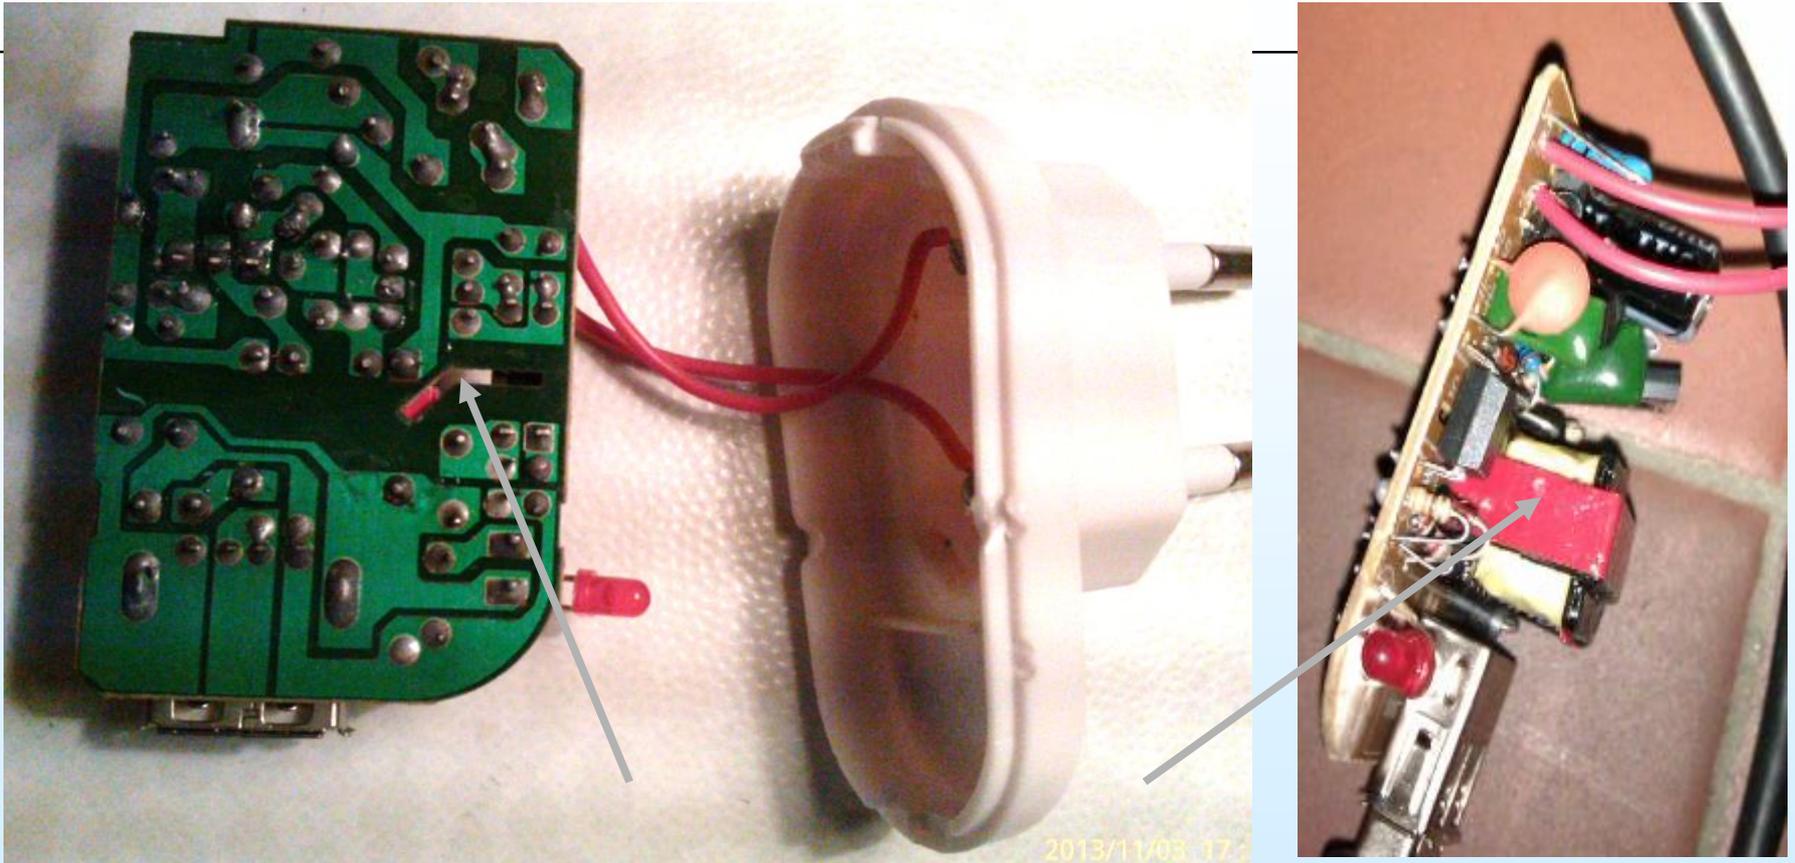
I-phone like charger

The cell phone charger, see above, broke down at 1800V ac, while it should withstand 3000V. The slot on the PCB was made in order to increase creepage distance between the pins of the transformer (visible as a red patch through the slot). Nowadays good chargers may have flying secondary contacts - loose wires, rather than fixed to the PCB, in order to increase the distance. Cl. 5.2 of IEC 60950-1

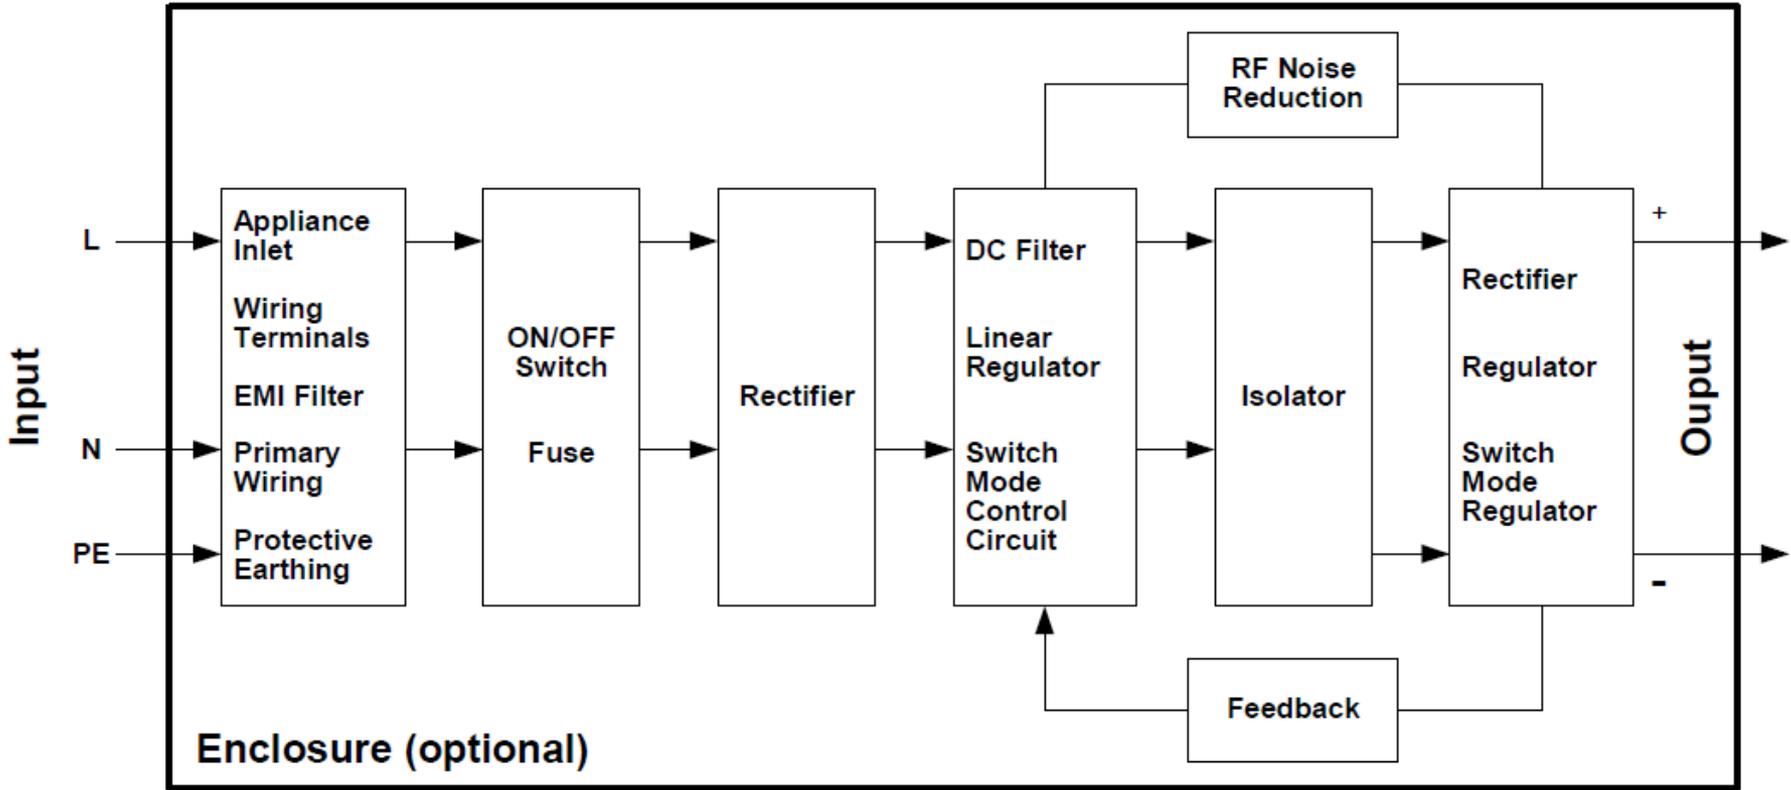
2. I-phone like charger: schematics

Fig. A typical bloc diagram of a power supply

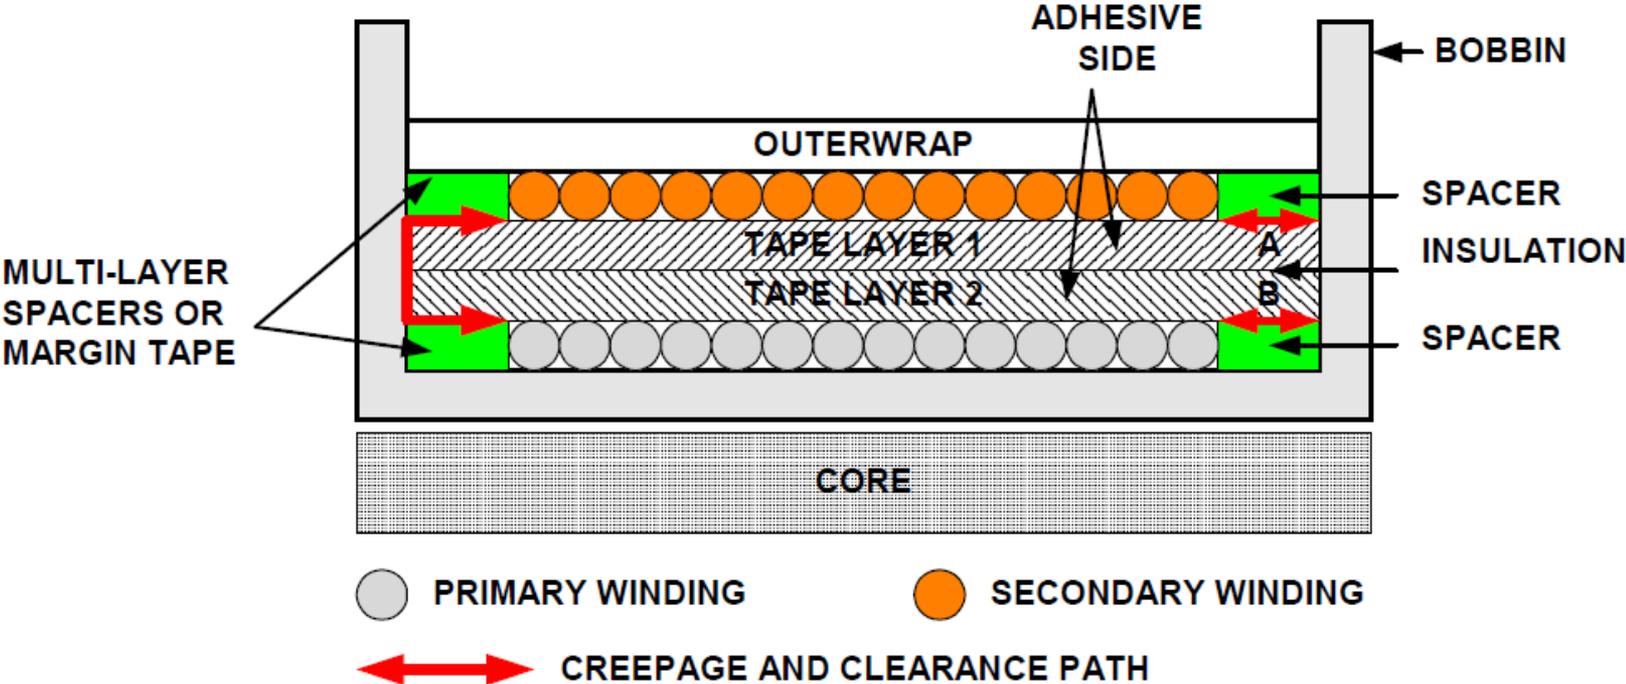
I-phone like charger: transformer construction

Fig. Decrease of insulating distances in an isolating transformer

Again an example that omitting or reducing essential insulation in critical places, may render the product cheaper but also dangerous in use.

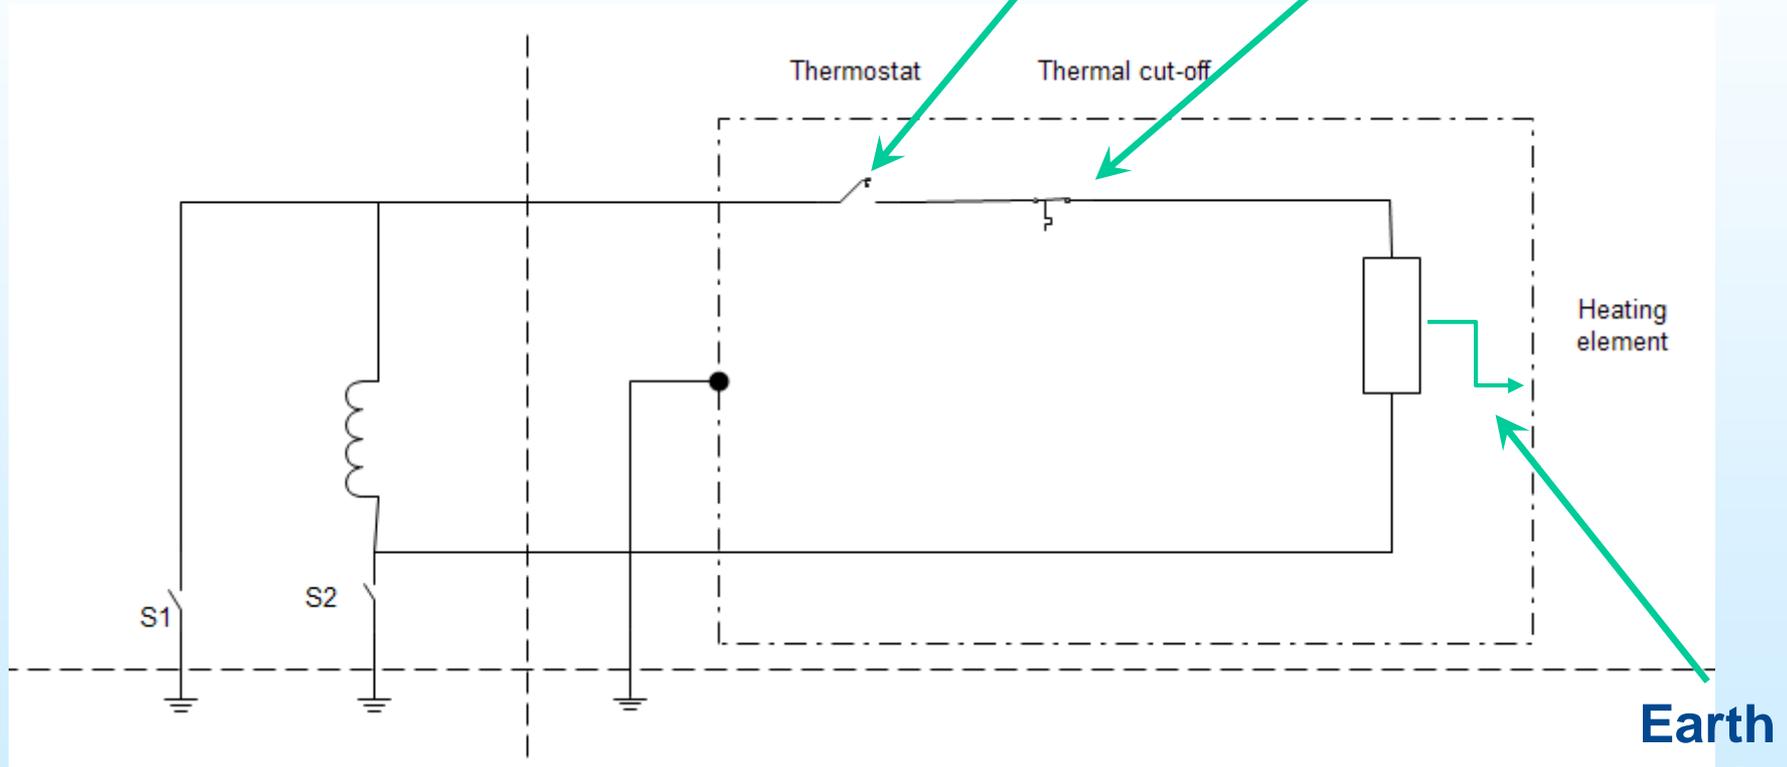
Deep fat fryer schematics

Both temp. controllers
are in same phase

Fig. A bloc diagram of a potentially unsafe deep fat fryer, depending polarity of the mains (S1 or S2 closed)

Cl. 19 of IEC 60335-2-13

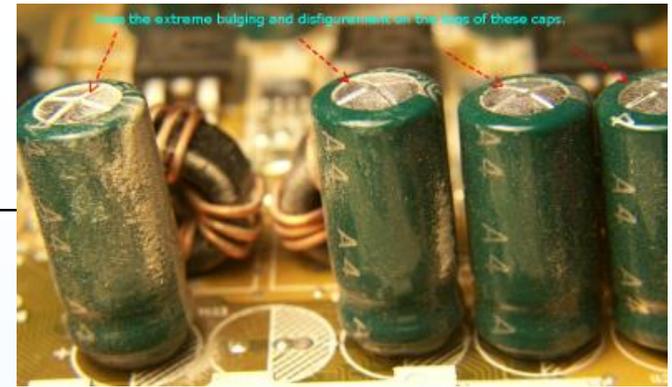
Faulty electrolytic capacitors

A counterfeit issue in Asia caused damage in a large number of power supplies of computers already on the market in 2002. After a few hours of operation of the counterfeited capacitor, the electrolyte would leak hydrogen gas, before bursting the metal body of the capacitor. The electrolyte would then leak its brownish filling and could cause a fire.

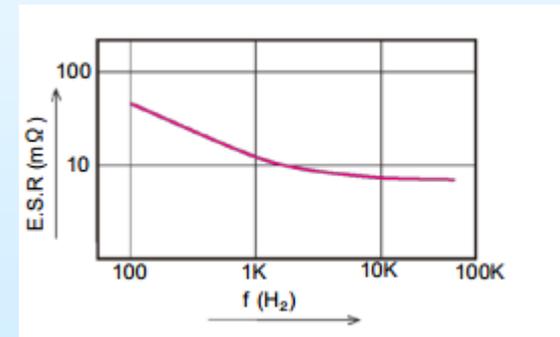
Safety issue: ESR versus frequency

Tantalum capacitors have an equivalent series resistance (ESR) ten times smaller than the ESR of aluminium electrolytic capacitors, which allows for larger currents to pass through the capacitor with less heat generated

Just replacing a tantalum by an electrolytic capacitor, may lead to excessive heating, eventually to a fire in the equipment.

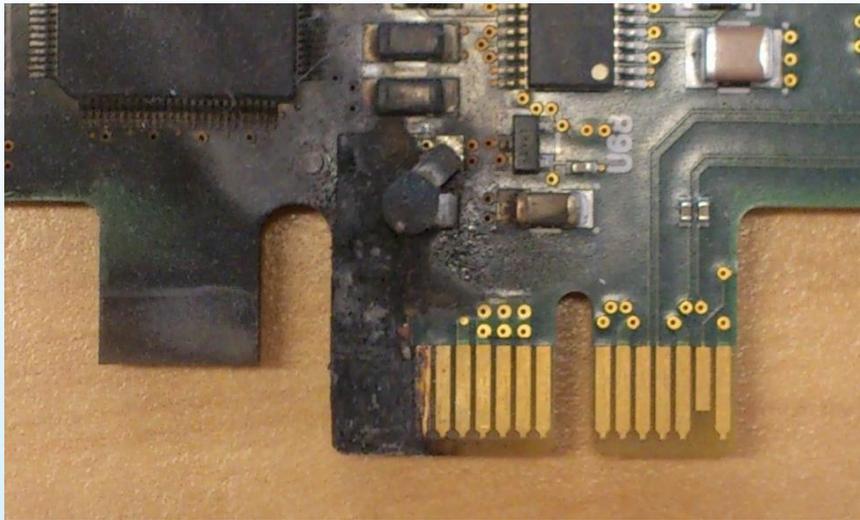
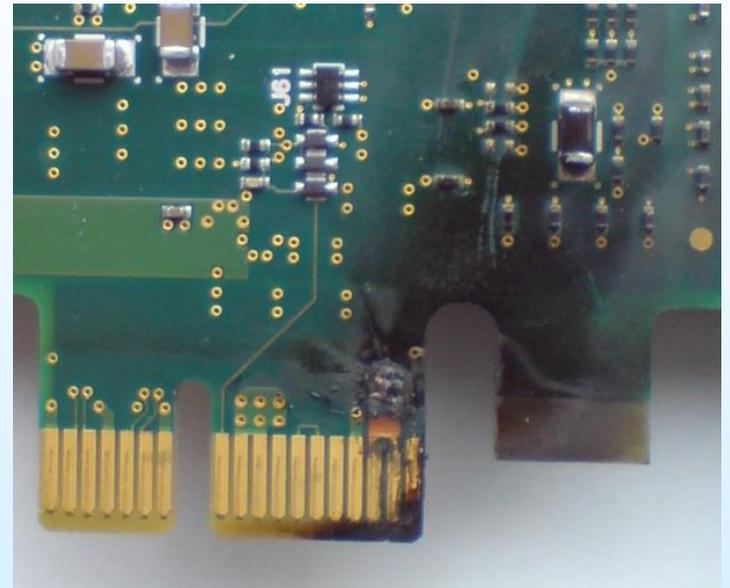
Counterfeited plug-in card

Photos of counterfeited plug-in card product fire issue
