Door Lock and Door Retention Components

A Canadian Perspective

September 3, 2002

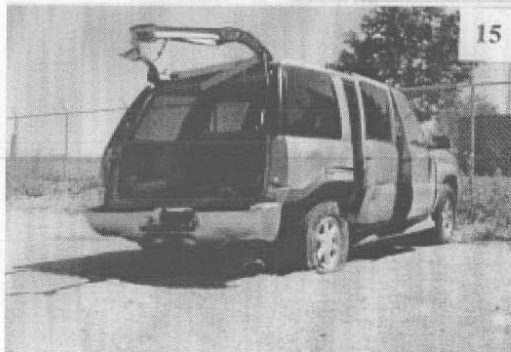
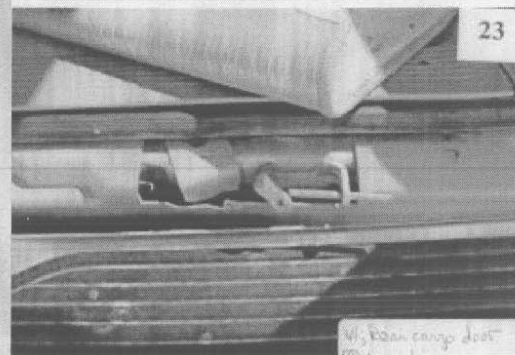
2000 Cadillac Escalade (CHI2 1515)

Rear cargo door failure one occupant was ejected

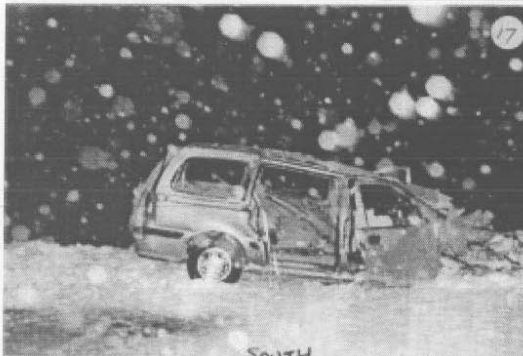
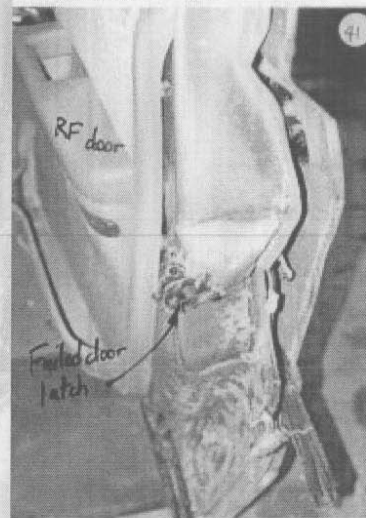
2000 Chevrolet Venture
(LTVS 1296)

Sliding side door separation and Rear cargo door failure
three occupants were ejected

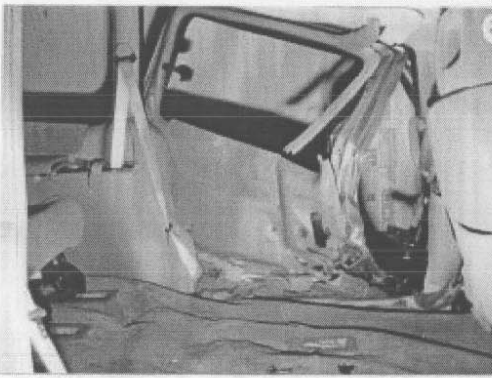
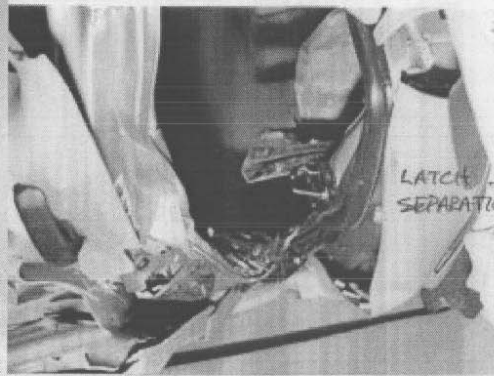
2001 Pontiac Montana (SID4-1606)

Seat anchorage failure followed by side door latch separation, one occupant partially ejected

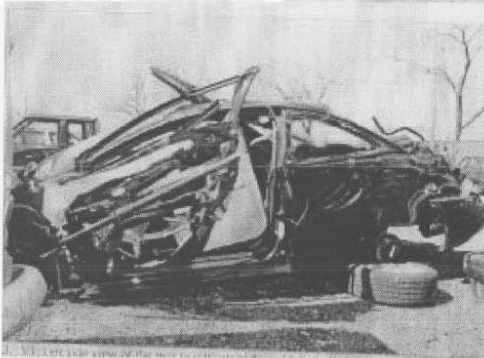
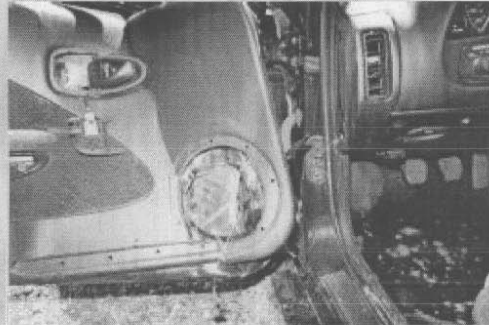
1997 Saturn SC2 (ASF2-1915)

Driver side door failure, one occupant was ejected

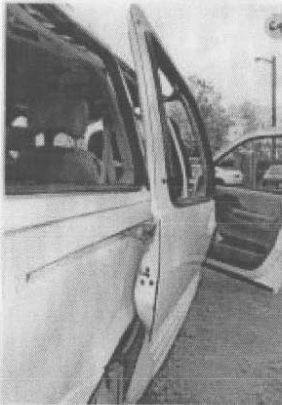
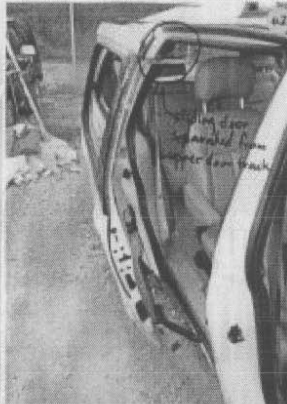
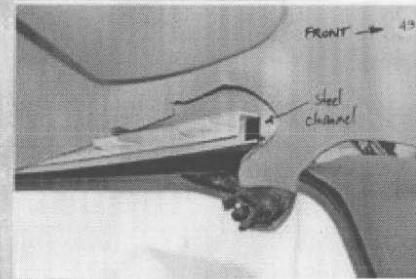
1999 Oldsmobile Silhouette (LTVS-1273)

Sliding side door failure, two occupants were ejected

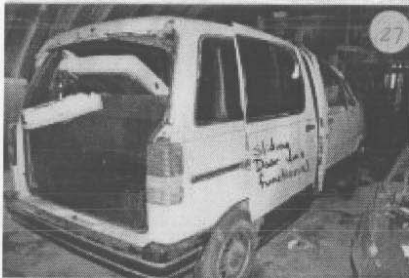
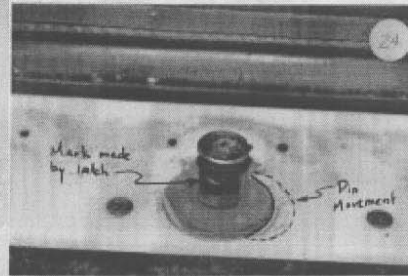
1992 Ford Aerostar XL (LTVS-1206)

Rear door failure

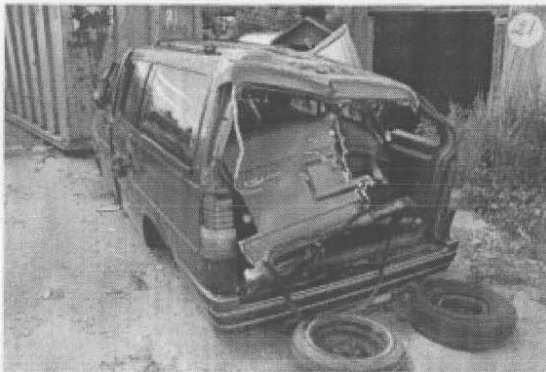
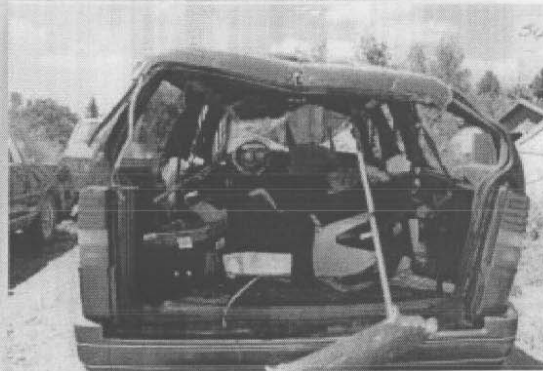
1993 Ford Aerostar XL (LTVS-1280)

Rear door failure, one occupant was ejected

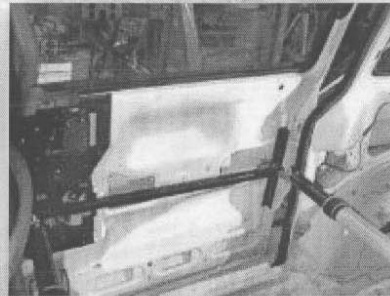
Inside view of the sliding door, post-test

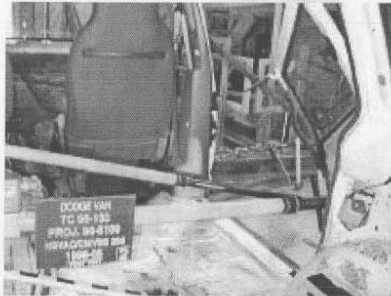
Inside view of the sliding door after maximum load test

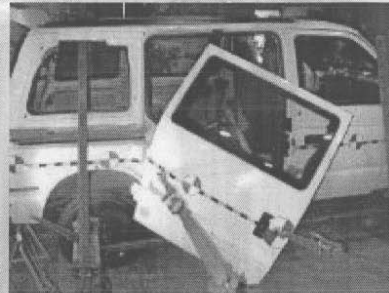
Outside view of the sliding door after maximum load test

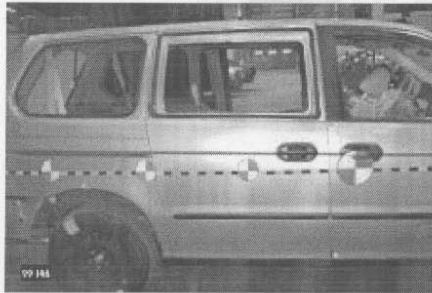
Outside view of the sliding door, pre-test

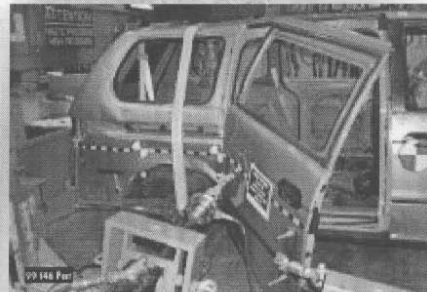
Outside view of the sliding door, post-test

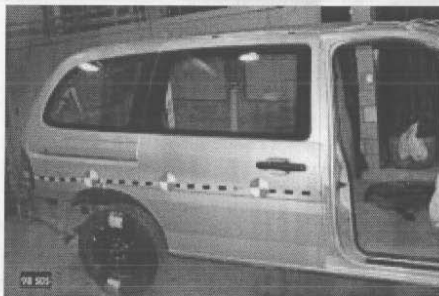
Outside view of the sliding door pre-test

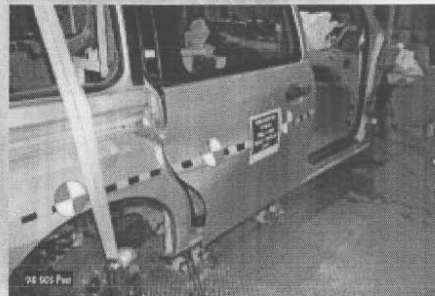
Outside view of the sliding door post-test

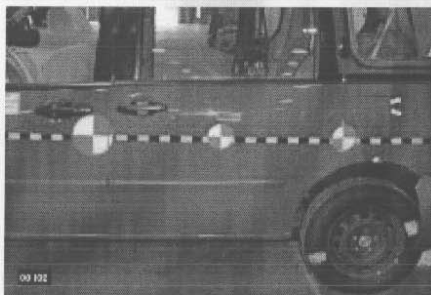
Outside view of the sliding door pre-test

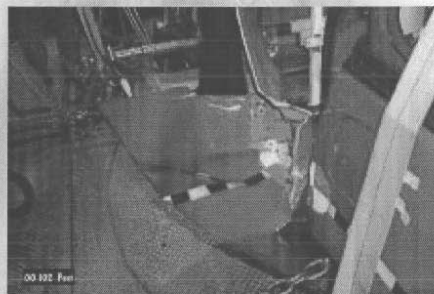
Outside view of the sliding door post-test

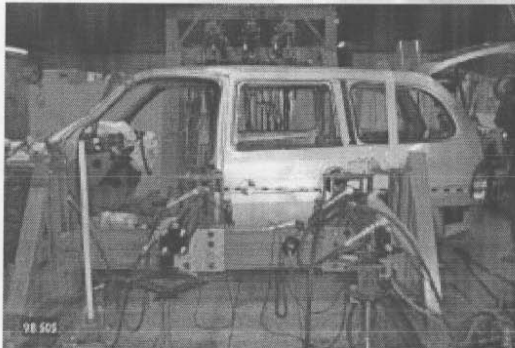
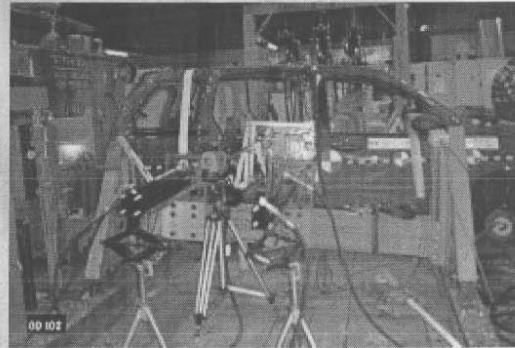
View of the test vehicle on the vehicle test structure

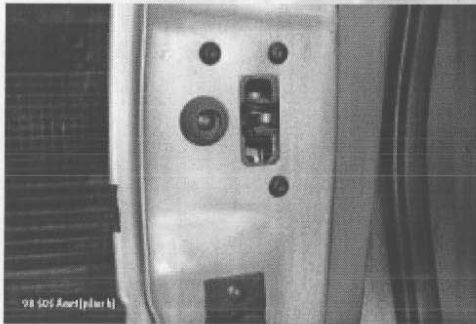
B Pillar door latch

Pre-test

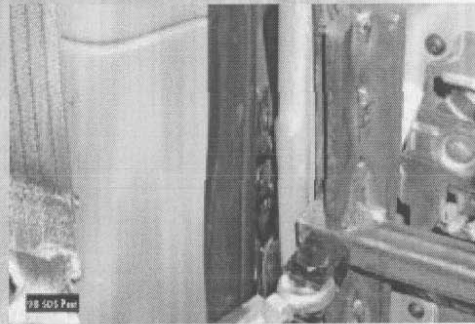
Post-test

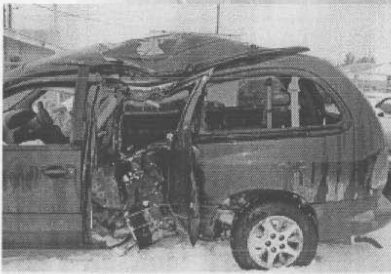
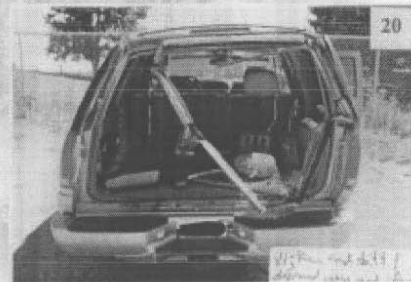
- Rear minivan and SUV hatch doors continue to fail in field
- Sliding side doors with pin type latches do not provide structural integrity
