ST/SG/AC.10/C.3/2008/47
14 April 2008

Protection of shell and service equipment on portable tanks

Transmitted by the expert from Australia*

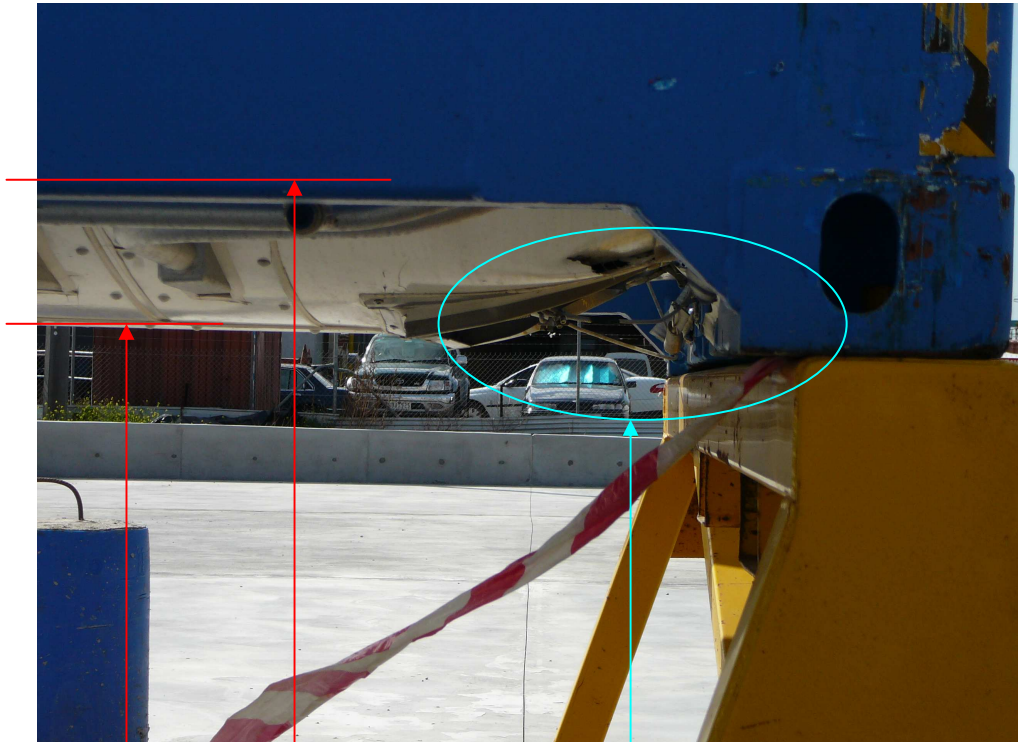
5. The design of the portable tank was such that the bottom of the valve structure, vent fittings and shell insulation all sat below the line of the longitudinal side rails. When the tank was landed without being properly aligned on the cradle, the load was taken by the bottom of the tank and valve (see photograph below). The same situation would occur if the tank had been landed on top of another container in the same manner, noting portable tanks are stacked in ship board stows and container terminals, so the risk is not isolated to the use of materials handling equipment such as pin cradles.

Bottom of the tank insulation
and the lower portion of valve

Longitudinal side rail

Area where the tank
landed on the pin cradle
Note: valve has been
removed

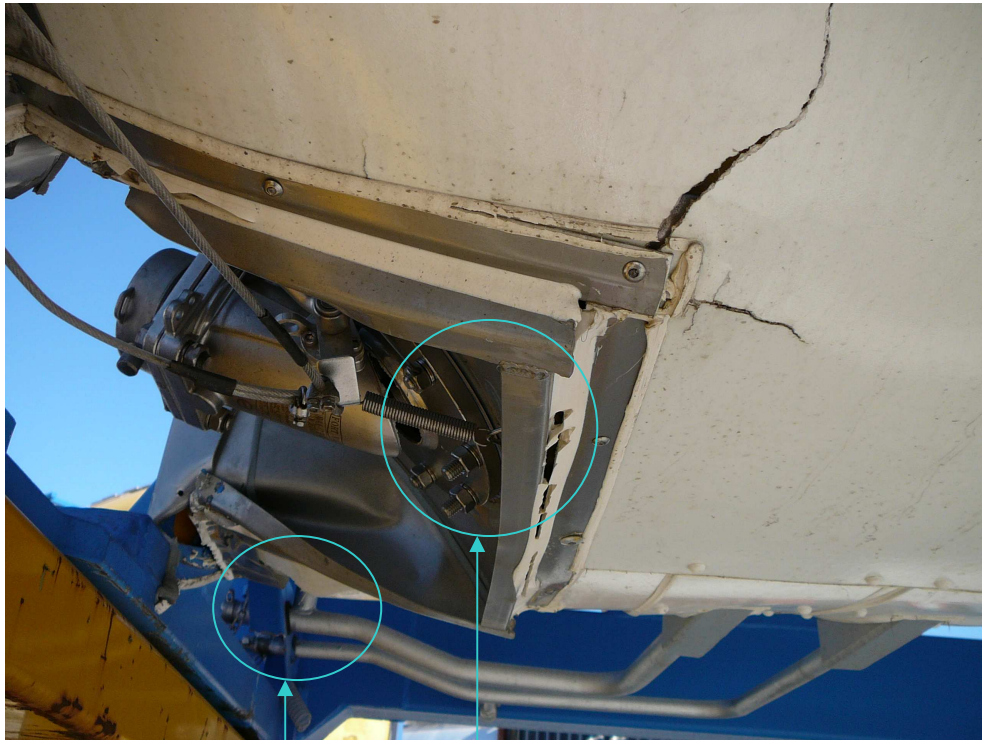
6. As a result of the landing, the insulation and vent lines were pushed up and a securing bracket on the vent lines was sheared. More seriously, the valve stem was pushed up and sheared off at the flange. The impact was also sufficient to displace the internal stop valve resulting in a slow leak of the contents from the tank. While compliance with section 6.7.2.6.3 should have prevented displacement of the foot valve, it appears the amount and type of damage to the valve stem may have made the leak inevitable. The level of protection of the valve stem was a major factor in this incident.

Damaged Valve stem

Displaced vent line and sheered bracket

7. It was determined by the Australian authorities that the tank did not comply with the requirements of the UN Model Regulations/IMDG code with respect to 4.2.1.2 (protection of the shell) and section 6.7.2.5.1 (protection of service equipment against the risk of being wrenched off or damaged during handling and transport).

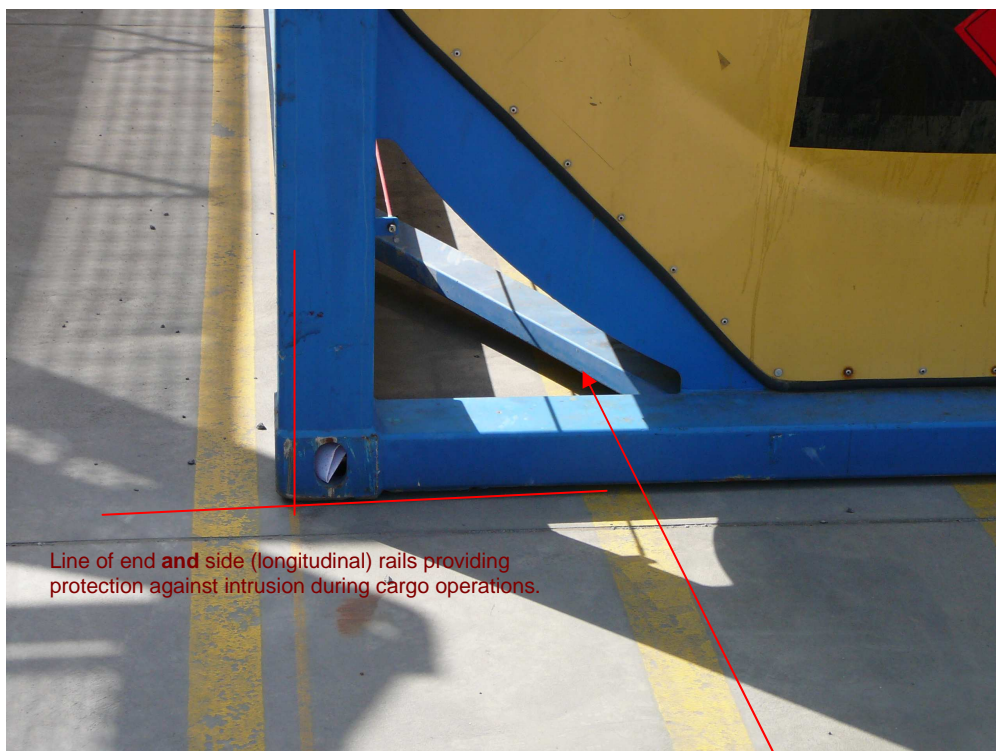
9. During investigation of this incident Australian authorities examined other tanks to assess the level of protection provided to bottoms openings and fittings. In many examples the level of protection provided was much greater than that provided for the tank involved in this incident. In most cases, the arrangement of longitudinal rails, end rails and/or corner braces was such that intrusion into the area surrounding the valve and fittings by handling devices such as pin cradles or while stacking, would be prevented. An example is provided in the following image.

Line of end and side (longitudinal) rails providing protection against intrusion during cargo operations.

Additional protection provided by corner cross brace set just above the line of the side and end rail.

(e) *Protection against vertical impact which may consist of enclosures, fenders, corner braces and appropriately positioned longitudinal and end rails.*
