### CONCLUSIONS OF A SEVER ACCIDENT

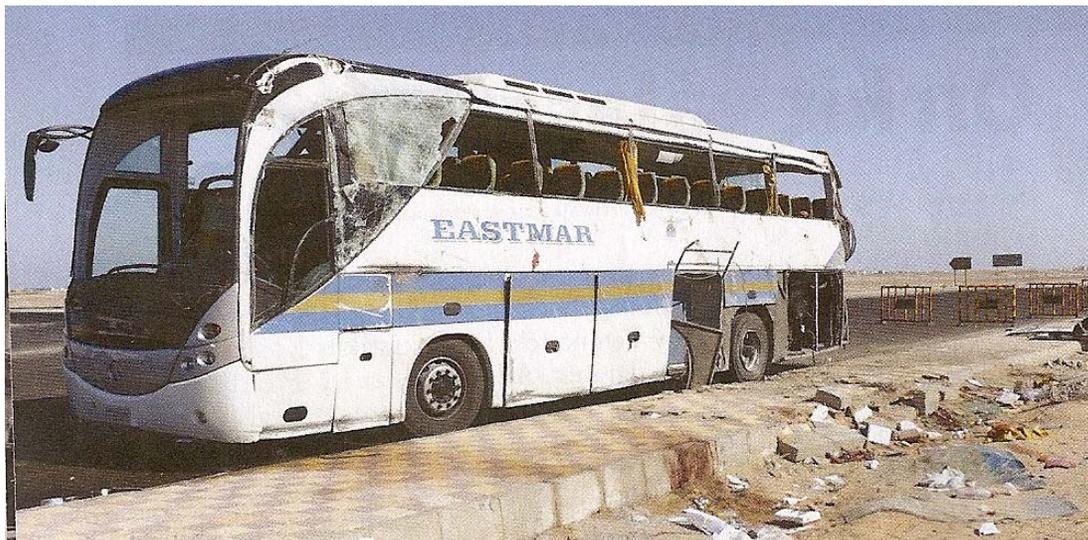
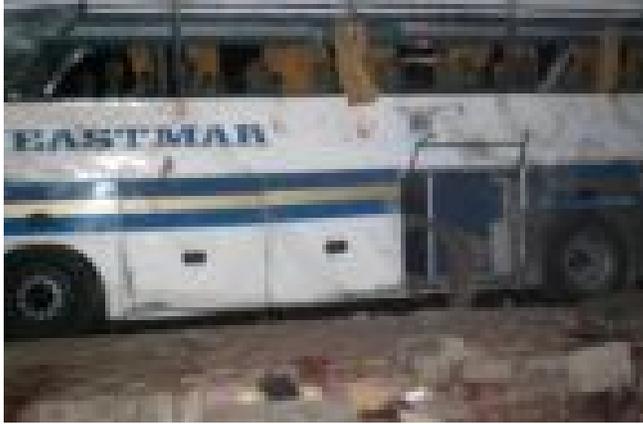
3. The superstructure was strong enough, no significant structural deformation. The casualties were caused by ejection of the passengers, mainly by partial ejection. This was said by the doctors and by the surviving passengers. All the side windows were broken, the outside panel of the side wall and the ground was covered with blood. The surviving passengers said that all passengers fell onto the left side of the bus, compressing the people sitting next to the window to the window and to the road surface and they were rased and ground by the broken glass fragments and by the ground. (see the bloodstains on the side wall panels and on the ground)

- 6.1. if the superstructure is strong enough, there are no significant, large scale structural deformations, so the survival space remains intact, the most dangerous injury mechanism: the intrusion and compression is avoided.

- 6.2. but there is no solution for the second most dangerous injury mechanism: ejection of passengers (both total and partial ejection shall be considered)

- the use of laminated glazing in side windows
  - to reconsider the necessity of side window as emergency exit and the usability of breakable side window as emergency exit

- to study the effectiveness of the safety belts in rollover
  - to consider all the possible injury mechanisms together in rollover
8. Hungary is planning to provide two documents to GRSG on its October session:
