**BUREAU  
VERITAS**

**B.L.E.V.E TEST REPORT**

# Test Description

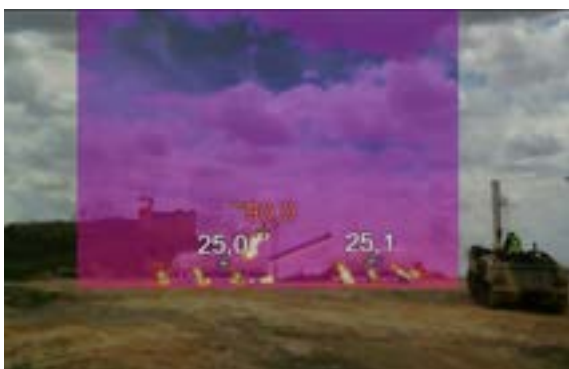
PHOTO N° 1  
23/05/2019 13:39:55

Max Temp.	~90,0°C
A Fuel Tank Temp.	25,1°C
B Fuel Tank Temp.	25,0°C

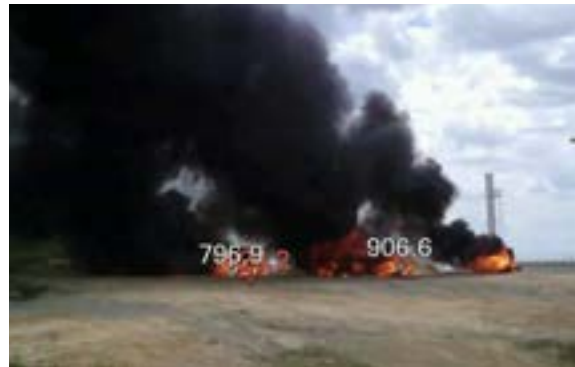
PHOTO N° 3  
23/05/2019 13:41:20

Max Temp.	1029,7°C
A Fuel Tank Temp.	923,5°C
B Fuel Tank Temp.	966,5°C

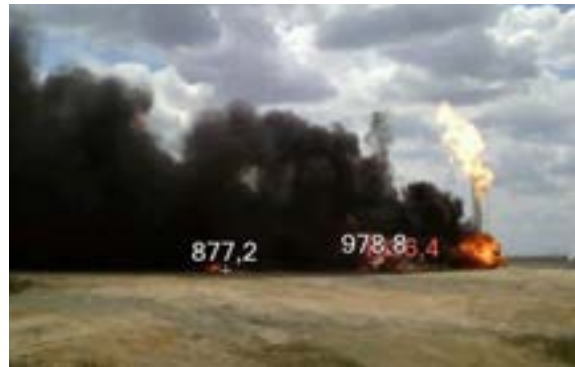
PHOTO N° 5  
23/05/2019 13:43:38

Max Temp.	1081,2°C
A Fuel Tank Temp.	983,8°C
B Fuel Tank Temp.	1019,9°C

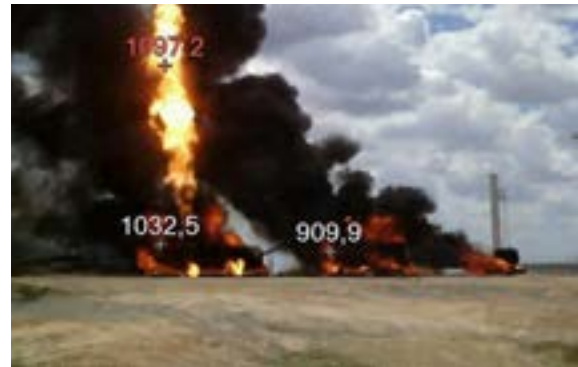
PHOTO N° 9  
23/05/2019 13:47:48

Max Temp.	1121,5°C
A Fuel Tank Temp.	891,0°C
B Fuel Tank Temp.	950,8°C

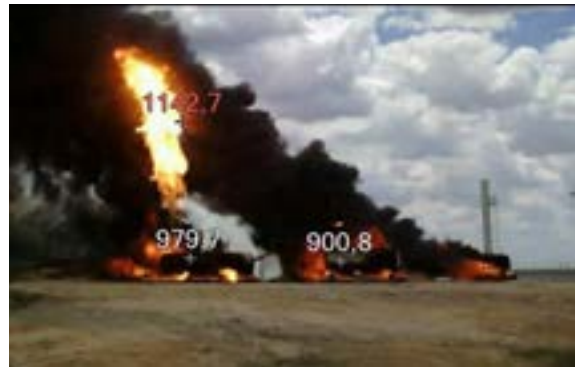
PHOTO N° 11  
23/05/2019 13:49:46

Max Temp.	1128,9°C
A Fuel Tank Temp.	953,6°C
B Fuel Tank Temp.	1013,7°C

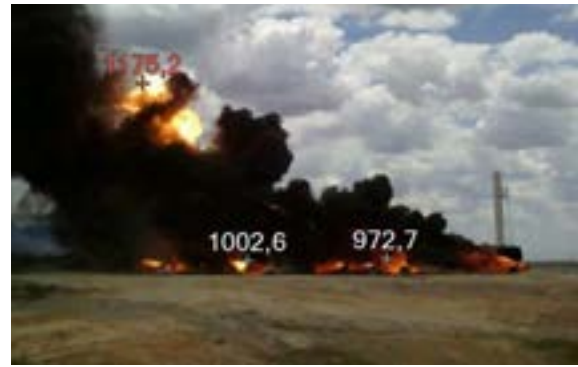
PHOTO N° 13  
23/05/2019 13:51:42

Max Temp.	1143,2°C
A Fuel Tank Temp.	920,6°C
B Fuel Tank Temp.	1013,1°C

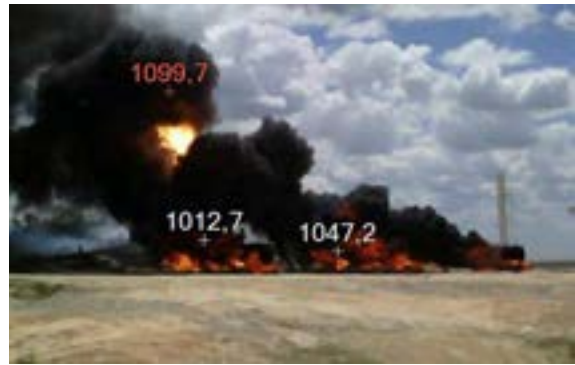
PHOTO N° 15  
23/05/2019 13:53:28

Max Temp.	1136,7°C
A Fuel Tank Temp.	976,7°C
B Fuel Tank Temp.	1081,3°C

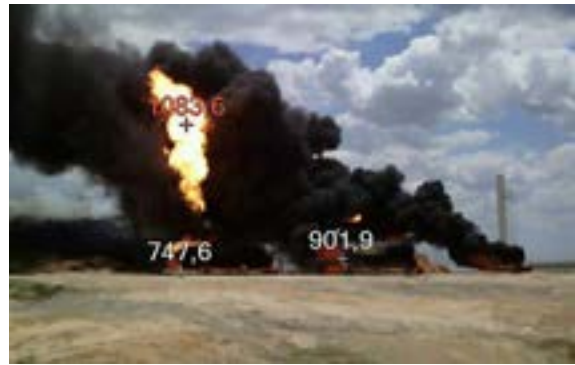
PHOTO N° 19  
23/05/2019 13:57:51

Max Temp.	1093,8°C
A Fuel Tank Temp.	959,5°C
B Fuel Tank Temp.	1018,8°C

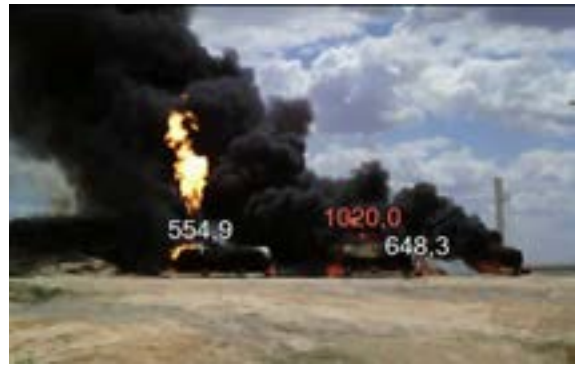
PHOTO N° 21  
23/05/2019 13:59:47

Max Temp.	1132,8°C
A Fuel Tank Temp.	737,2°C
B Fuel Tank Temp.	733,2°C

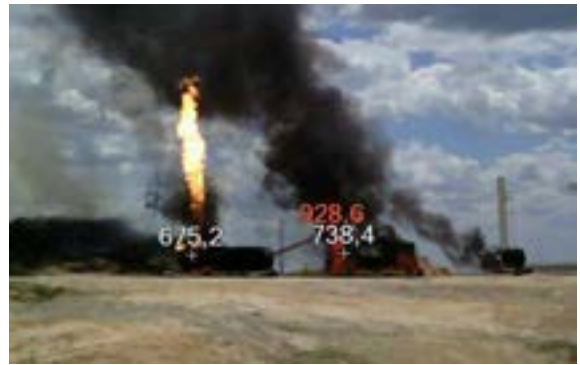
PHOTO N° 23  
23/05/2019 14:01:12

Max Temp.	1087,2°C
A Fuel Tank Temp.	844,3°C
B Fuel Tank Temp.	410,0°C

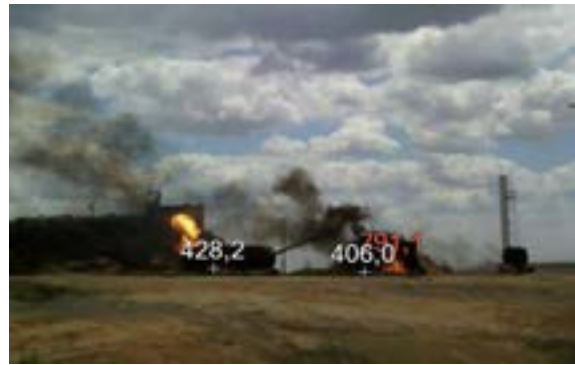
PHOTO N° 29  
23/05/2019 14:07:00

Max Temp.	777,3°C
A Fuel Tank Temp.	454,6°C
B Fuel Tank Temp.	468,3°C

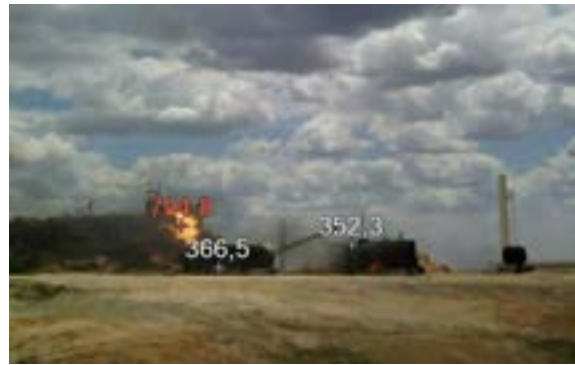
PHOTO N° 31  
23/05/2019 14:09:17

Max Temp.	787,5°C
A Fuel Tank Temp.	656,8°C
B Fuel Tank Temp.	556,7°C

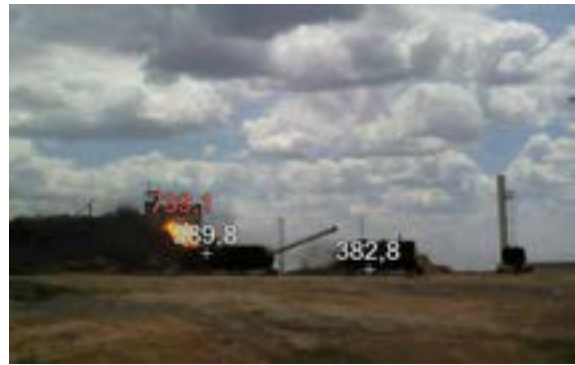
PHOTO N° 33  
23/05/2019 14:11:14

Max Temp.	711,5°C
A Fuel Tank Temp.	338,6°C
B Fuel Tank Temp.	333,2°C

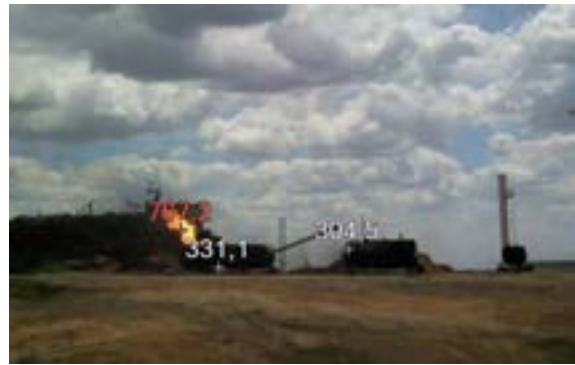
PHOTO N° 35  
23/05/2019 14:13:00

Max Temp.	797,4°C
A Fuel Tank Temp.	317,6°C
B Fuel Tank Temp.	360,2°C

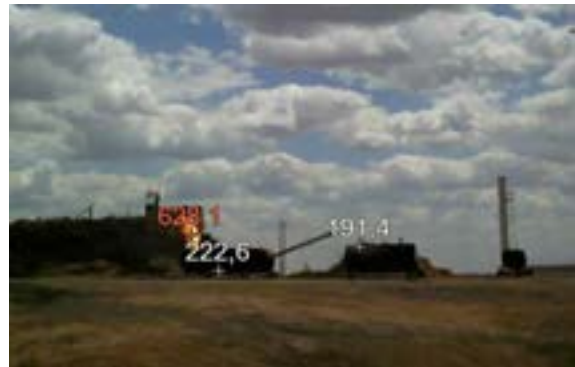
PHOTO N° 49  
23/05/2019 14:27:34

Max Temp.	660,0°C
A Fuel Tank Temp.	215,2°C
B Fuel Tank Temp.	234,7°C

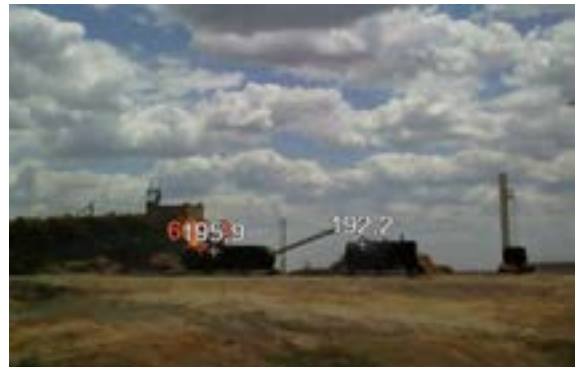
PHOTO N° 51  
23/05/2019 14:29:30

Max Temp.	610,7°C
A Fuel Tank Temp.	194,9°C
B Fuel Tank Temp.	205,9°C

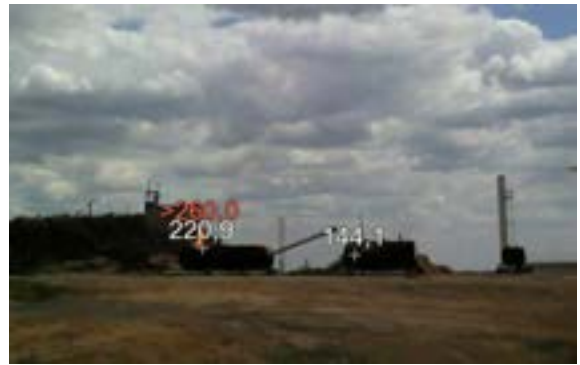
PHOTO N° 77  
23/05/2019 14:55:01

Max Temp.	>260,0°C
A Fuel Tank Temp.	140,0°C
B Fuel Tank Temp.	242,8°C

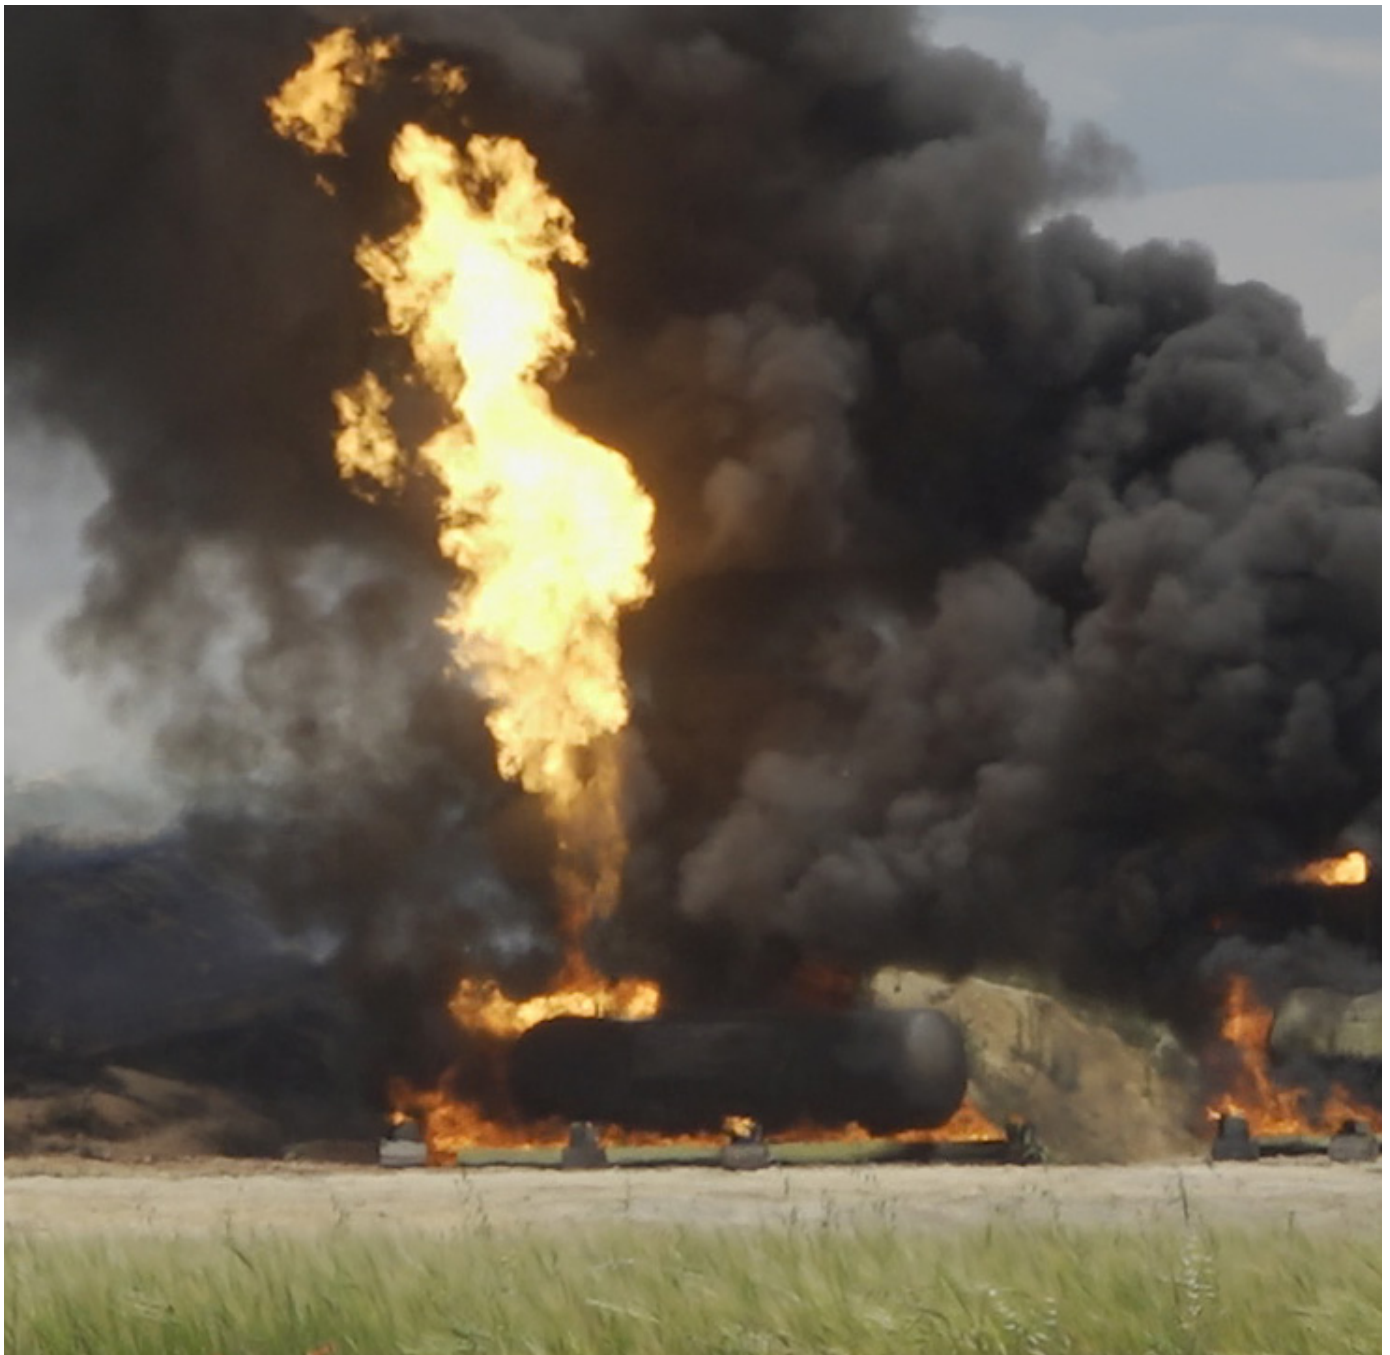
# Fuel Tank B

## 10,000 litres/5,000 litres LPG PROPANE-TK3D MESH

- 3.** There were no after test structural damage in any part of the fuel tank structure.
- 4.** There was no partial or total fuel tank metallurgical smelting.

- 8.** The thermal radiation/flames only managed to damage the tank visually.
- 9.** The TK3D Alloy Mesh after opening the tanks were INTACT and in PERFECT operating condition.
