SFBM S.p.A.

Specific tests on CNG4 cylinders

Provider 2

Doc. No. 19500-R Rev. 2 – March 2018

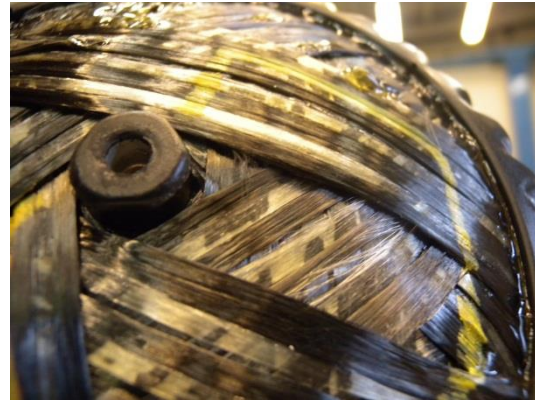
- ✓ exposed fibers in the dome of the capped side of cylinder 3 (Figure 1-9);
- ✓ exposed and frayed fibers on both side domes of cylinder 5 (Figure 1-10 and Figure 1-11);
- ✓ partially exposed fibers for cylinder 12 (Figure 1-12).

Figure 1-10: Exposed and frayed fibers – Cylinder 5

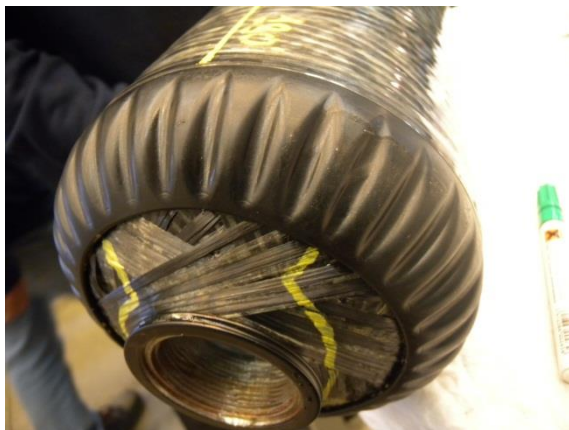
Figure 1-11: Partially exposed fibers – Cylinder 5

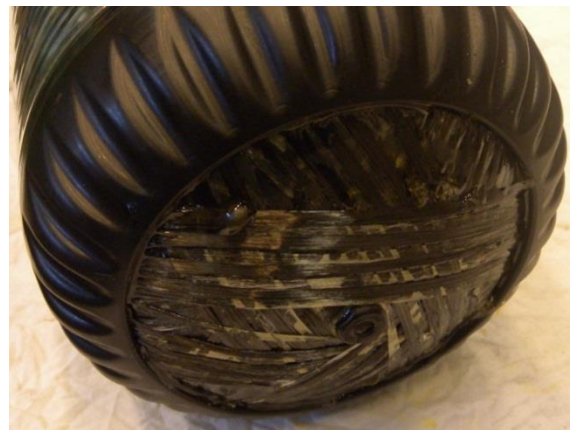
Figure 1-12: Partially exposed fibers – Cylinder 12

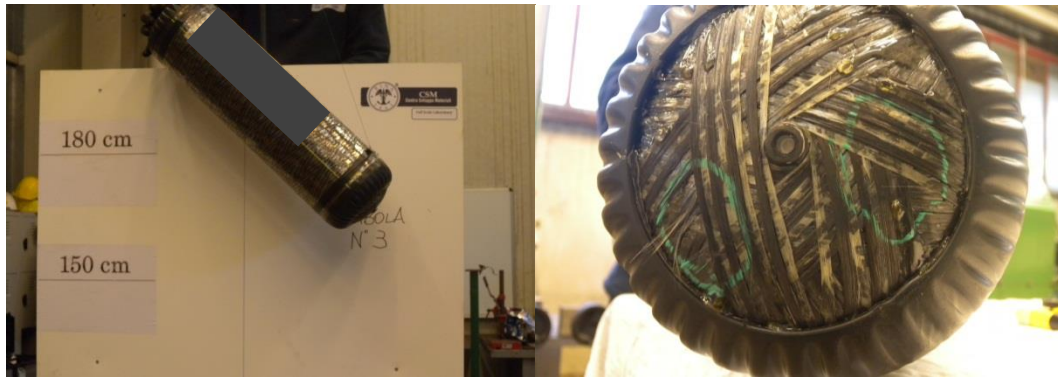
Cylinder 3 was 45° angle drop tested on capped side. Visual inspection after the test showed fibers fraying as reported in Figure 3-4.

Figure 3-4: Fibers fraying in the dome area after 45° angle drop on capped side – Cylinder 3

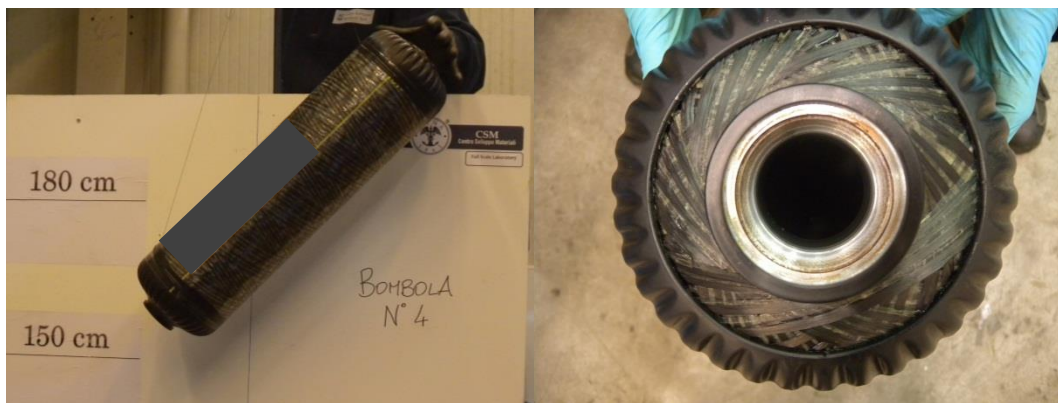
Cylinder 4 was 45° angle drop tested on valve side. Visual inspection after the test did not show any damage (Figure 3-5).

Figure 3-5: No damages after 45° angle drop on valve side – Cylinder 4

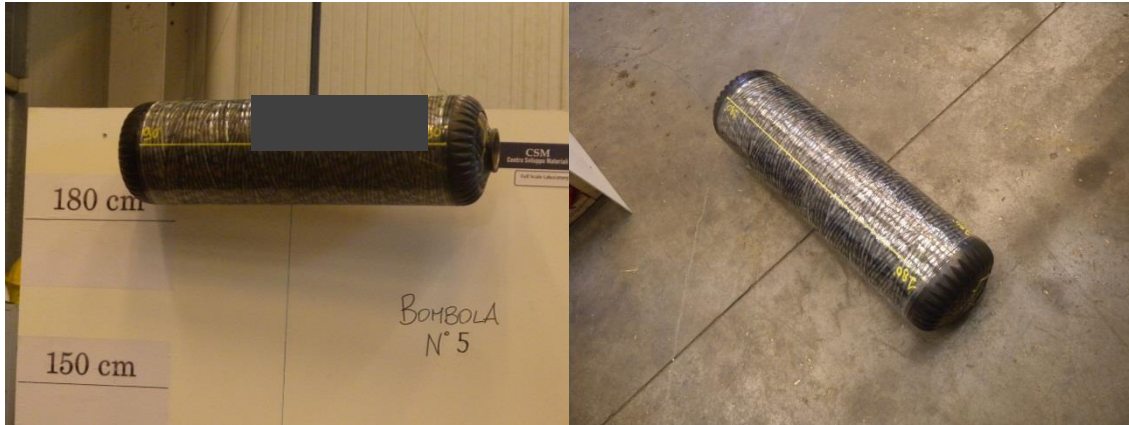
Cylinder 5 was horizontally drop tested. Visual inspection after the test did not show any damage (Figure 3-6).

Figure 3-6: No damages horizontal drop – Cylinder 5

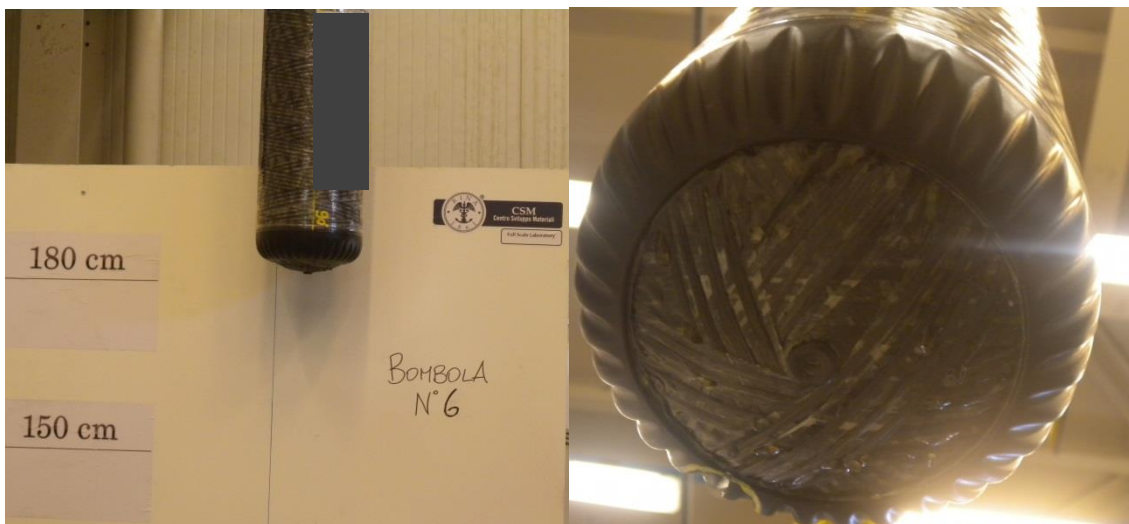
Cylinder 6 was vertically drop tested on both sides (Figure 3-7). The test on the capped side produced an abrasion of the fibers as reported in Figure 3-8; the test on the valve side showed an abrasion of the border of the cylinder connection, as shown in Figure 3-9.

Figure 3-7: Vertical drop on capped side – Cylinder 6

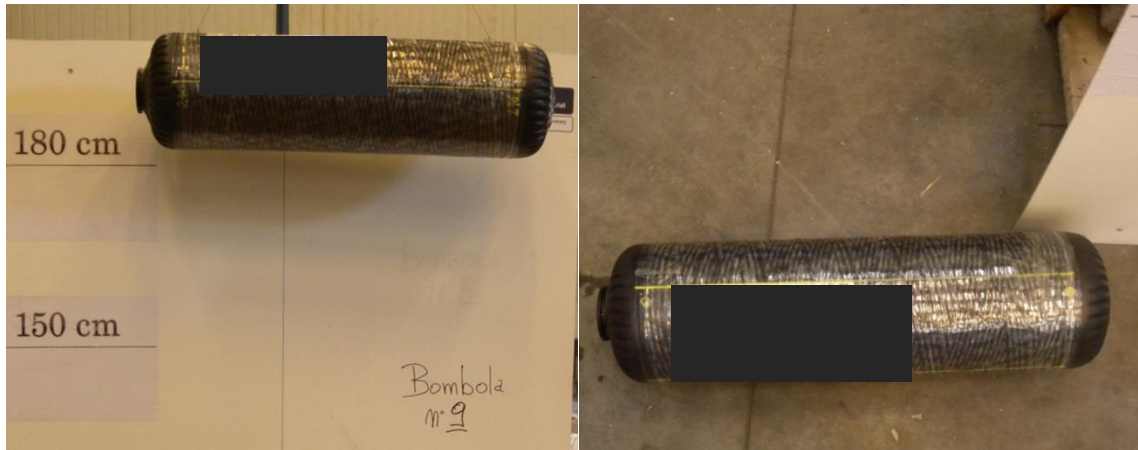
Cylinder 9 was horizontally drop tested. Visual inspection after the test did not show any damage (Figure 3-12).

Figure 3-12: Horizontal drop – Cylinder 9

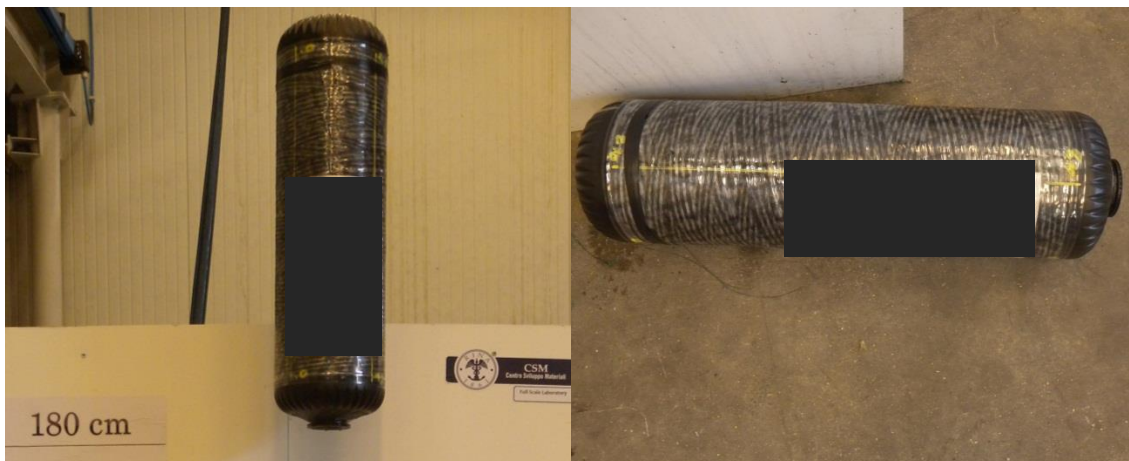
Cylinder 10 was vertically drop tested on both sides (Figure 3-13 and Figure 3-14). Visual inspections after the tests did not show any damage.

Figure 3-13: Vertical drop on valve side – Cylinder 10

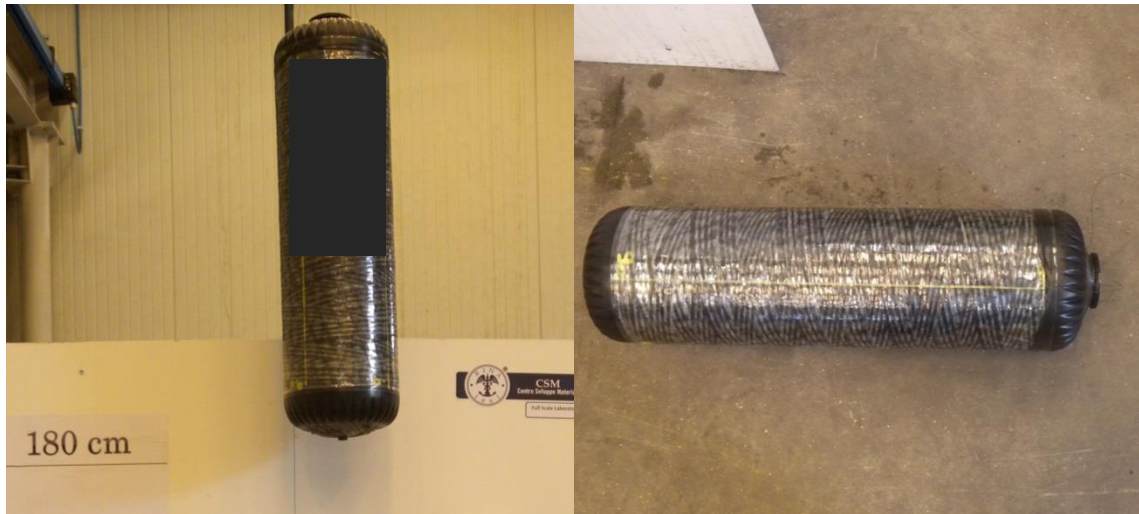
Figure 3-14: Vertical drop on capped side – Cylinder 10

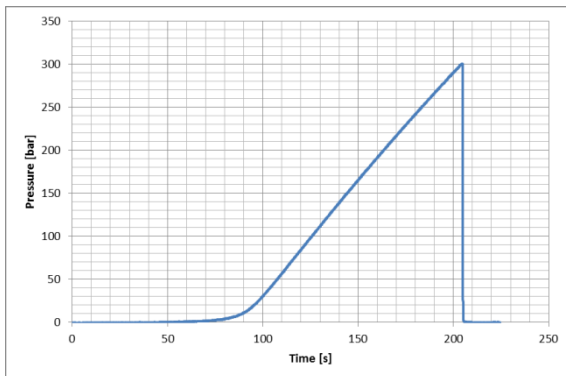
After the drop tests, each cylinder has been hydraulically tested according to Regulation ECE ONU R110 A11 Option 2. Tests have been performed with the same procedure described in Chapter 2. Cylinder 3 blew up once the target pressure of 300 bar was achieved; cylinder 8 blew up after 23 s holding at 300 bar. Remaining cylinders passed the test, although all of them were creaking at pressure values over 200 bar. Pressure-time plots of each test are reported in the following.

Figure 4-3: Second hydraulic test – Cylinder 3

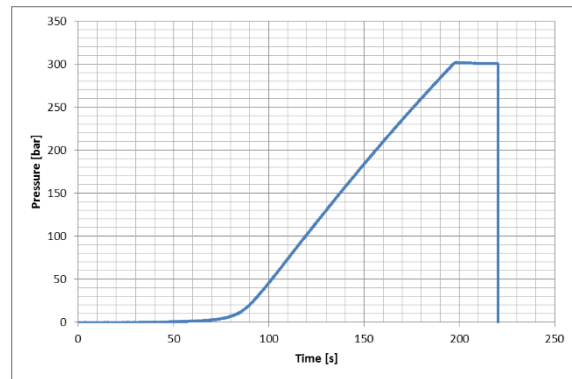
Figure 4-8: Second hydraulic test – Cylinder 8

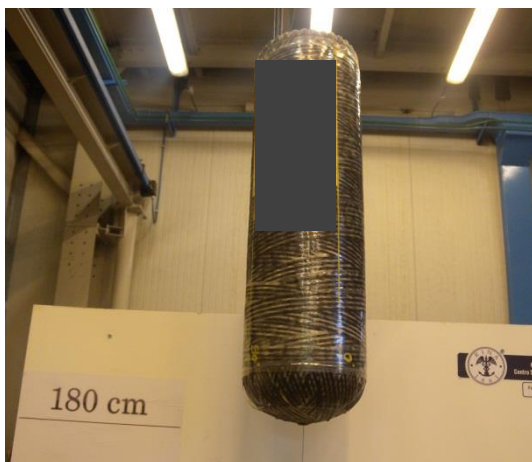
Cylinder 2 has been tested with both sides vertical drops. After both tests the cylinder does not appear to have damages.

Figure 6-1: Cylinder 2 – Vertical drop, capped side

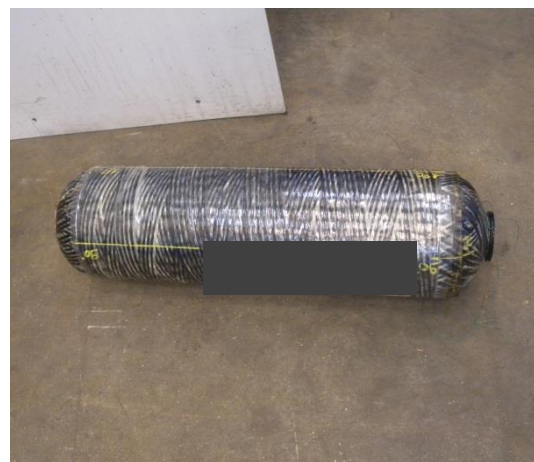
Figure 6-2: Cylinder 2 after the vertical drop, capped side

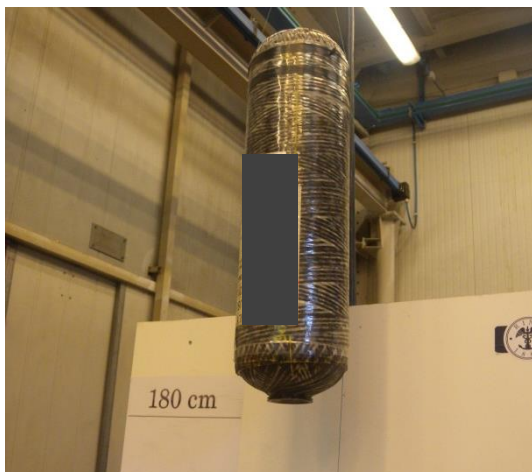
Figure 6-3: Cylinder 2 – Vertical drop, valve side

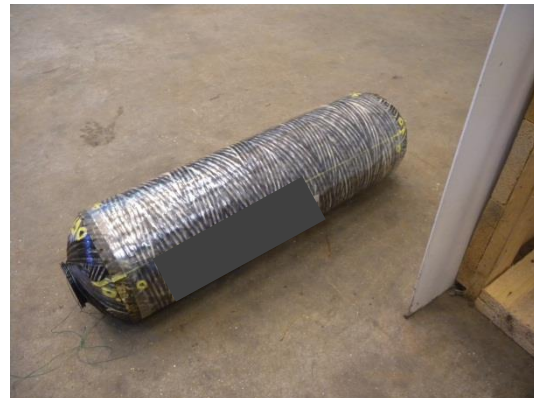
Figure 6-6: Cylinder 10 – After vertical drop, capped side

Cylinder 2 has been tested with both sides vertical drops. As shown in Figure 6-7 and Figure 6-8, the cylinder has been highly damaged in the dome area of the capped side.

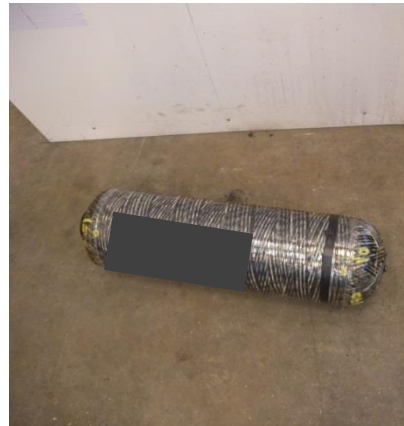
Figure 6-10: Cylinder 10 – After vertical drop, valve side

No further damage was observed after the vertical drop test on the valve side.

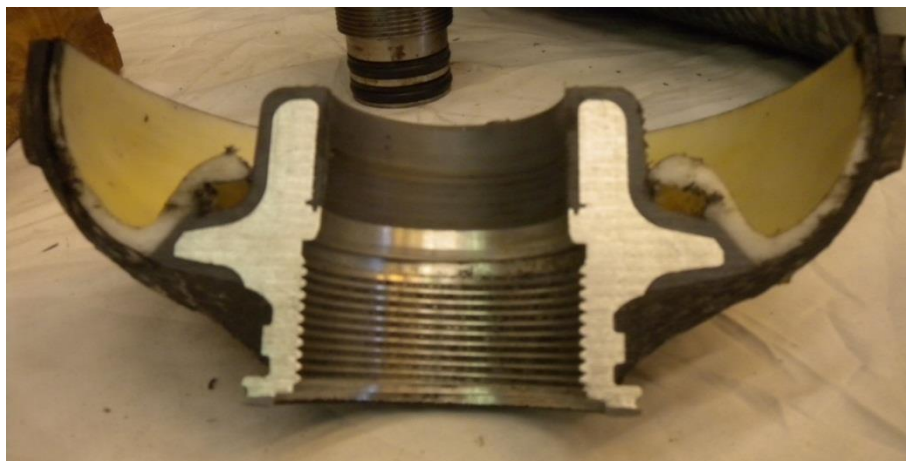
Figure 8-3: Cylinder 7 – Detailed view of the valve connection area

Measurements showed a non-uniform thickness. Particularly in the cylindrical area the composite thickness was constantly of 5 mm (Figure 8-1). In the dome areas, the thickness was higher close to the cylindrical zone and at the top of the dome, whilst a strong thinning was observed in the intermediate zone. In that area, the wall thickness can be lower than 2.5 mm. In some cases, also a lack of superimposition of the fibers was observed (Figure 8-2). In Figure 8-3 a picture of the valve connection area after cutting is presented.

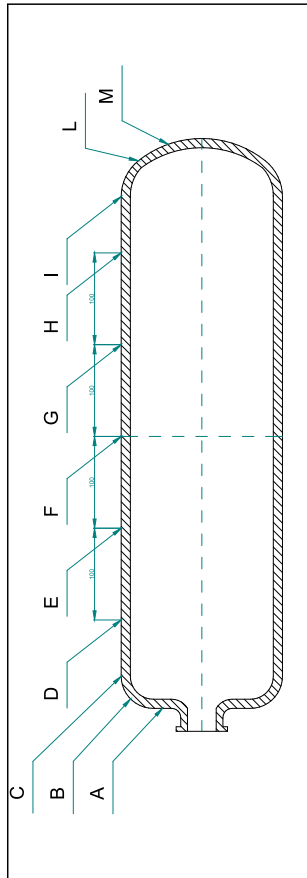
Figure 8-4: Cylinder 7 – Results of the wall thickness measurements

The results of the measurements taken on cylinder 7 are reported in Figure 8-4.
