Case study: Gas explosions at Pike River coal mine – New Zealand

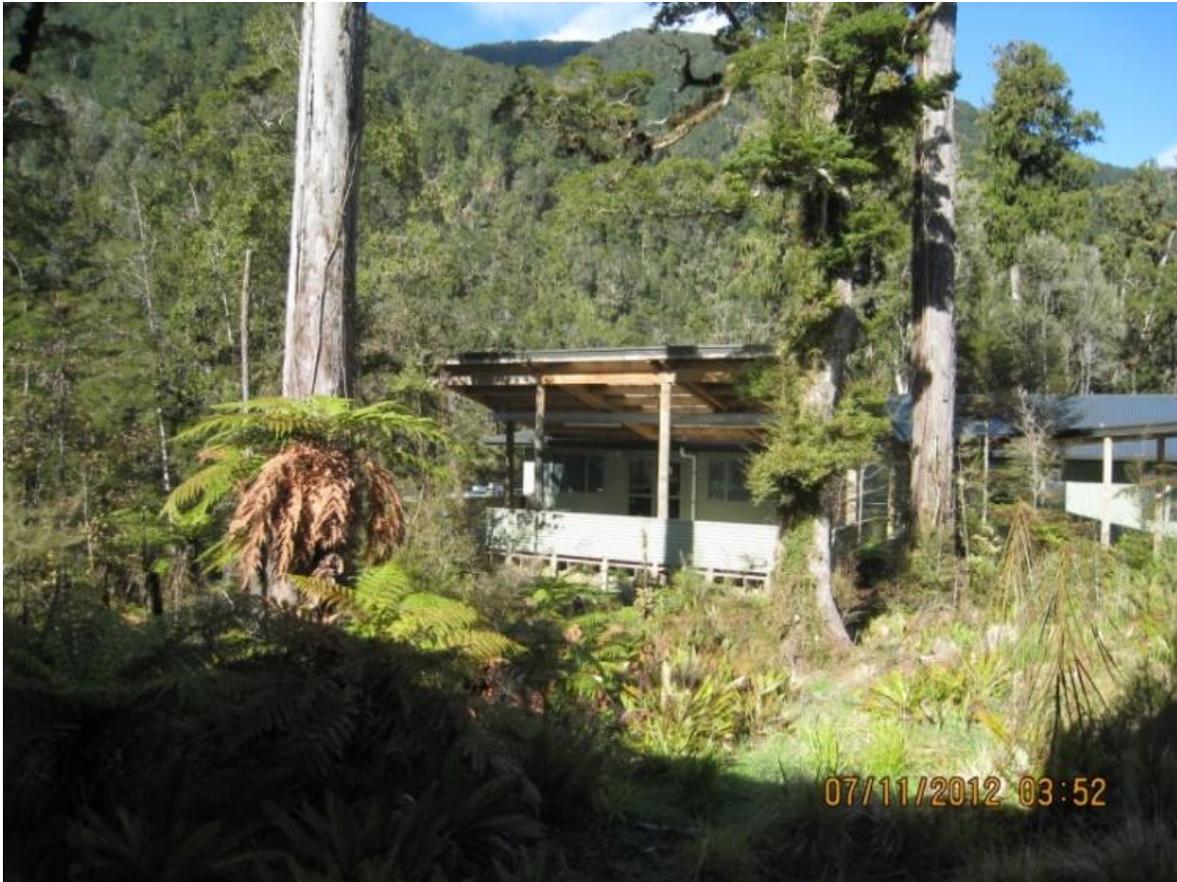
Initial conditions: The Pike River coal mine is located 46 km NNE of Greymouth on the west coast of South Island, New Zealand. The surface installation and infrastructure was largely complete and had earned an environmental protection award for its sensitive design and implementation (Figure 1).

Figure 1. Surface installations reflect the environmental sensitivity of the area with buildings merging into the forest
