Informal document No. **GRSG-91-7**
(91st GRSG, 17-20 October 2006
agenda item 1.2.5.)

ROLLOVER ACCIDENT WITH EJECTION OF OCCUPANTS

Date: 15.12.2005 early morning, gloom
Place: Pécsdevecser, south Hungary

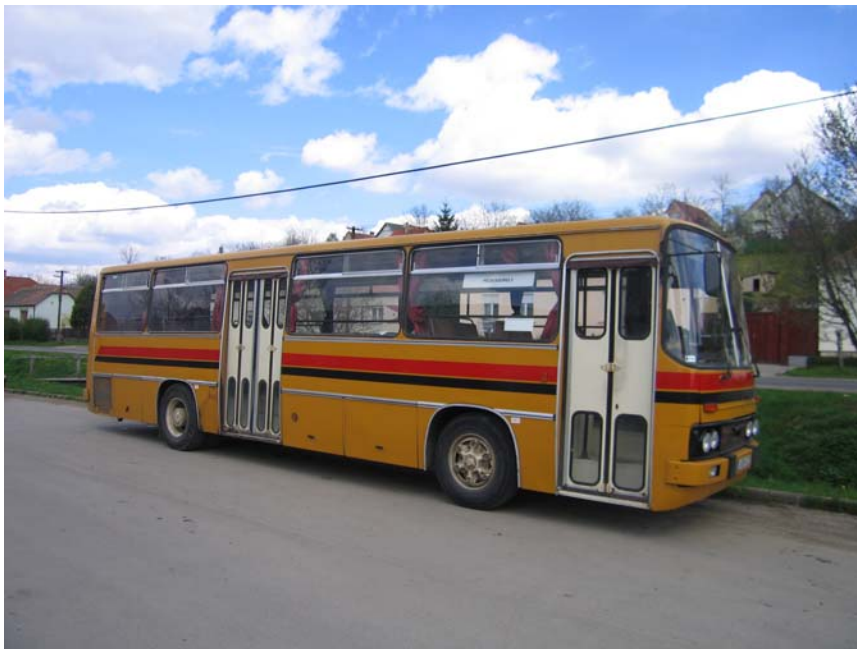
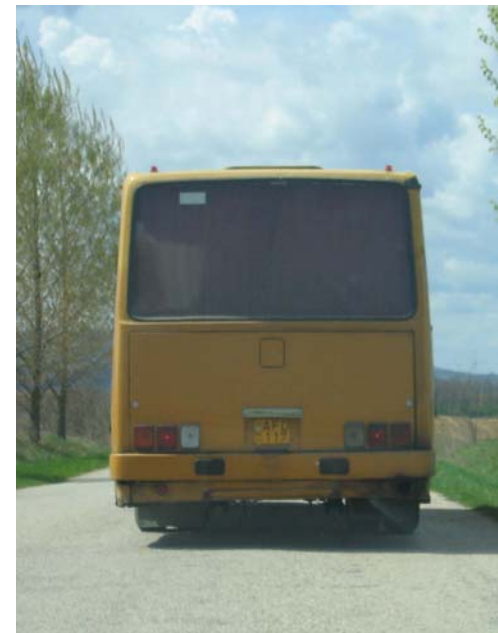
Type: IKARUS C56
Class: local, intercity class II
Mass: 16,5 tons
Length/height: 12m/3m
Age: 6 years old, good technical conditions
Occupants: 15+1 on board
Approved: according to R.66

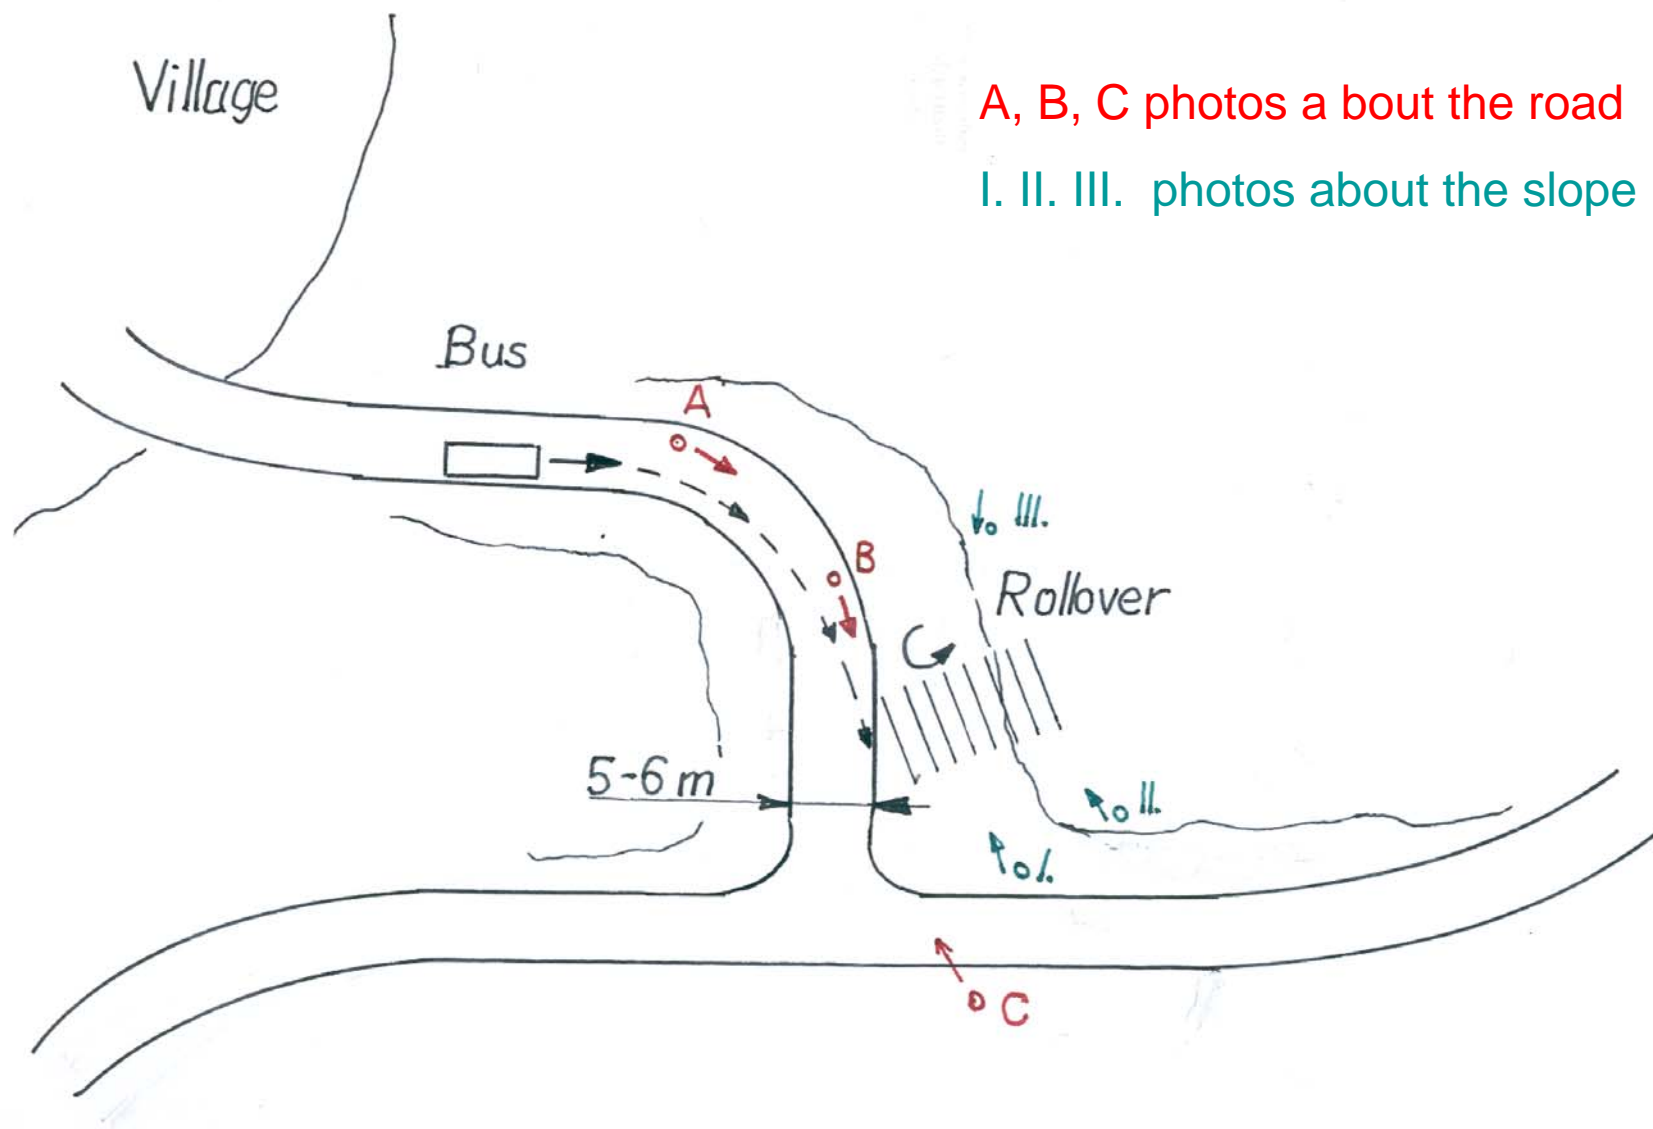
A, B, C photos about the road

I. II. III. photos about the slope

- Narrow hilly road
- 5-10 cm fresh snow on it, it was snowing
- Stone guard on roadside
- The bus drove slightly upwards with a speed of 30-40 km/h
- Sharp right curve (90°)

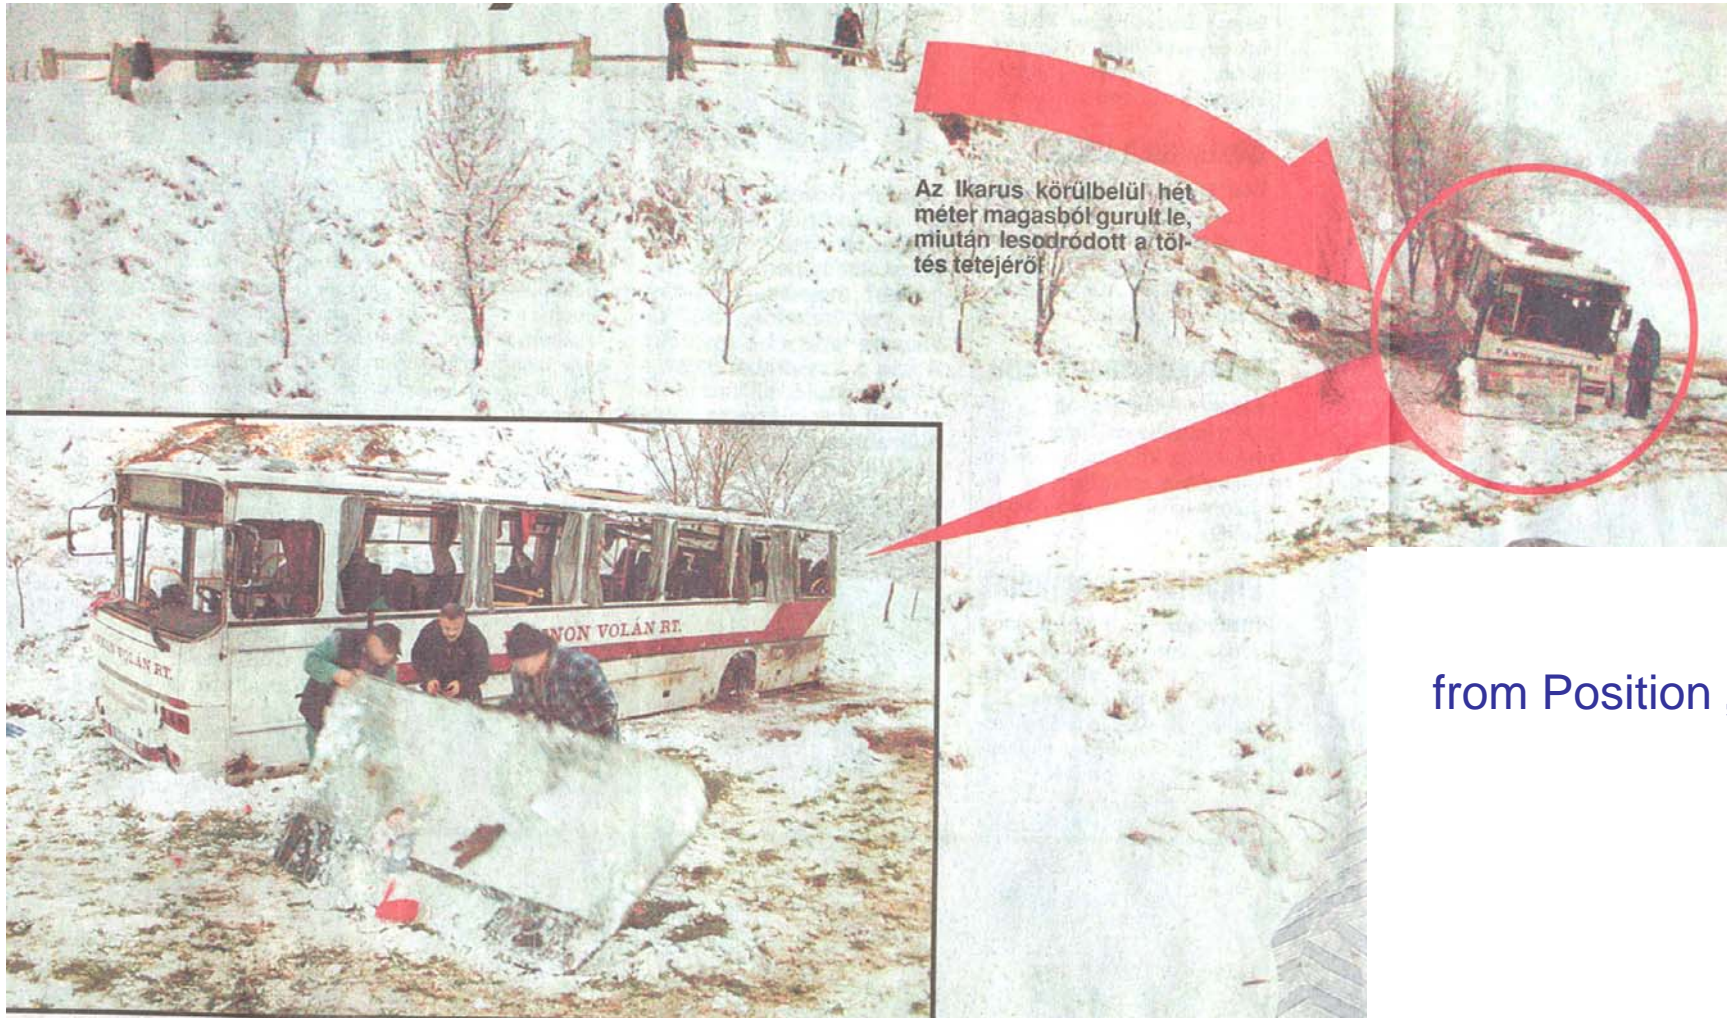
- The bus drove on the narrow snowy road upwards, slight inclination
- In a sharp right curve (90°) the bus slipped
- Broke through the stone guard on the other side and the rollover started
- It was a slow process, the driver cried „keep yourself!”
- 2 ¼ rotation and finally it stopped on its left side (the passengers mentioned 2-3, 3, 3-4 rotations)
