**Proposals for amendments to the Regulations annexed to ADN:
other proposals**

Addendum 1 Report inspection interval PO tanks – Tank Assist

Case: Inspection interval
barge's tanks
Propylene Oxide
Report number: 1721004/01
Date: 07th March 2017

Addendum 2 Inspection report and testing on cargo tanks of ex-Chemgas 17 – Manufacturer Siemerink

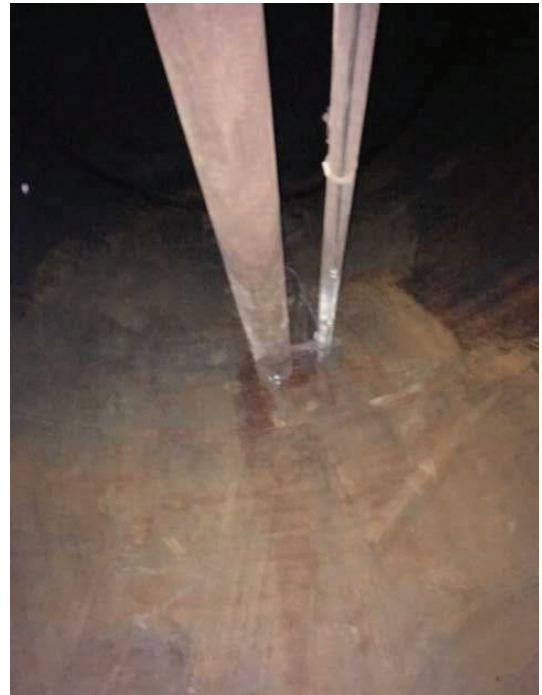
Cargo tank

During the surveys of the above mentioned vessel, Bureau Veritas has found no deviations in the structure of the cargo tanks or the presence of heavy rust deposits.
